### **Remaining Works for Transmitting Station at Cloudy Hill, Tai Po**

Application for Working Consent (Submit revised Tree Survey Report & Tree protection record)

## Tree Risk Assessment Form 1 : Tree Group Inspection

**Contract No : SS J524**

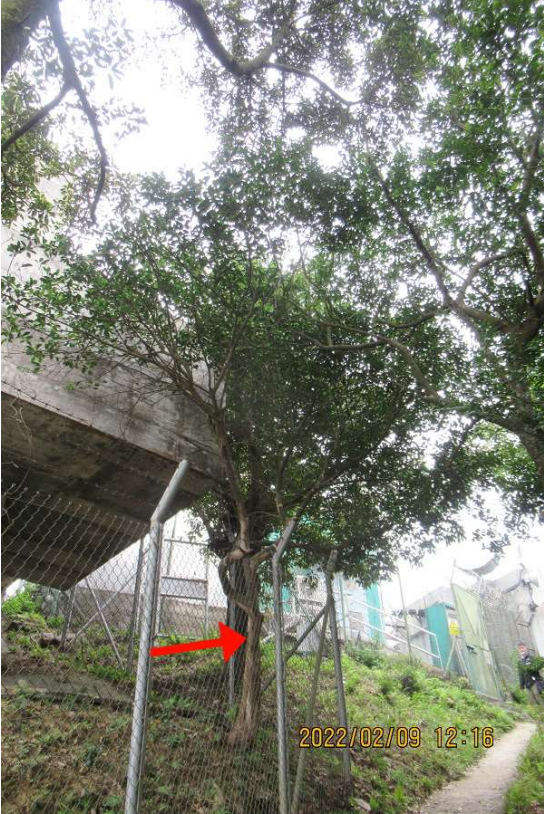
Pic 1)T1-Whole view of tree

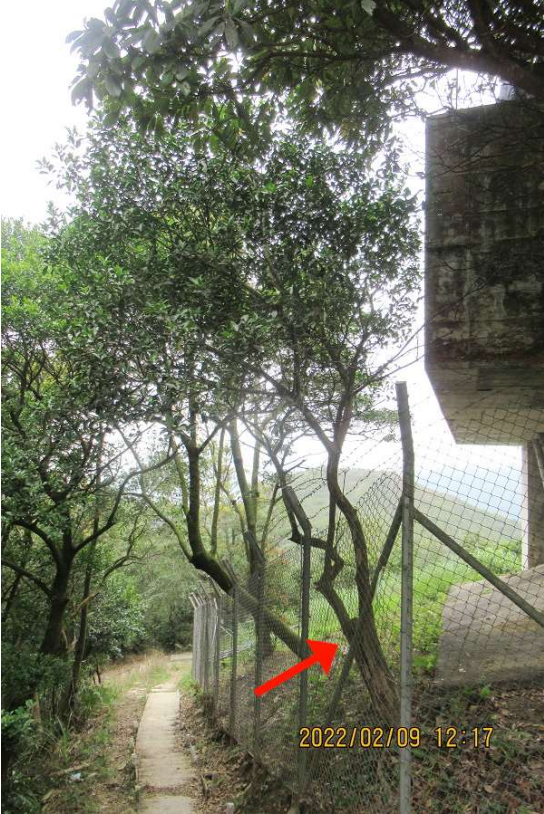
Pic 2)T1-Whole view of tree from other side

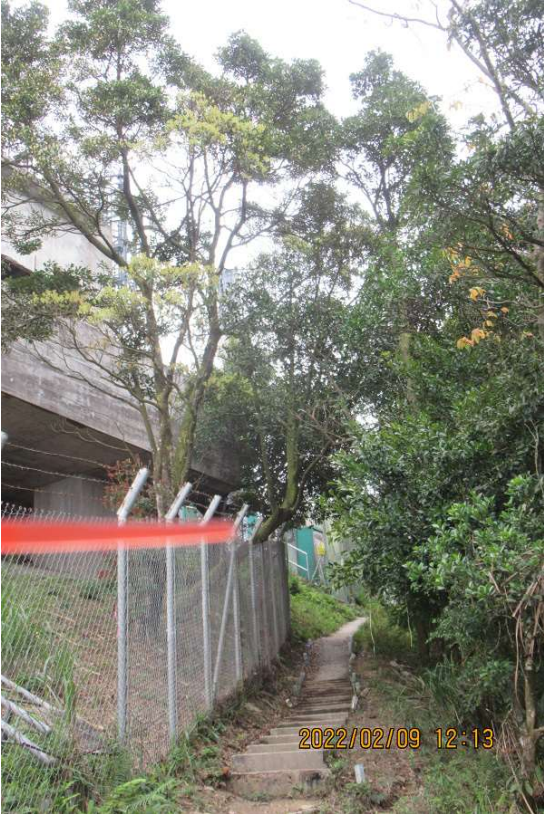
Pic 3)T2-Whole view of tree

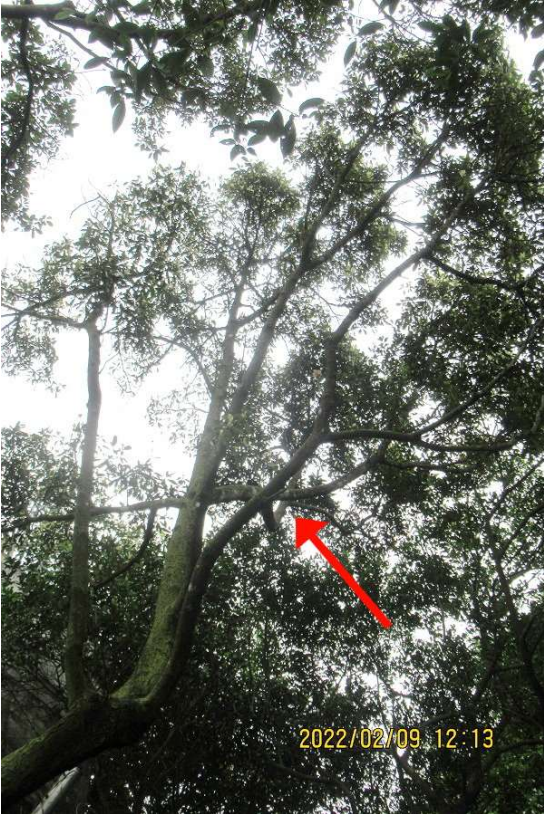
Pic 4)T2-Crown view

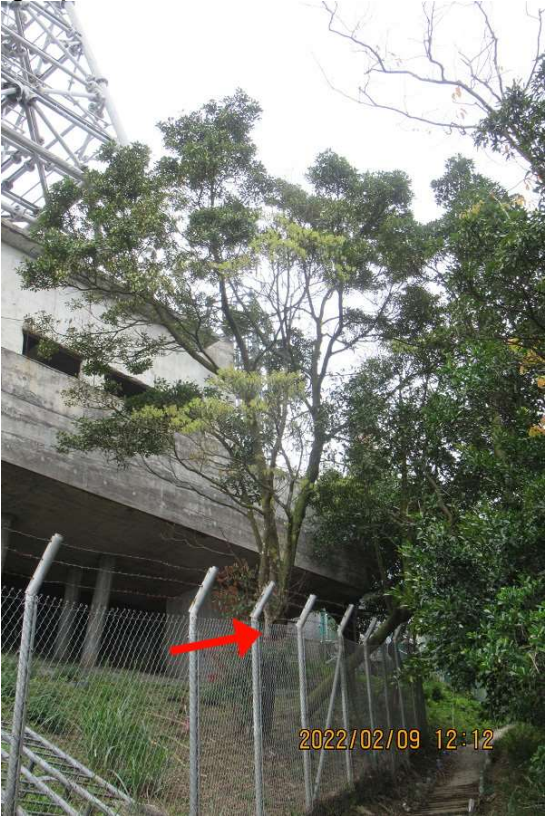
Pic 5)T3-Whole view of tree

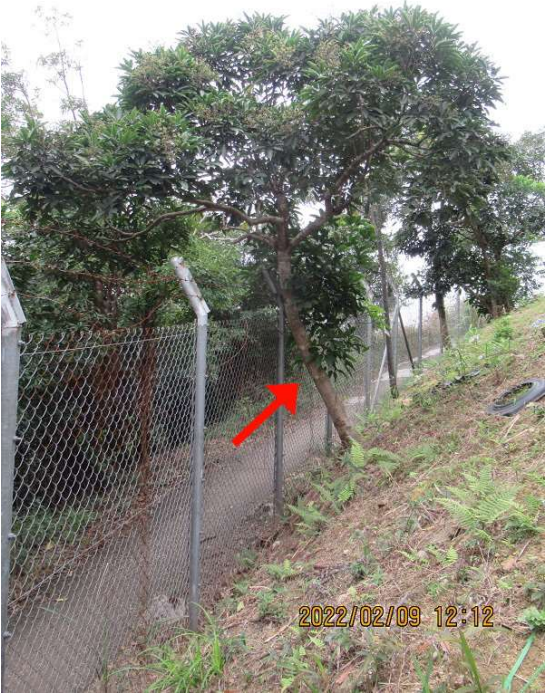
Pic 6)T4-Whole view of tree

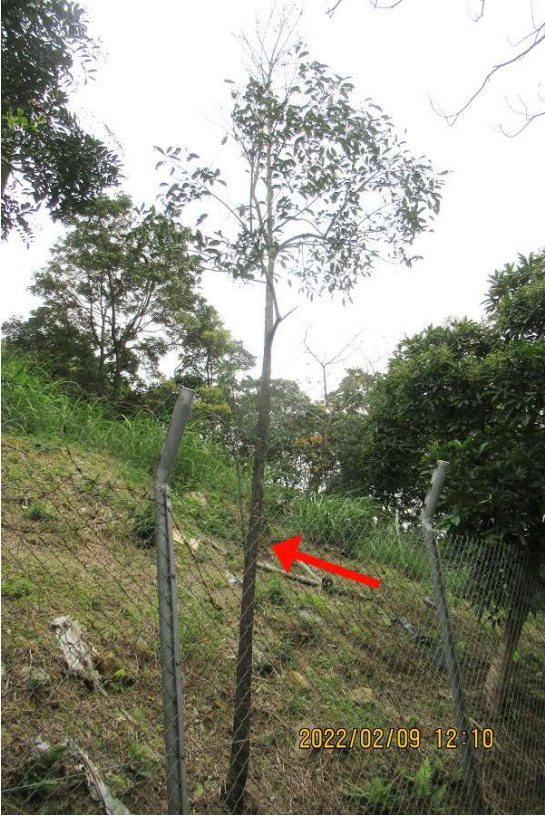
Pic 7)T5-Whole view of tree

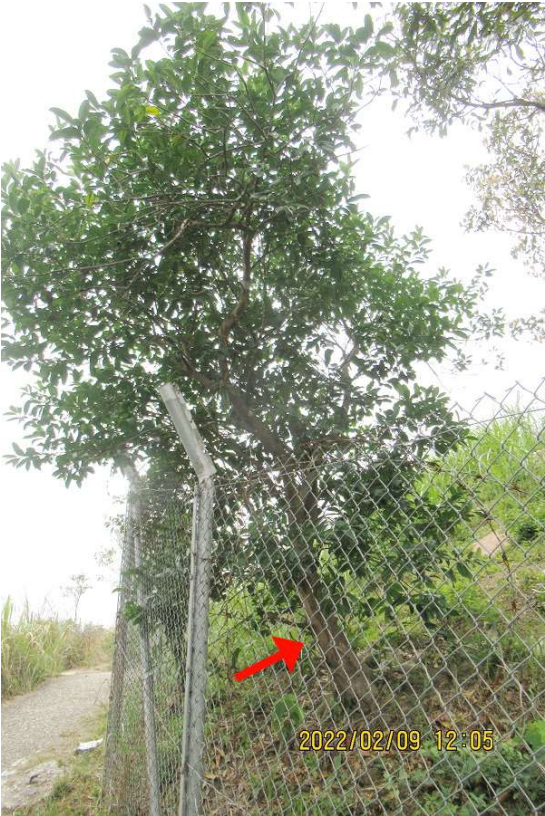
Total 31 numbers of trees are spotted within the survey area. Only 1 tree (T10, *Pyrenaria spectabilis* (syn. *Tutcheria spectabilis*) 石筆木) are defined as restricted species (conservation species). It is the species of conservation important protected under Cap.96. It should be properly protected and retained throughout the works period. Please refer to the “Tree management practice note No.1 – Tree Preservation during construction” Issued by Greening, Landscape and Tree Management Section Development Bureau of HKSAR. Other 30 trees are not defined as rare and protected species of trees within the site boundary. (\*Ref. iii – vii).

Pic 12)T10-Whole view of tree

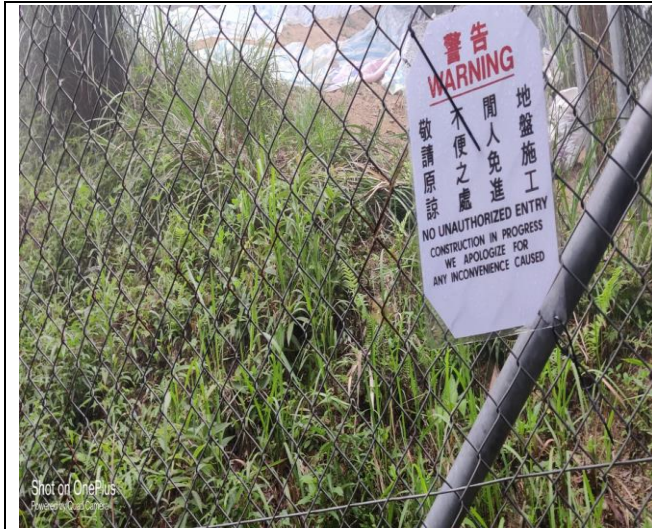
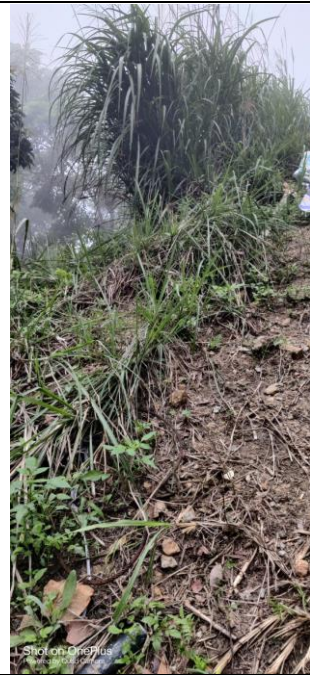
Removal of the materials on the slop
