**DRAINAGE IMPROVEMENT
WORKS AT YUEN LONG –
STAGE 2**

Contract No.: DC/2022/02

**Pre-Construction
Condition Survey
Report for Impacted
Graded Historic
Buildings**

**Wing Tat Civil Engineering
Company Limited**

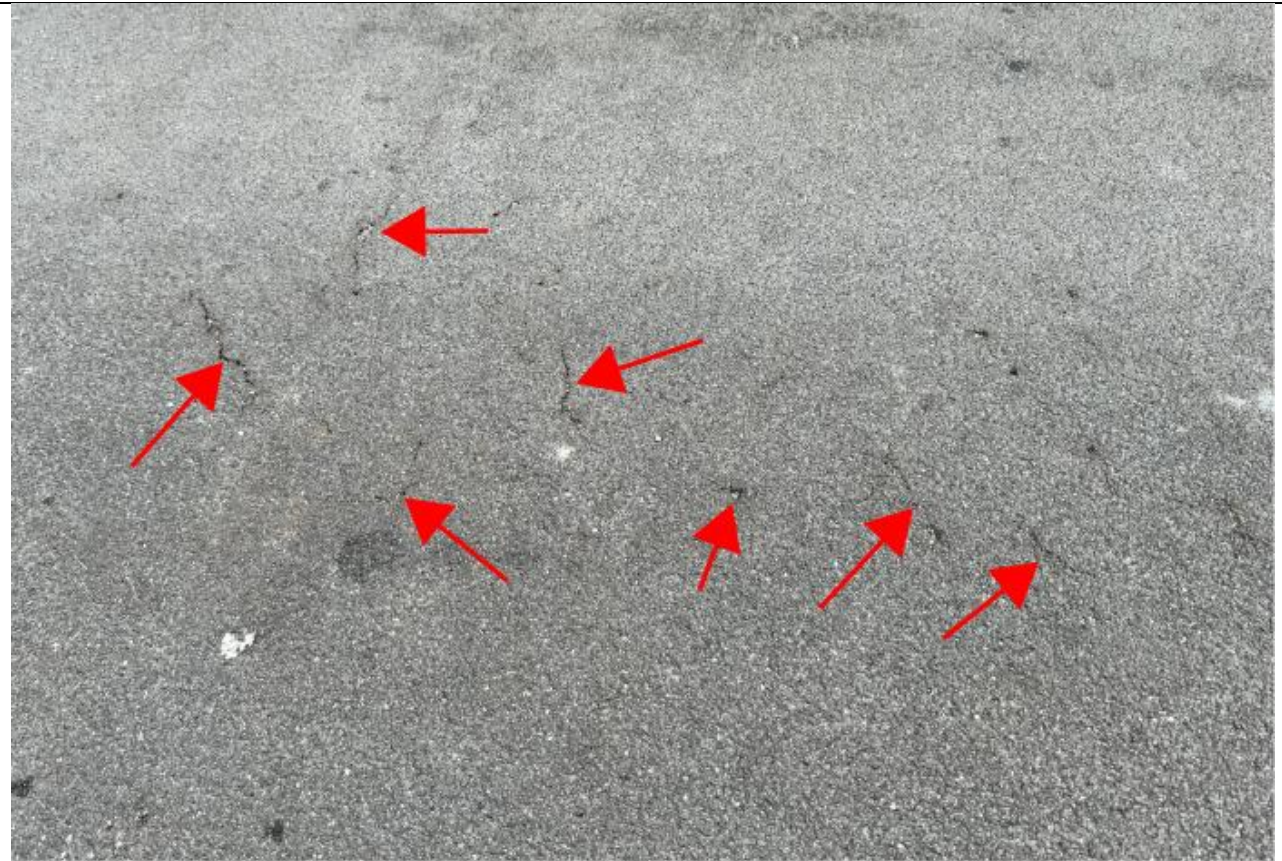
D1.1

Damage to tarmac covering was found on the Bridge Deck

Repaving the bridge surface should be considered to avoid possible damage to the underlaying material during construction activity.

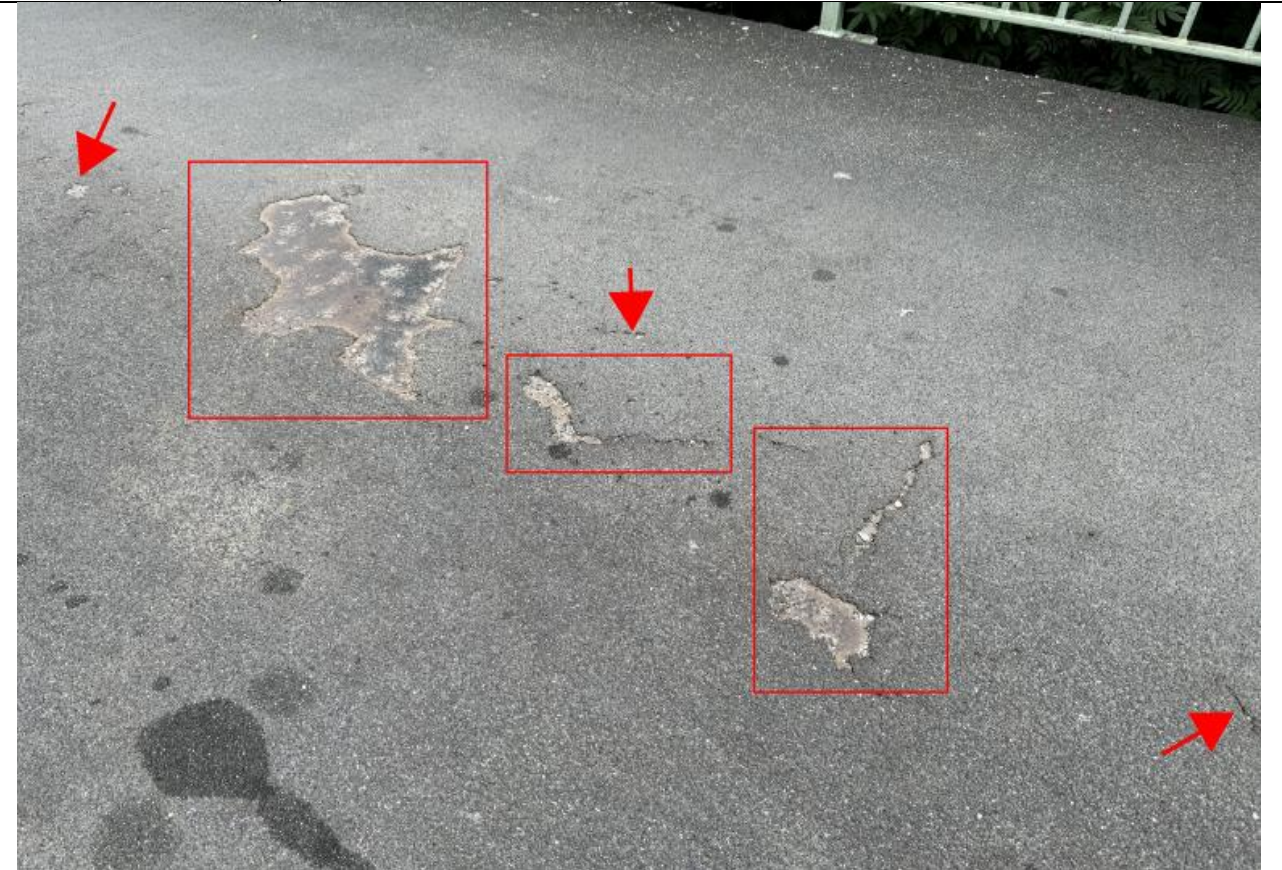
D1.2

Damage to tarmac covering was found on the Bridge Deck

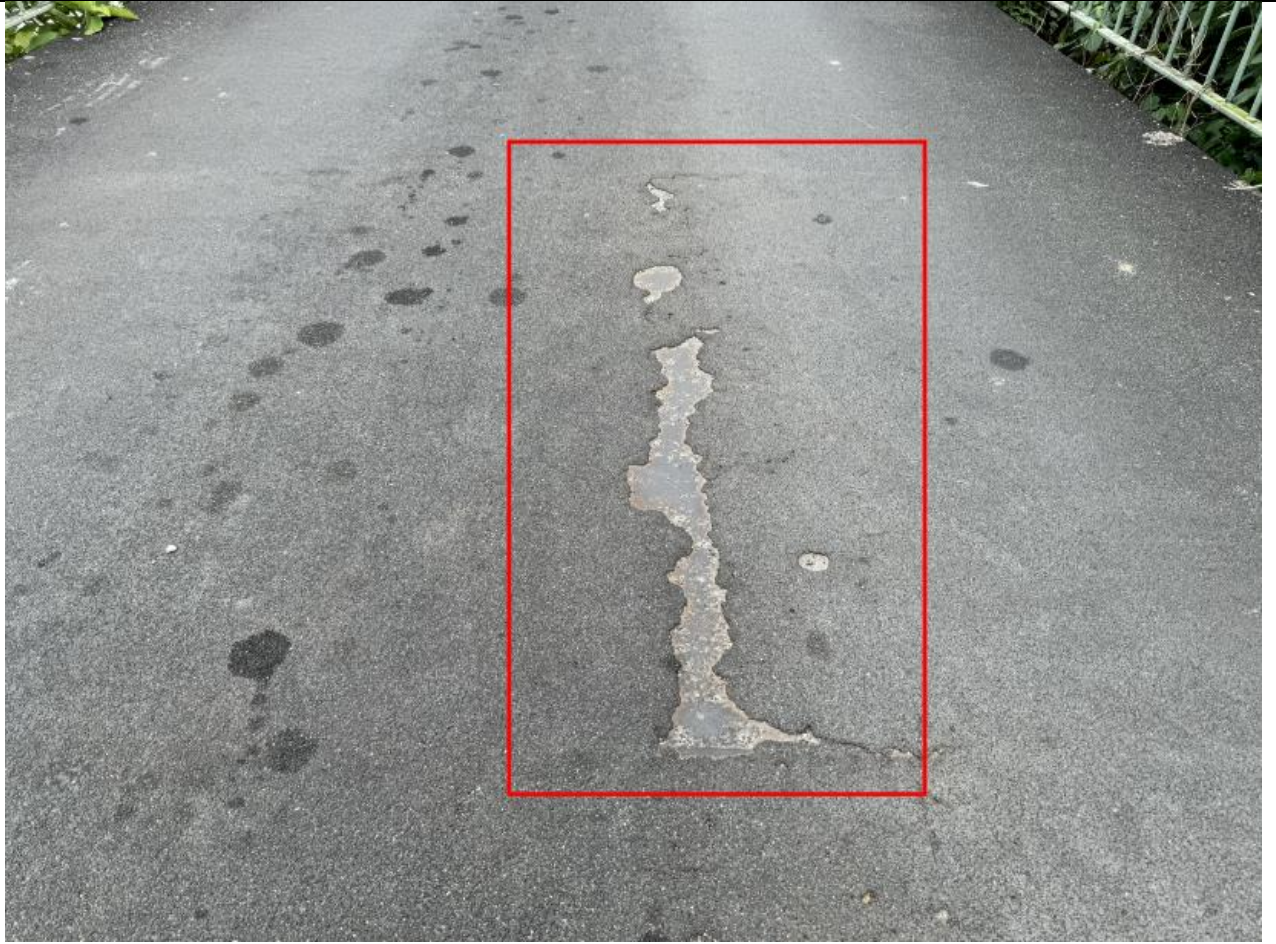
D1.3

Damage to tarmac covering was found on the Bridge Deck

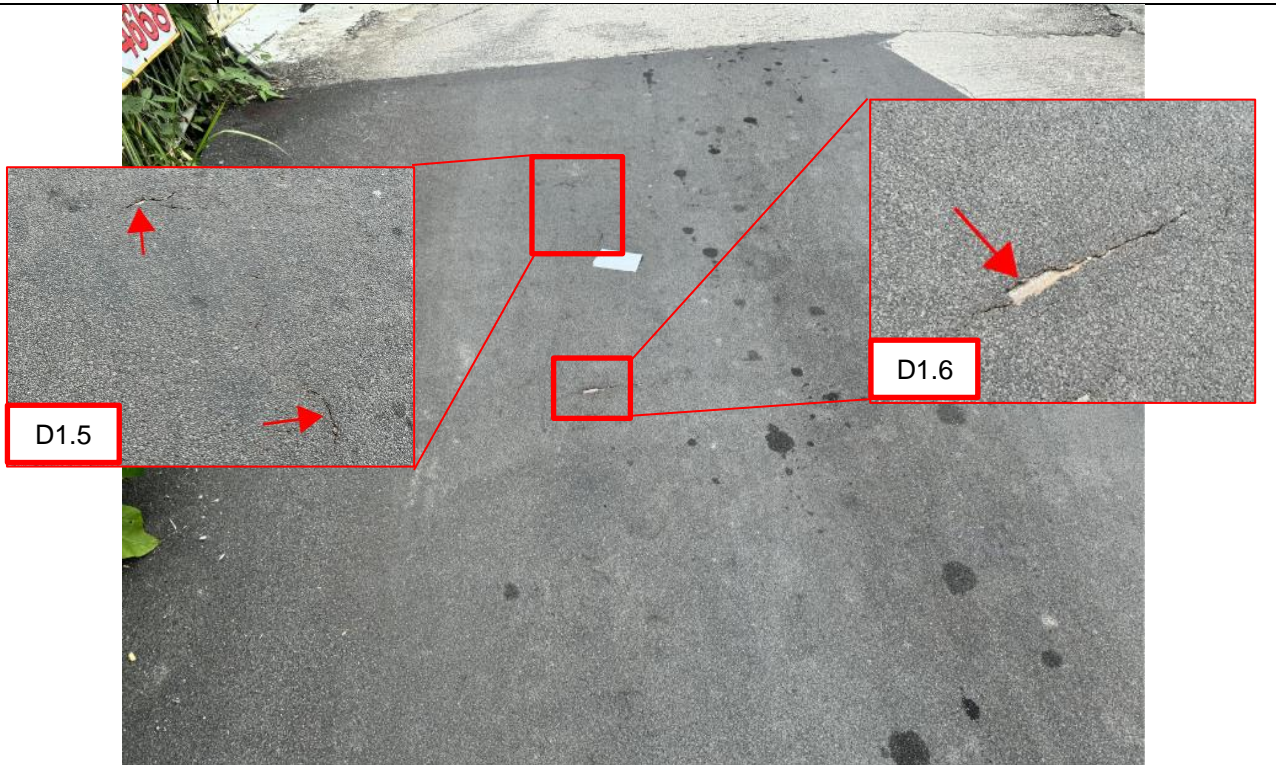
D1.4, D1.5, D1.6

Damage to tarmac covering was found on the Bridge Deck

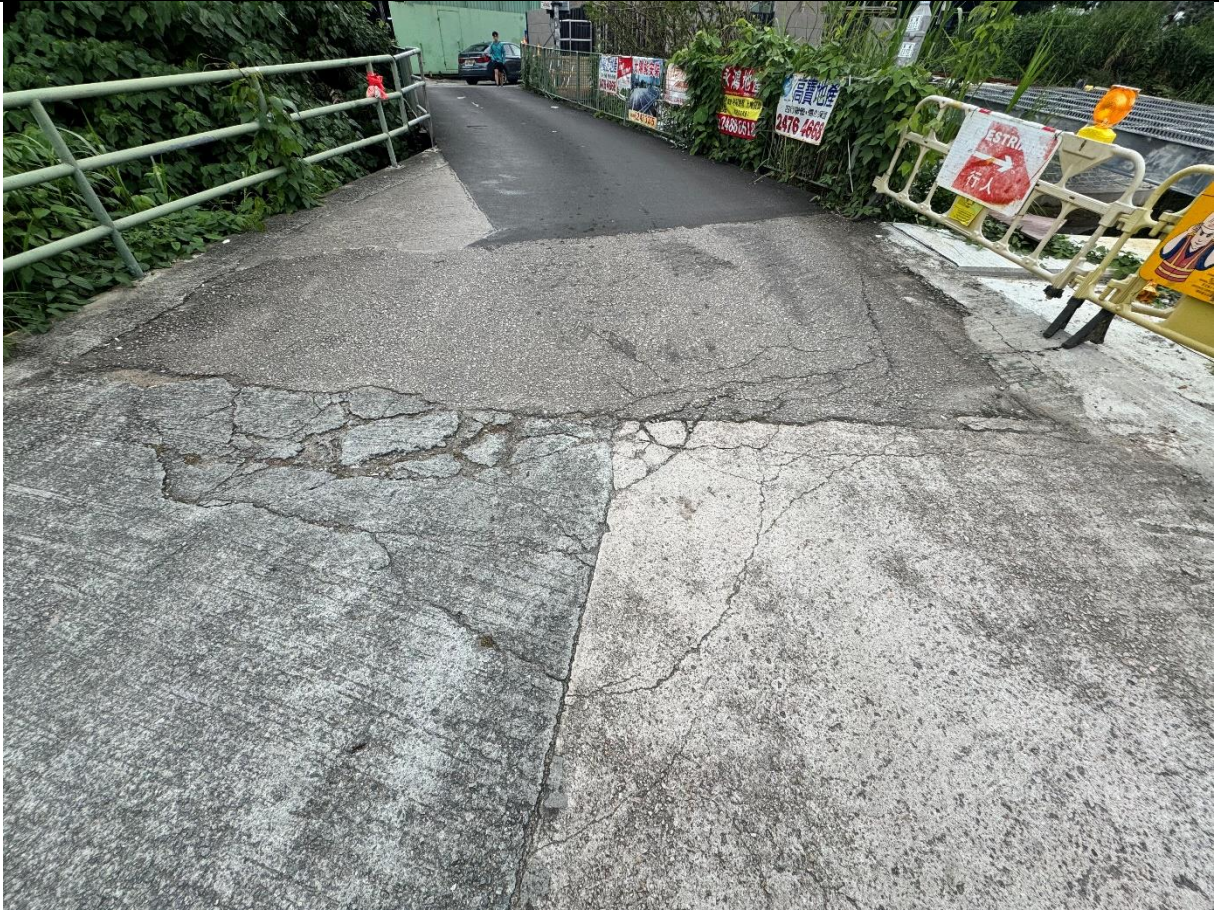
D1.7

Crazing was found on the connection road to the Bridge

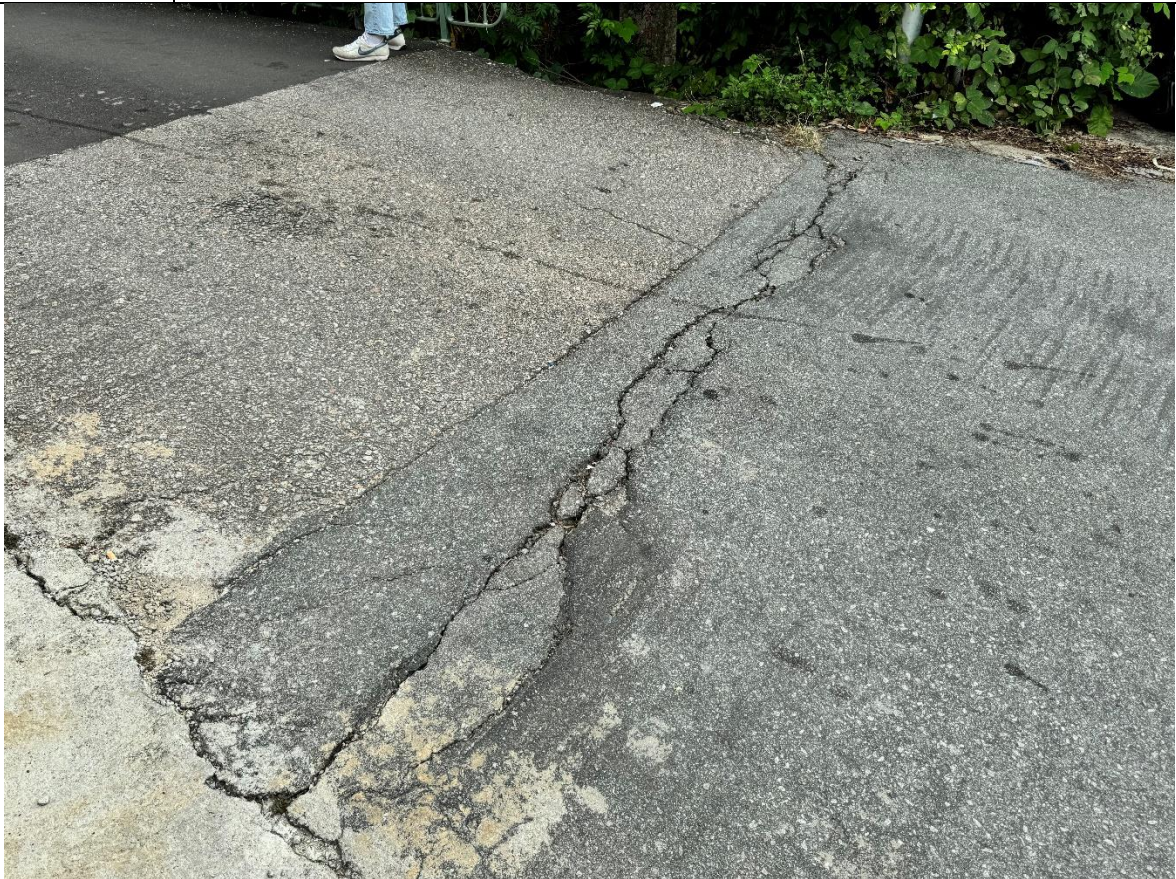
D1.8

Crazing was found on the connection road to the Bridge

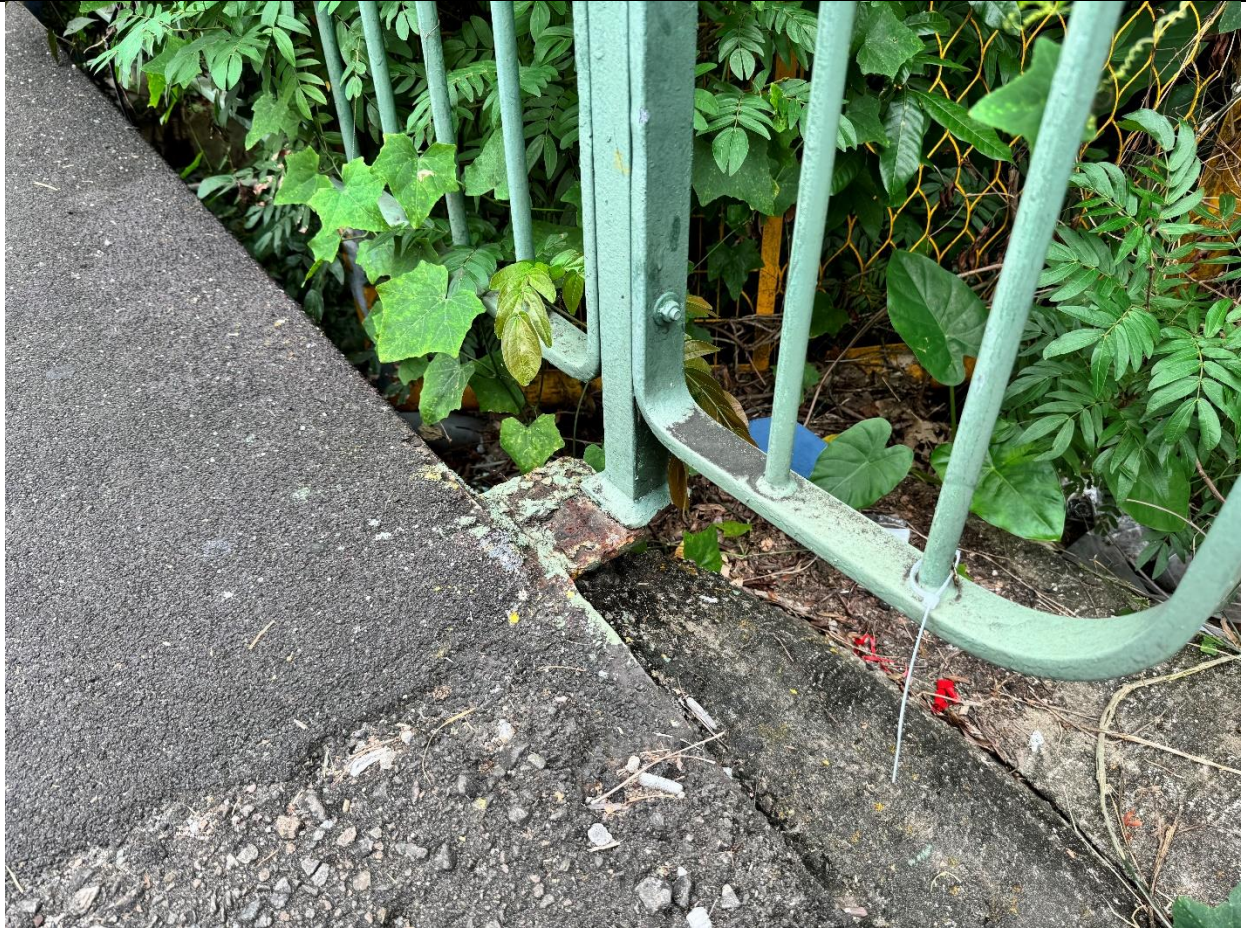
D1.9

Rust stains were found on the S Parapet

Replacement of parapets/parapets fixings is also recommended as they are found loosely held on the edge of the bridge.

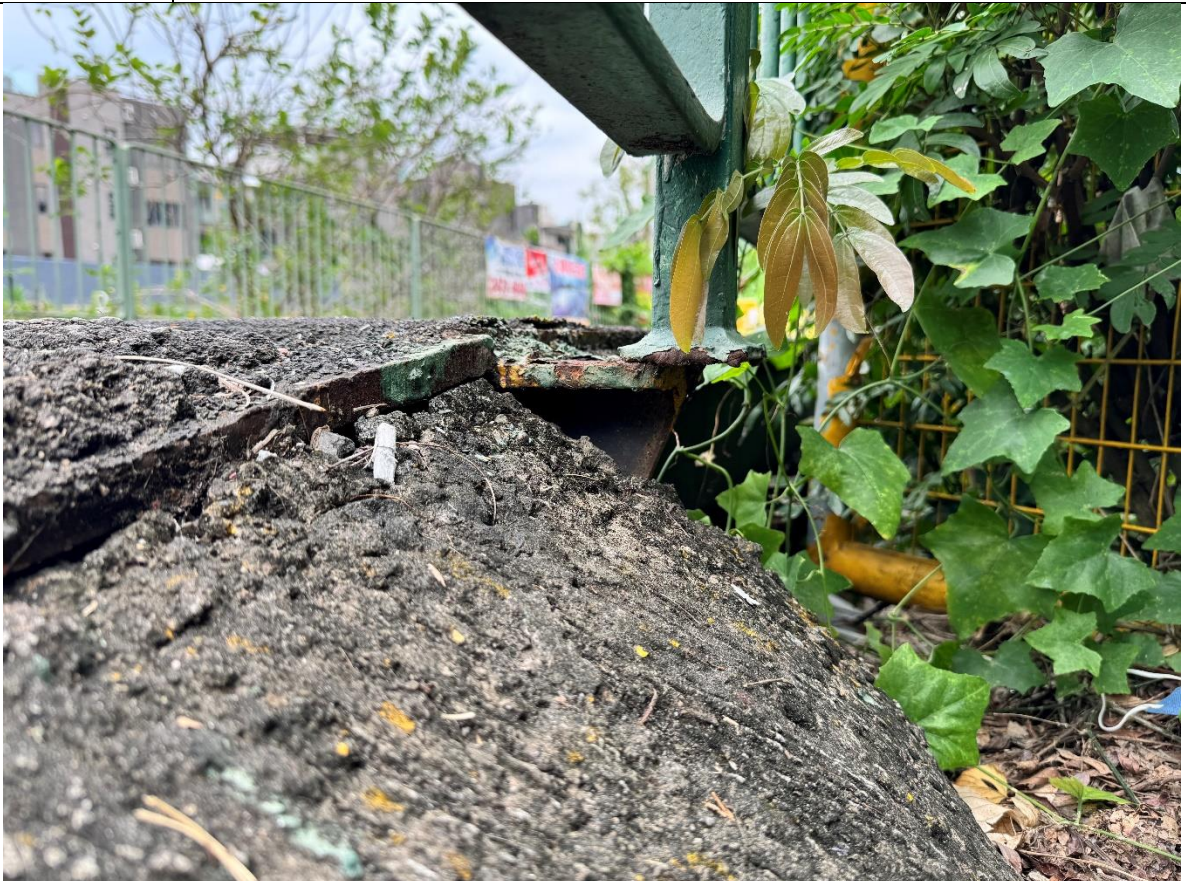
D1.10

Unstable weld connection was observed on the S Parapet

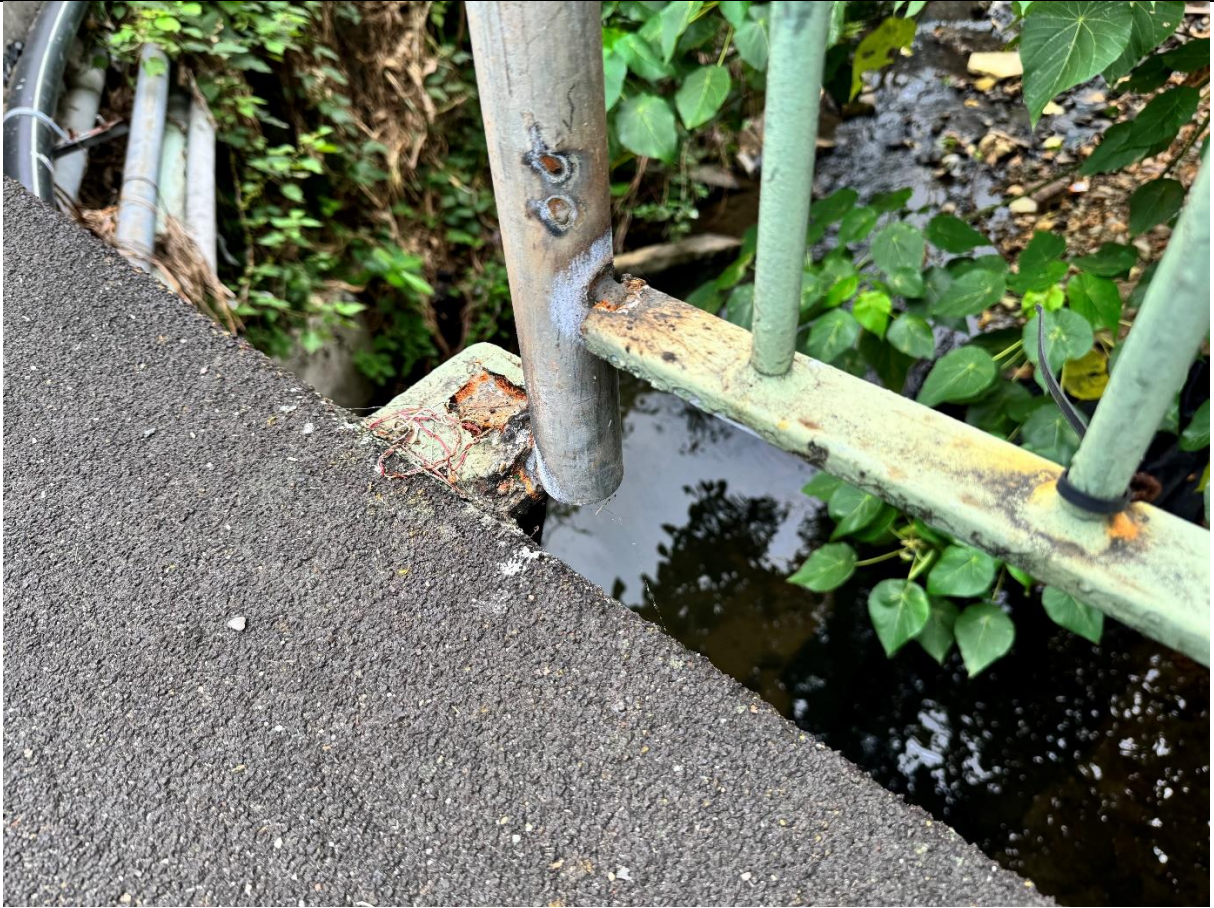
D1.11

Rust stains were found, and unstable weld connection was observed on the S Parapet

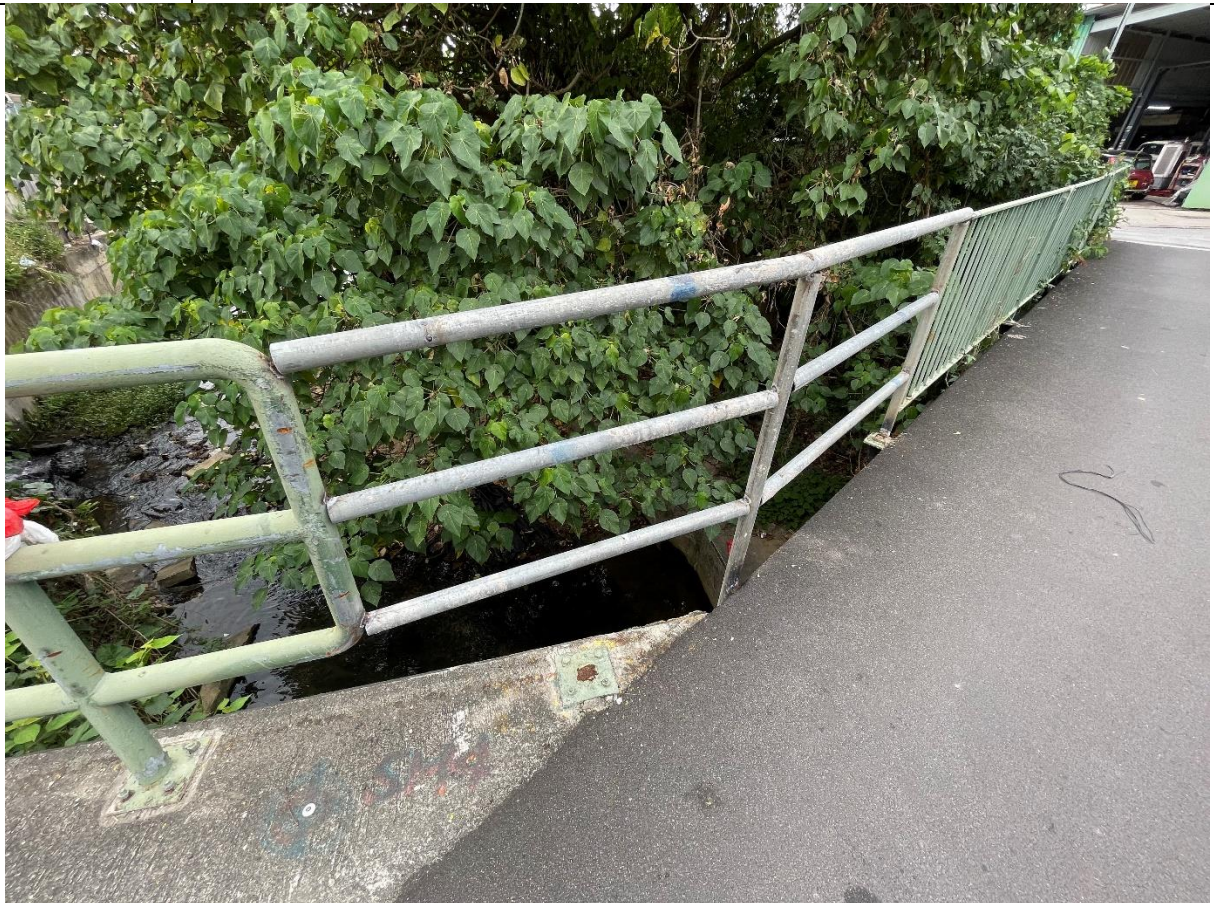
D1.12

Unstable weld connection was observed on the S Parapet

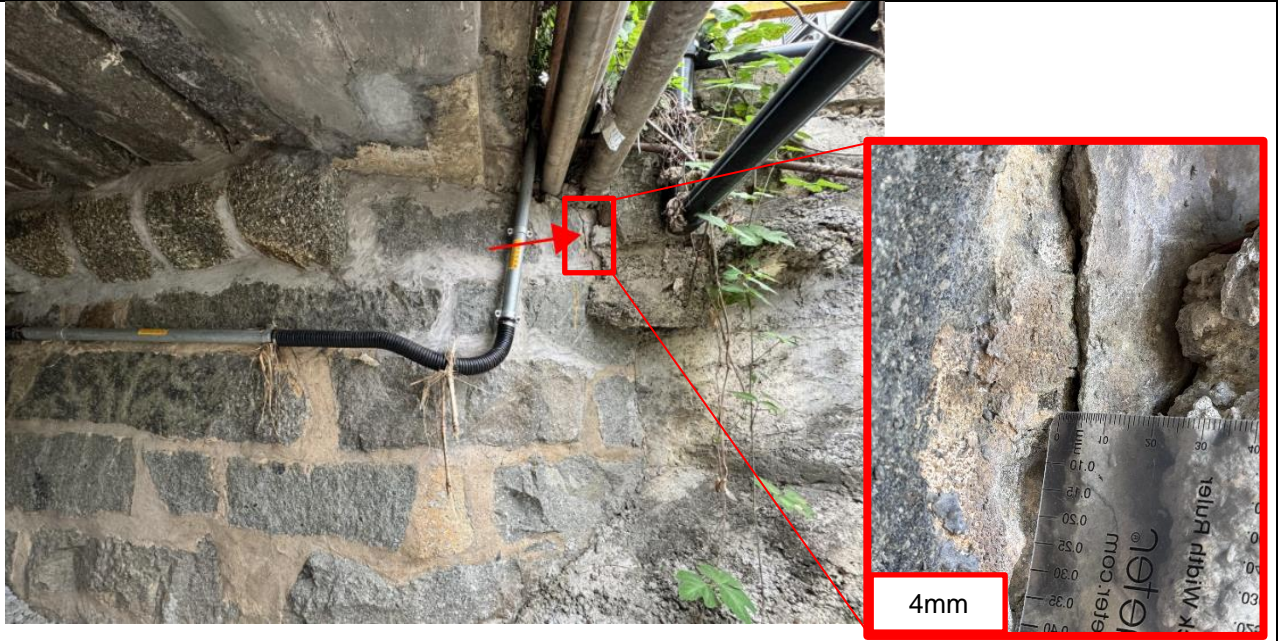
D1.13

Severe Crack was found on the W Abutment

For cracks wider than 1mm on structural elements, installation of tell-tales is recommended to monitor the possible propagation of existing cracks.

Cracking on the abutment and pier was found in the subject building should be kept in view.

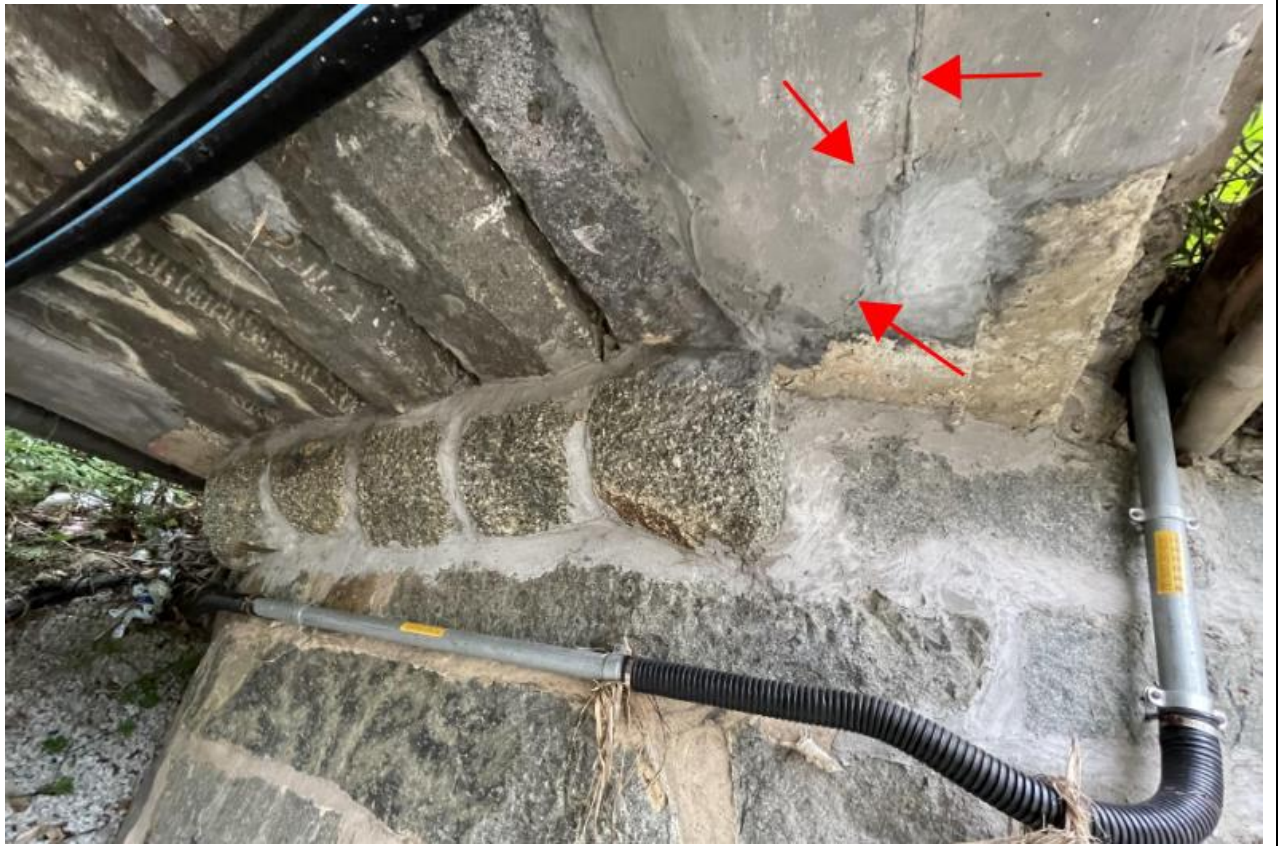
D1.14

Hairline Crack was found on the grouting near W Abutment

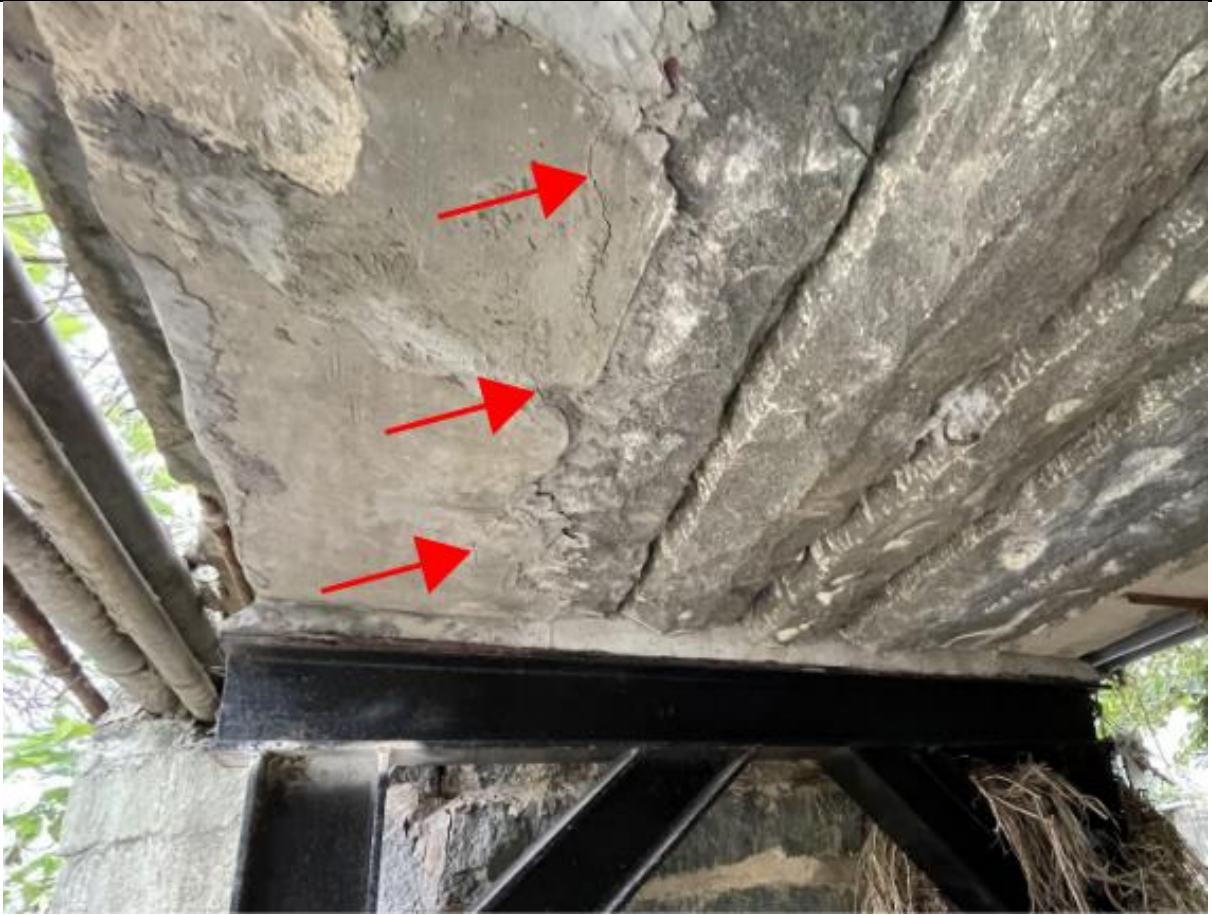
D1.15

Hairline and Minor Cracks were found on the grouting near W Abutment

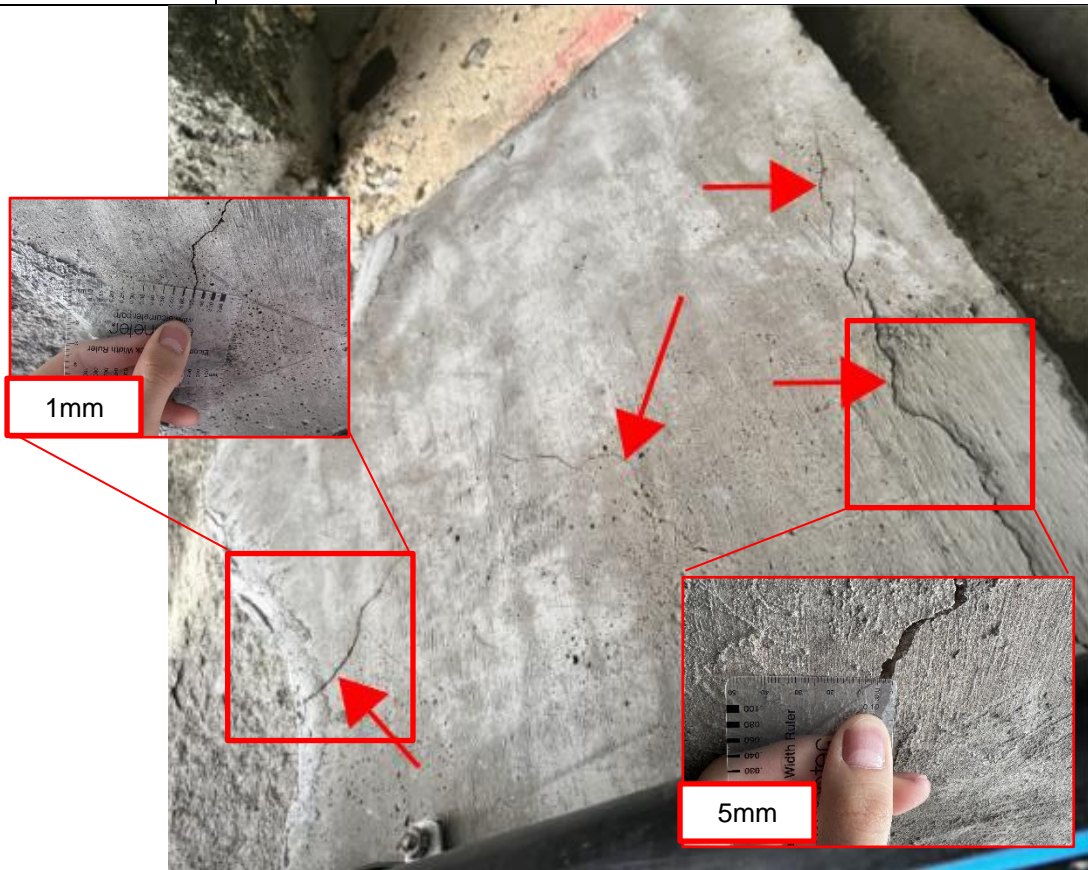
D1.16

Minor Crack and Severe Cracks were found on the grouting near W Abutment

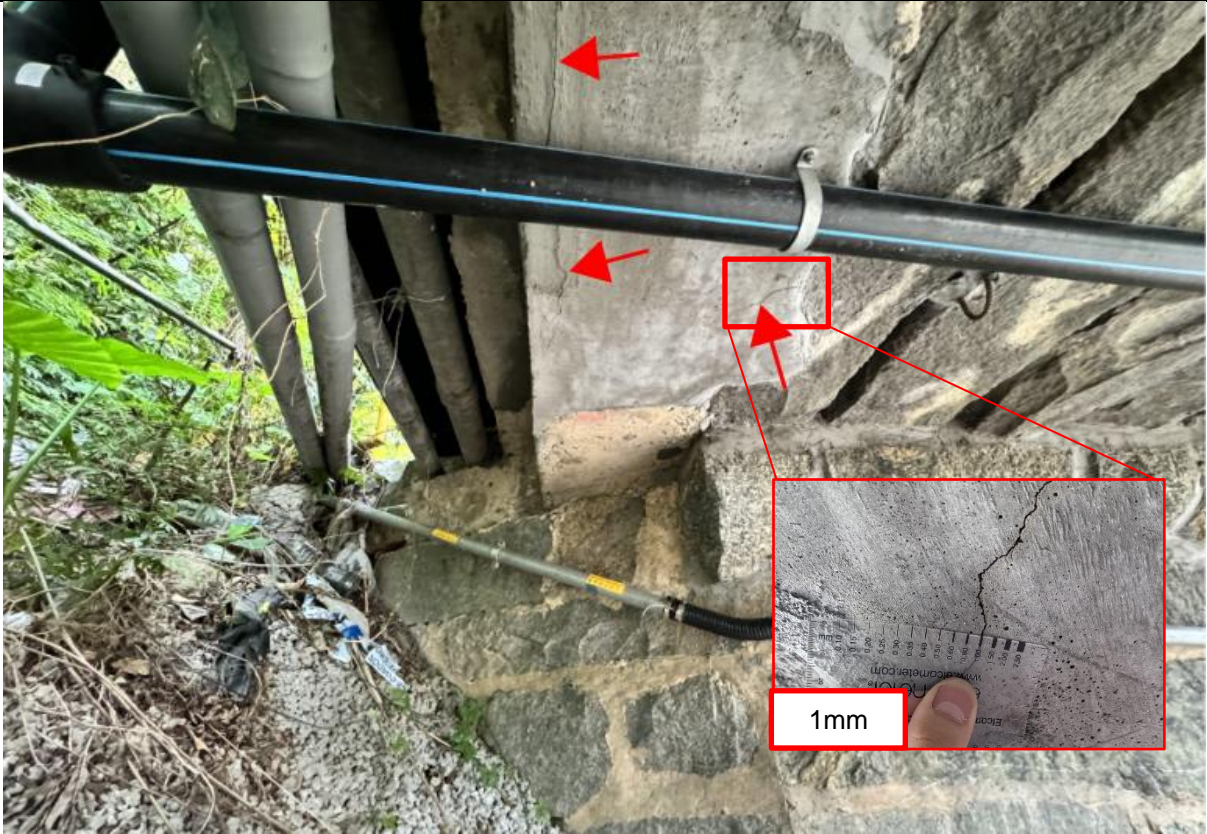
D1.17

Hairline Crack and Minor Crack were found on the grouting near W Abutment

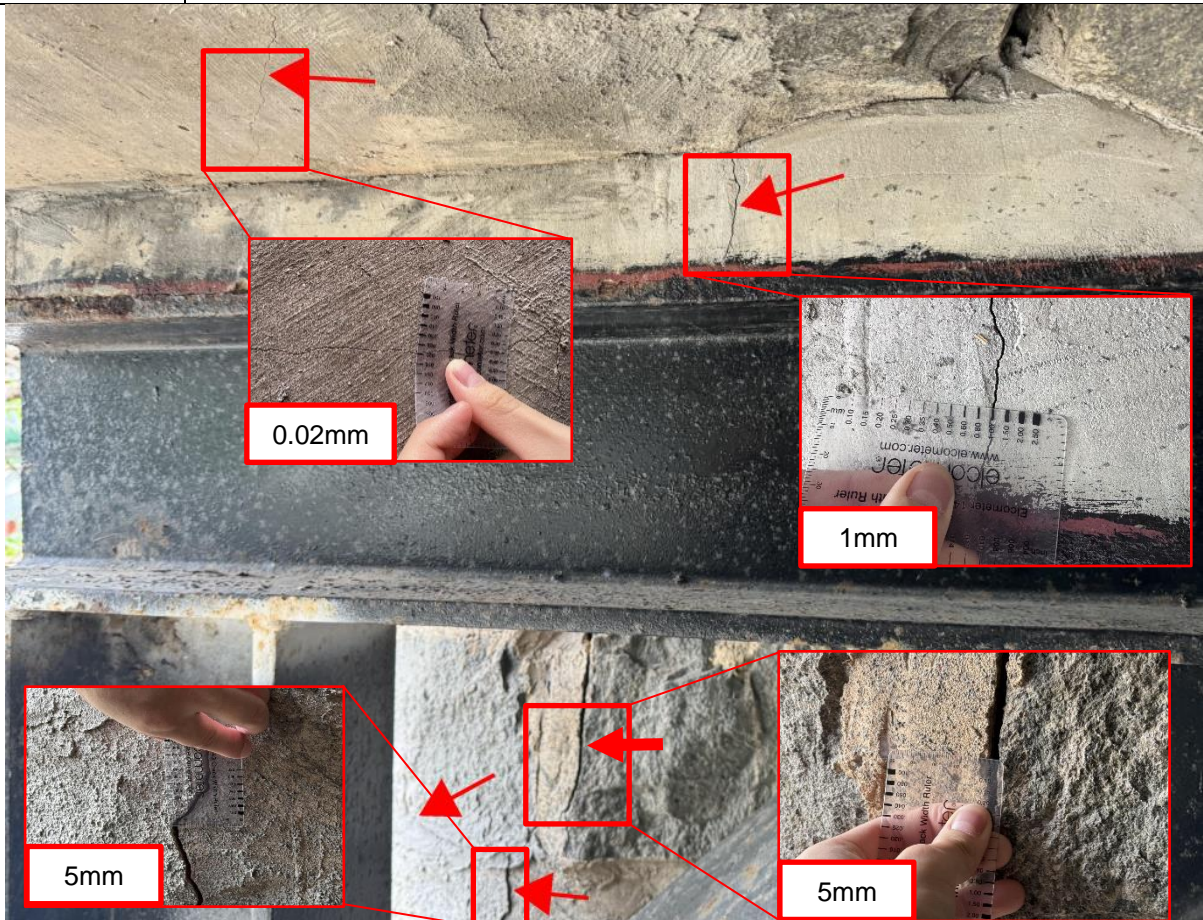
D1.18

Hairline Crack and Minor Crack were found on the grouting near W Abutment;
Severe Cracks were found on the Pier

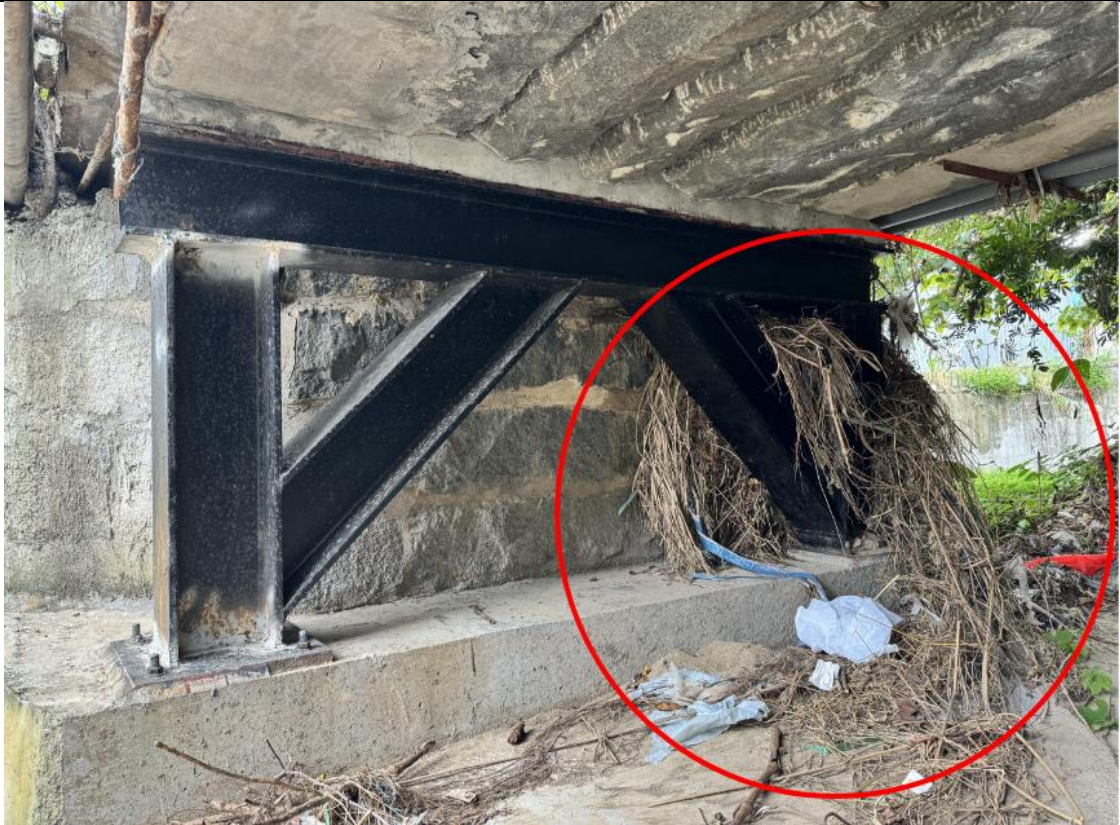
D1.19

Debris and Waste were observed near Steel Support

Removal of debris and waste under the bridge is recommended.

It is also recommended to remove debris and waste under the bridge, which are likely to affect the flow capacity of the existing river, to ensure the safety of work environment nearby.

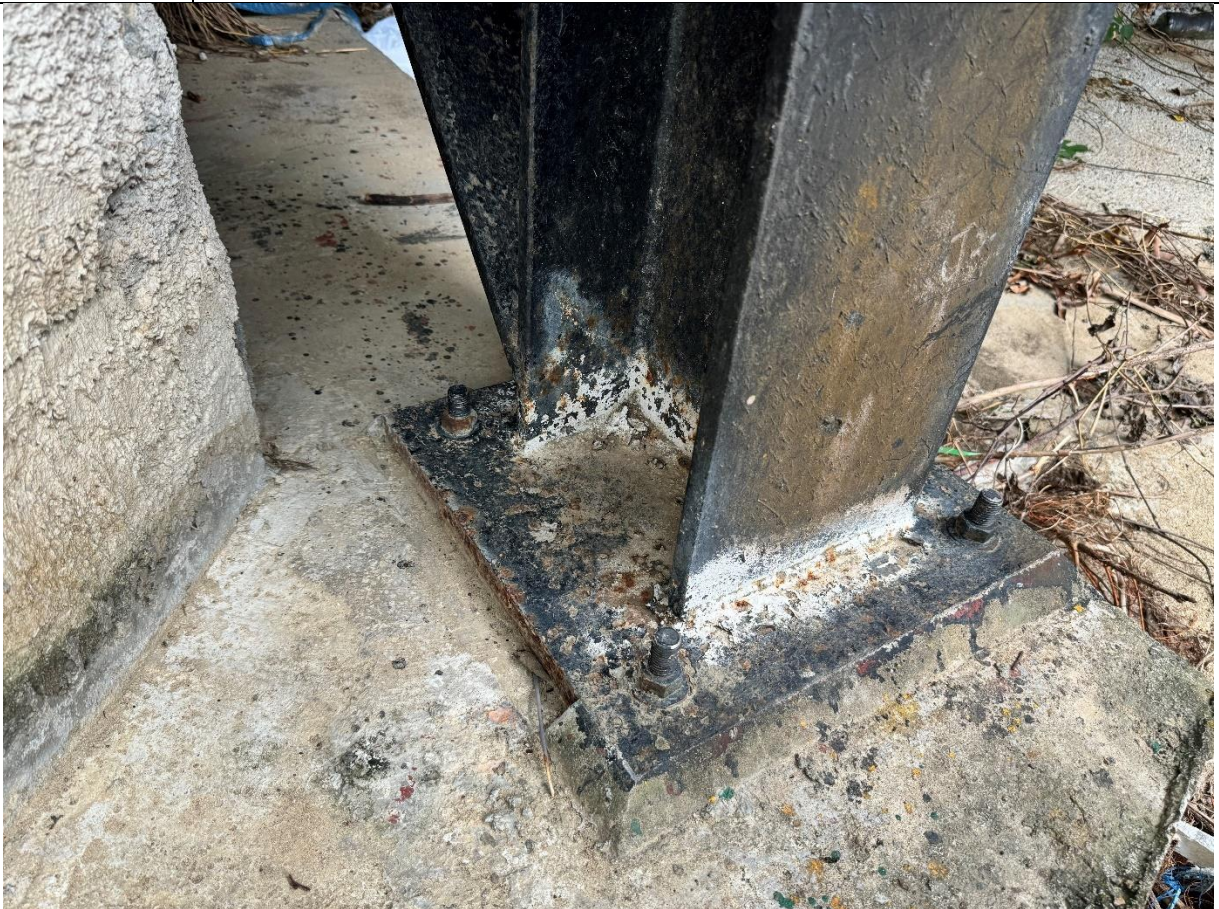
D1.20

Rust stains were observed on the Steel Support

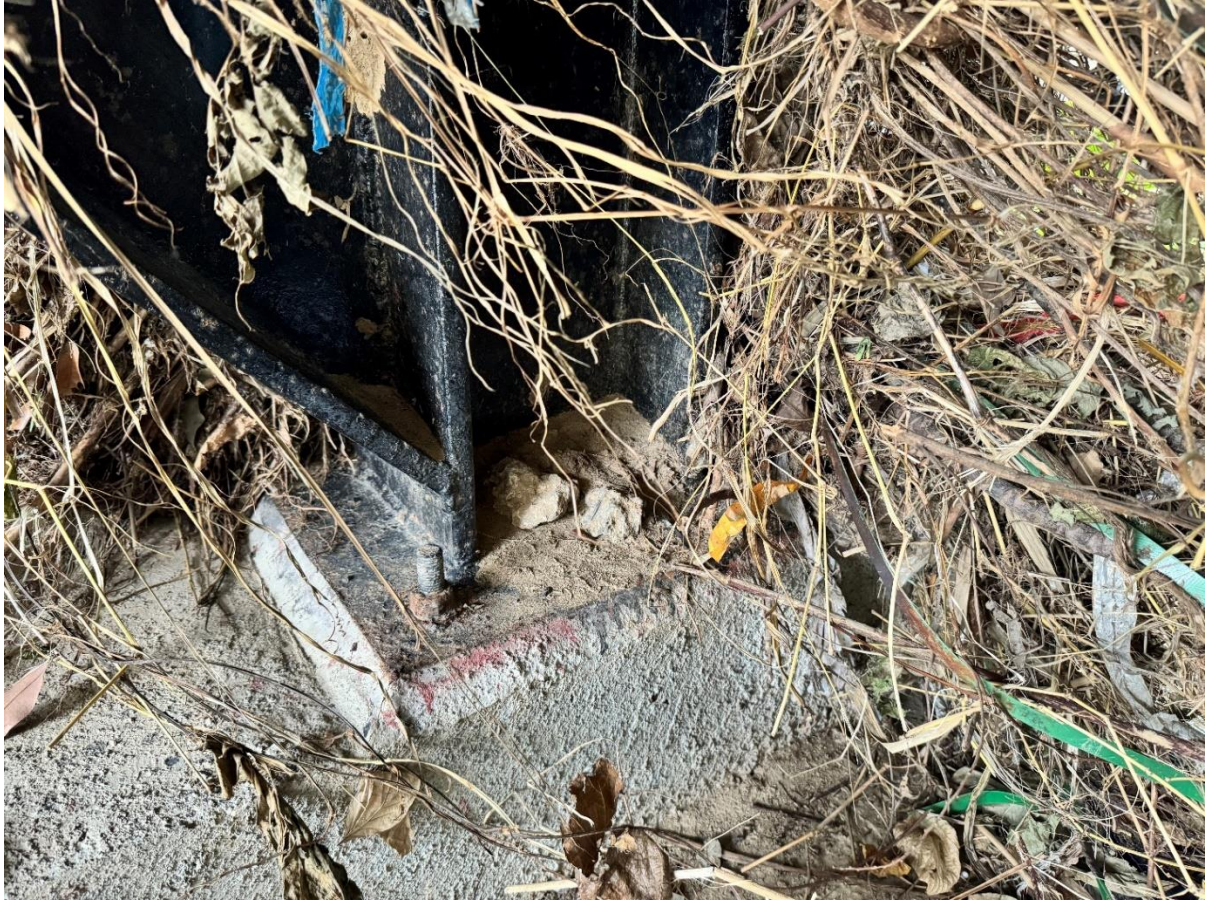
D1.21

Rust stains were observed on the Steel Support

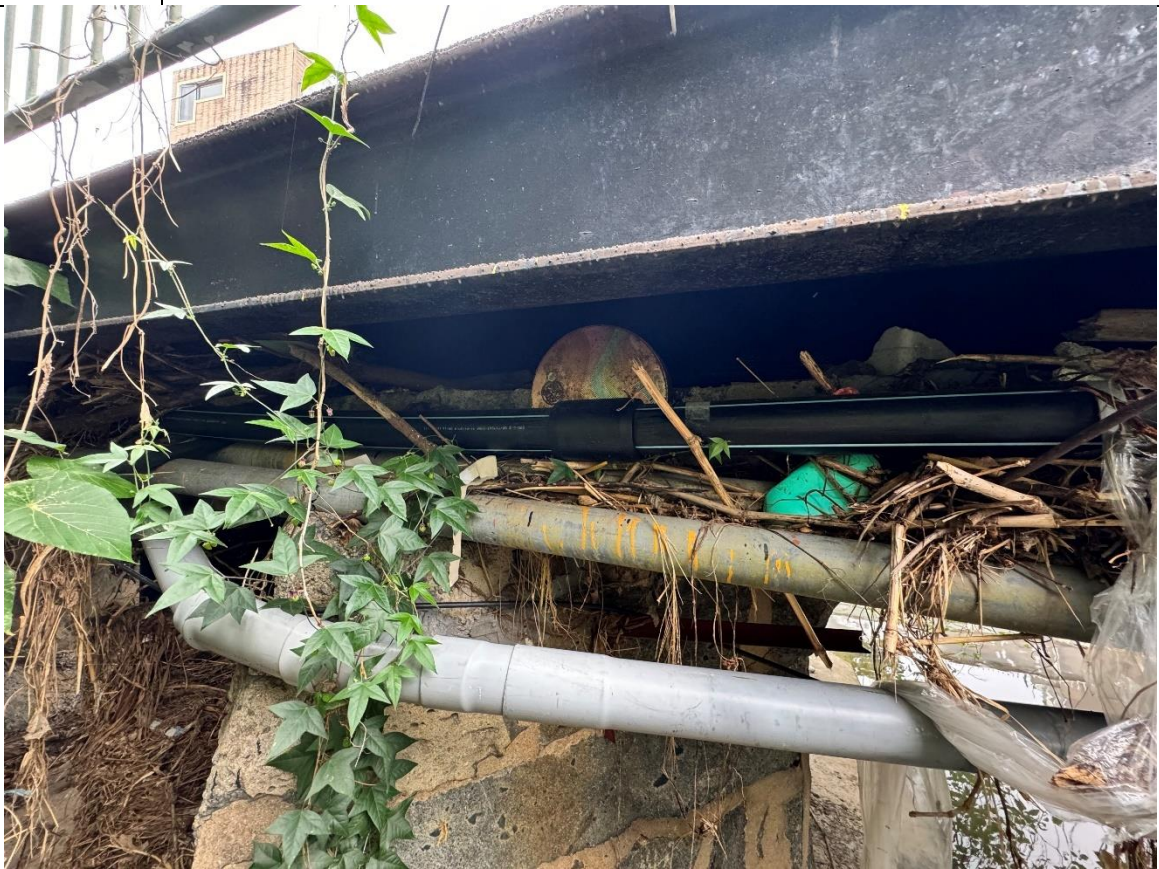
D1.22

Debris and Waste were observed stuck at the Pier

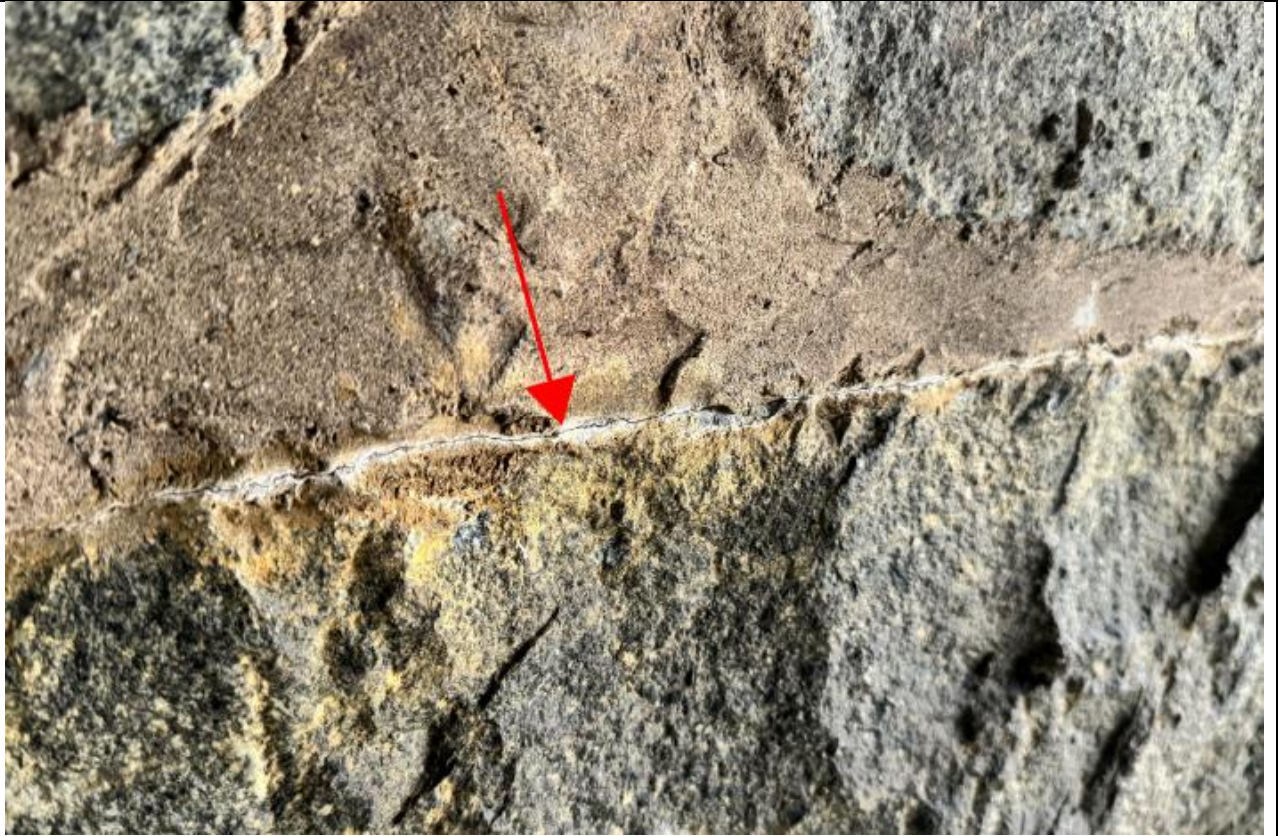
D1.23

Minor Crack was found on the Pier
