**DRAINAGE IMPROVEMENT
WORKS AT YUEN LONG –
STAGE 2**

Contract No.: DC/2022/02

**Pre-Construction
Condition Survey
Report for Impacted
Graded Historic
Buildings**

**Wing Tat Civil Engineering
Company Limited**

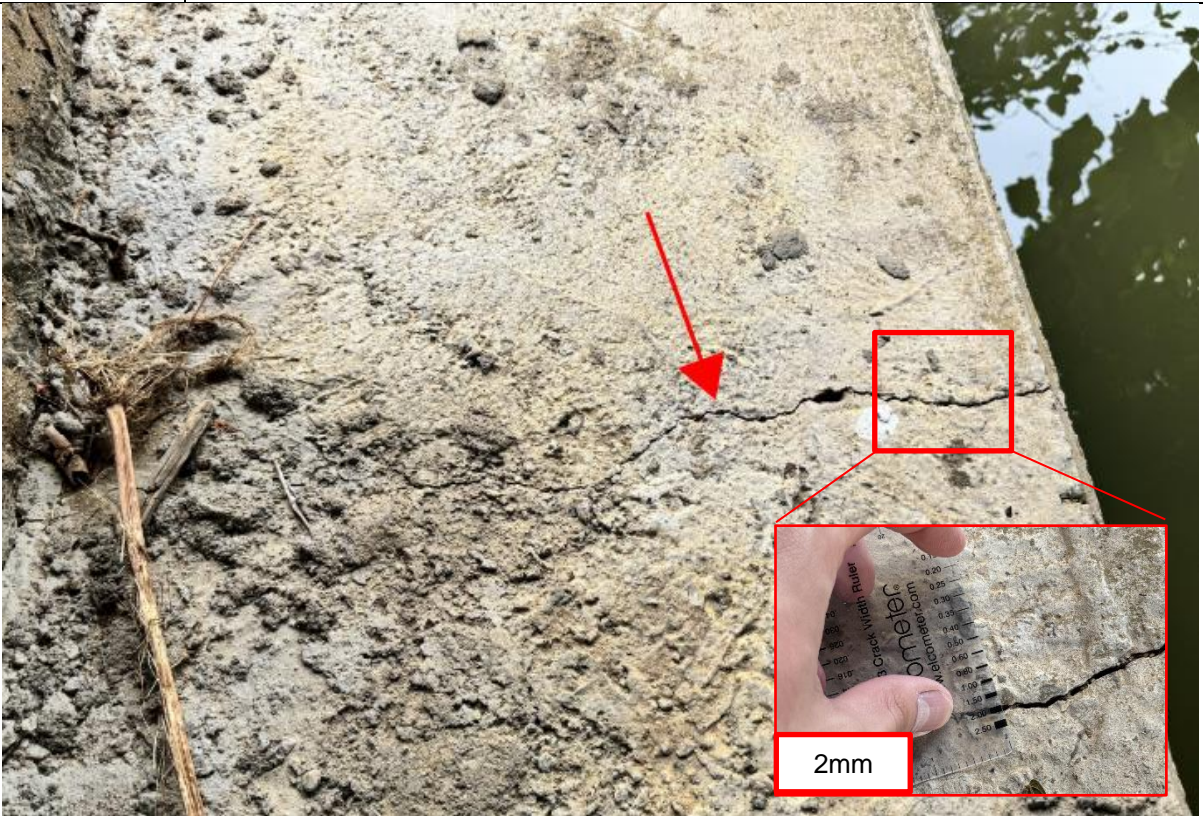
D1.24

Severe Crack was found on the R.C. Foundation of the Pier

Cracking on the abutment and pier was found in the subject building should be kept in view.

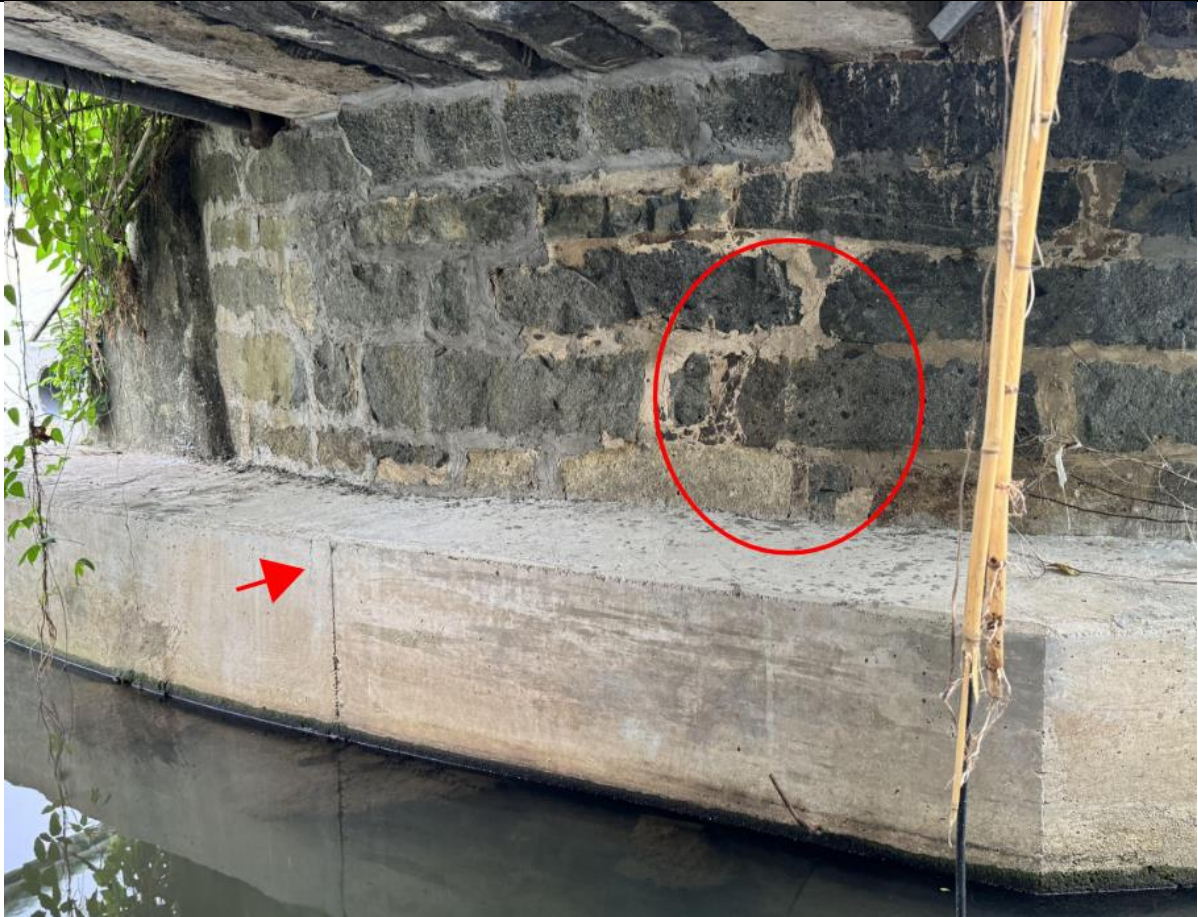
D1.25

Hairline Crack and Minor Crack were found on the E Abutment and the R.C. Foundation

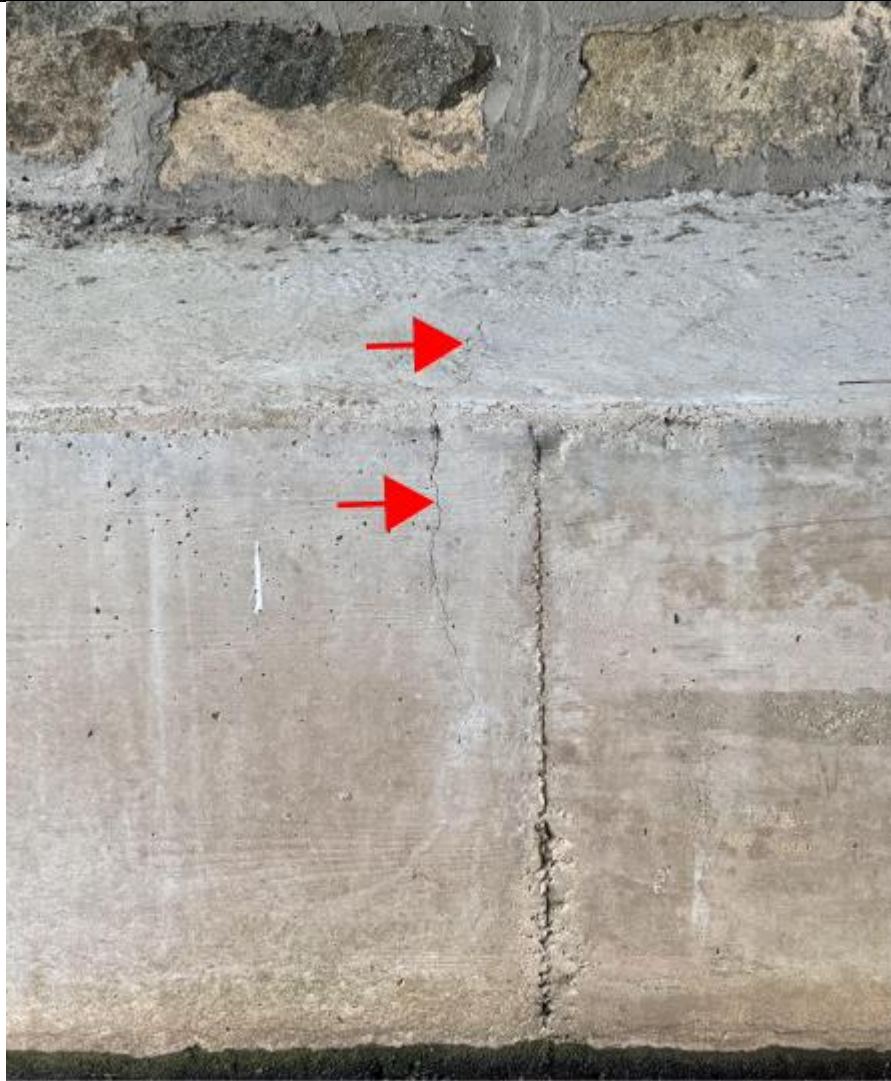
D1.27

Hairline Crack was found on the R.C. Foundation of E Abutment

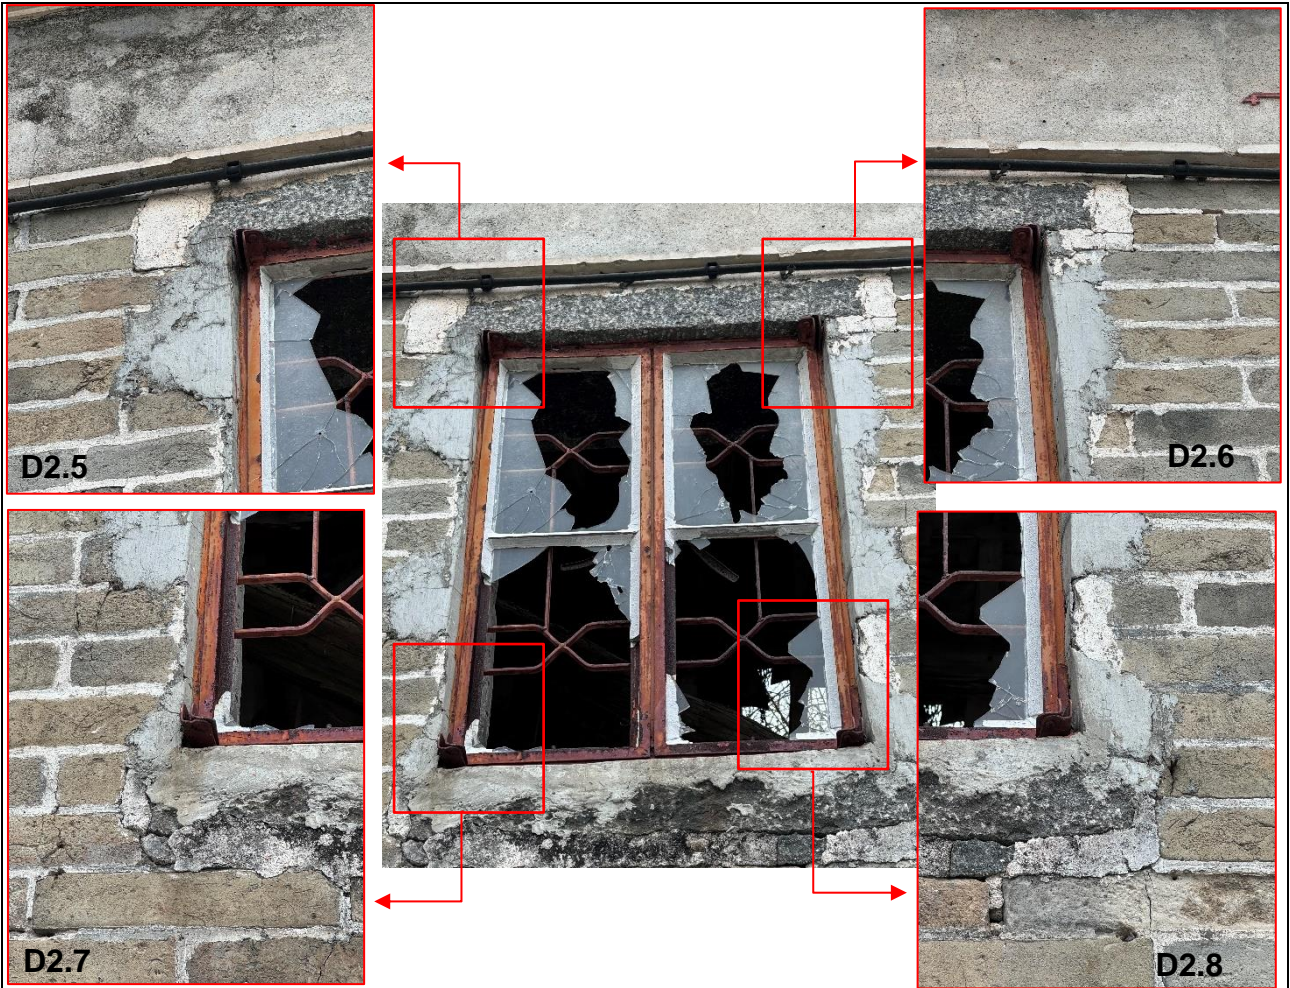
D2.5-D2.8

Minor cracks were found on windows 1.

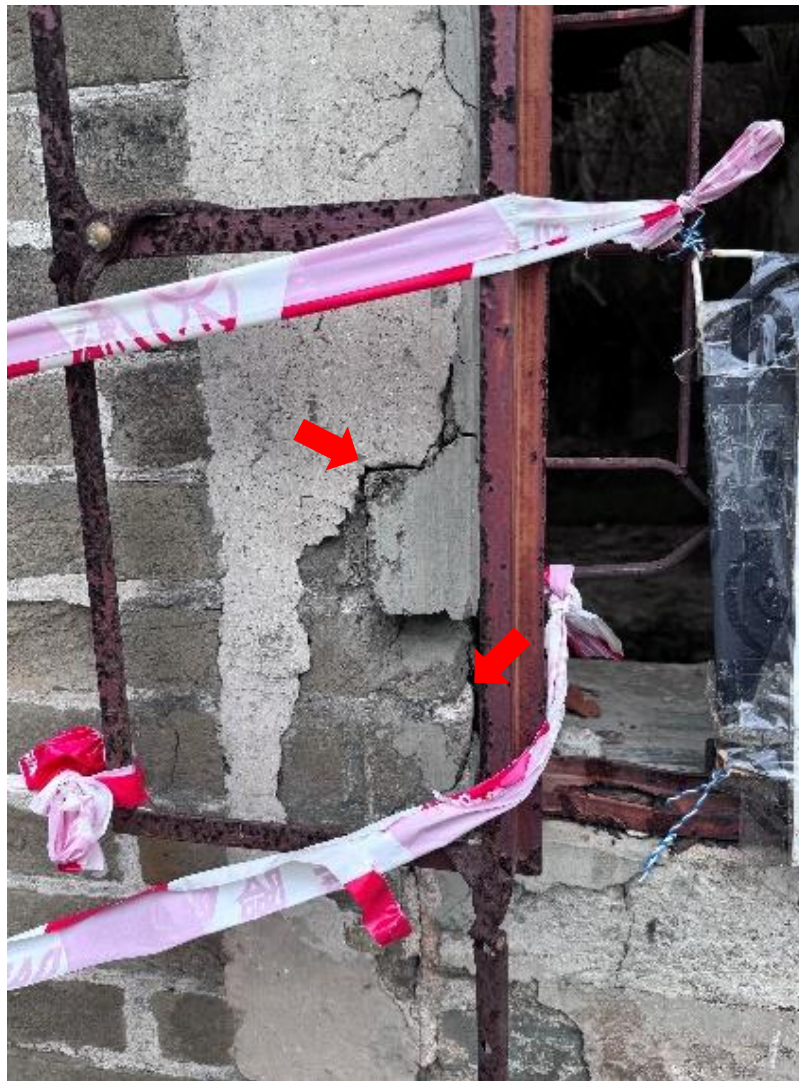
D2.11

Minor concrete spalling and severe crack (wider than 2mm) was found on windows 2.

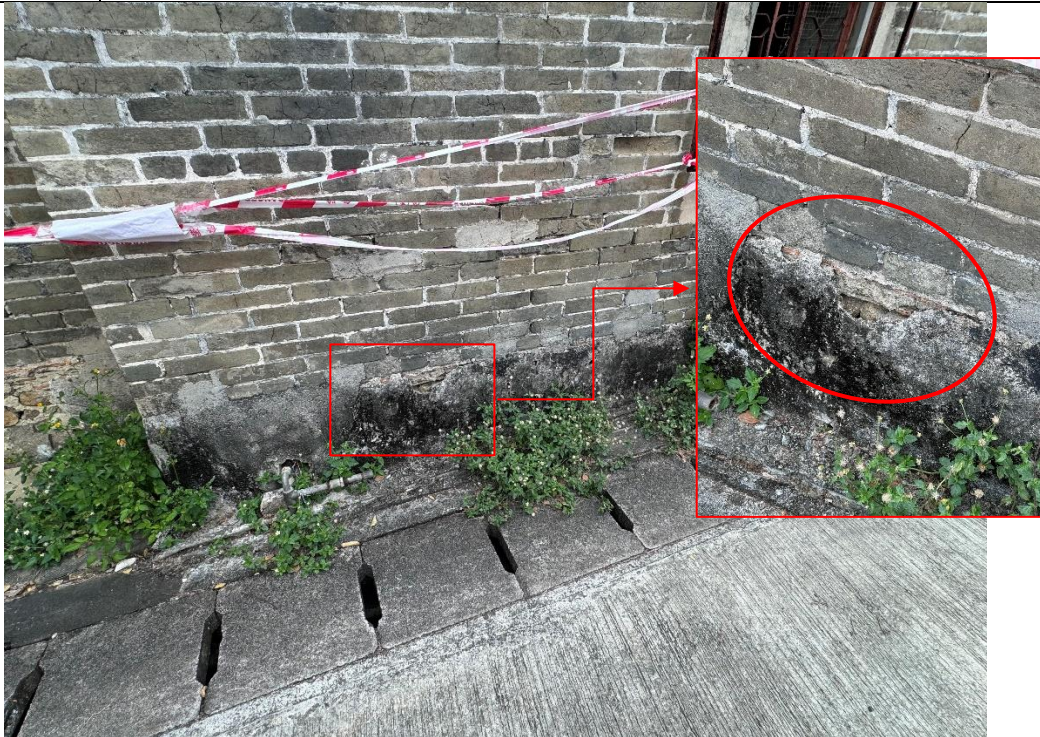
D2.16

Minor spalled concrete was found under the west wall.

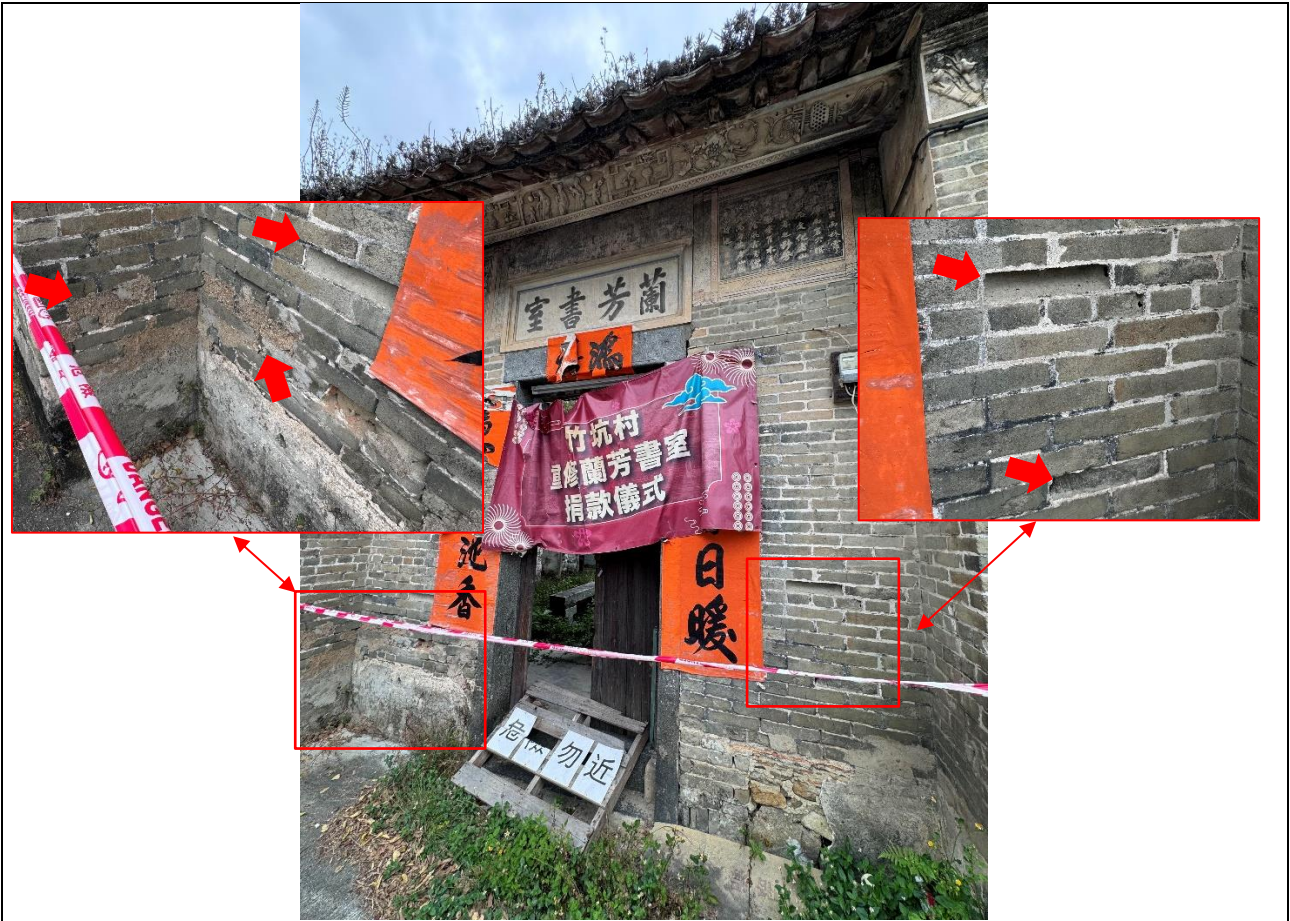
D2.19, D2.20

Some blocks were missing and weathered.

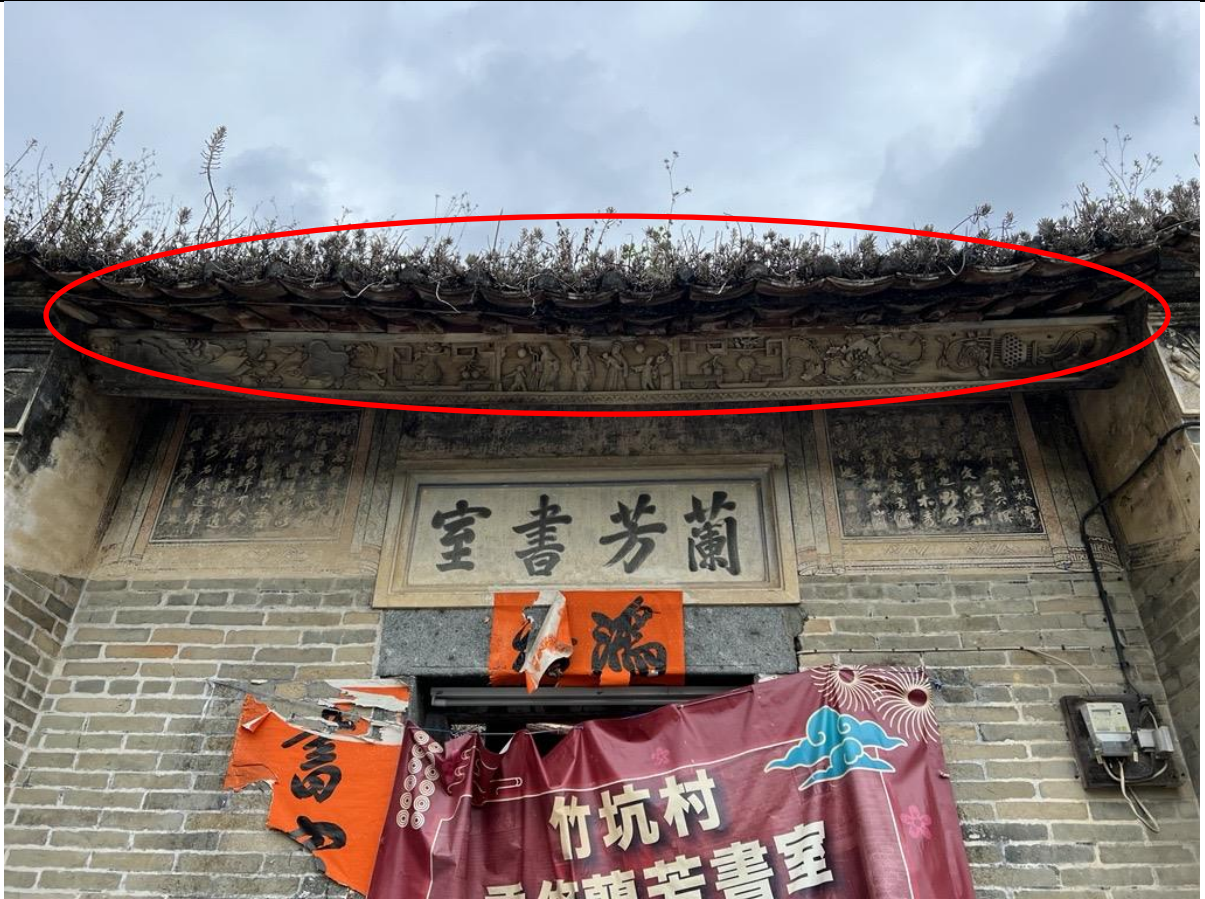
D2.23

The eaves of study hall was deformed.

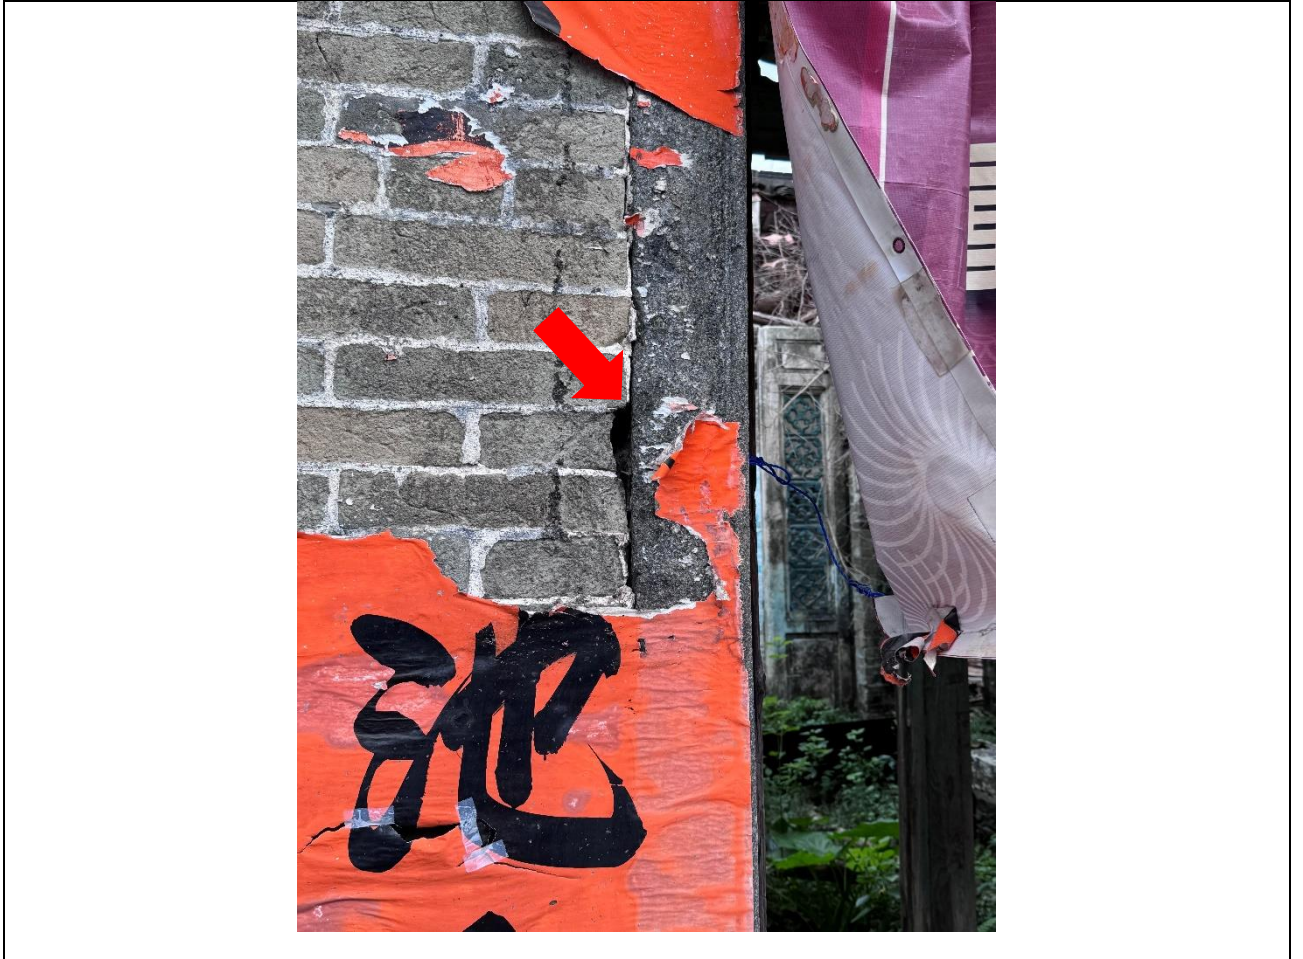
D2.25

The block was broken.

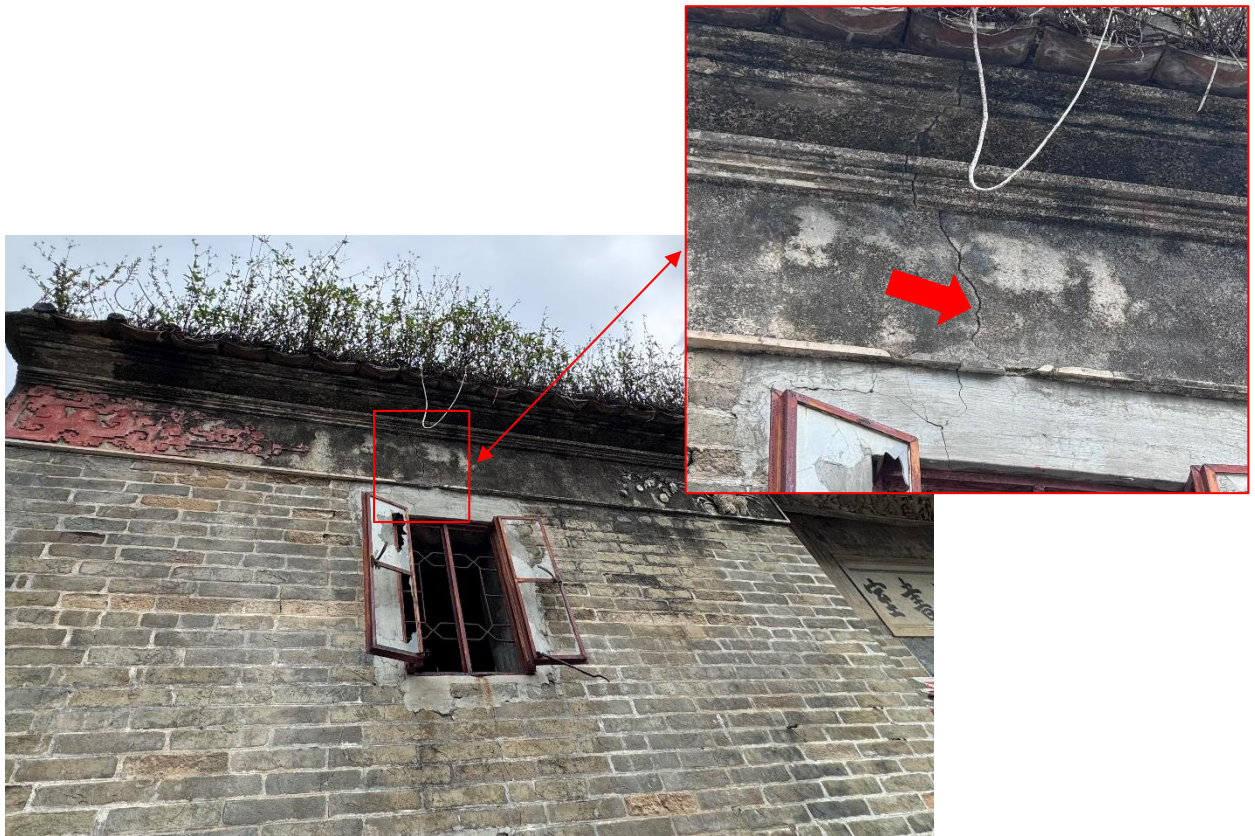
D2.26

Minor crack was found on the eaves.

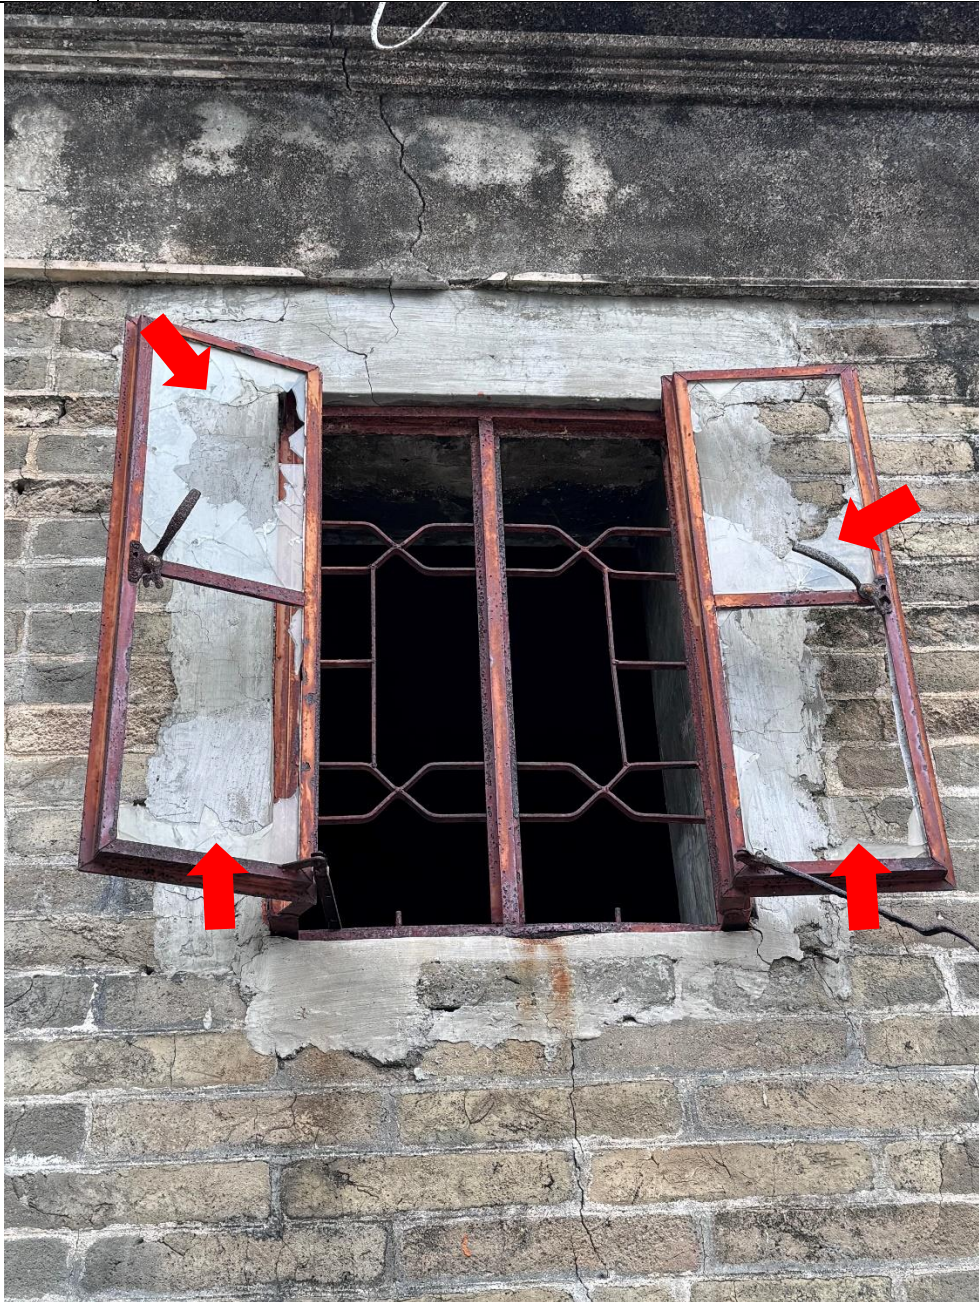
D2.29

The glass of on windows 3 was broken.

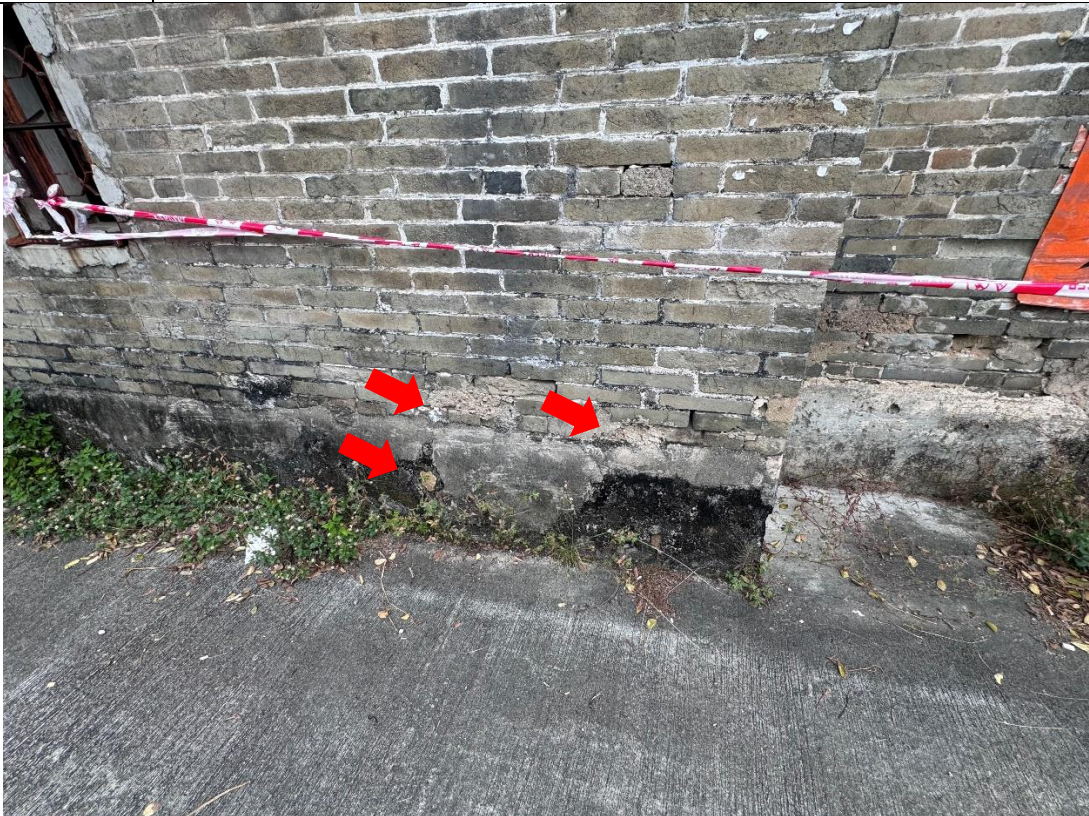
D2.33

Some blocks were broken and weathered, and the minor concrete spalling was appached on the footing.

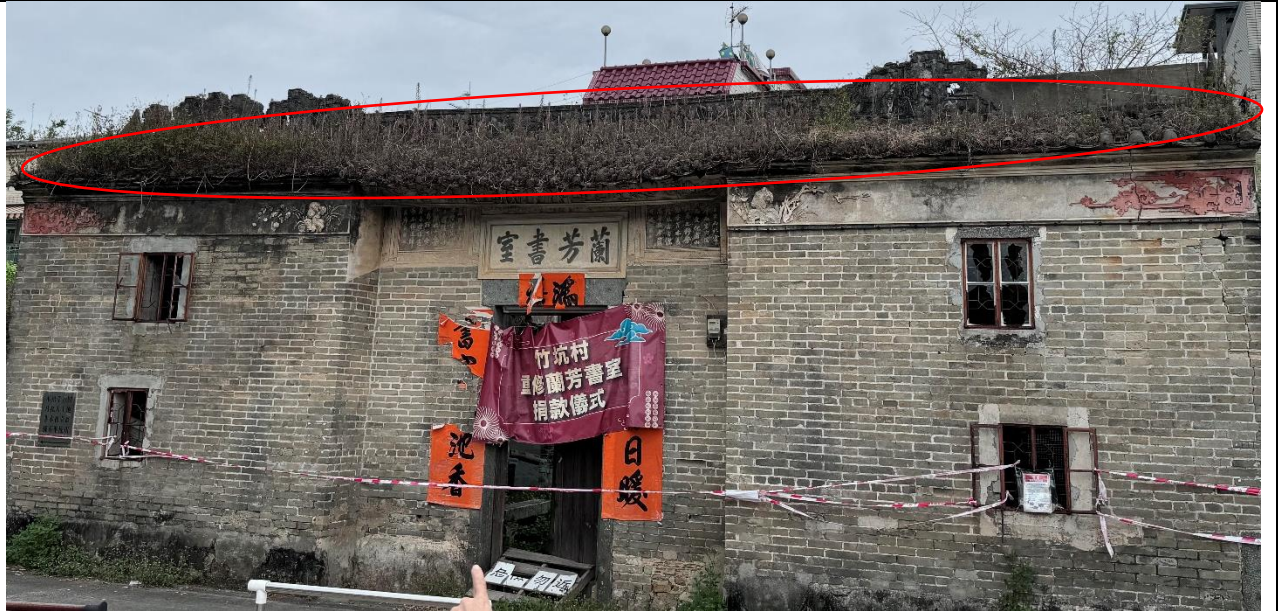
D2.34

Large of vegetation growing on the roof of the study hall.

Removal of vegetation on building structures prior to the commencement of works is recommended. Repair work to the interior structures should also be considered.

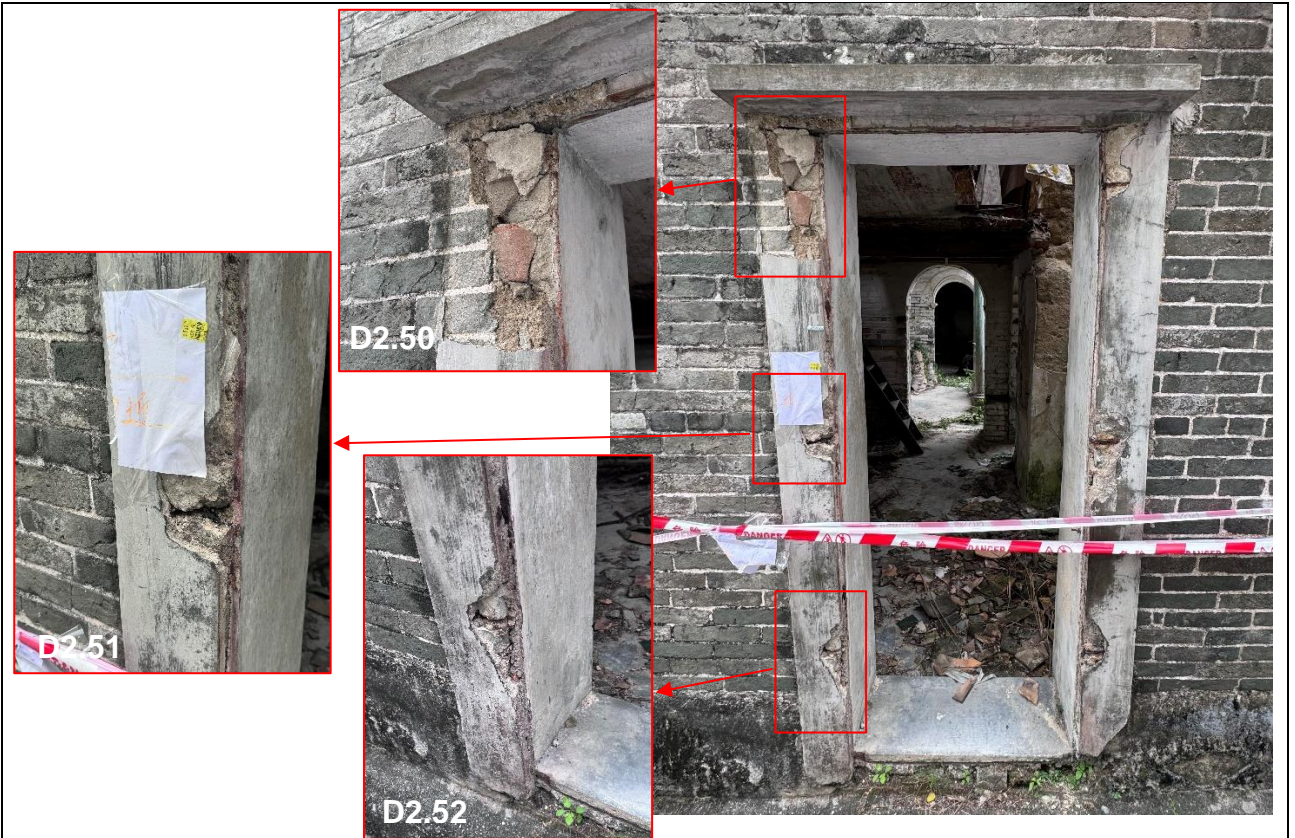
D2.50-D2.52

Major concrete spalling was found on the side door frame.

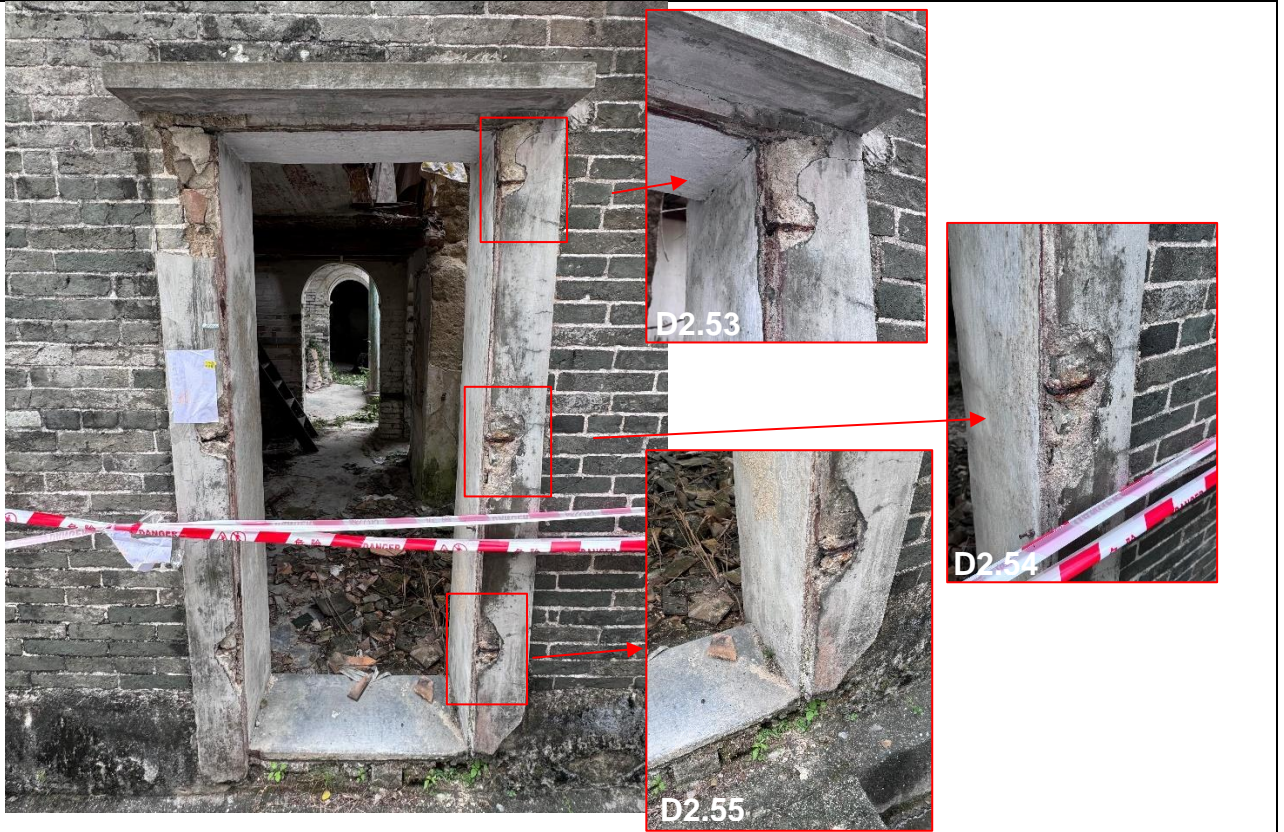
D2.53-D2.55

Major concrete spalling was found on the side door frame, and reinforcements were exposed.

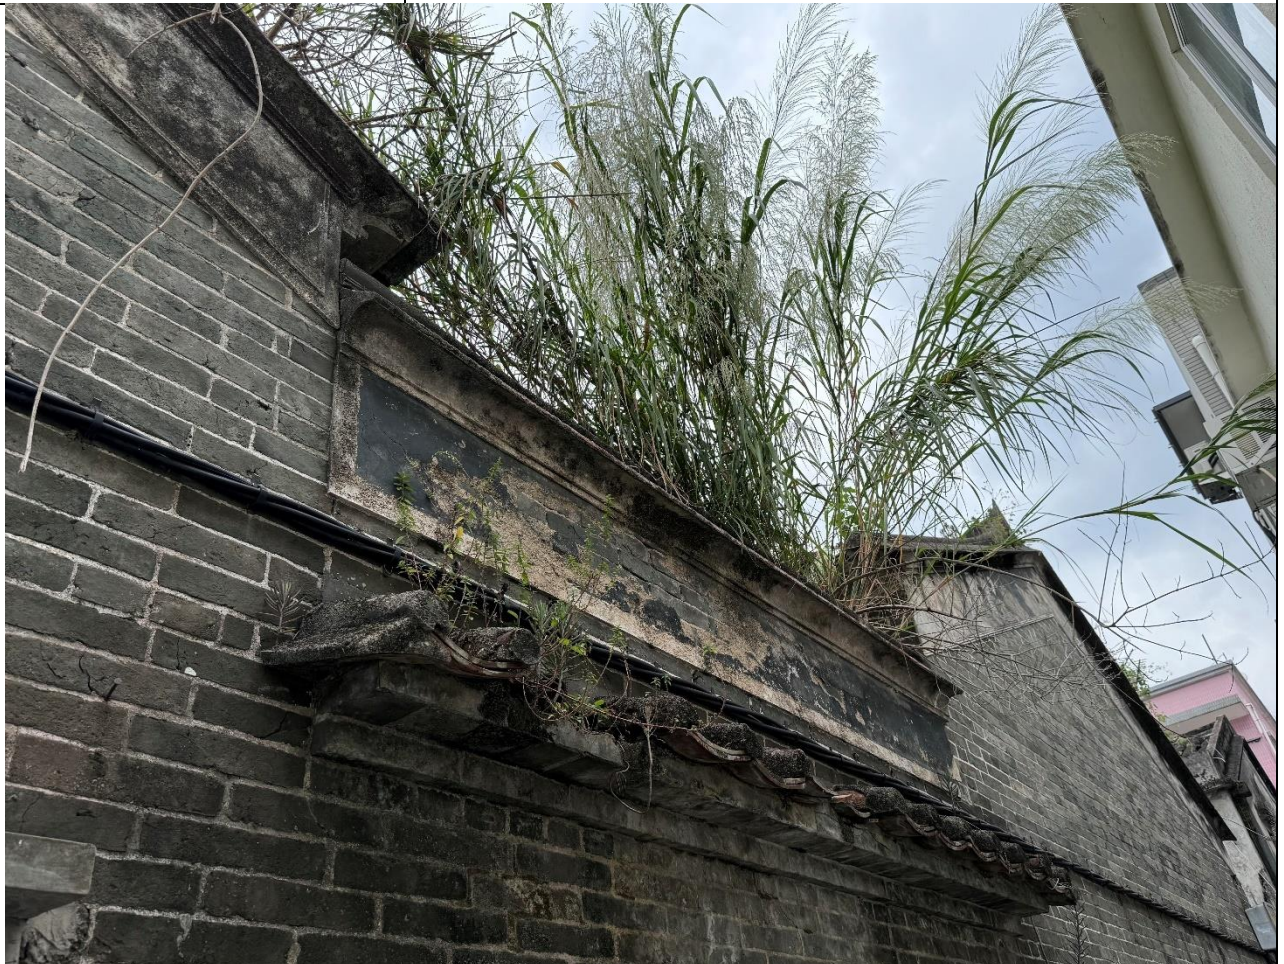
D2.56

Vegetation growing on the south wall of the study hall.

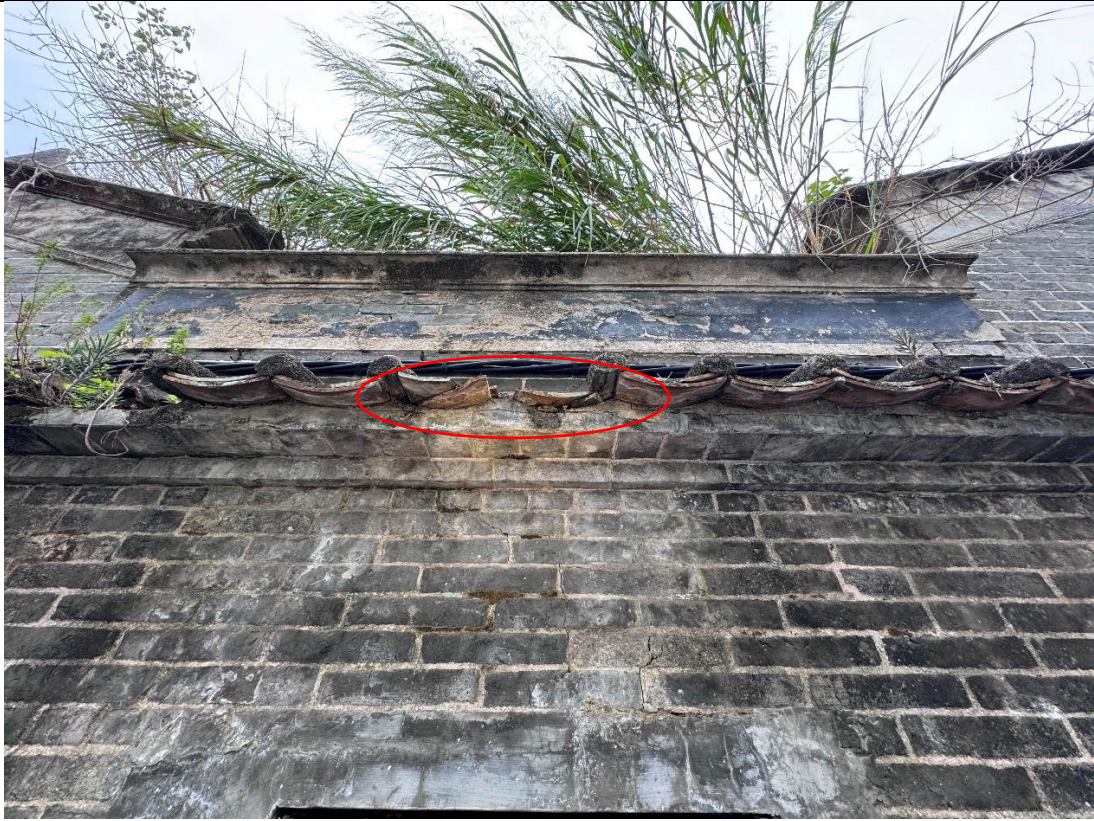
D2.57

Some tiles were missing.

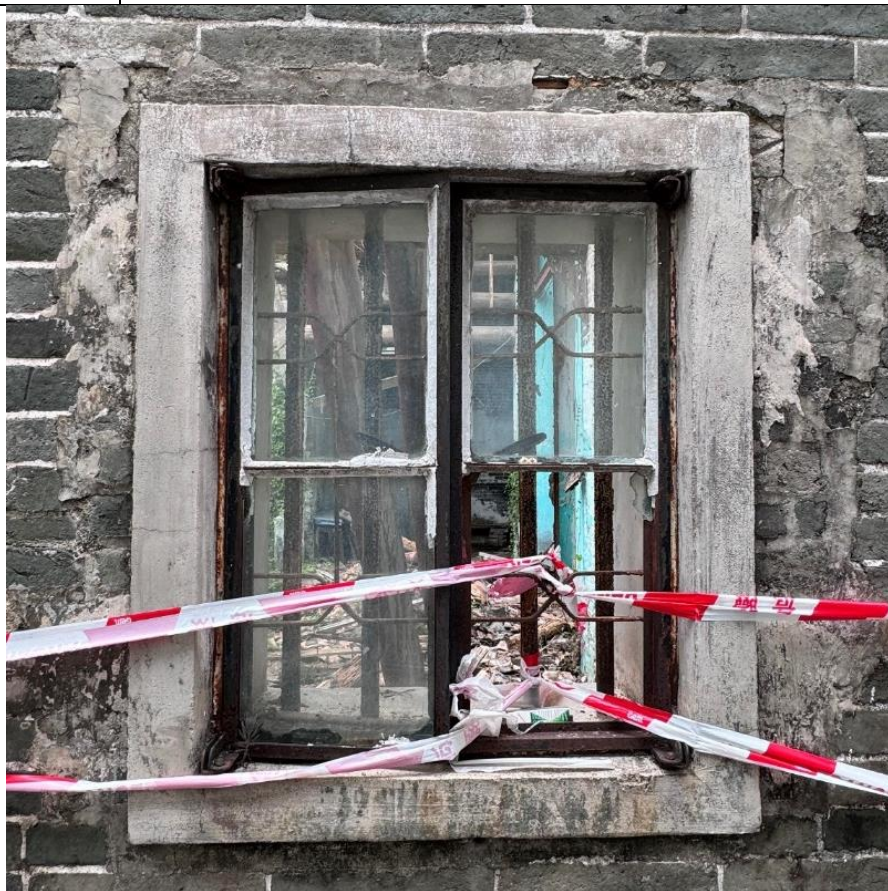
D2.62

The glass of window 6 was broken on the south wall of study hall.

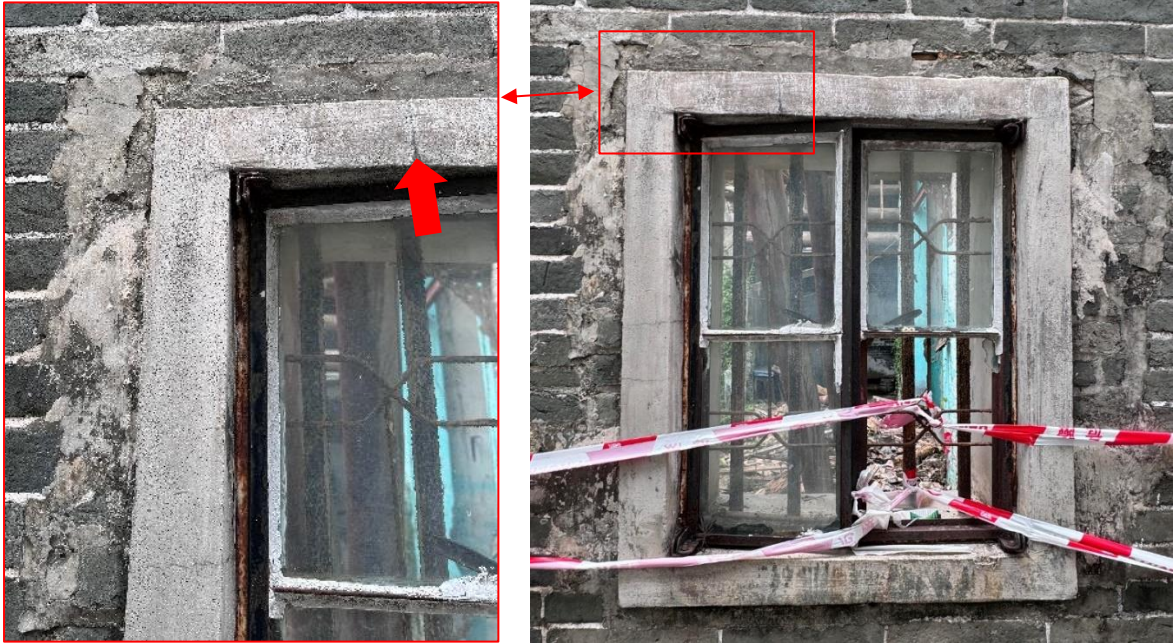
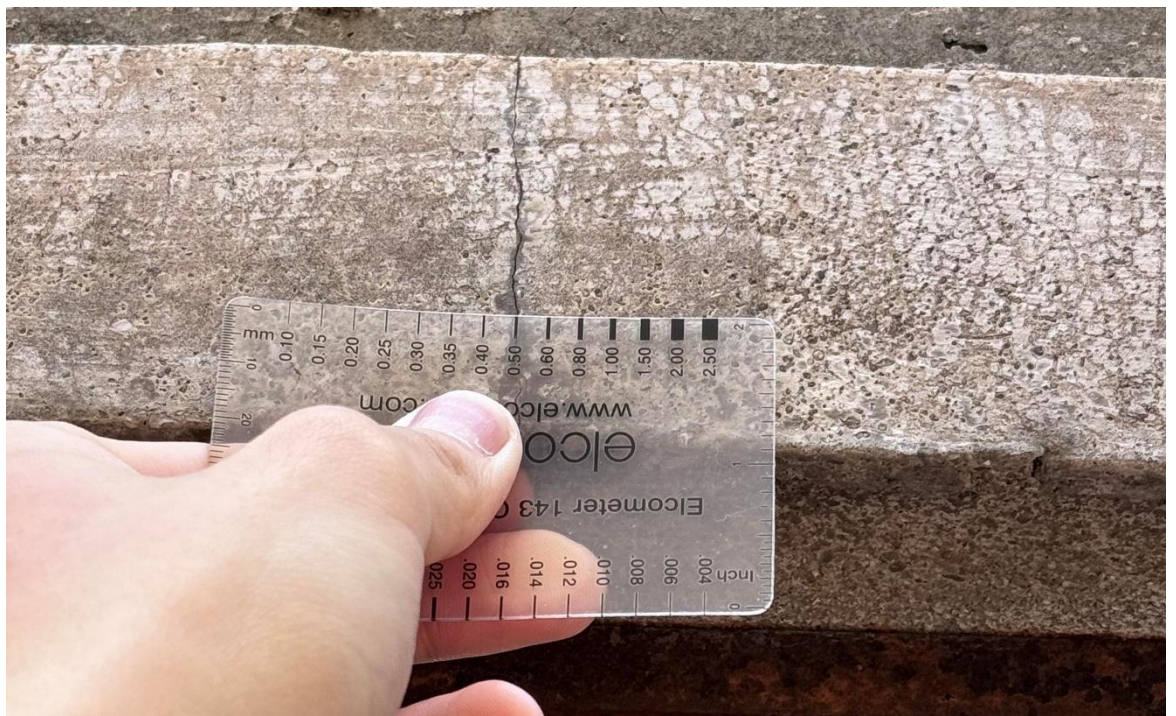
D2.63

Hairline cracks (less than 1mm) were found.

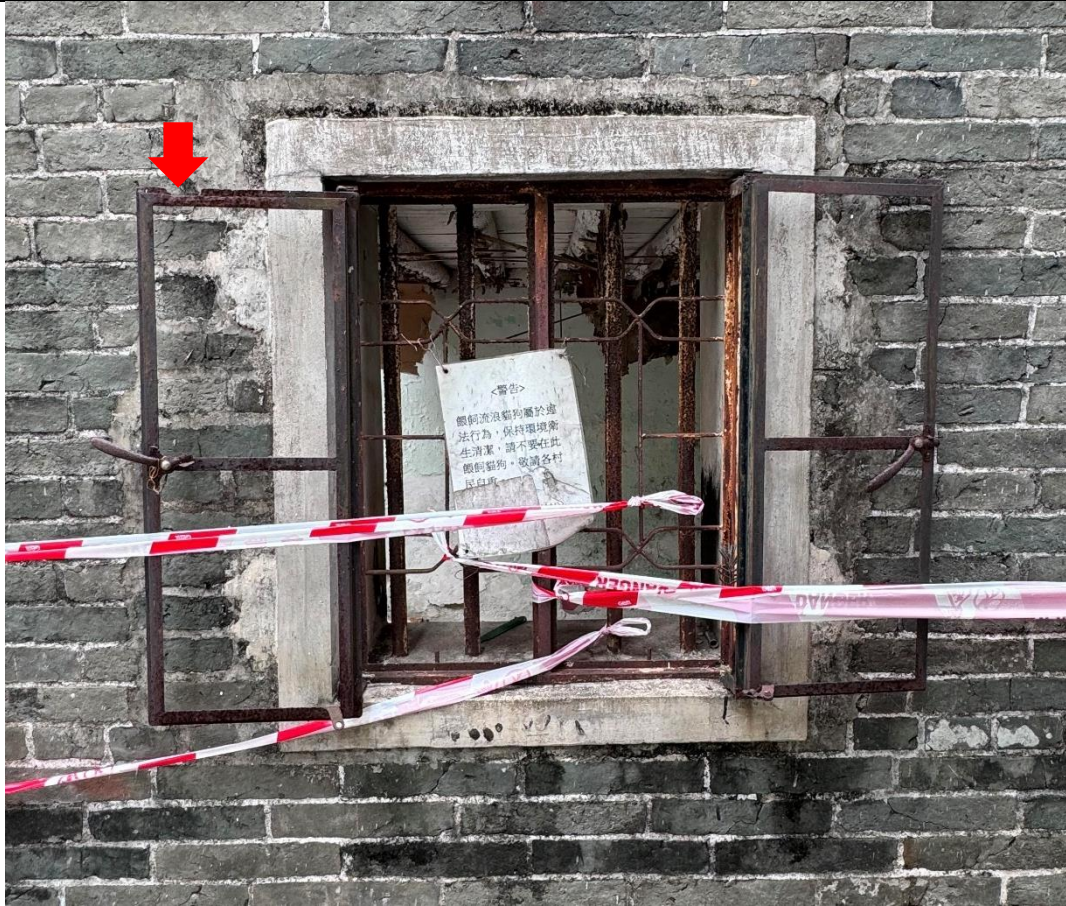
D2.65

The glass of window 7 was missing, and the steel frame was broken.

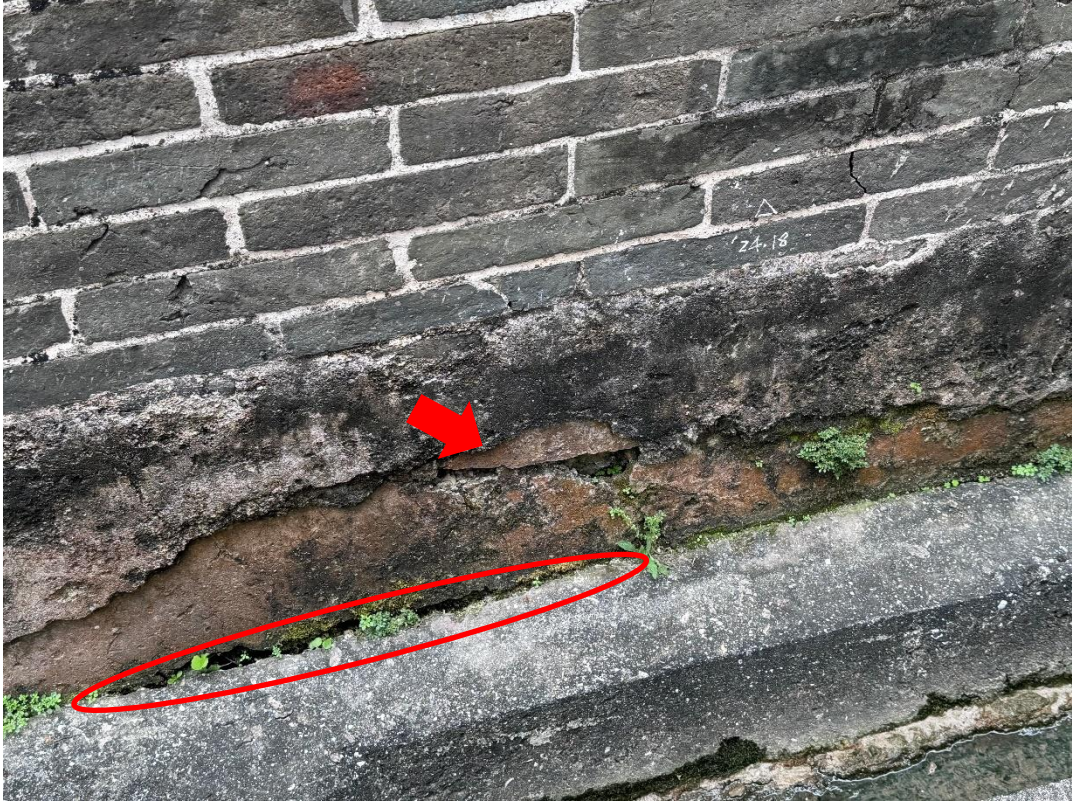
D2.67

A gap was found, and some concrete spalling were found under the south wall of study Hall.

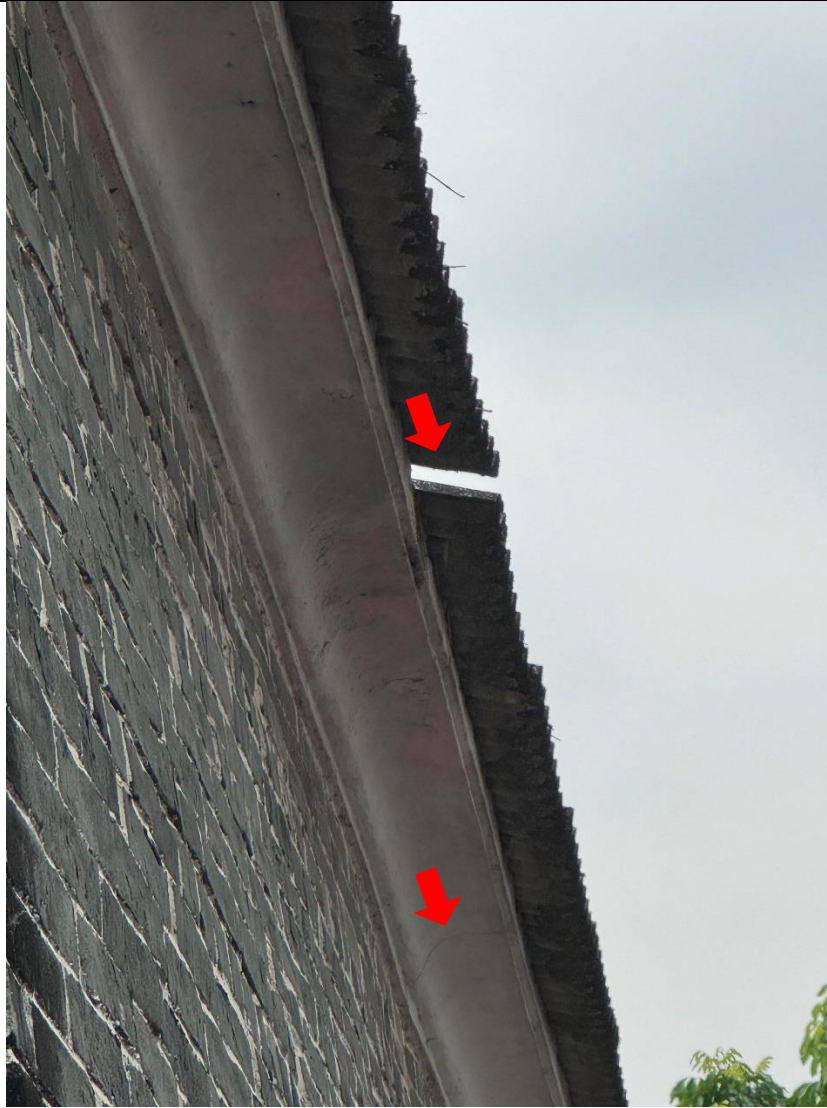
D3.17

Hairline cracks was found, and the roof tiles were missing on the north wall eaves of the Chapel.
