**DRAINAGE IMPROVEMENT
WORKS AT YUEN LONG –
STAGE 2**

Contract No.: DC/2022/02

**Pre-Construction
Condition Survey
Report for Impacted
Graded Historic
Buildings**

**Wing Tat Civil Engineering
Company Limited**

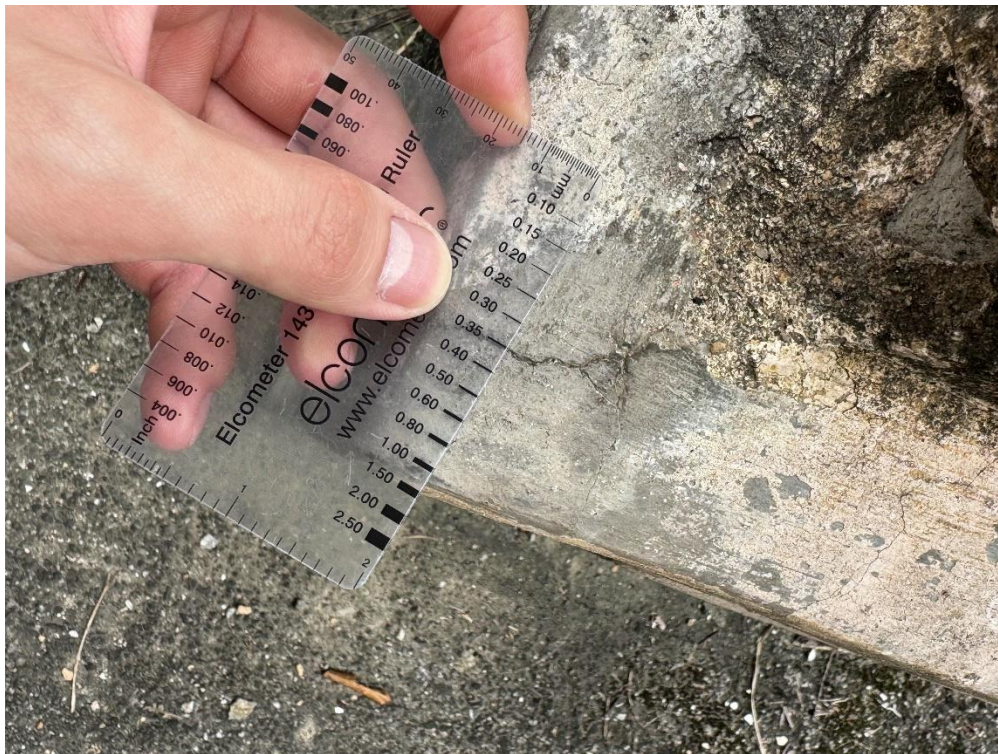
D3.22

The concrete at the bottom of left side column was spalled. Hairline cracks (less than 1mm) is appeared on the footing of left-side column.

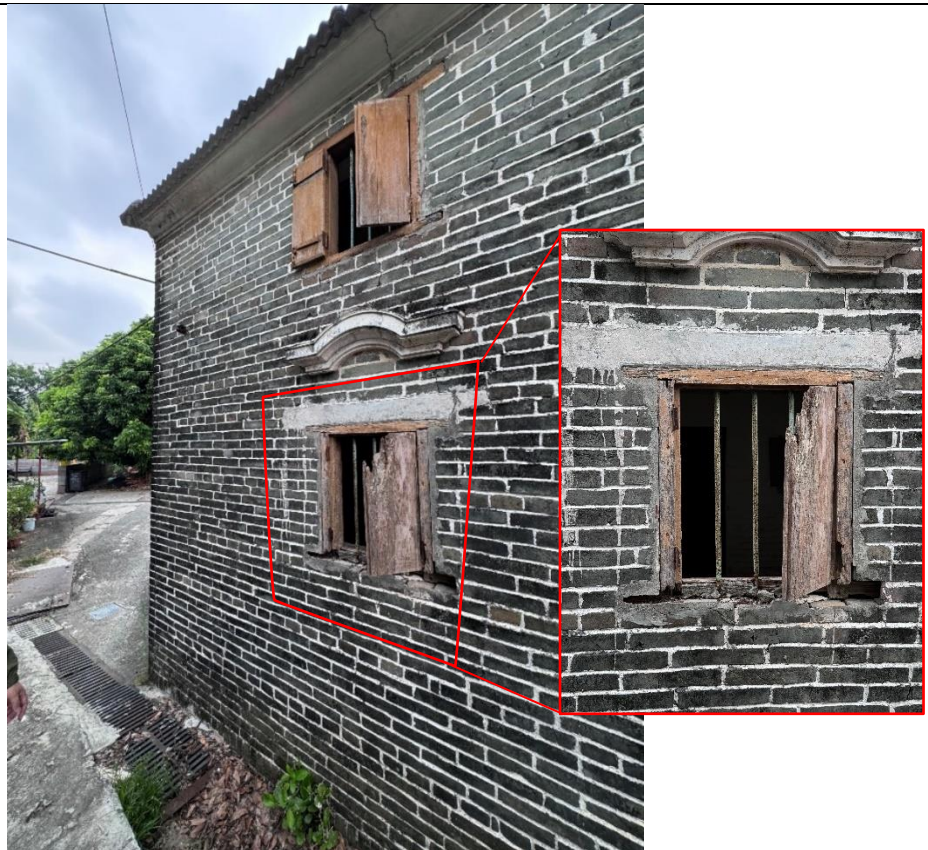
D3.28

Window3 was broken at the south wall of the Chapel.

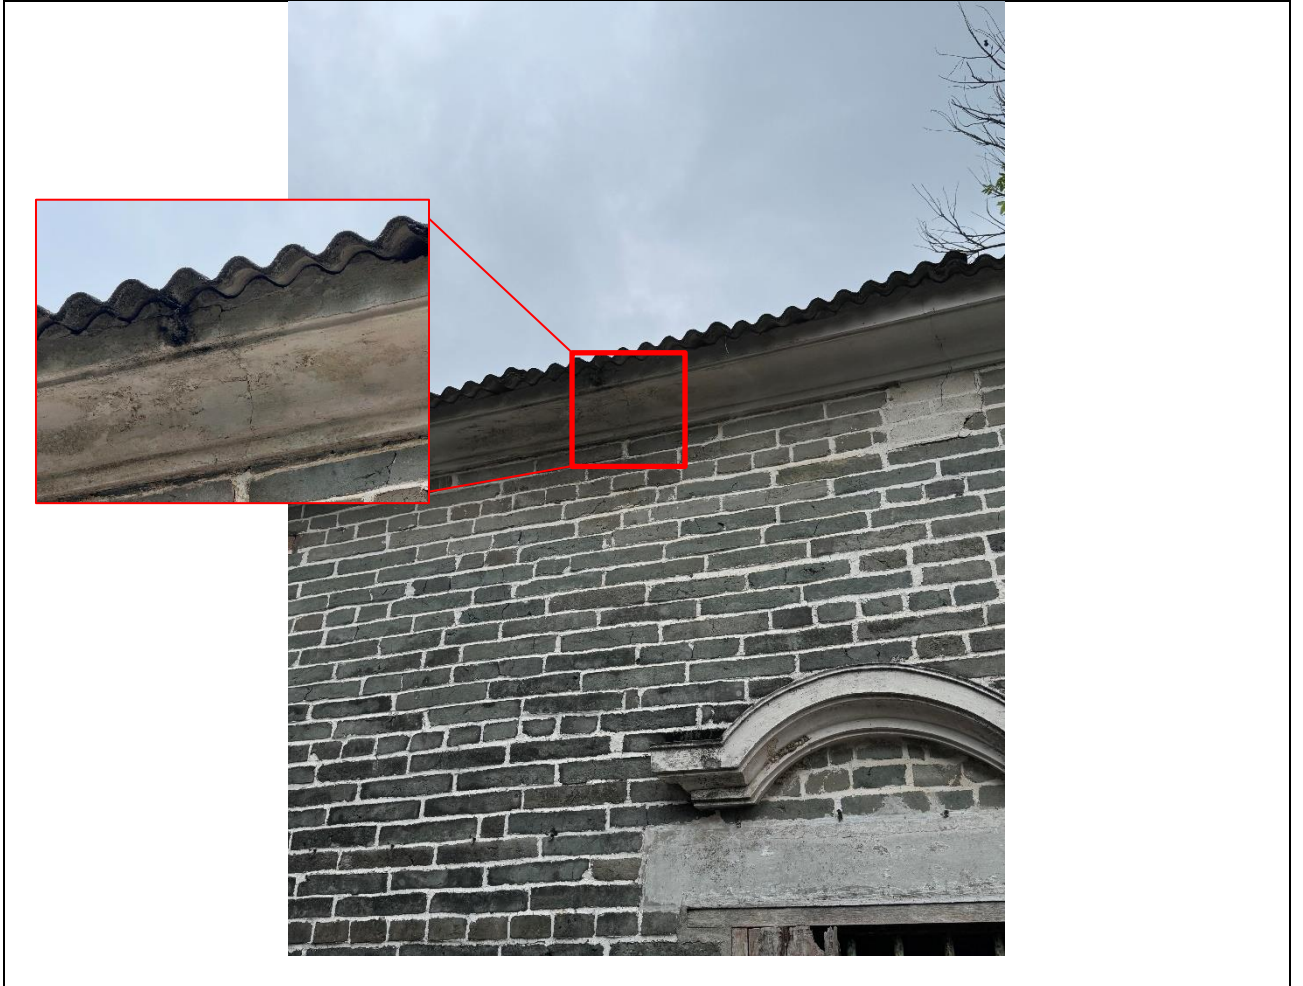
D3.37

Minor crack was found on the south wall eaves of Chapel.

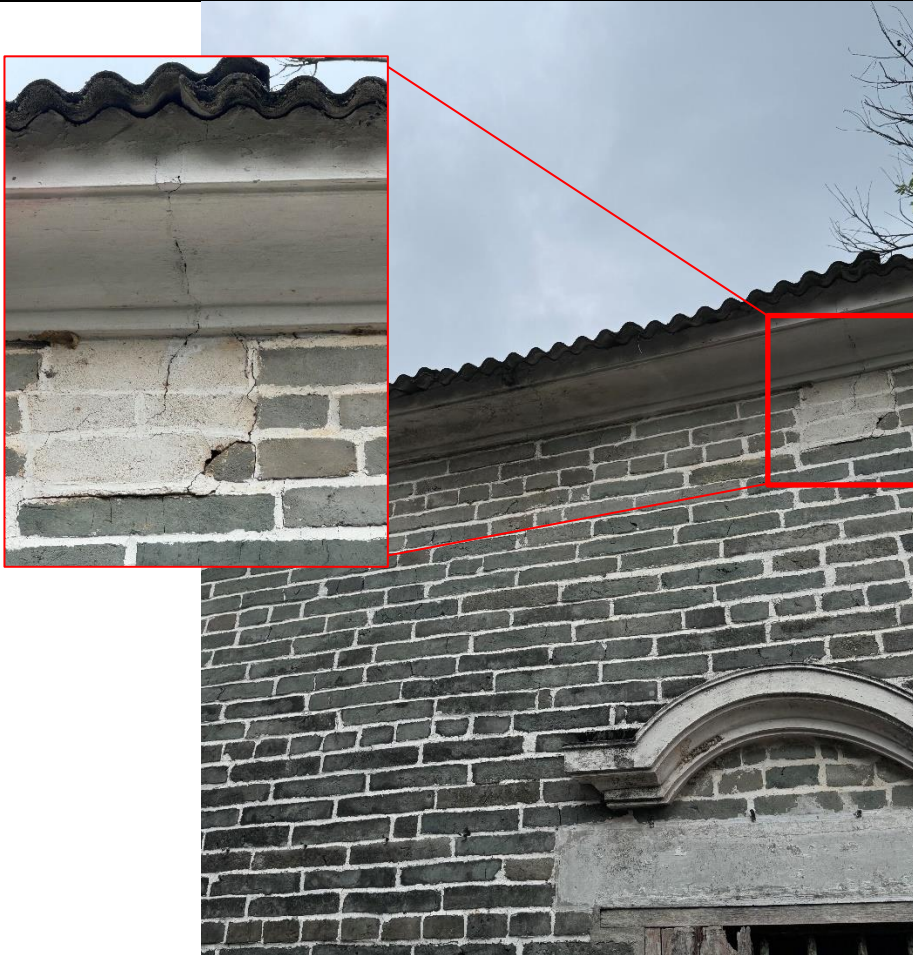
D3.38

Minor crack was found on the south wall eaves of Chapel.

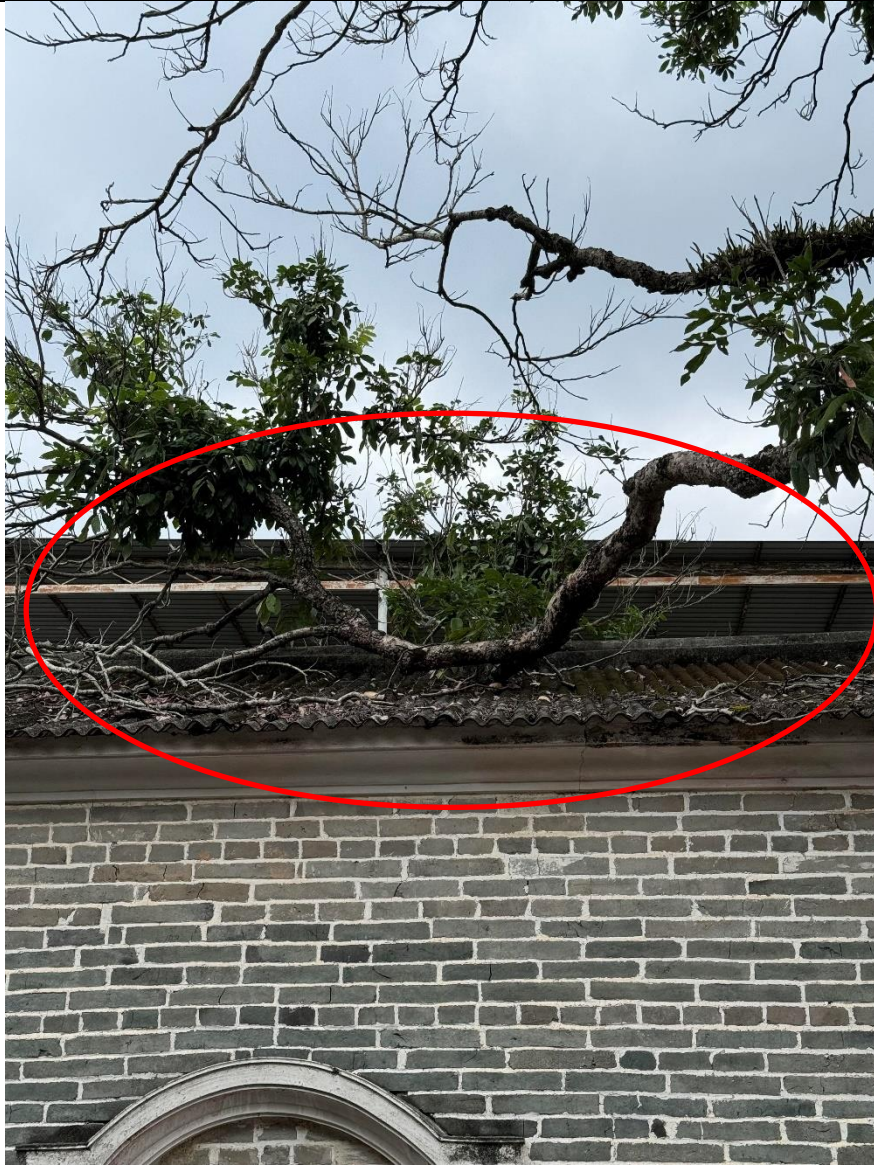
D3.40

Tree branches were fallen on the roof at the south wall of the Chapel.

Removal of vegetation on building structures and fallen tree branches on roof top prior to the commencement of works is recommended. Removal and repair work to the spalling on balcony at the main entrance should also be considered.

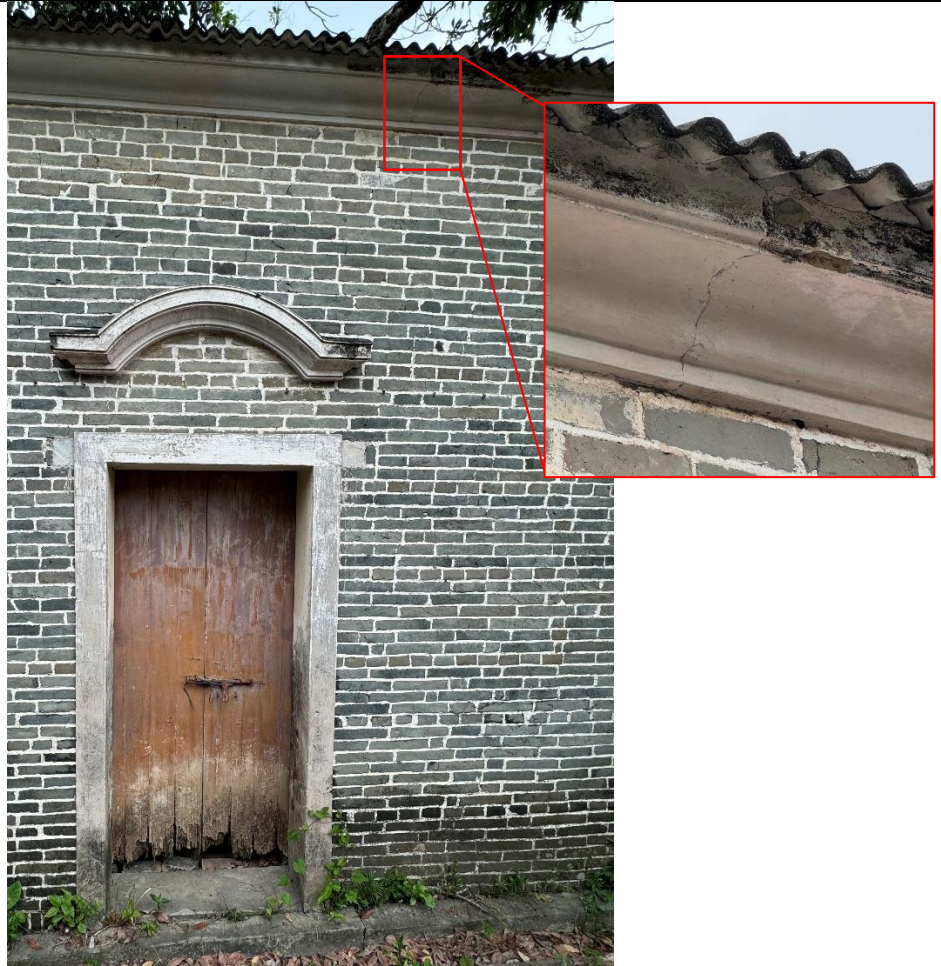
D3.42

Minor crack was found on the south wall eaves of Chapel.

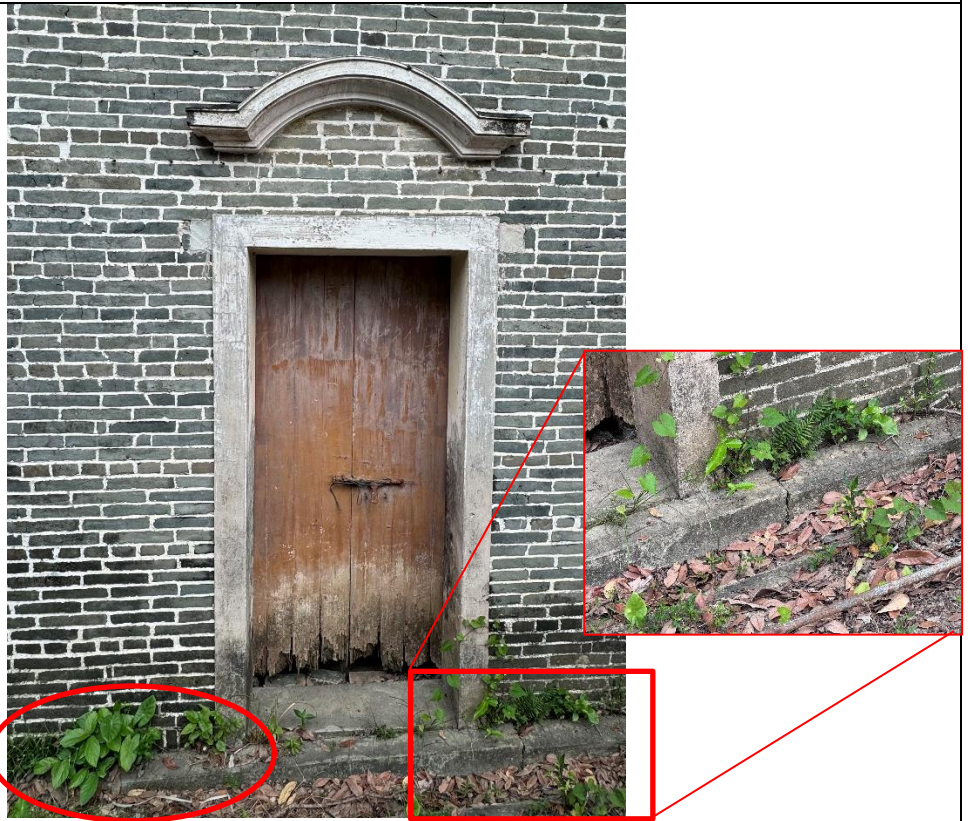
D3.43

Some vegetations growth at the side door and severe crack was found on the foundation.

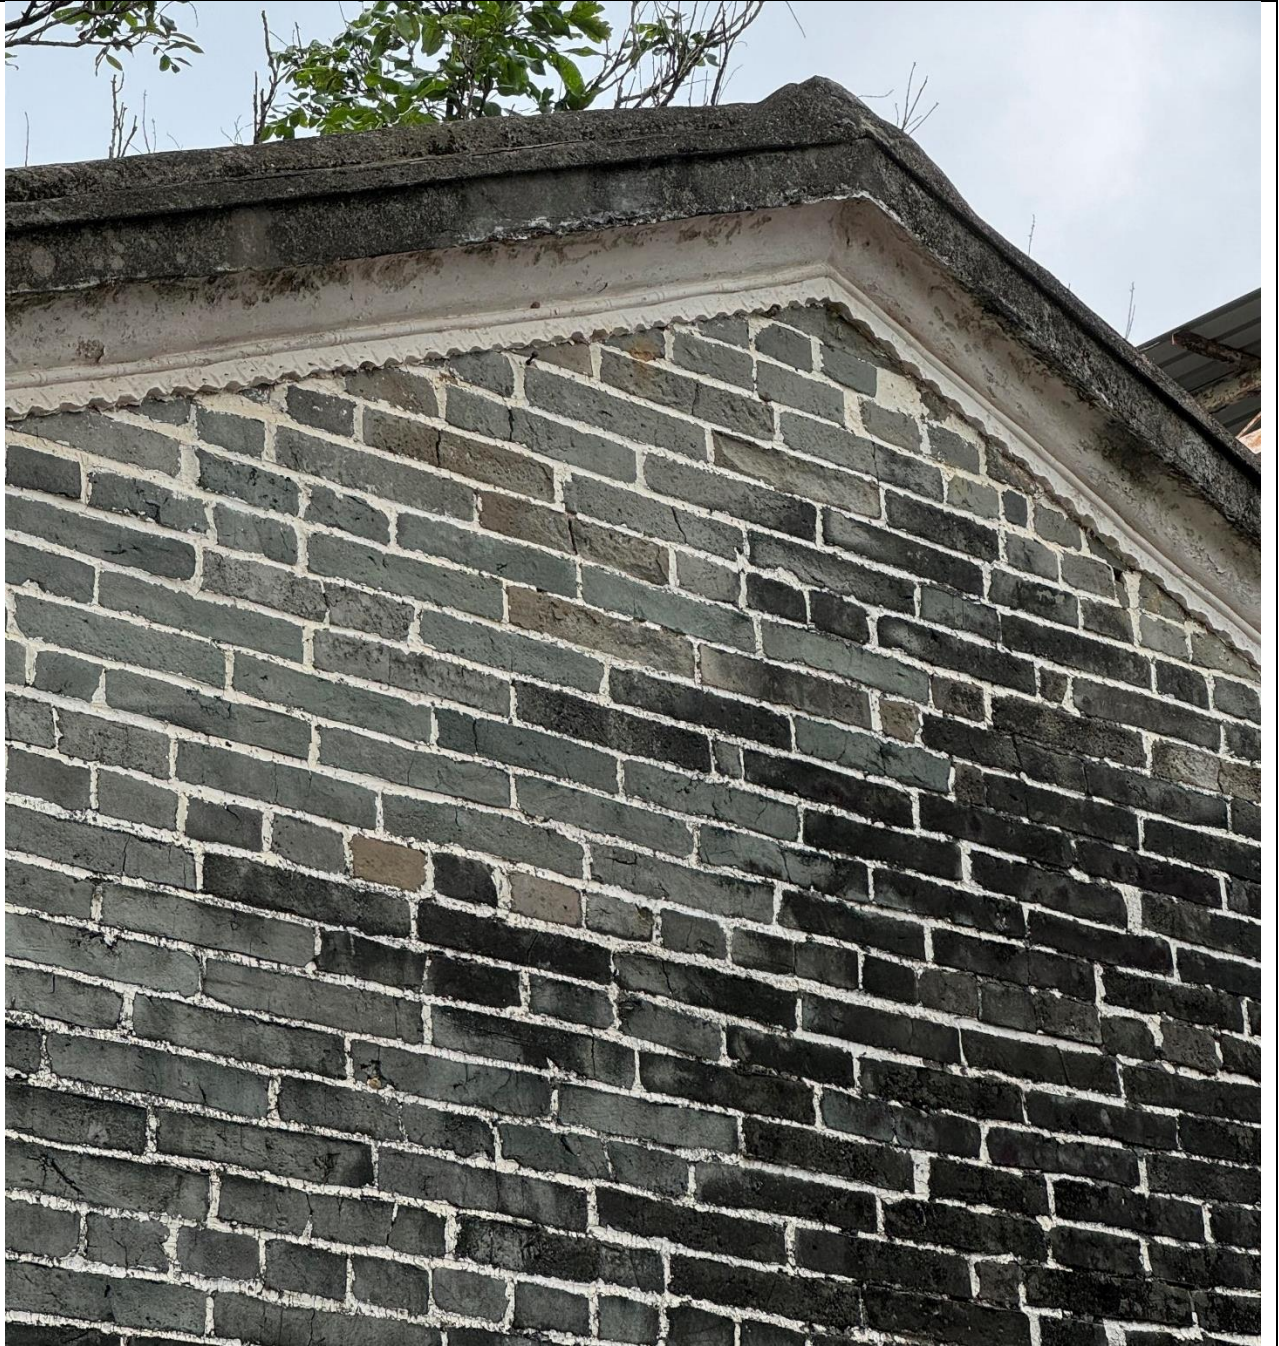
D3.54

Minor and severe cracks were found on the south wall of the Chapel.

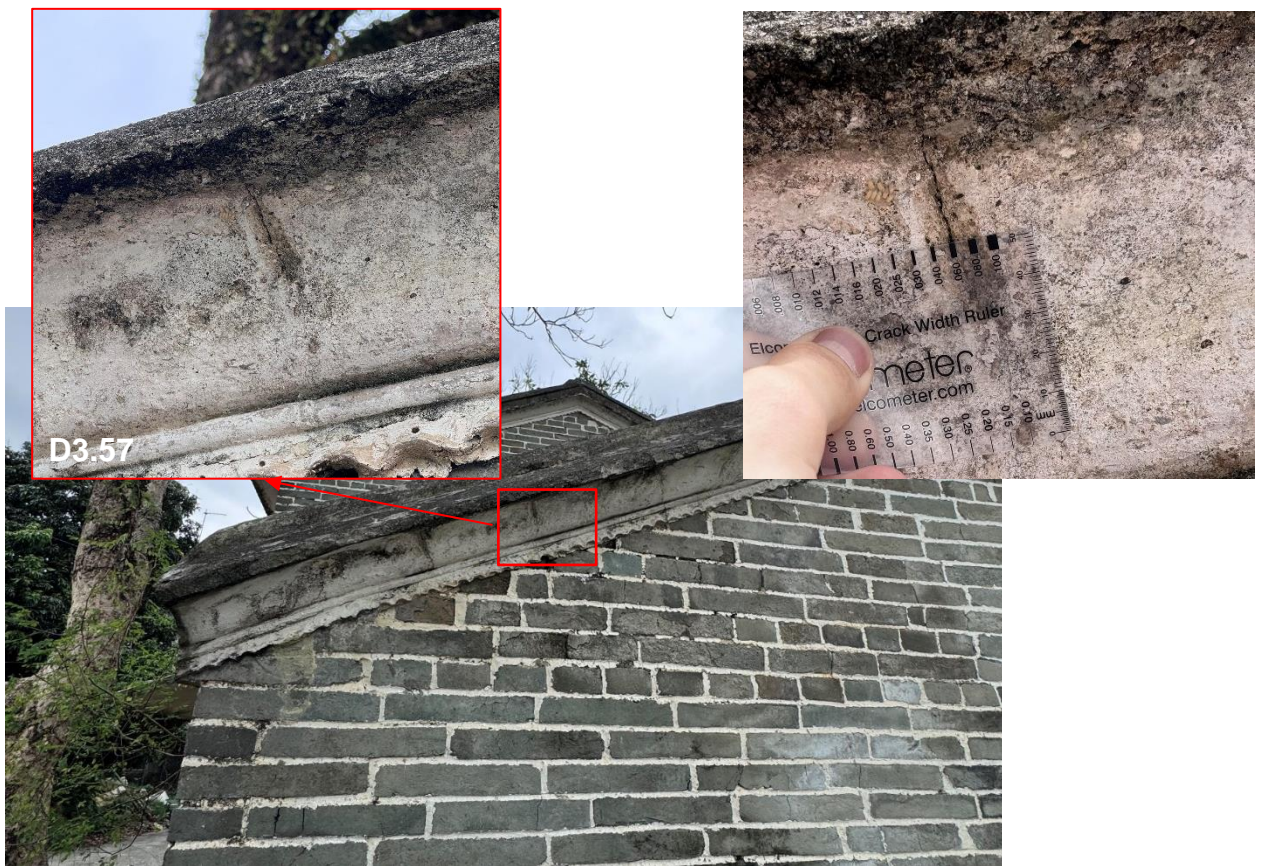
D3.57

Hairline crack (less than 1mm) was found on the east wall eaves of the storeroom2.

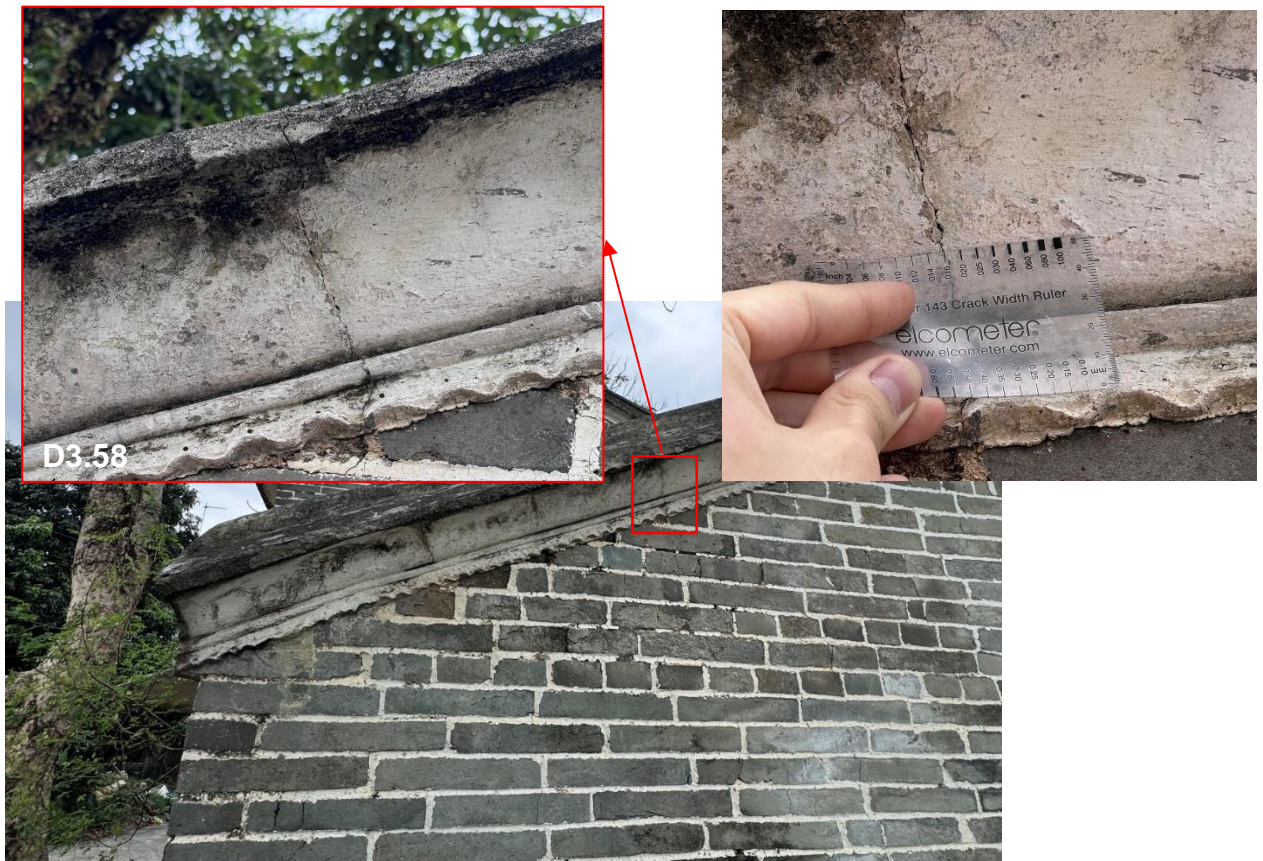
D3.58

Hairline cracks (less than 1mm) were found on the east wall eaves of the storeroom2.

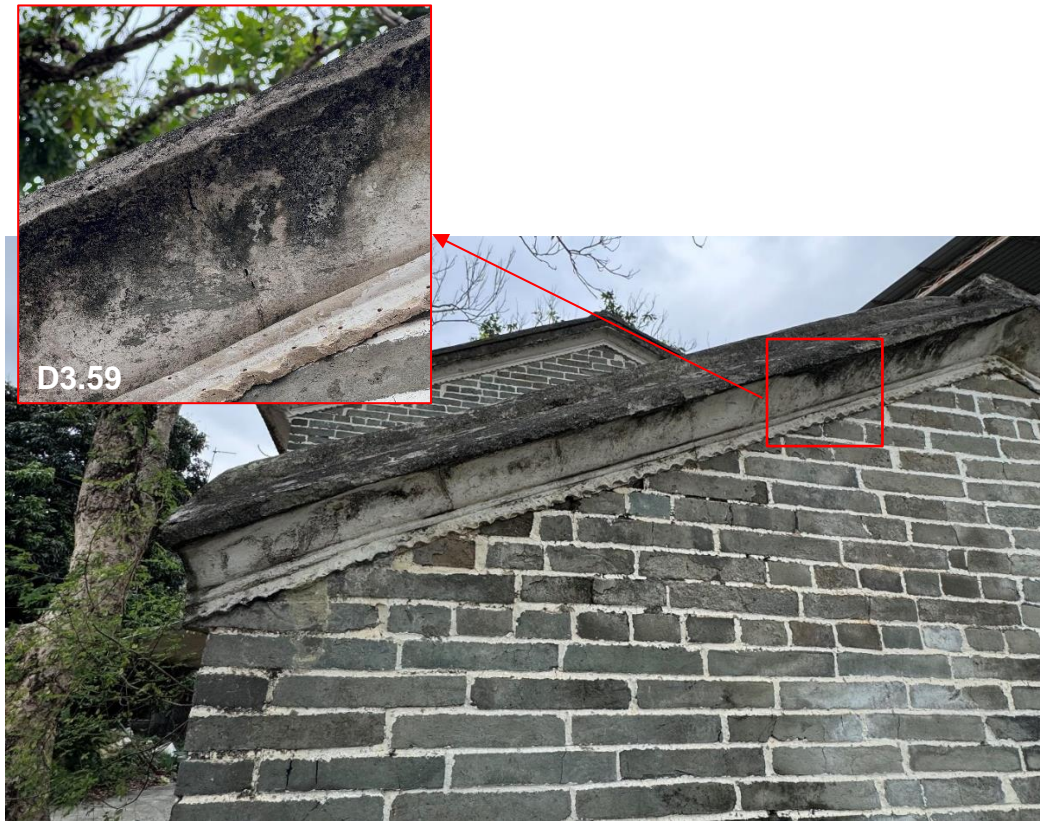
D3.59

Hairline cracks were found on the east wall eaves of the storeroom2.

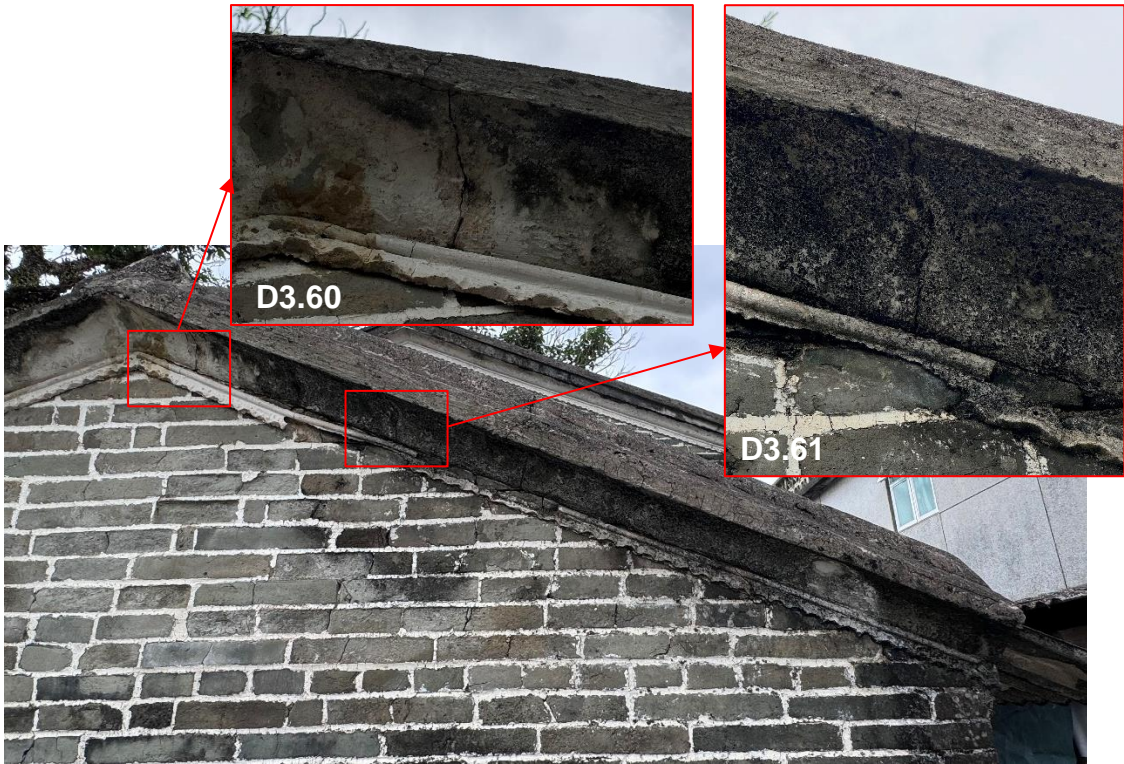
D3.60, D3.61

Hairline cracks were found on the east wall eaves of the storeroom2.

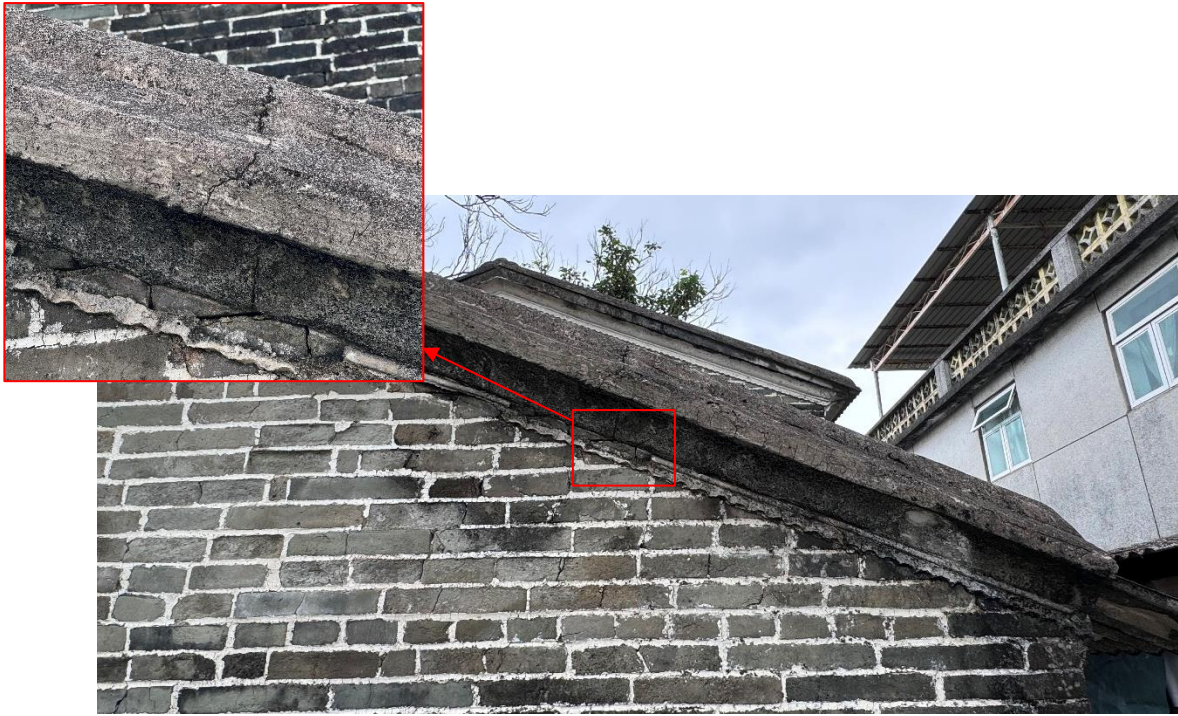
D3.62

Hairline cracks and minor cracks were found on the east wall eaves of the storeroom2.

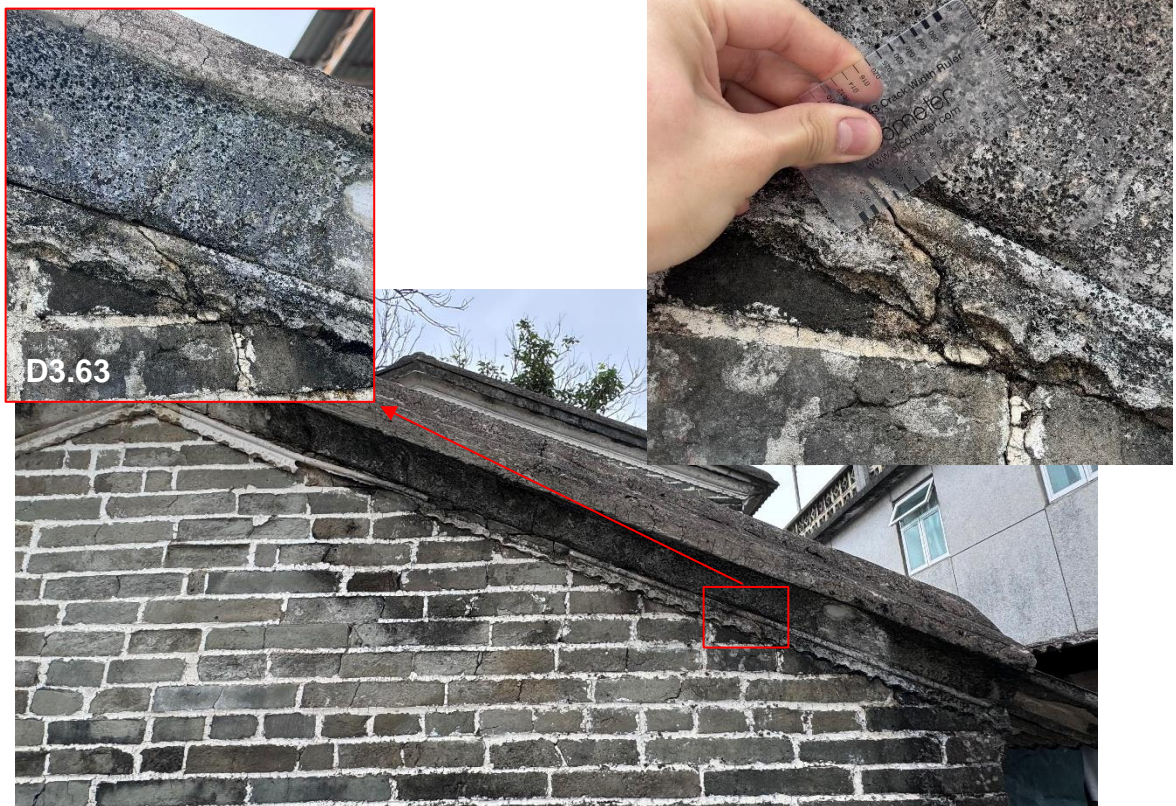
D3.63

Minor crack was (less than 2mm but wider than 1mm) found on the east wall eaves of the storeroom2.

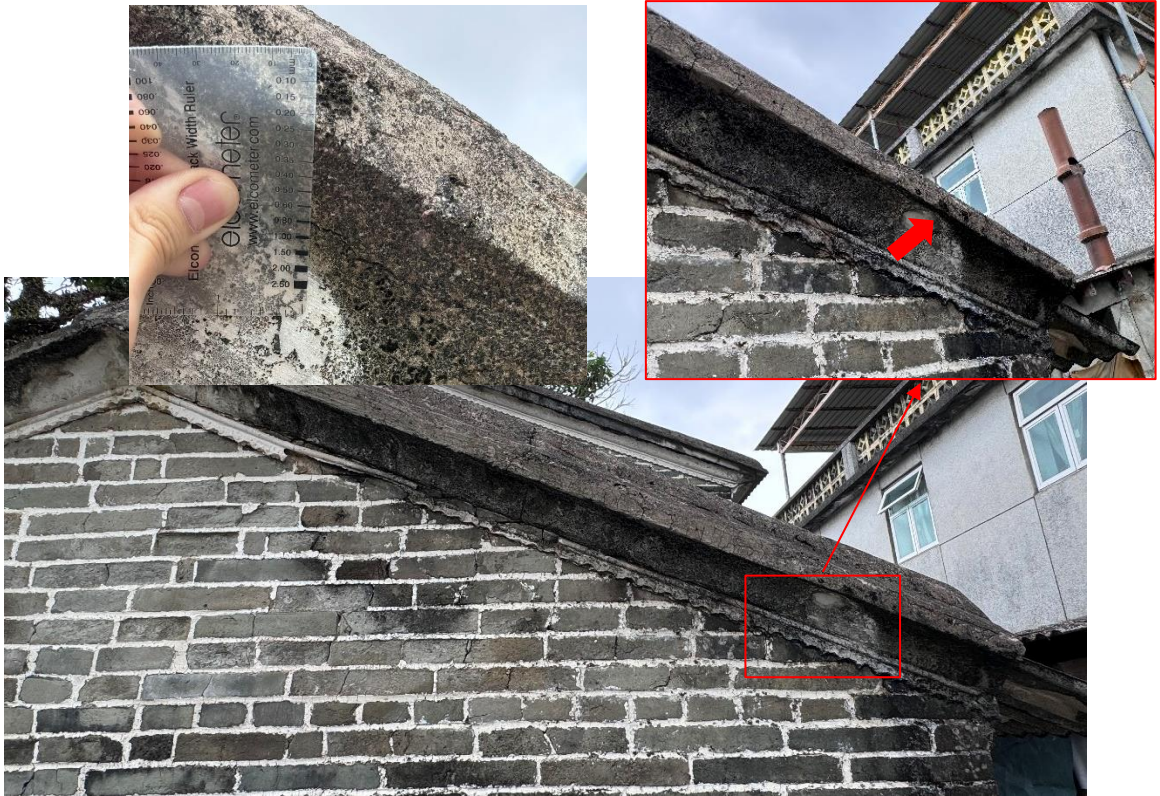
D3.64

Hairline crack (less than 1mm) was found on the east wall eaves of the storeroom2.

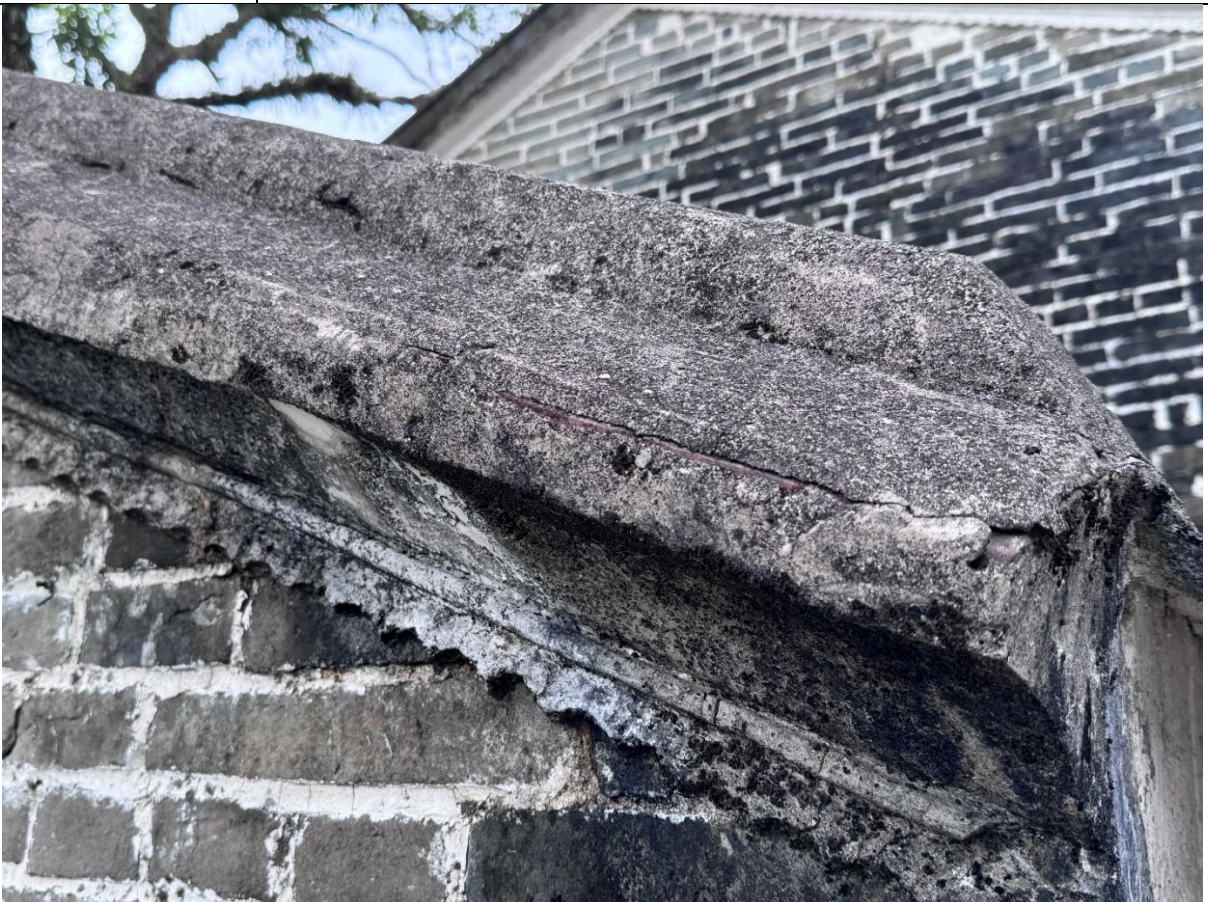
D3.65

Minor concrete spalled was found on the eaves of the storeroom2 and the reinforcement was exposed.

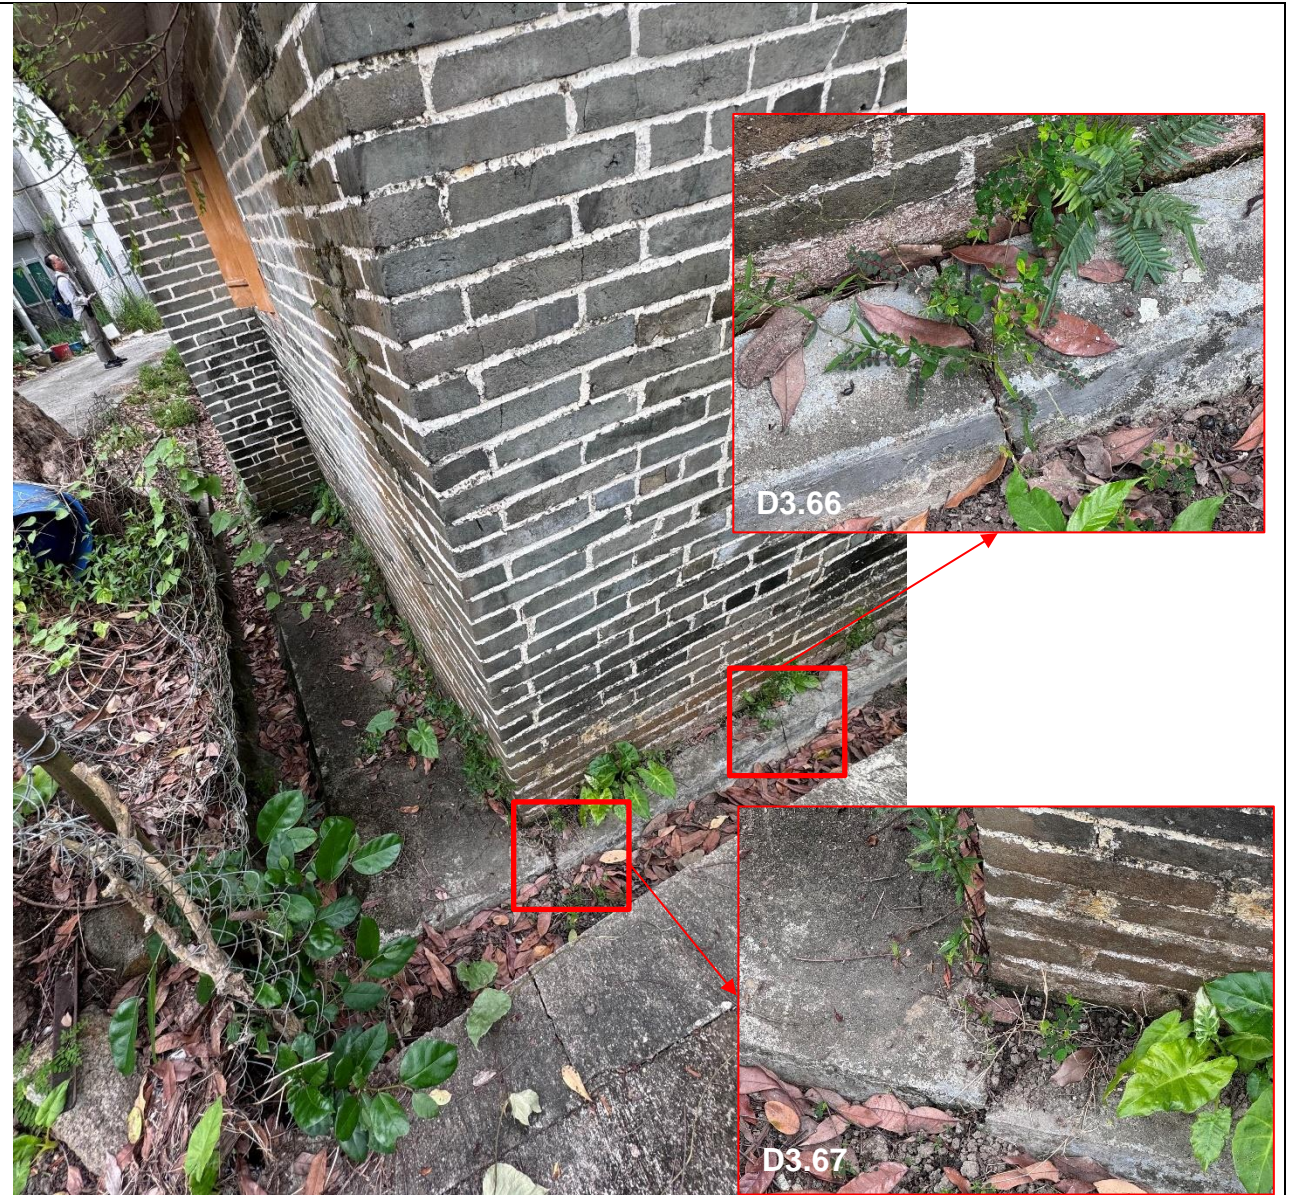
D3.66, D3.67

Severe cracks were found on the foundation of the storeroom2.

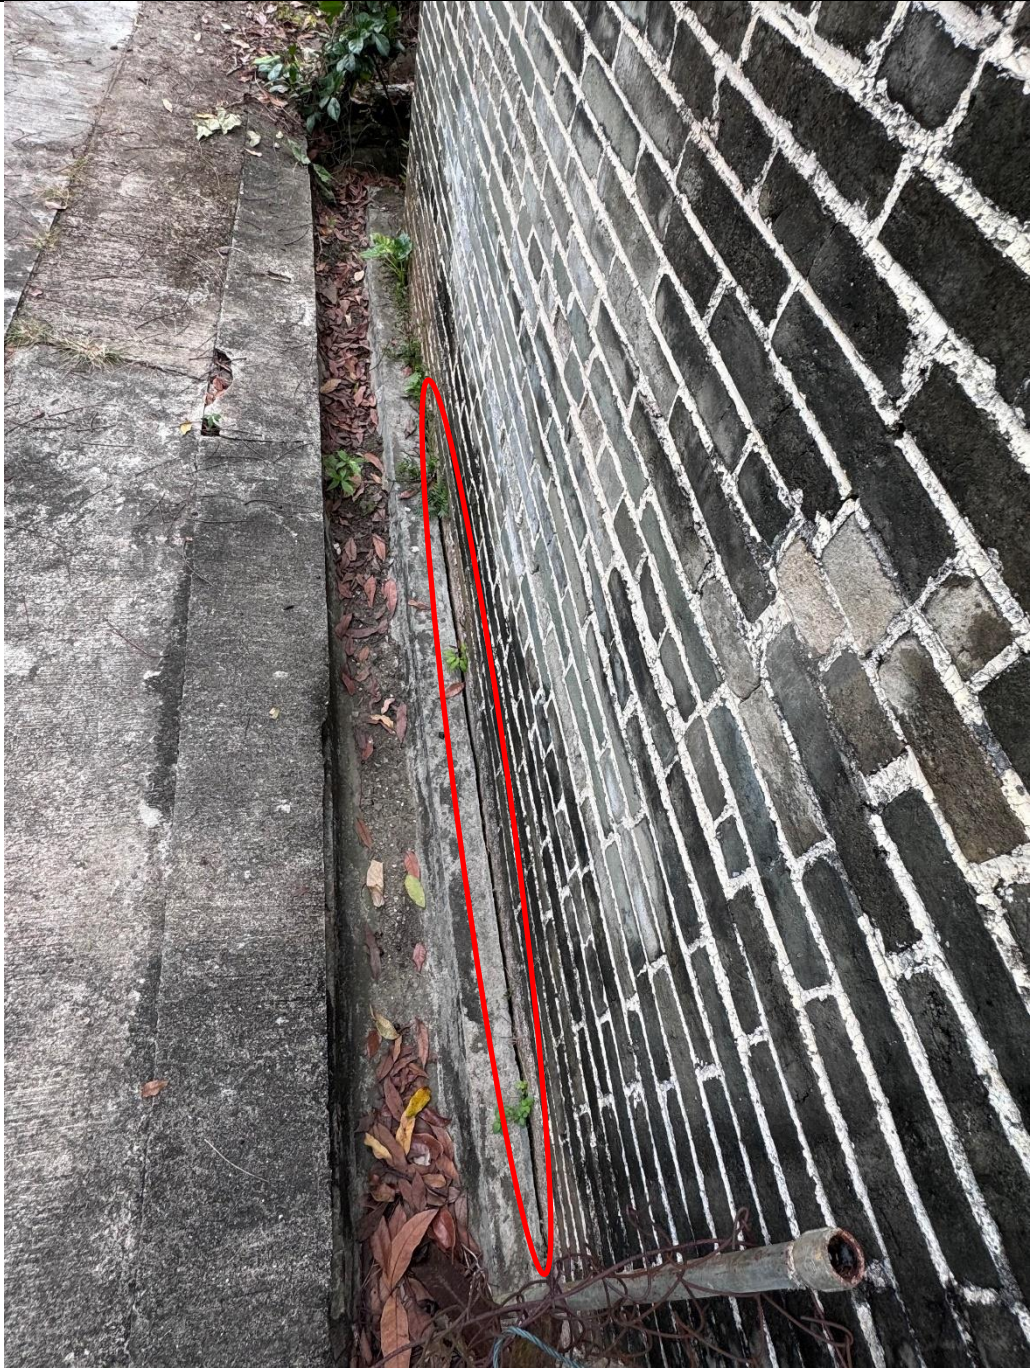
D3.68

A gap between brickwork wall and surface channel was found at the east wall of the storeroom 2
