**Agreement no. CE 47/2014 (GE)
-Landslip Prevention and Mitigation
Programme near Bride's Pool Road,
Tai Po – 3SE-D/SA2**

**Monthly Environmental Monitoring and
Audit Report for
April 2024**

(Version 1.0)

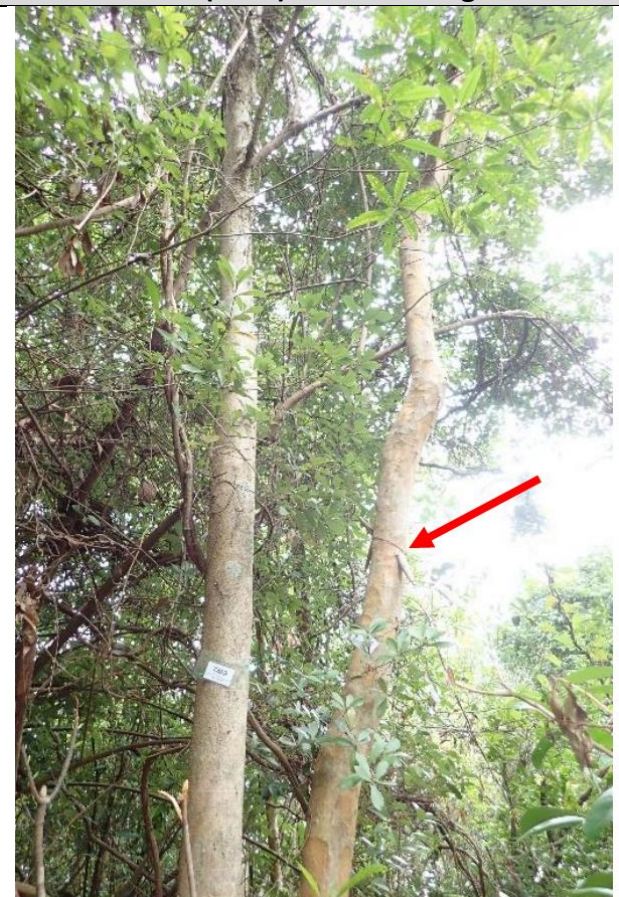
T470: Baseline stage

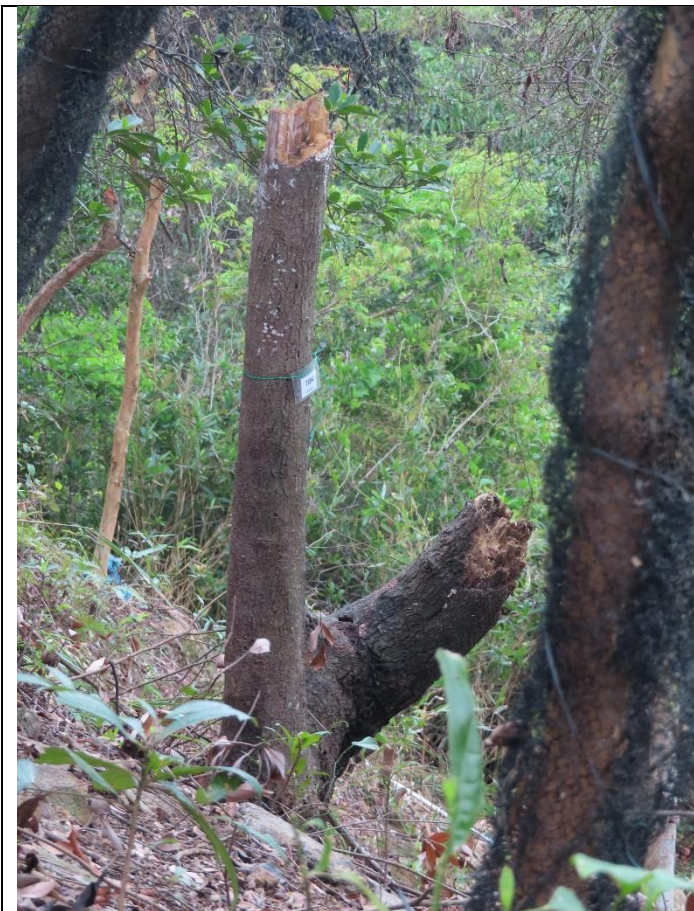
- 3.4.4 T470, T694 and T702 were found dead during the reporting period. The main trunk of T694 was broken (**Appendix B3**). However, it is not likely caused by the construction work as no construction works was conducted nearby T694 during the reporting period and the trunk is broken instead of chopped.

T694: Dead (Main trunk broken)

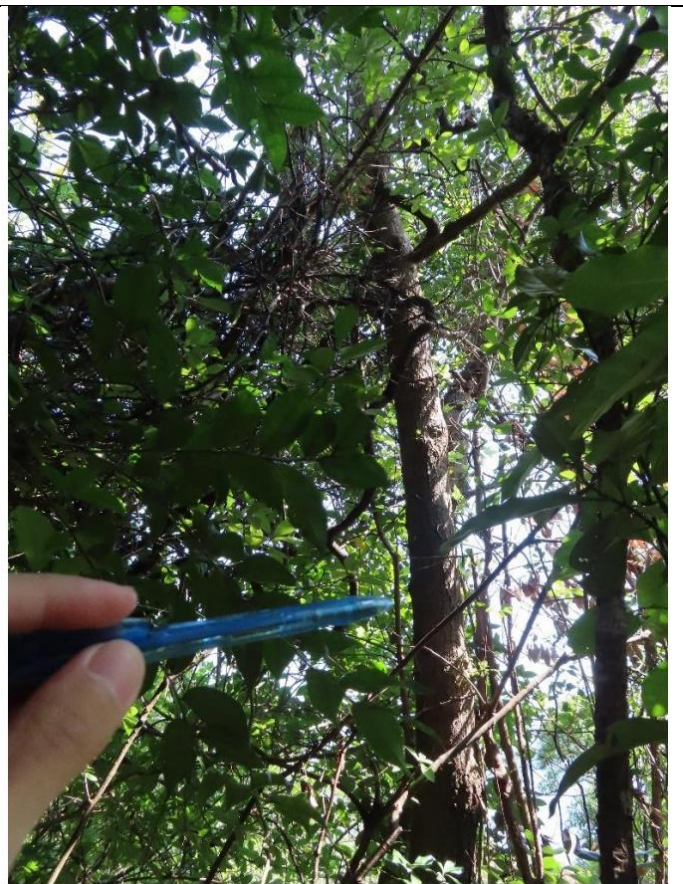
T694: Baseline stage

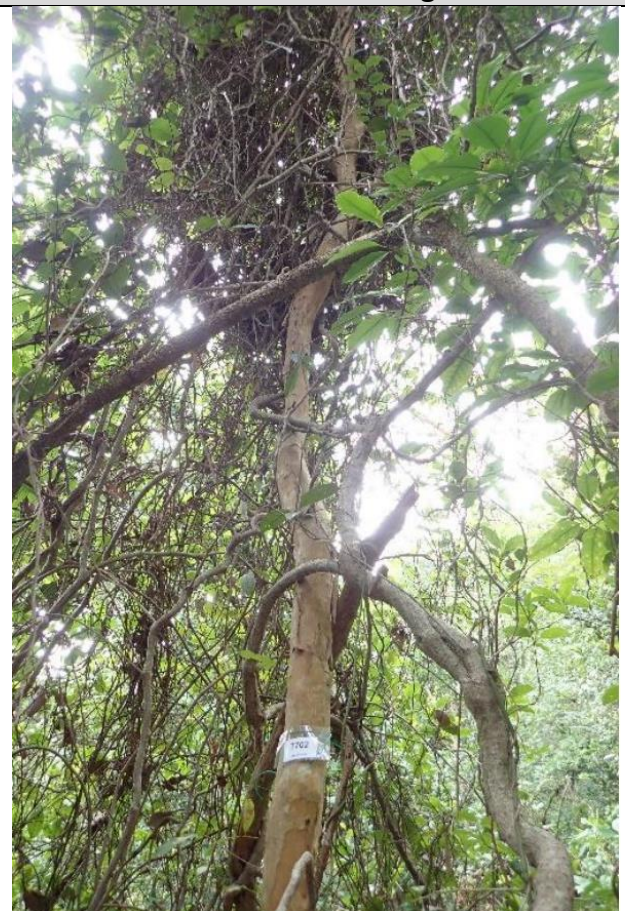
- 3.4.5 As poor health conditions were found in T470 (dead branches and covered by climbers) and T702 (covered by climbers and low foliage) during baseline stage, plus mitigation measures were done by the Contractor (i.e. temporary access was built on top of the root of trees and protection net was wrapped on the tree trunk) (**Appendix B3**), therefore it is not likely that the dead of T470, T694 and T702 were caused by the construction works. No compensation of trees were needed for this case.

T702: Baseline Stage

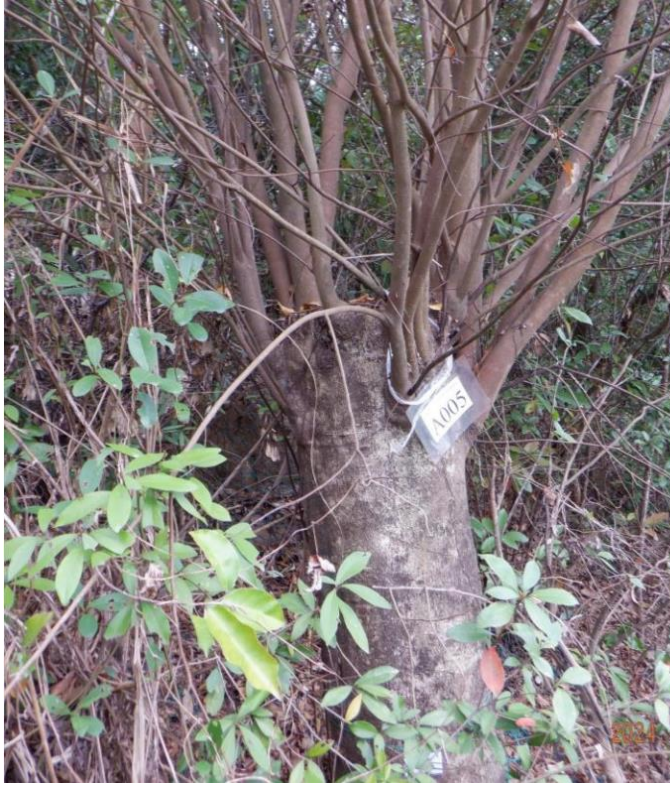
A005 from Catchment 3 (Before chop)
Photo taken in February 2024

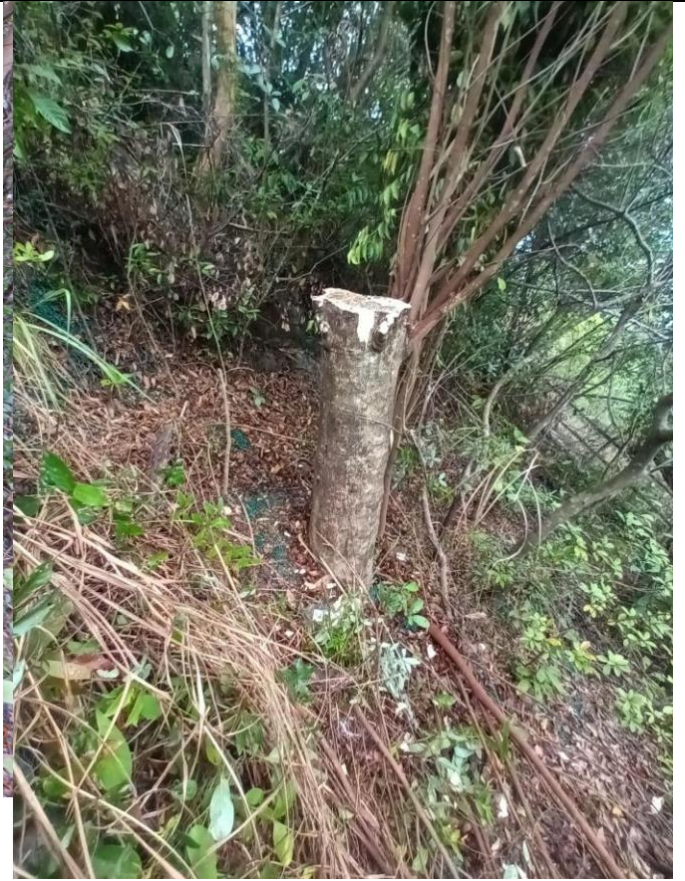
- 3.4.9 Before the construction work started (15 April 2024), the Contractor noted that there was an *A. sinensis* in Catchment C chopped by unknown party. The Contractor has informed EPD immediately after knowing this situation. The photo records of the affected *A. sinensis* were shown in **Appendix B.**

A005 from Catchment 3 (Chopped)
Photo taken in March 2024
