# Civil Engineering and Development Department

**Agreement no. CE 47/2014 (GE)  
-Landslip Prevention and Mitigation  
Programme near Bride's Pool Road,  
Tai Po – 3SE-D/SA2**

**Monthly Environmental Monitoring and  
Audit Report for  
May 2024**

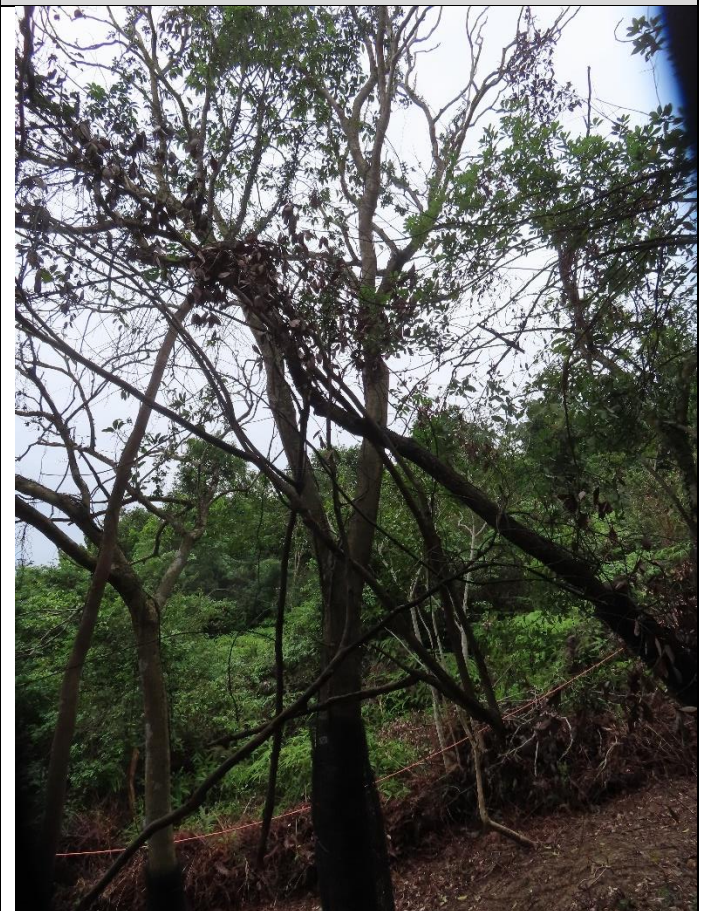
**T420**

- 3.4.3 A total of 177 trees were surveyed during the reporting period, most of them do not have significant difference compared to the baseline period. It is noted that T420 was found seriously in low foliage and have broken branches during the reporting period (**Appendix B3**). However, no obvious wound or cut was found on the tree trunk, mitigation measure were done by the Contractor (i.e. Tree Protection Zone with orange net and porous and non-water holding material cover), therefore it is not likely that situation of T420 was caused by the construction works. As there is no direct evidence linking the dead tree to the construction works of the Project, compensation of tree is not needed.

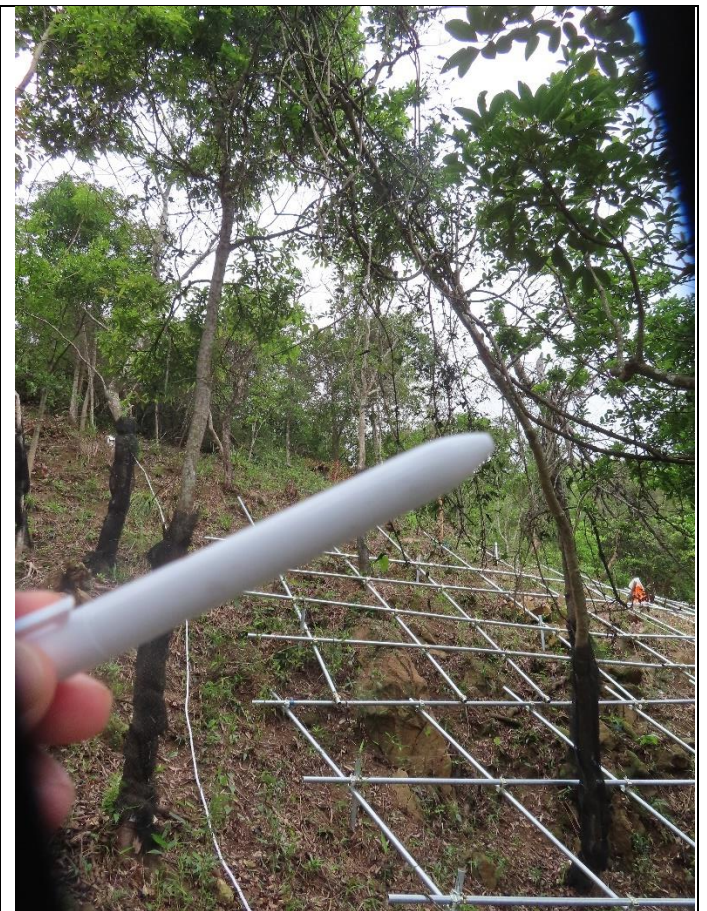
- 3.4.4 T683 and T685 were found dead during the reporting period. The leaves of both two trees were fully fallen, T685 was also found broken branches during the reporting period (**Appendix B3**). No wound or cut was found on the trunk of two trees. As two trees were protected well with porous and non-water holding material cover, it is not likely the dead of two trees were caused by the construction work. No compensation of trees is needed.

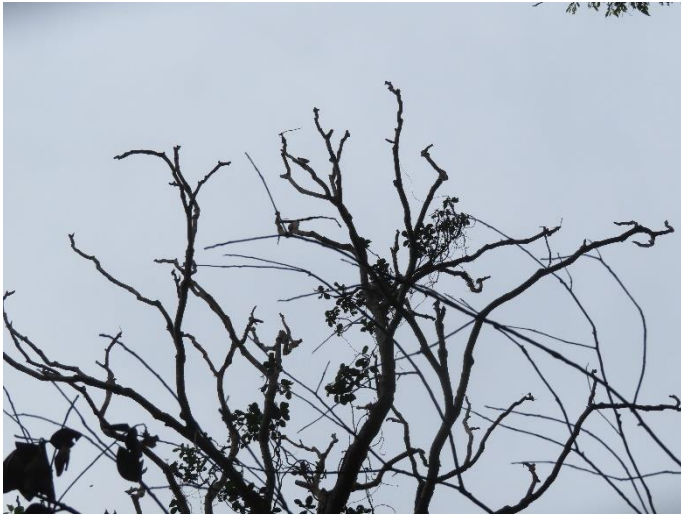
**T420 (low foliage, broken branches)**

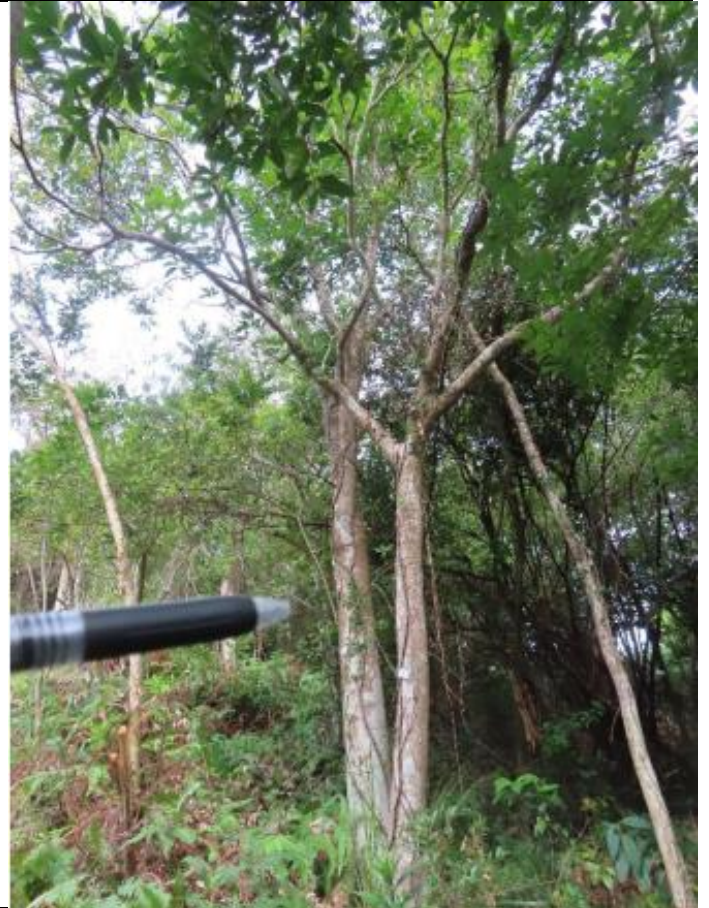
**T420 (baseline stage)**

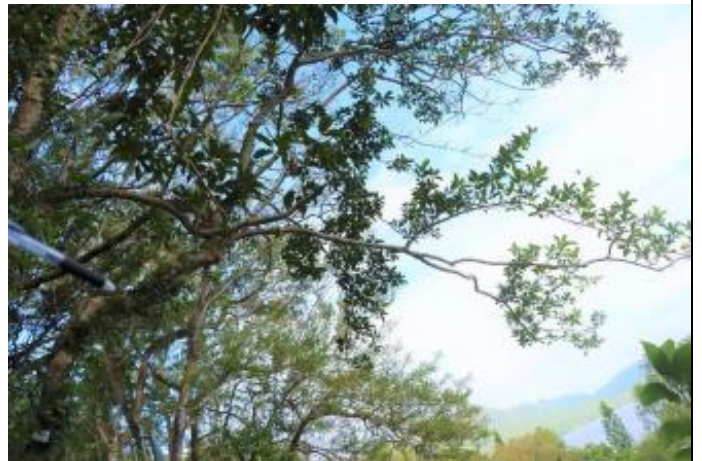
- 3.4.6 T564 was found chopped during the reporting period. The reason of chopping of tree is under investigation. If the reason is related to construction works, compensation tree should be planted by the Contractor.

**T564 (dead, chopped)**

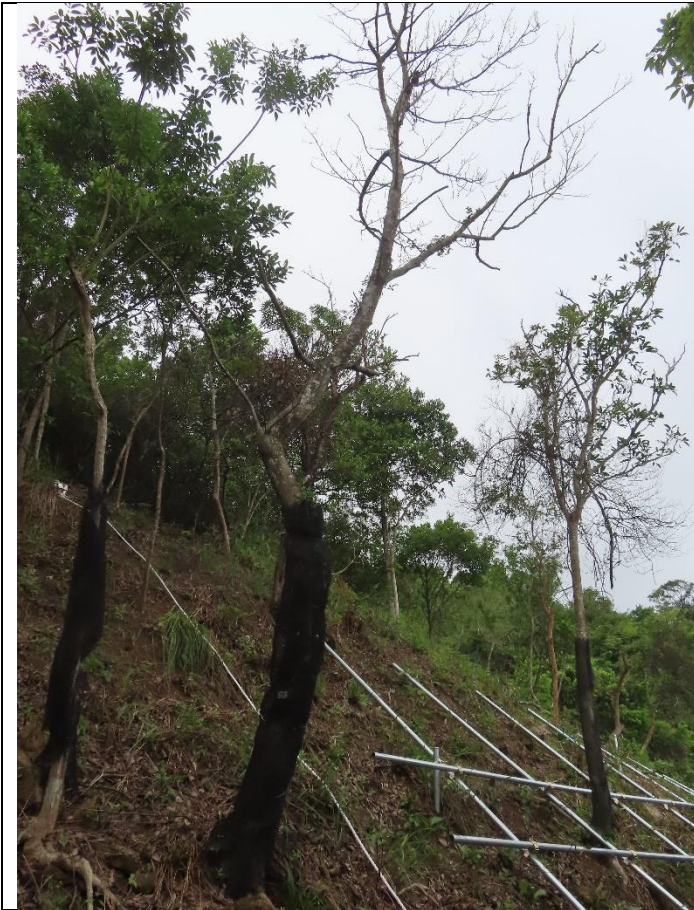
**T683 (dead)**

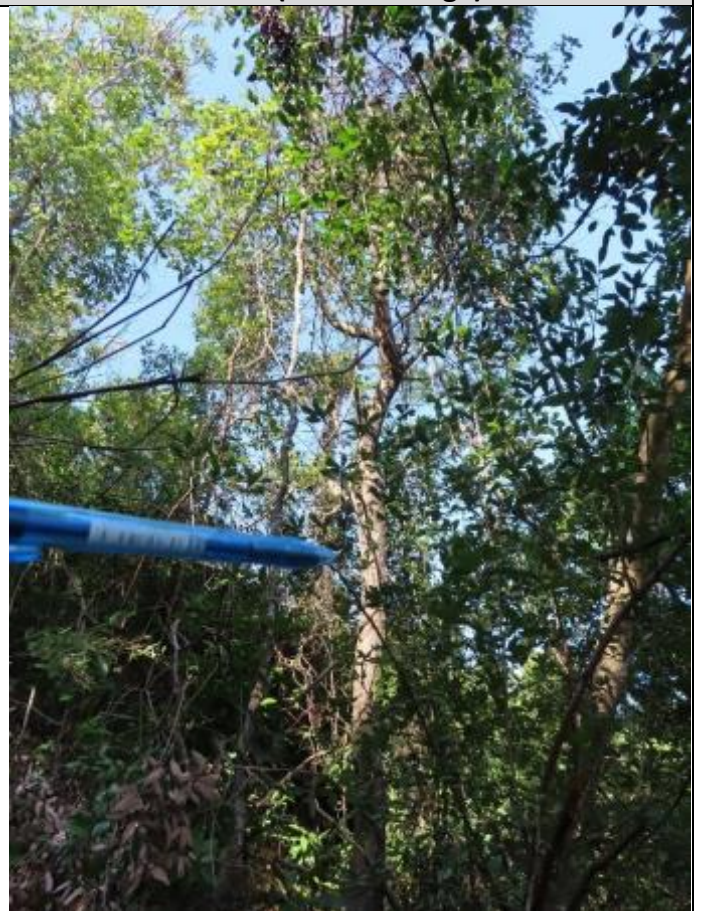
**T685 (baseline stage)**
