Civil Engineering and Development Department

**Agreement no. CE 47/2014 (GE)
-Landslip Prevention and Mitigation
Programme near Bride's Pool Road,
Tai Po – 3SE-D/SA2**

**Monthly Environmental Monitoring and
Audit Report for
July 2024**

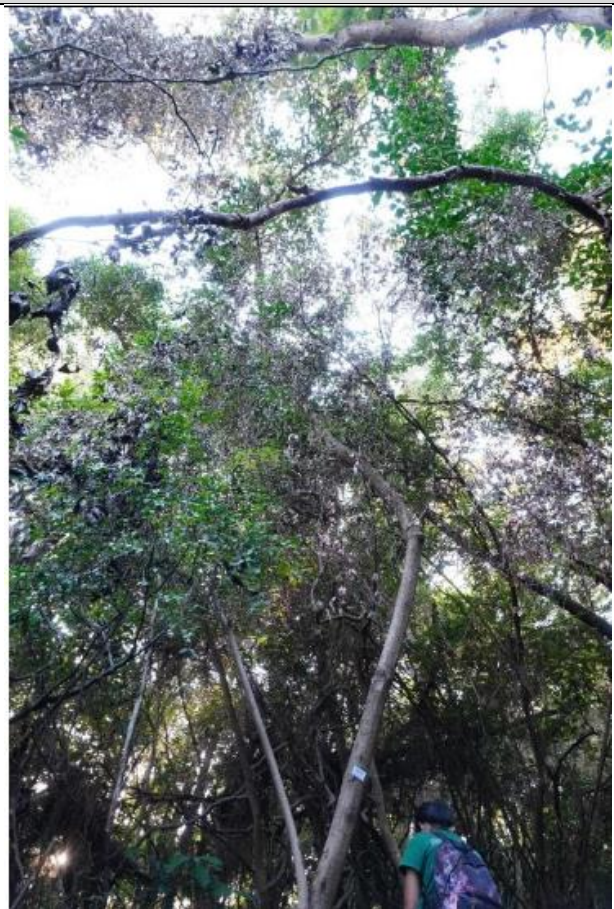
T213 (baseline stage)

- 3.4.3 A total of 195 trees were surveyed during the reporting period, most of them do not have significant difference compared to the baseline period. It is noted that T210, T213, T236, T246 and T280 were found dead during the reporting period. However, no obvious wound or cut was found on the tree trunk. Therefore it is not likely that situation of T210, T213, T236, T246 and T280 were caused by the construction works, compensation of tree is not needed.

T213 (dead)

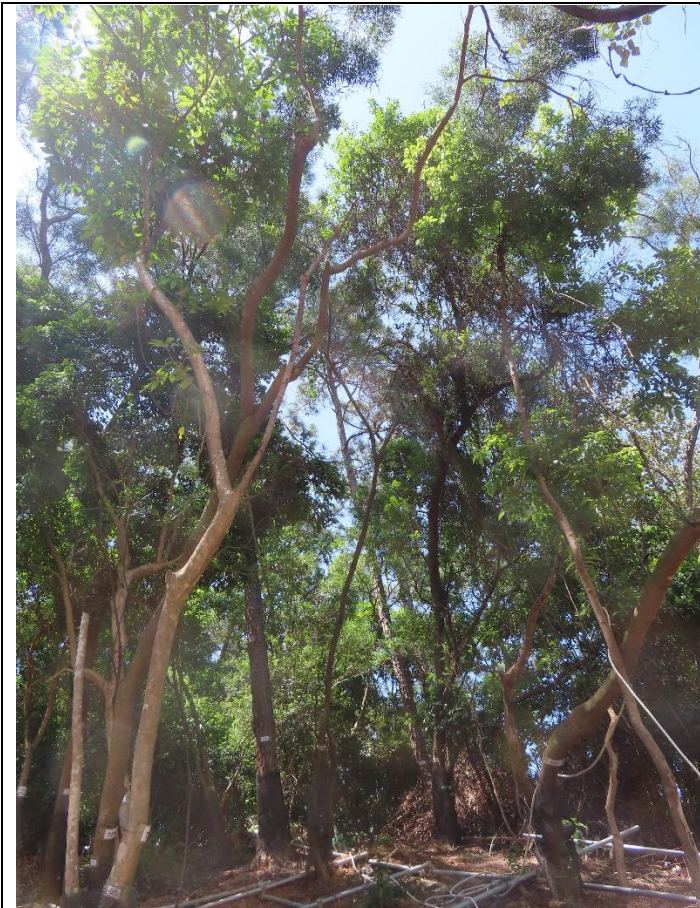
T236 (dead)

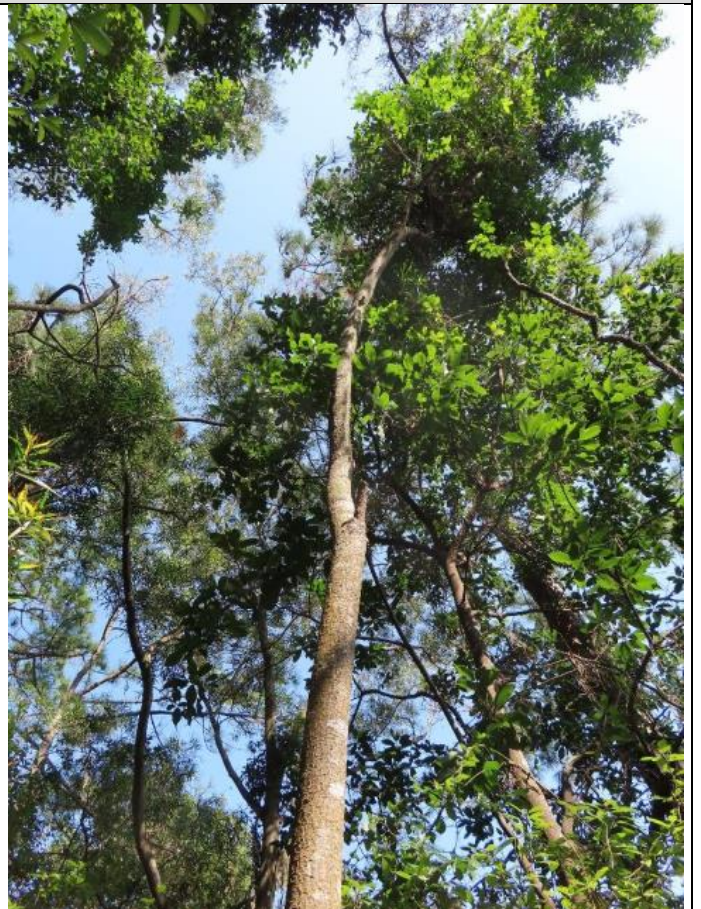
T246 (baseline stage)

T246 (dead)

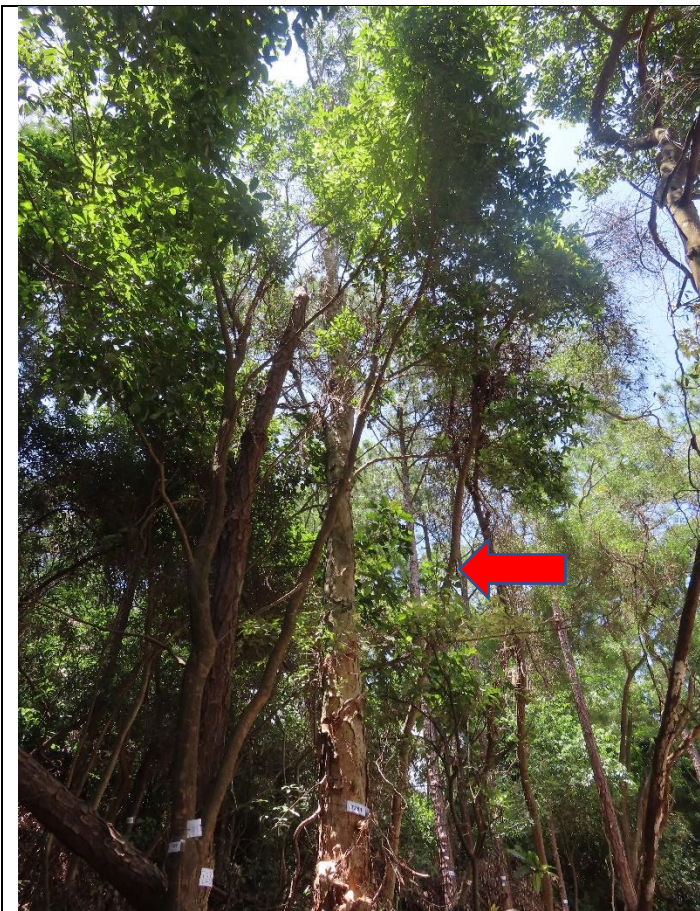
T280 (dead)

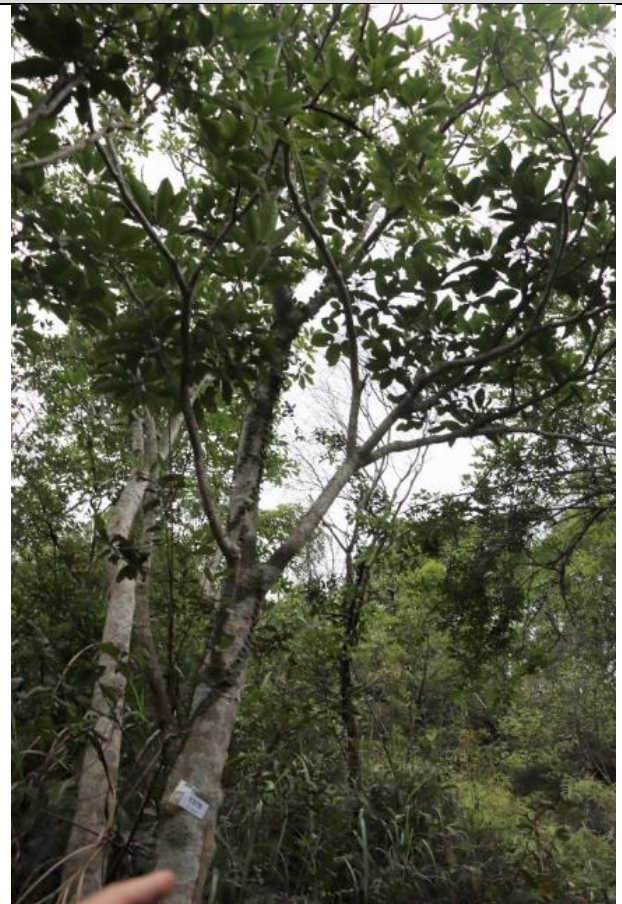
T376 (baseline stage)

- 3.4.4 T376, T391 and T420 were found unhealthy (i.e. low foliage) during the reporting period (**Appendix B3**). However, no obvious wound or cut was found on the tree trunk, mitigation measure were done by the Contractor (i.e. non-water holding material cover), and no construction work was conducted nearby these trees. Therefore it is not likely that situation of T376, T391 and T420 were caused by the construction works. As there is no direct evidence linking the tree to the construction works of the Project, compensation of tree is not needed.

T376 (low foliage)

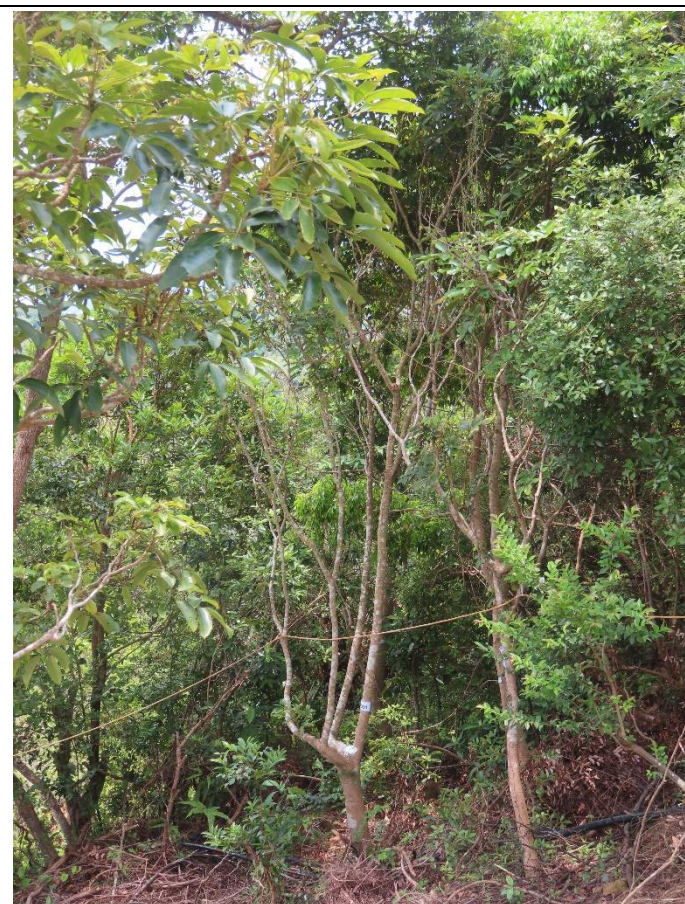
T391 (low foliage)

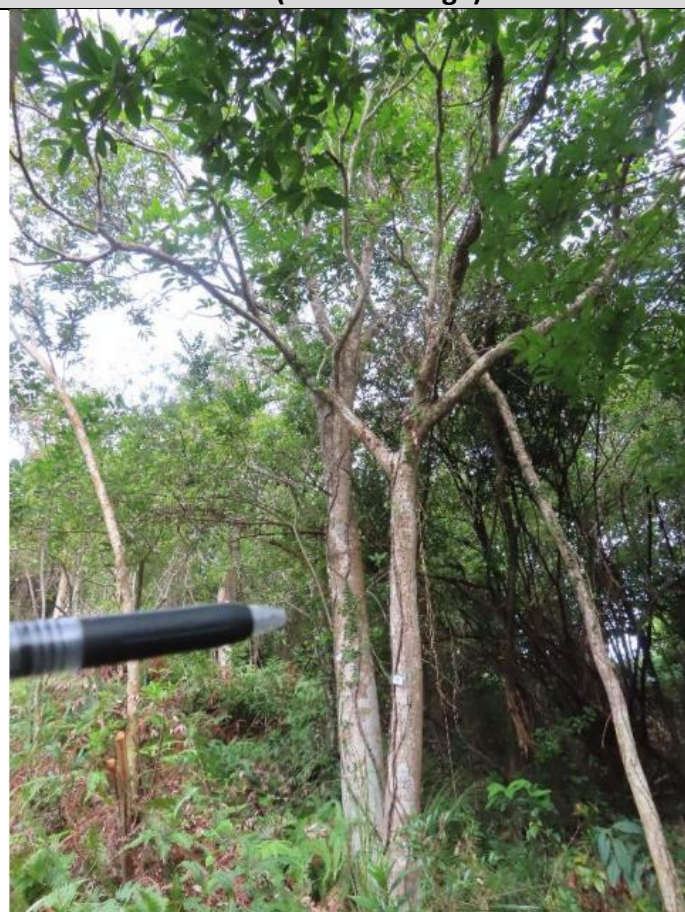
T420 (baseline stage)

T420 (low foliage)

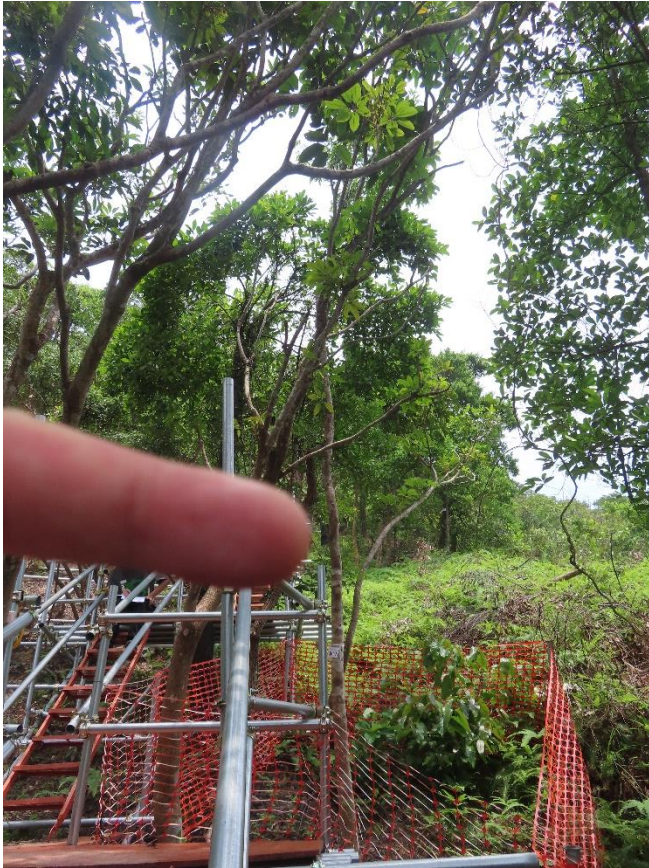
A019 (low foliage)

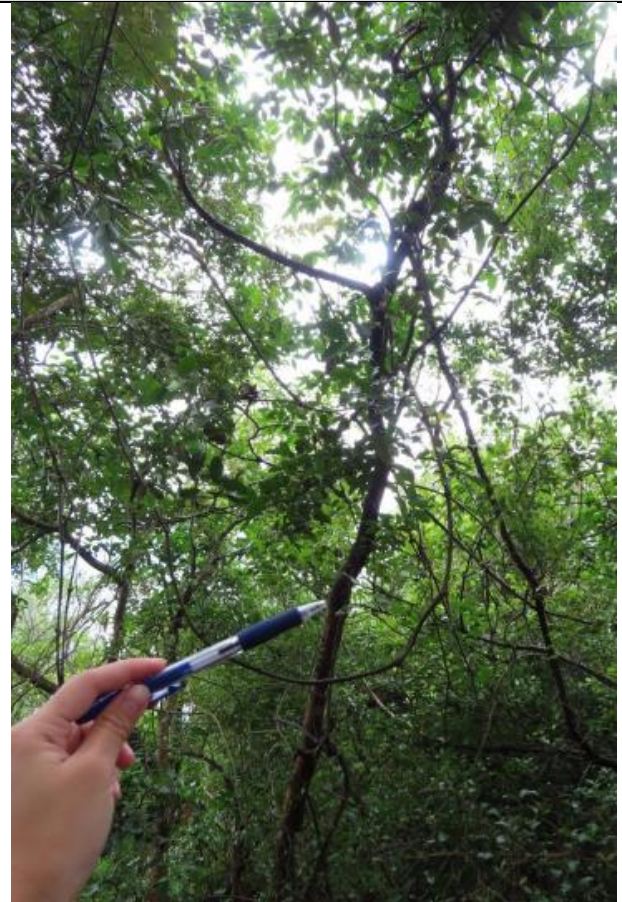
A023 (baseline stage)

A023 (low foliage)

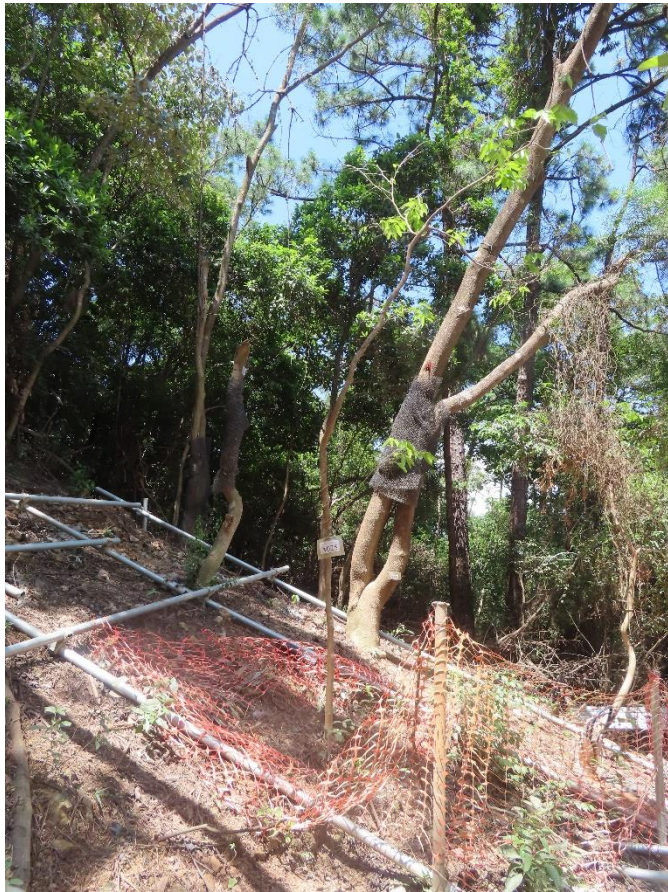
A025 (low foliage)
