Civil Engineering and Development Department

**Agreement no. CE 47/2014 (GE)
-Landslip Prevention and Mitigation
Programme near Bride's Pool Road,
Tai Po – 3SE-D/SA2**

**Monthly Environmental Monitoring and
Audit Report for
September 2024**

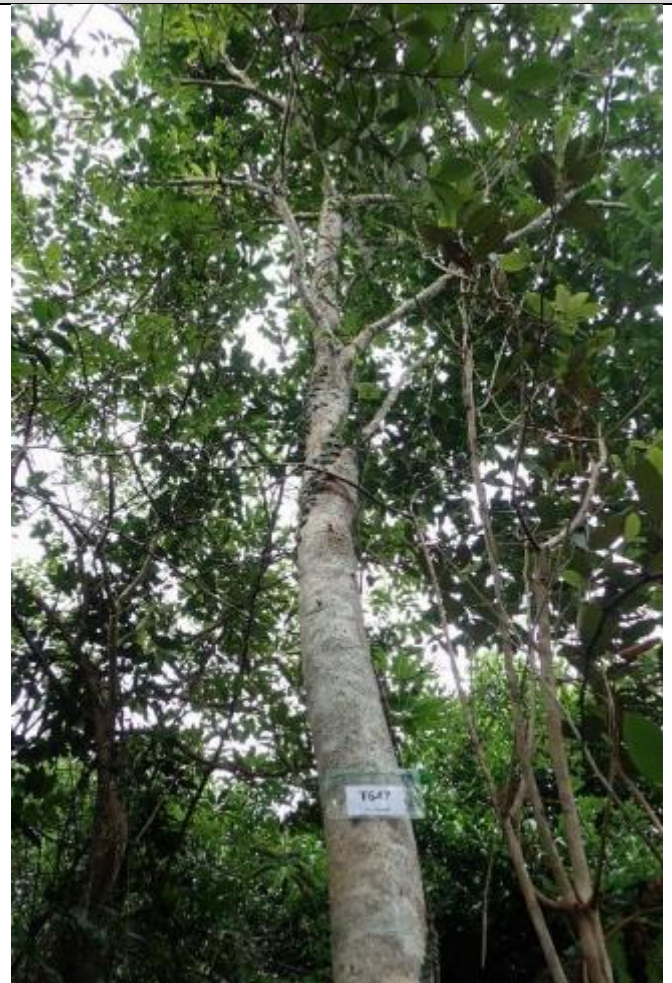
- 3.4.3 A total of 272 trees were surveyed during the reporting period, most of them do not have significant difference compared to the baseline period. It is noted that T418 and T647 were found low foliage during the reporting period (**Appendix B3**). However, no obvious wound or cut was found on the tree trunk. Therefore it is not likely that situation of T418 and T647 were caused by the construction works, compensation of tree is not needed.

T647 (low foliage)

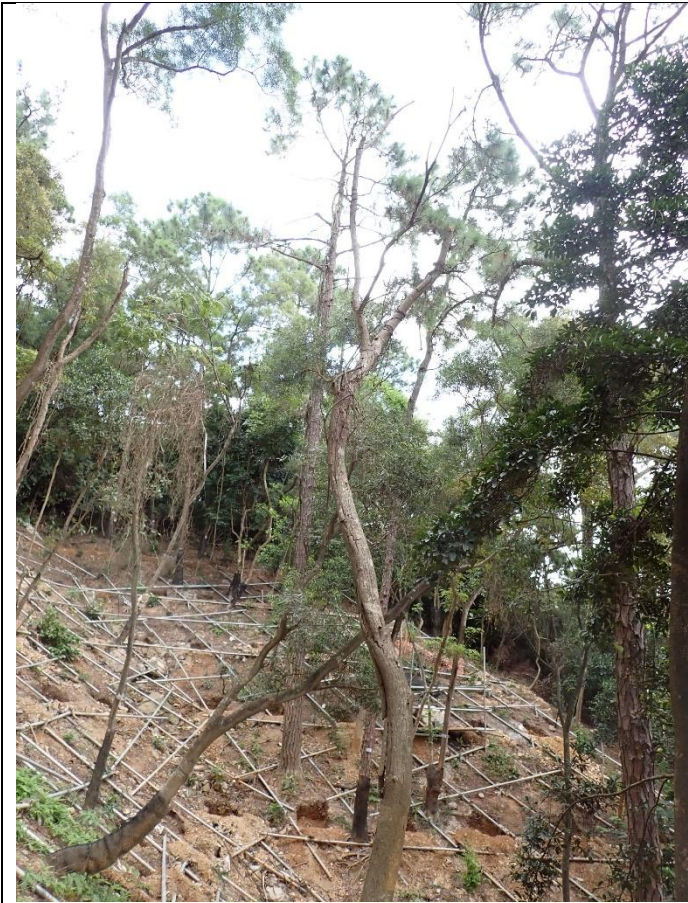
- 3.4.4 T194, T220, T445, T474 and T475 were found dead during the reporting period. The tree trunk of T220 are broken. As both tree trunk are broken instead of chopped, it is not likely the dead of T220 was caused by the construction work. No compensation of trees is needed. For T194, no obvious wound or cut was found on the tree trunk. Therefore it is not likely that situation of T194 was caused by the construction works, compensation of tree is not needed.

T194 (Dead)

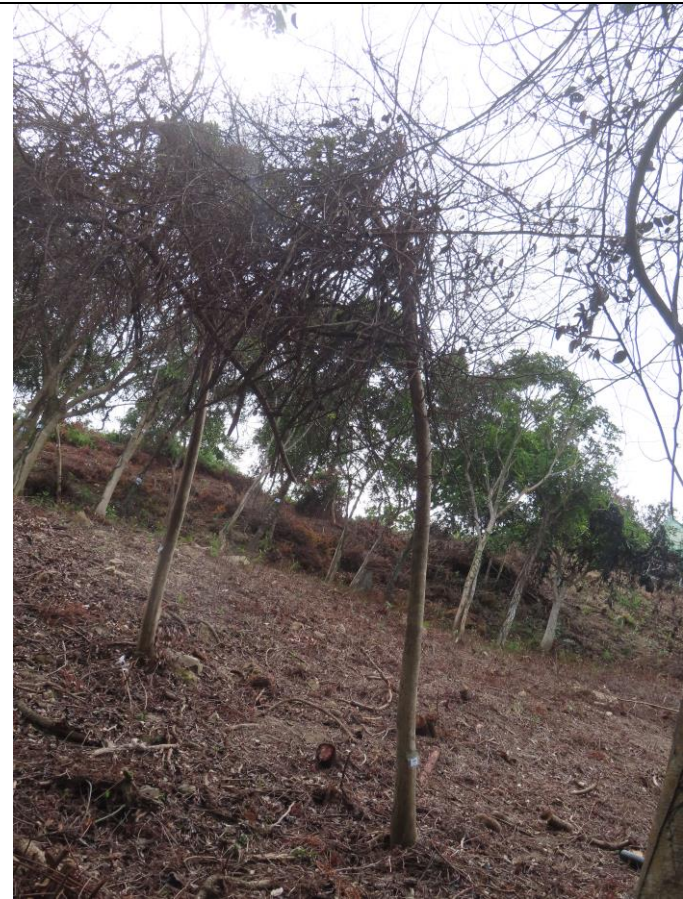
- 3.4.5 For T445, T474 and T475, considering unhealthy situation was found on T445, T474 and T475 at baseline stage (i.e. covered by climbers for T445, no foliage for T474 and T475) and no obvious wound or cut was found on the tree trunks, it is not likely that situation of T445, T474 and T475 were caused by the construction works, compensation of tree is not needed.

T445 (Dead)

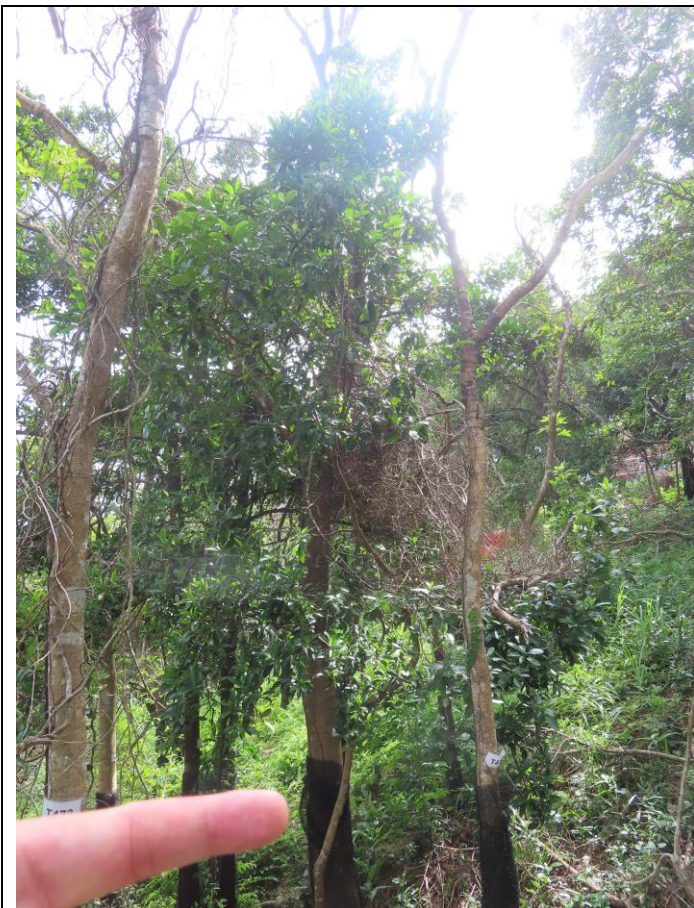
T475 (dead)
