Contract No. HY/2011/03

Hong Kong-Zhuhai-Macao Bridge Hong Kong Link Road Section between Scenic Hill and Hong Kong Boundary Crossing Facilities

Monthly EM&A Report No.96 (September 2020)

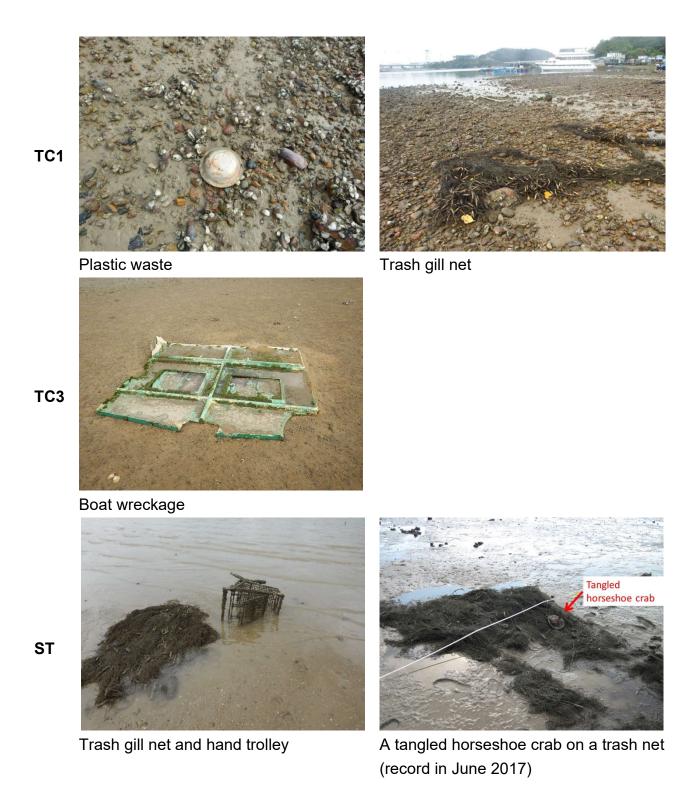
- 6.3.2 Since the field survey of June 2016, increasing number of trashes and even big trashes (**Figure 2.3 of Appendix I**) were found in every sampling zone. It raised a concern about the solid waste dumping and current-driven waste issues in Tung Chung Wan. Respective measures (e.g. manual clean-up) should be implemented by responsible governmental agency units.

Figure 2.3 Examples of photographic record of the big trashes found on the mudflat.
