# Central Police Station Conservation and Revitalisation Project

33rd Quarterly EM&A Report (1 April to 30 June 2024)

賽馬會文物保育有限公司 The Jockey Club CPS Limited

DATE 23 September 2024

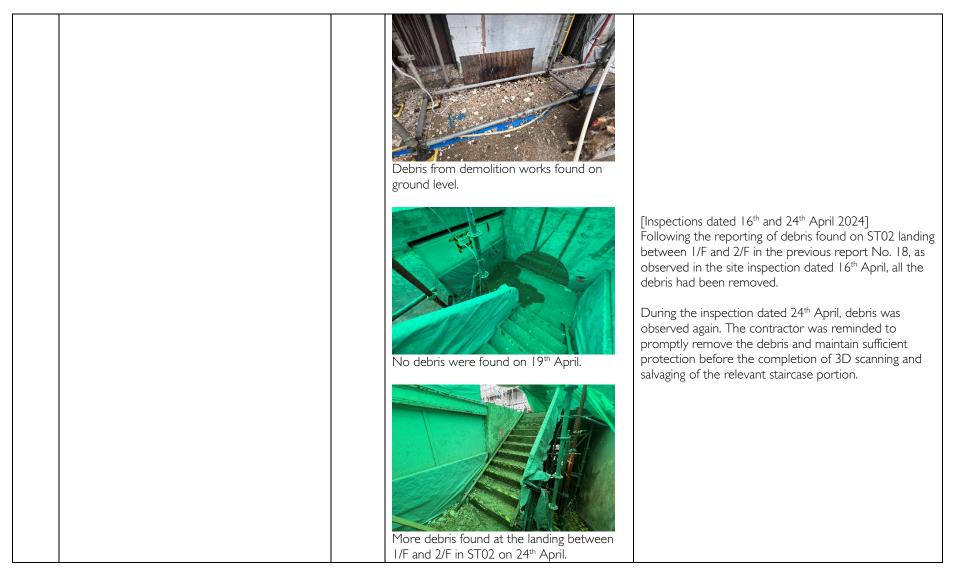
4.2	Is the site kept reasonably tidy?	4/10		[Inspections dated 2 <sup>nd</sup> , 9 <sup>th</sup> , 16 <sup>th</sup> , 24 <sup>th</sup> and 30 <sup>th</sup> April 2024] Most areas of the site are kept reasonably tidy, however during the recent inspections, more loose laying debris from the demolition works can be observed across the site. The contractor was reminded to maintain site tidiness as well as ensuring sufficient protection is provided to the Ground Floor portion.
			The site is generally being kept tidy.
