Project Title:
 Site Formation and Associated Infrastructural Works for Development of
 Columbarium, Crematorium and Related Facilities at Sandy Ridge Cemetery

Contract No.
 CEDD Contract CV/2017/02
 Development of Columbarium at Sandy Ridge Cemetery –
 Infrastructural Works at Man Kam To Road and Lin Ma Hang Road

Landscape & Visual Mitigation and Tree Preservation Plan

Appendix K	Tree condition report of Tree T2769 in January 2021

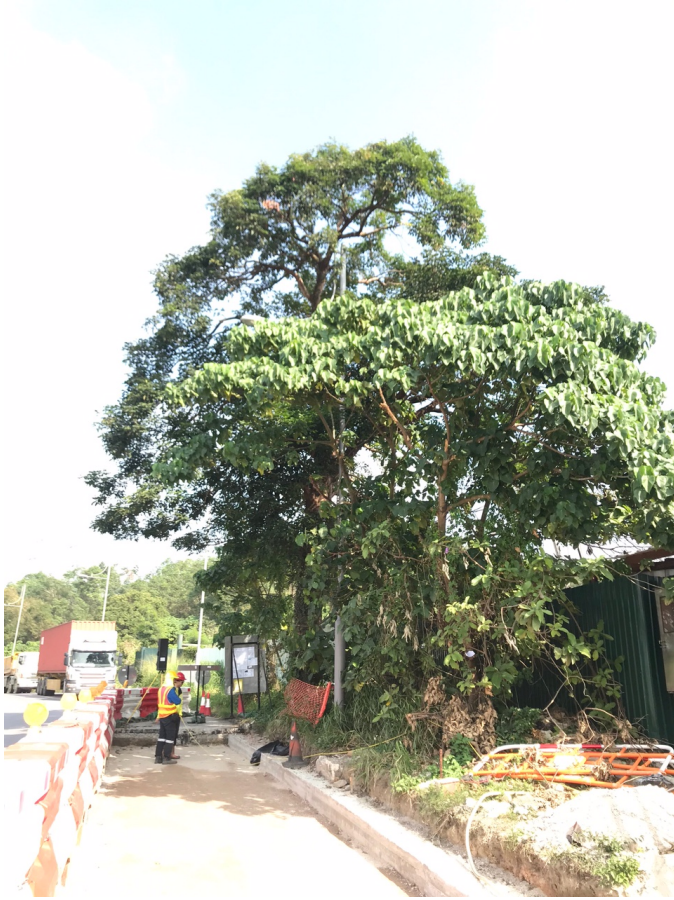
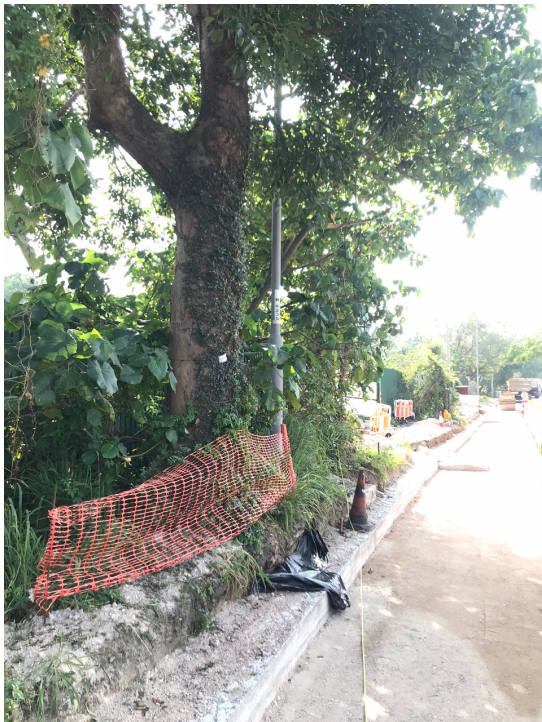
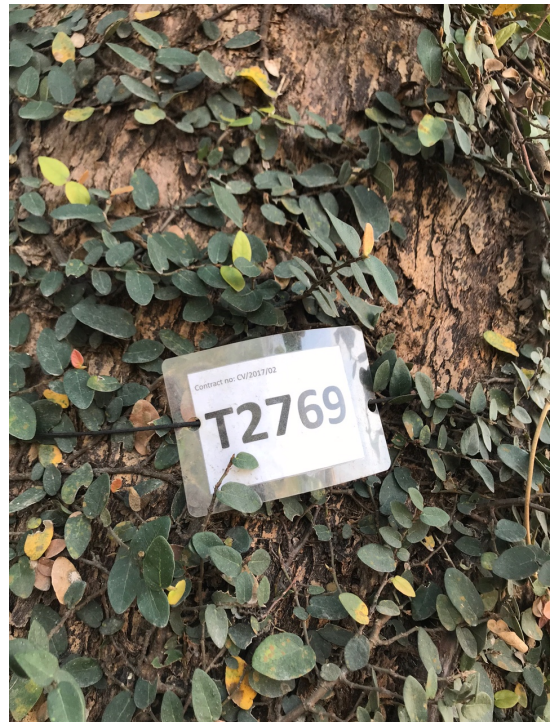
1) Tree condition at 27 Jan. 2019

General view

Tree condition is fair generally.

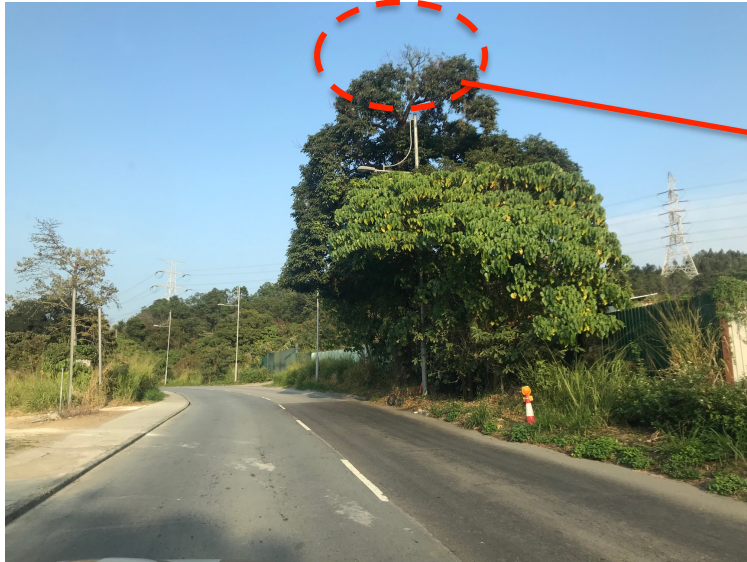
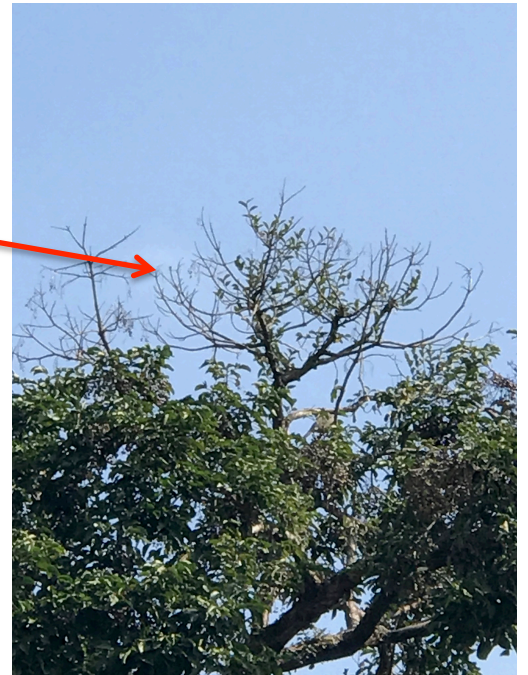
2) Tree condition at 23 Jan. 2020

General view, crown die back and abnormal foliage size

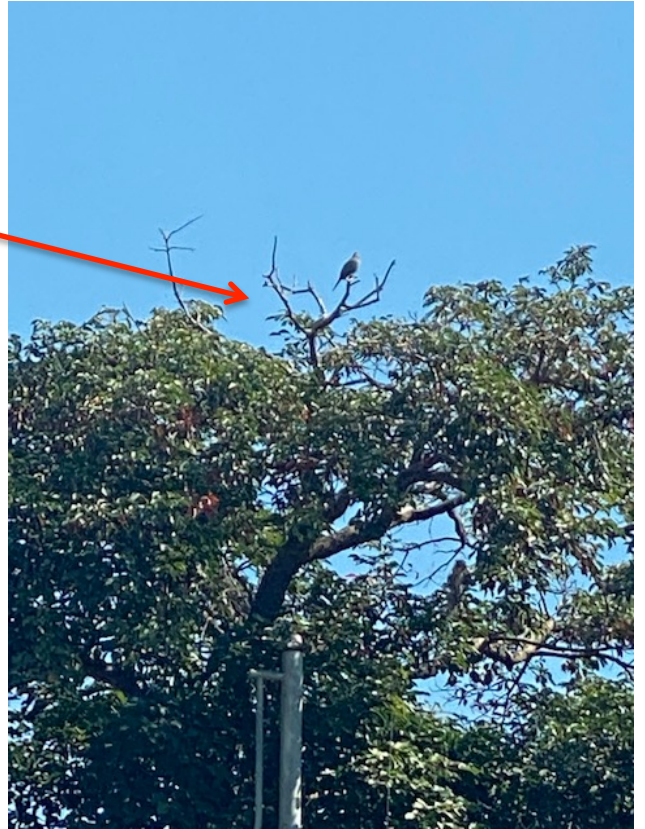
Crown die back fully

- 4.1.5 As per regular site inspections on January 2021, health problem was found on the proposed transplant tree T2769. Tree removal was recommended. Hence, no trees will be transplanted under this contract. Please refer to **Appendix K** for a tree condition report for T2769 prepared by an accredited arborist.

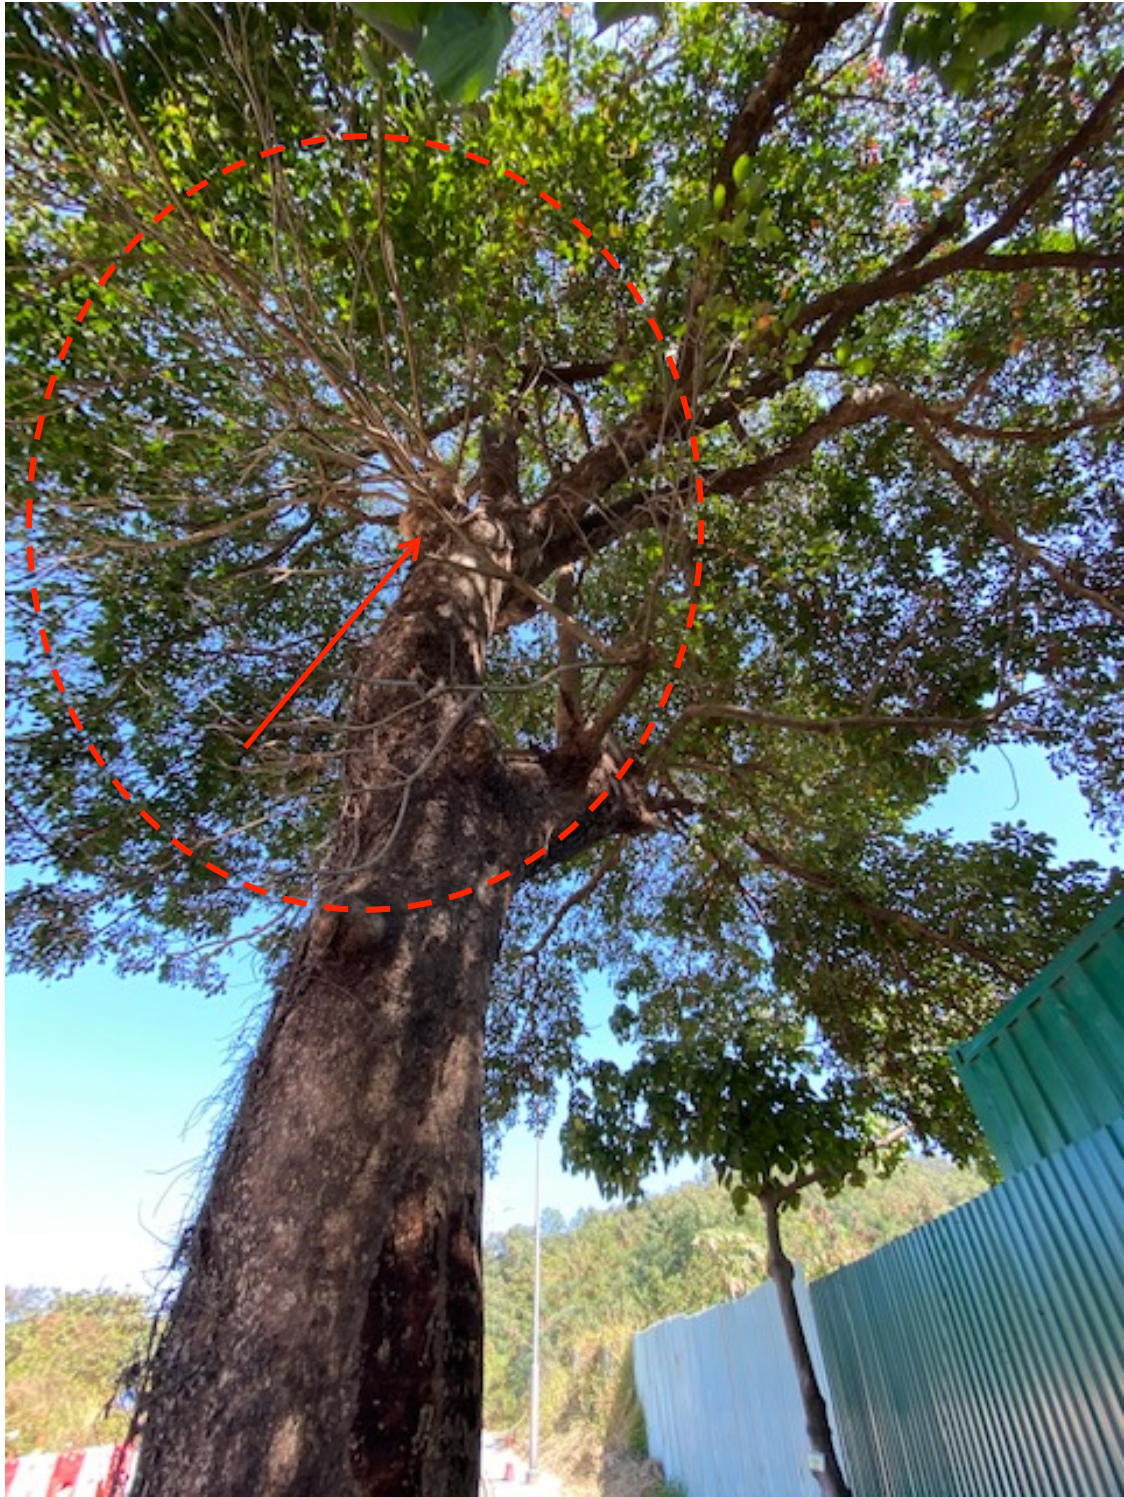
Dry out of lower branches

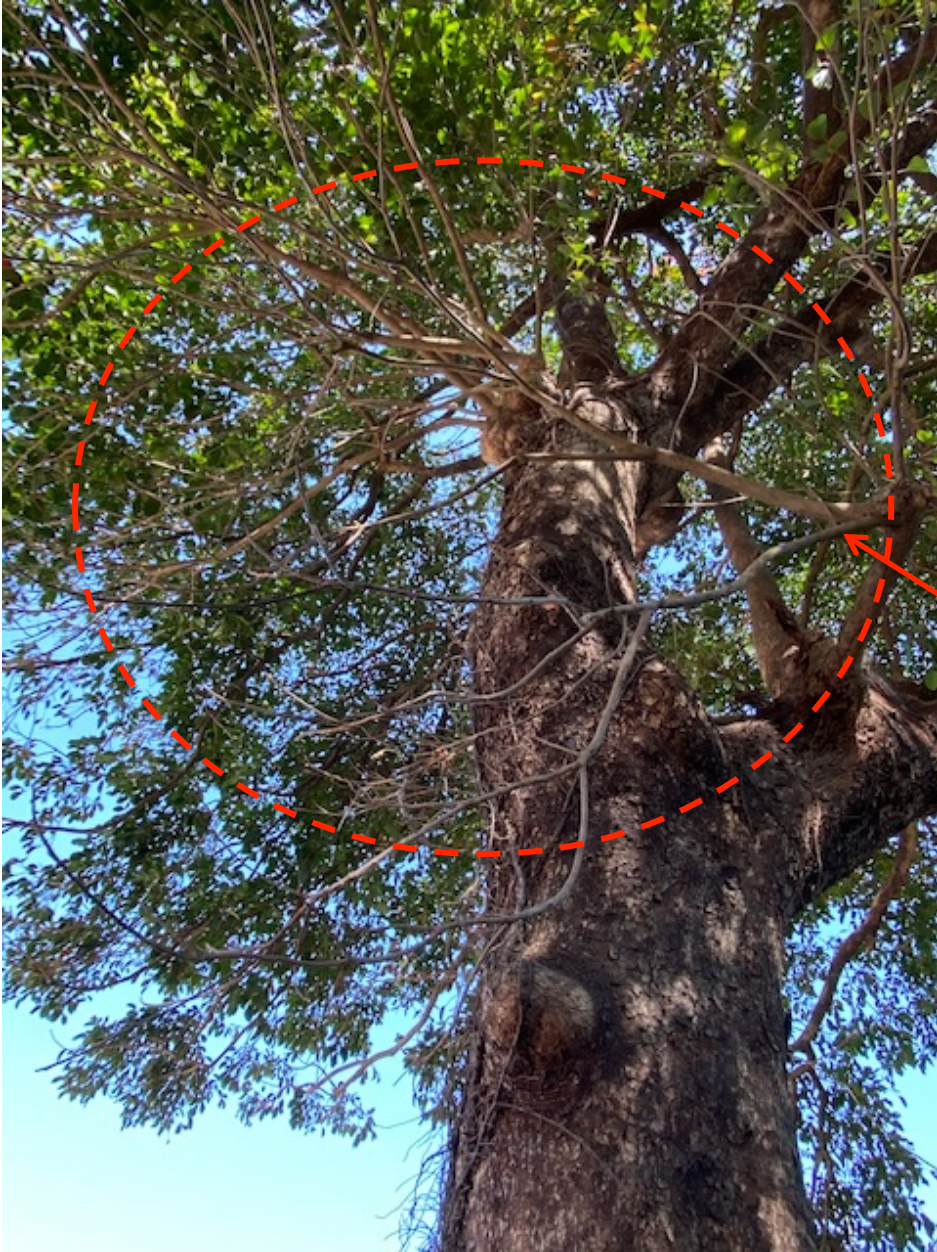
Dry out of lower branches

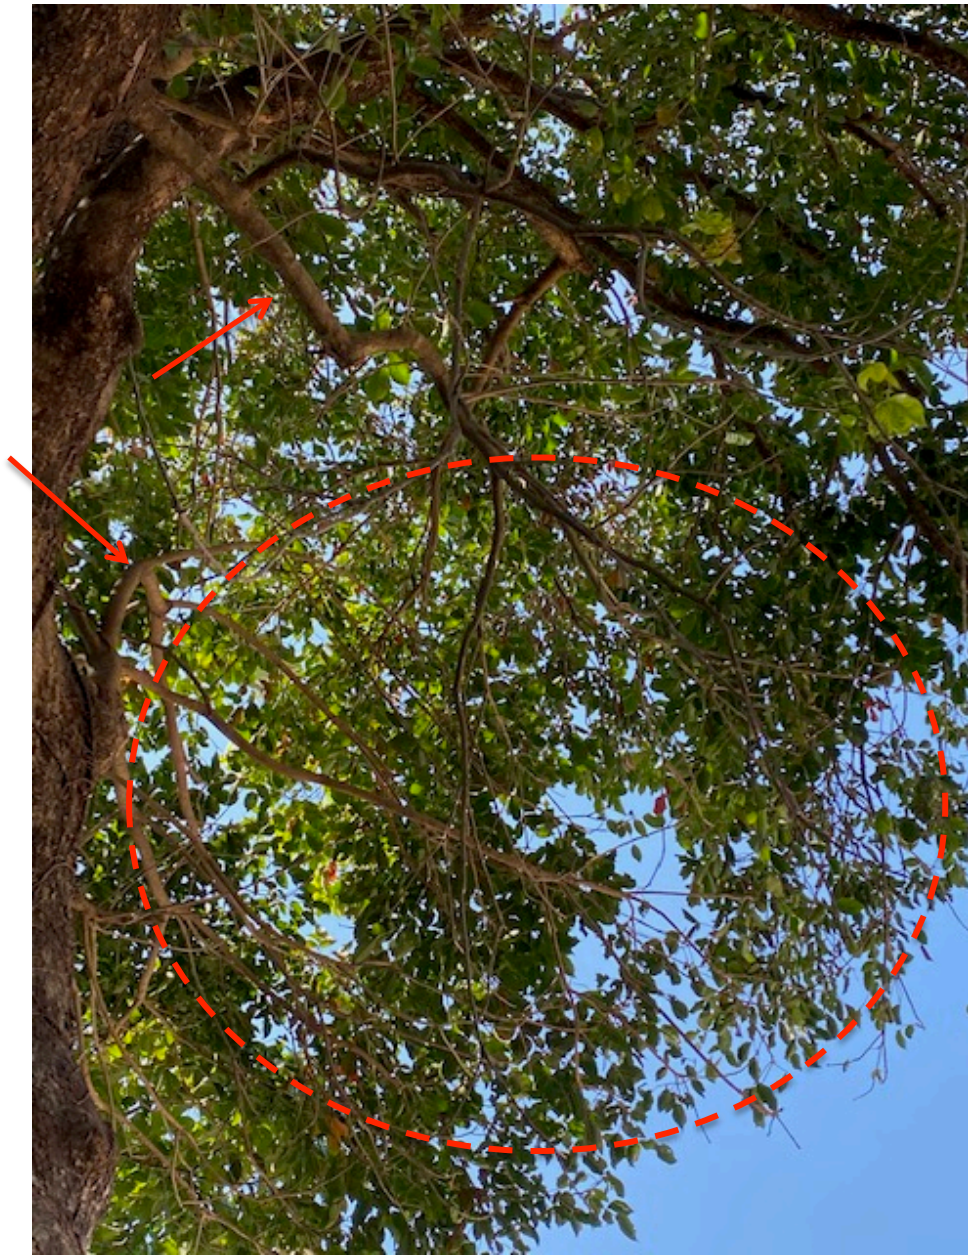
Abnormal foliage size and dry out of lower branches

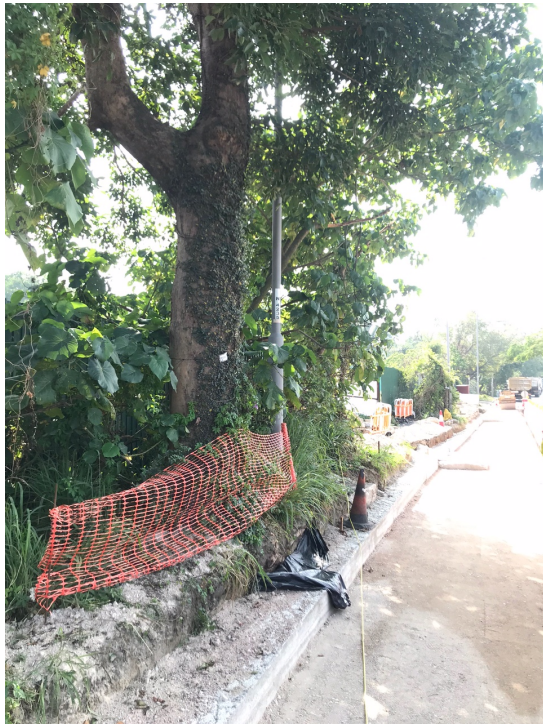
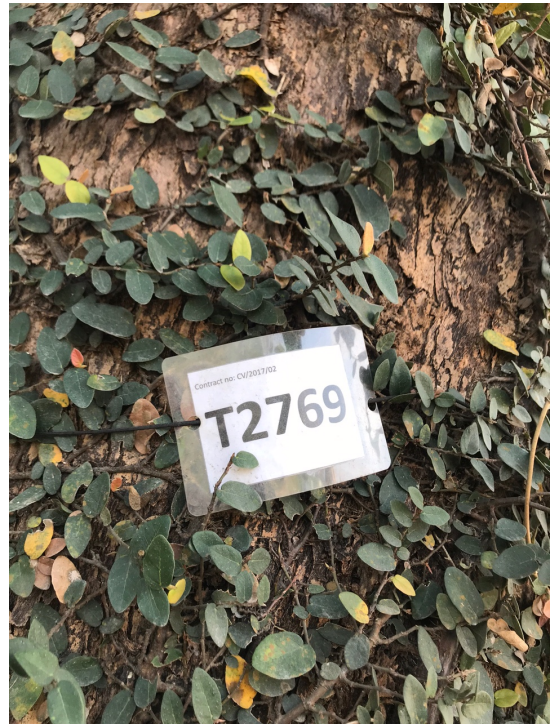
The condition lower trunk and root collar are fair. The climber of *Ficus pumlia* 薛荔 epiphytes grow on the tree trunk dated 27 Jan. 2019.

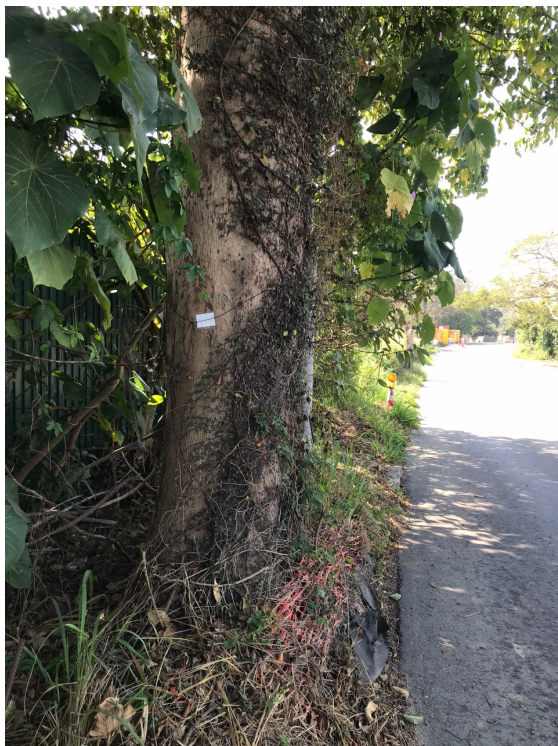
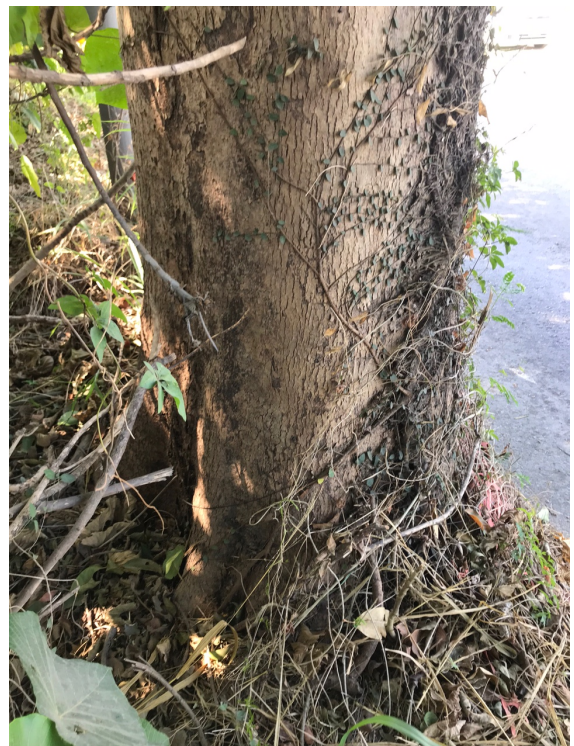
The condition of lower trunk and root collar are poor. And all *Ficus pumlia* 薛荔 is dry out from the early of 2020 until now. The root condition might occurred some serious problem.
