CEDD SERVICE CONTRACT No. WD/07/2022

YUEN LONG SOUTH FIRST PHASE DEVELOPMENT - ENVIRONMENTAL TEAM

LANDSCAPE AND VISUAL BASELINE REPORT

24 July 2024 TCS01267/22/600/R0052v2

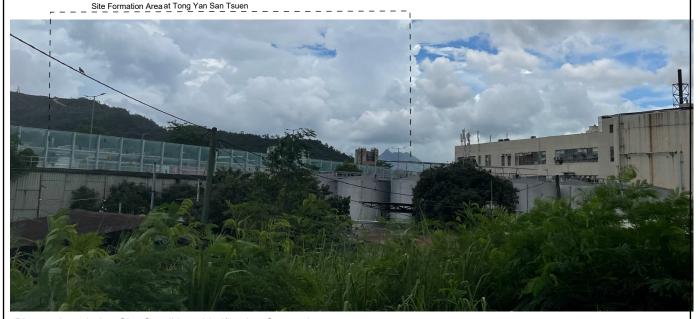
VSR5 Forefront Cyber Centre

^{*}Photo shown in the EIA Report was taken from the rooftop of the Forefront Cyber Centre, which was inaccessible in this reporting, and photo was taken from an alternative location north of the Yuen Long Highway that could provide a view of the Project Site

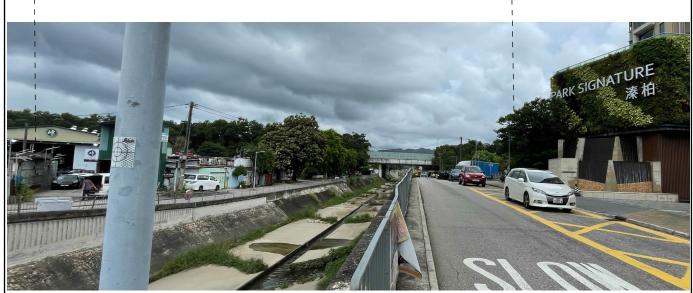
VSR9 Intersection of Kung Um Road and Shap Pat Heung Road

Infra-structure Works on Kiu Hing Road

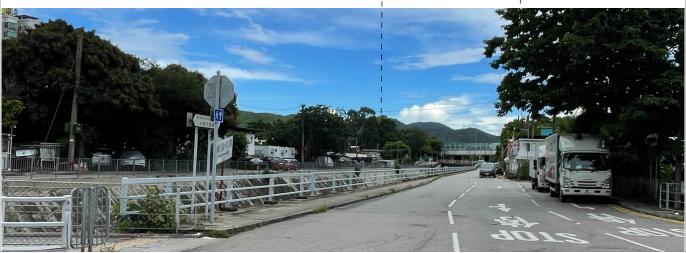
VSR40 Intersection of Tai Tong Road

Infra-structure Works on Yuen Long Highway
