翠谷工程有限公司 Green Valley Landfill, Limited

## South East New Territories (SENT) Landfill Extension

**Restoration and Ecological Enhancement Plan (Rev. 3)**

September 2021

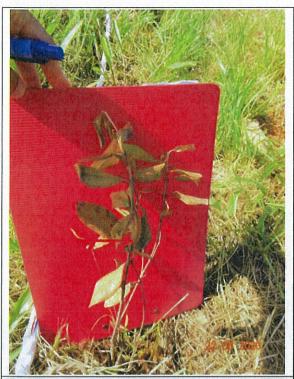
Photo 09 | S8 seedlings (*Rhodomyrtus tomentosa* 桃 金娘) in poor condition to be replaced.

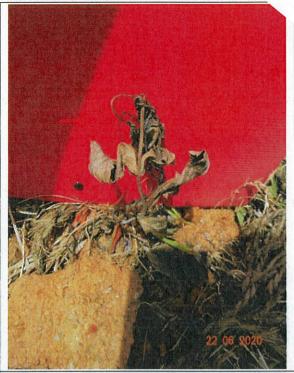
Photo 10 | S9 seedlings (*Stachytarpheta jamaicensis* 假馬鞭) in poor condition to be replaced.

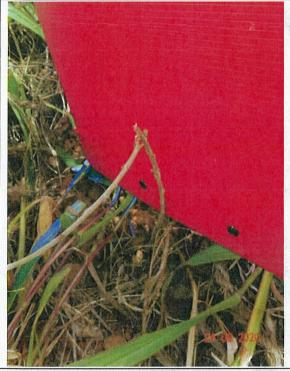
Photo 11 | S10 seedlings (*Lespedeza formosa* 美麗 胡枝子) in poor condition to be replaced.

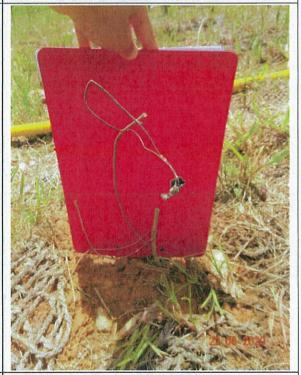
Photo 12 | S12 seedlings (*Vitex rotundifolia* 單葉蔓 荊) in poor condition to be replaced.

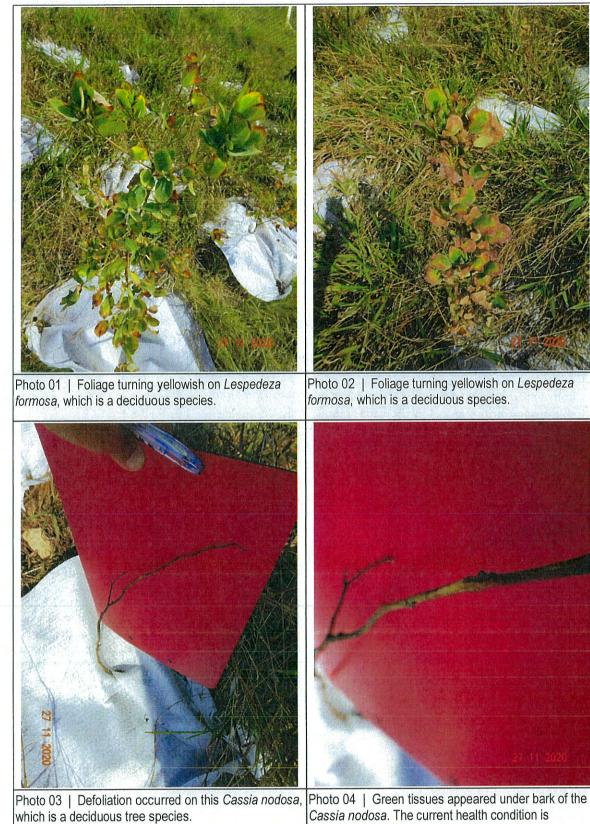
Cassia nodosa. The current health condition is assessed to be fair
