**Shatin to Central Link
Contract 1123 – Exhibition Station and Western Approach Tunnel
Submission of Landscape Plan for Further Environmental Permit No. FEP-13/364/2009/H
and FEP-03/376/2009**

**Shatin to Central Link –
Exhibition Station & Western Approach
Tunnel**

Landscape Plan
for
FEP-13/364/2009/H & FEP-03/376/2009

LS/20426 Contract 1123_H2624 - Exhibition Station and Western Approach Runnel
Initial Tree Survey Report

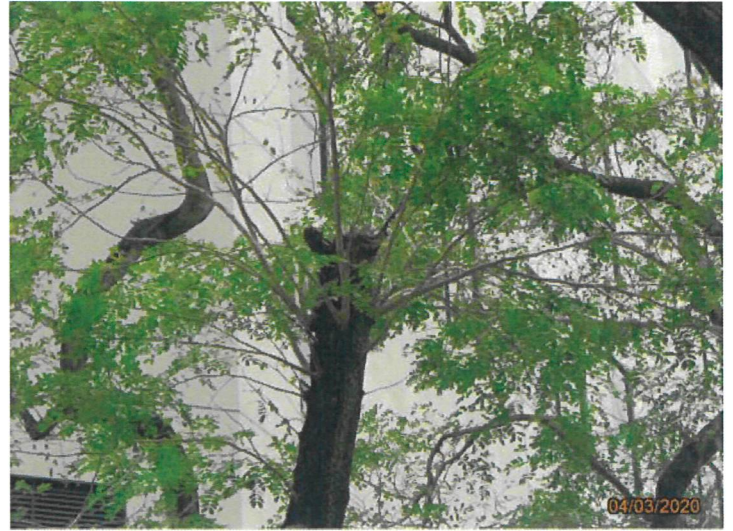
0001 - Broken branch (2)

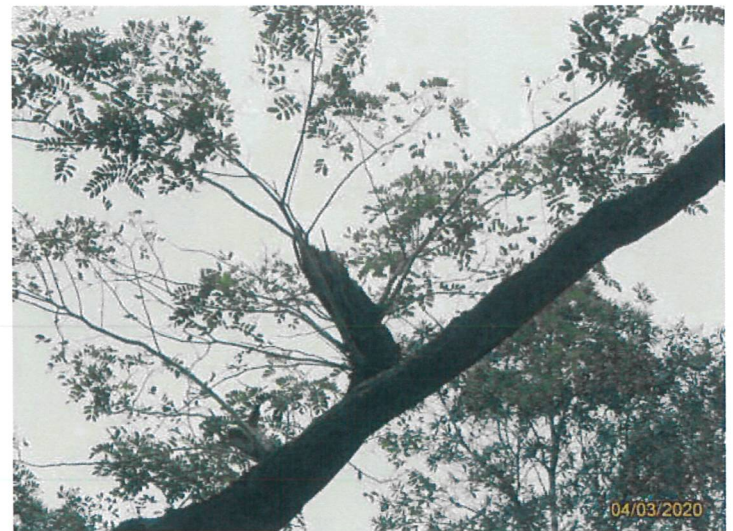
0001 - Broken branch (4)

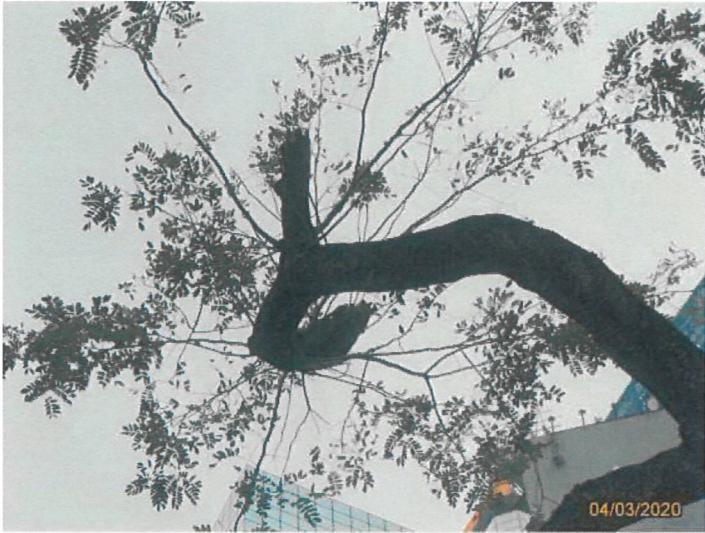
0001 - Broken branch (5)

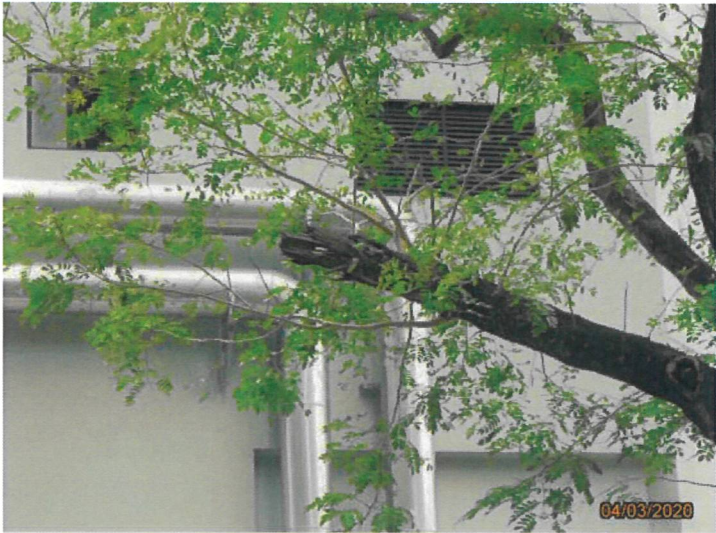
0001 - Broken branch

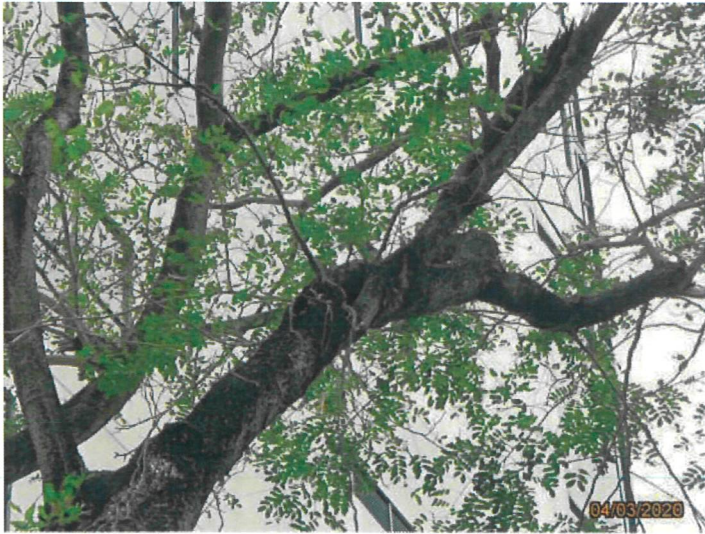
0001 - Cavity

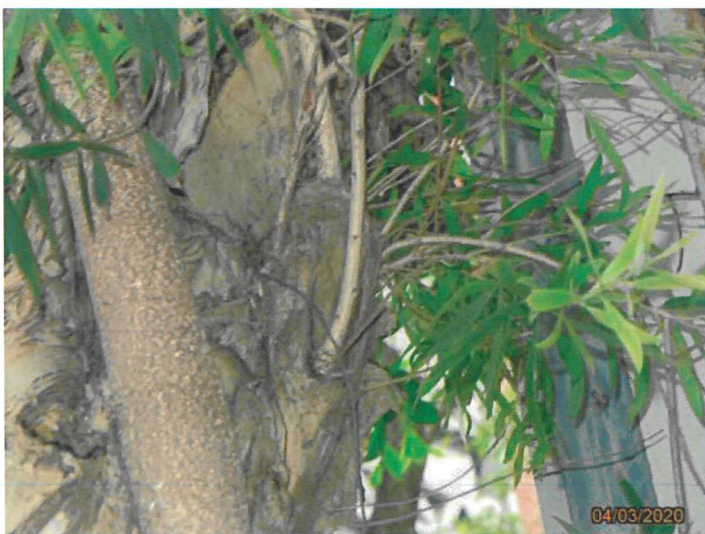
0004 - Broken branch

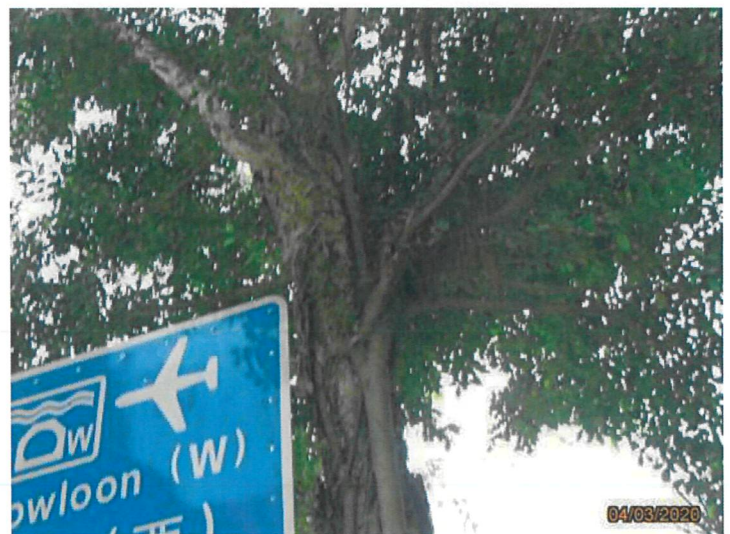
0004 - Coexisting with another tree and wound on branch

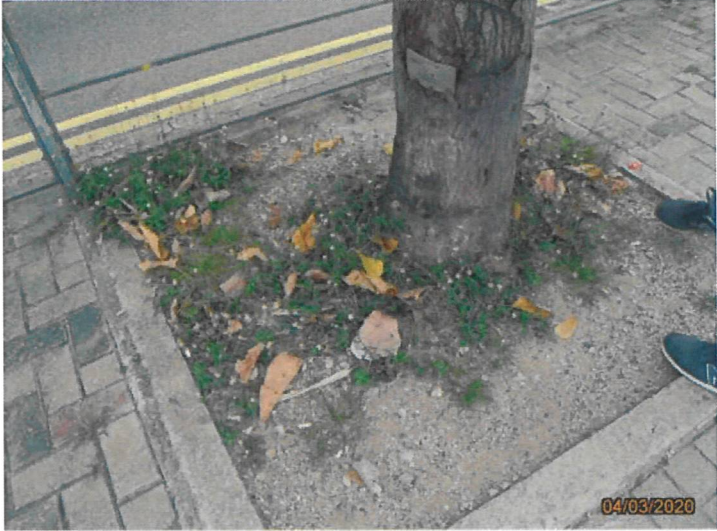
0337 - Restricted rooting area

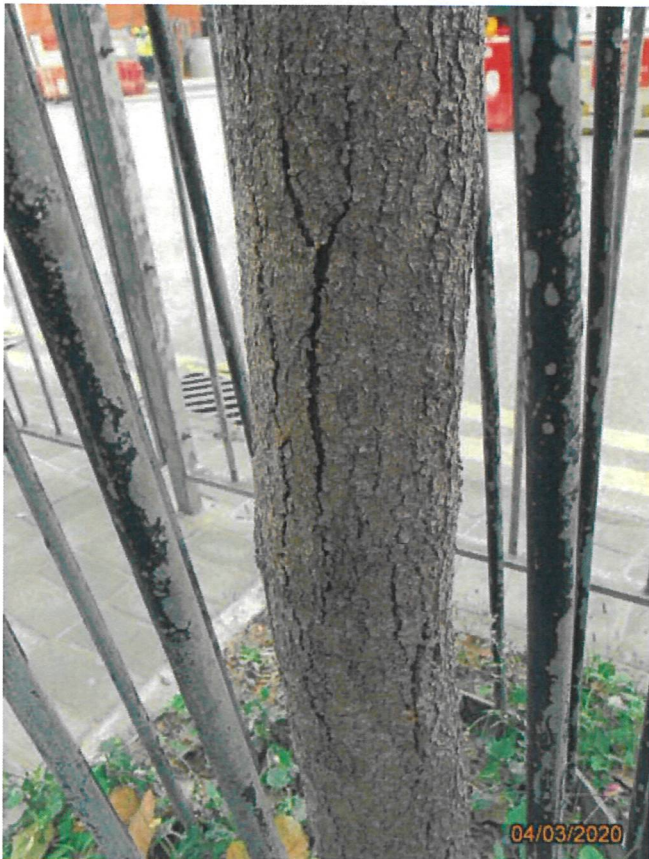
0493 - Cracks on trunk

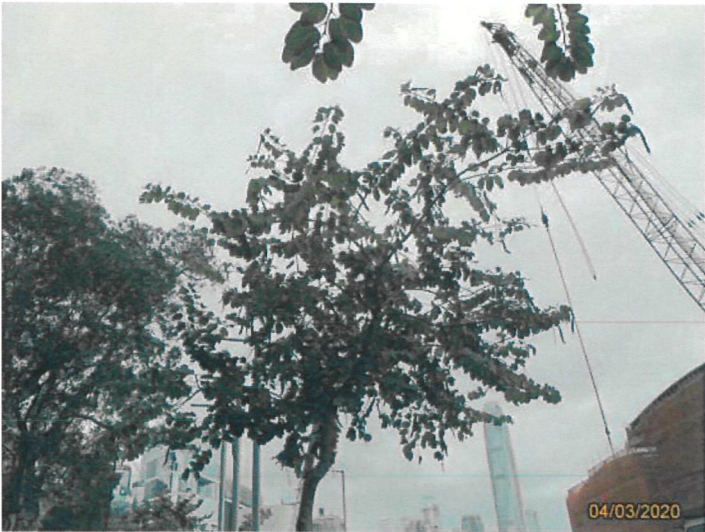
0493 - Crown condition

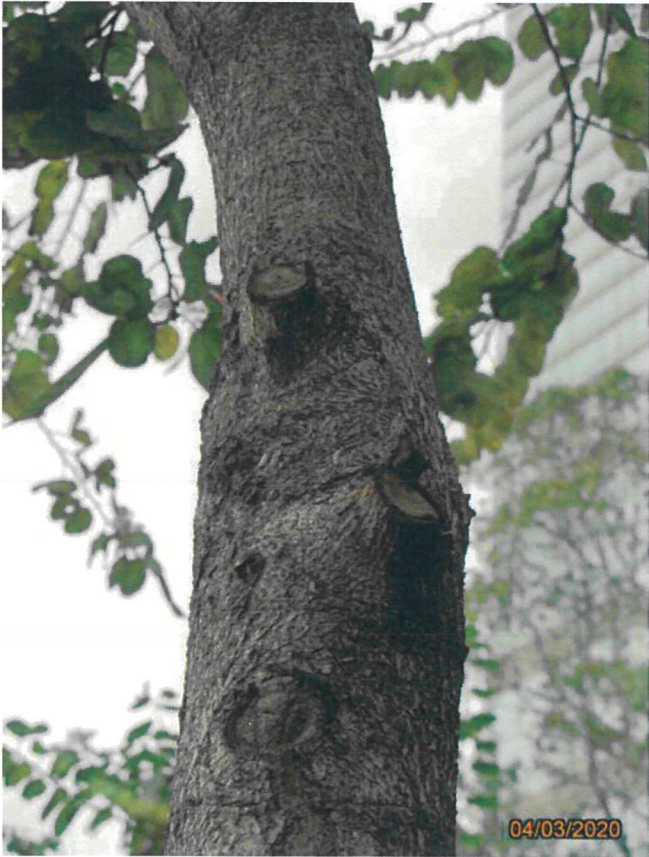
0493 - Pruned wound

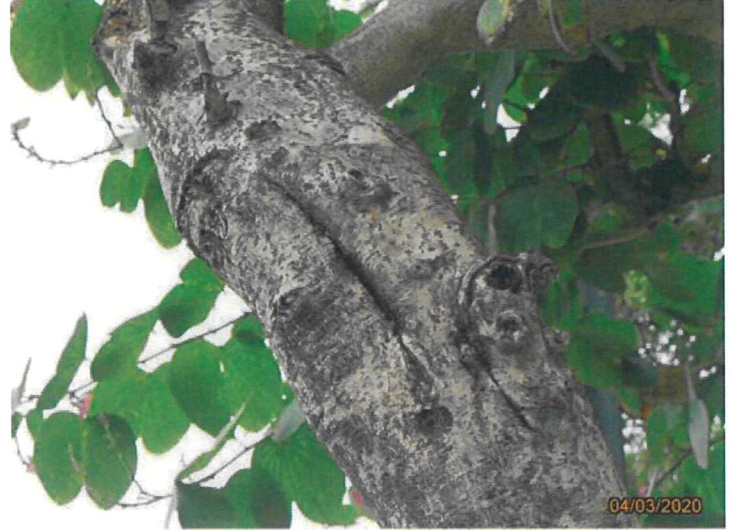
0498 - Cracks on trunk

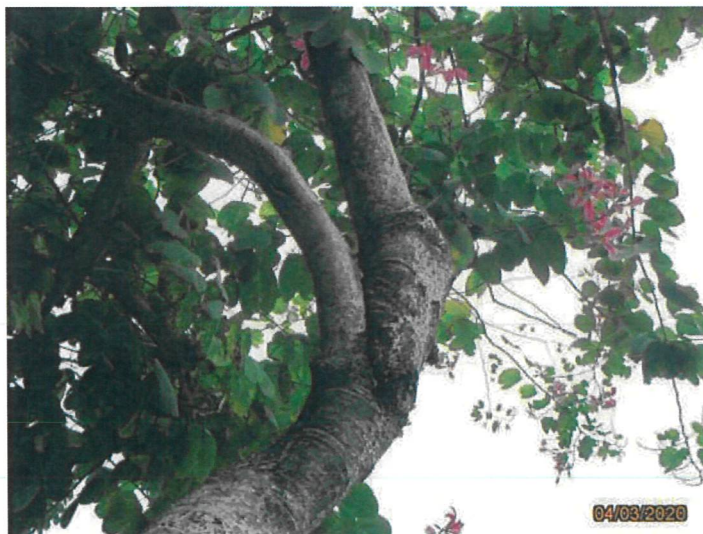
0498 - Included bark

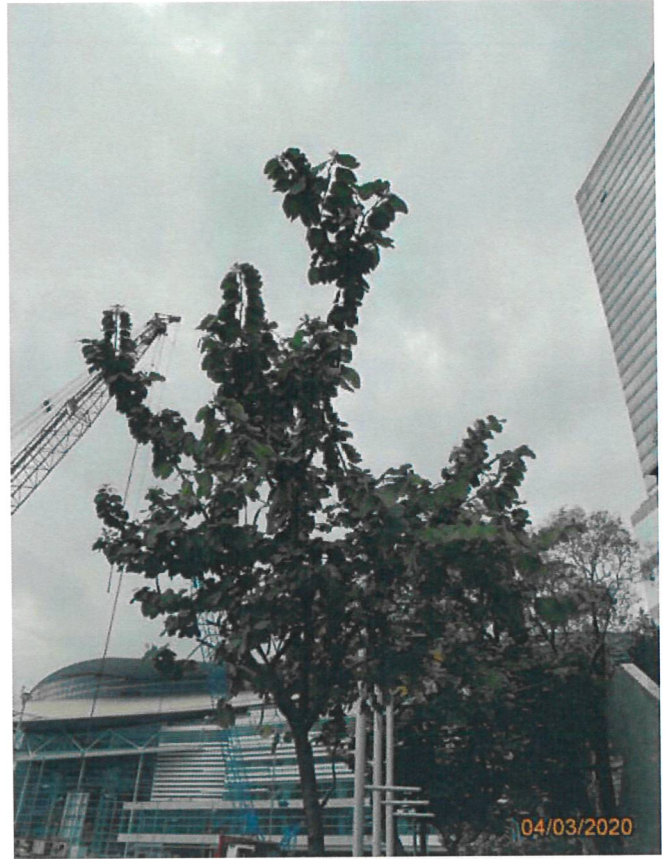
0499 - Crown condition

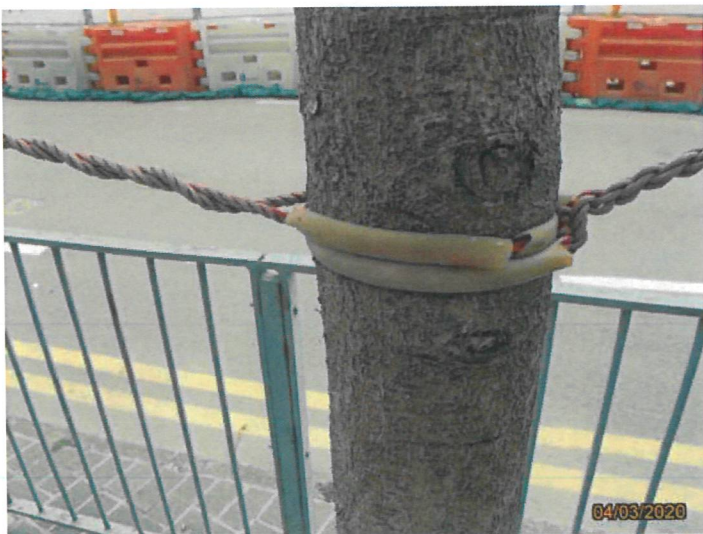
0499 - Restricted by tree guying

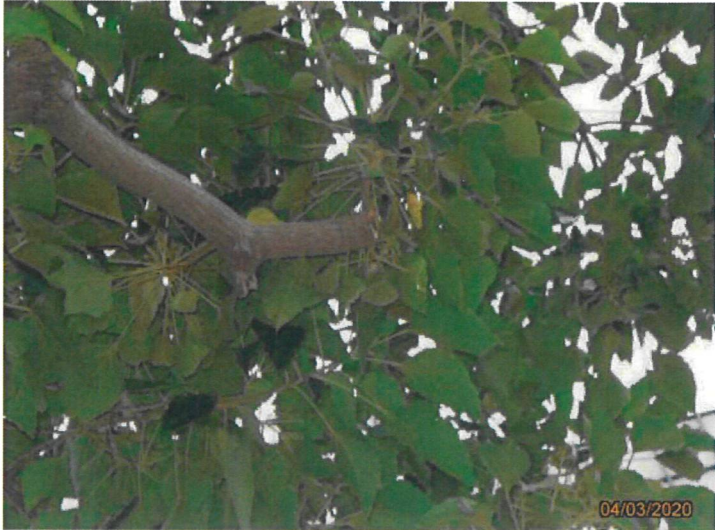
0503 - Broken branch

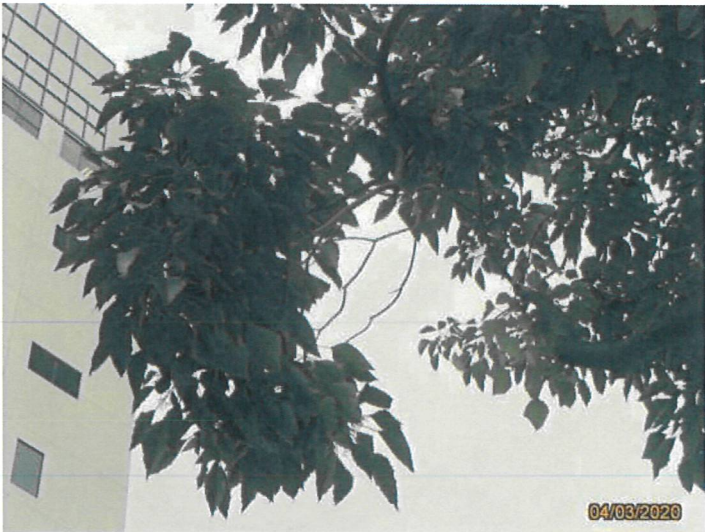
0503 - Dead branch

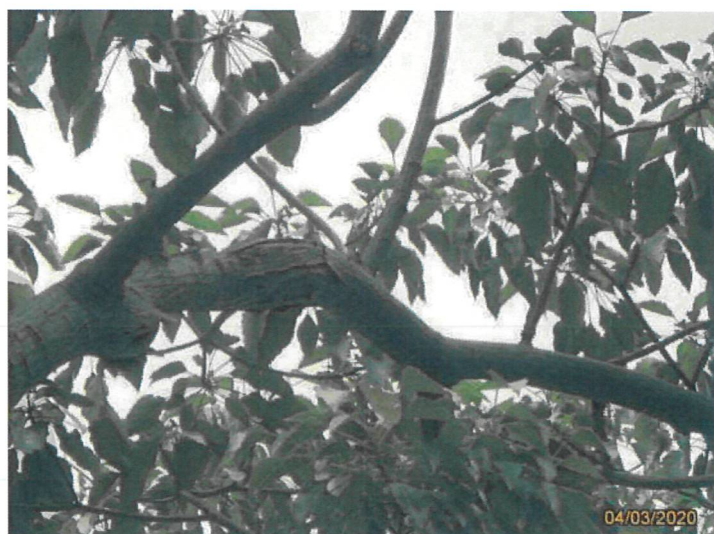
0504 - Crack on branch

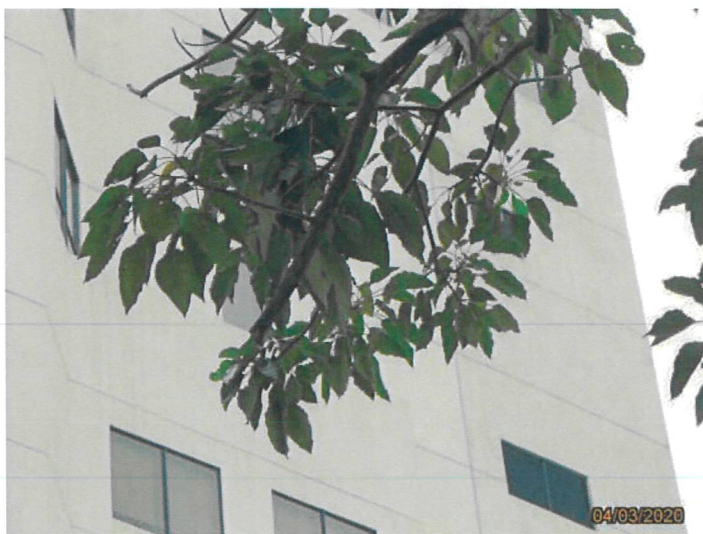
0505 - Broken branch (2)

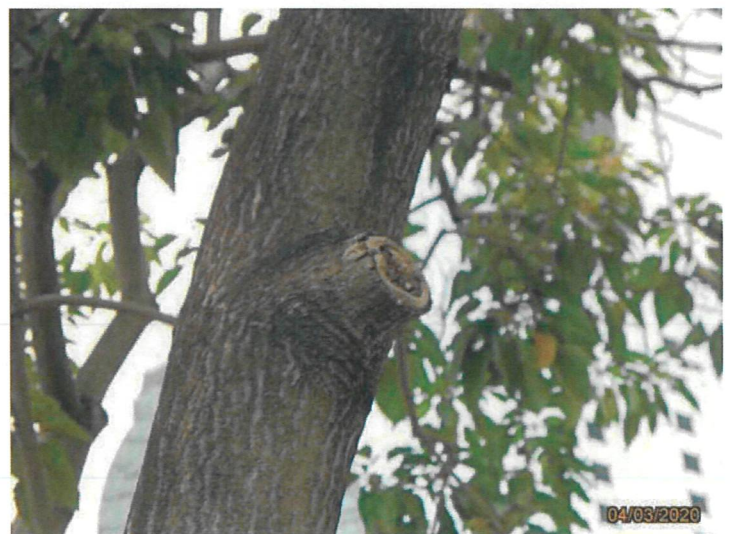
0505 - Broken branch

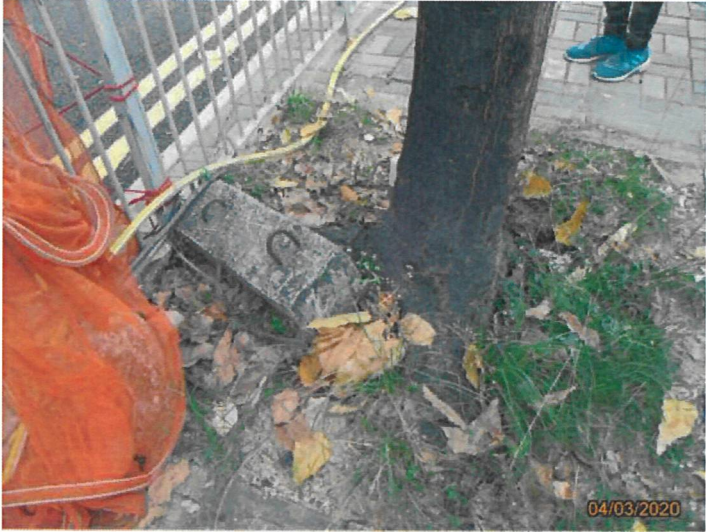
0505 - Concrete object on root

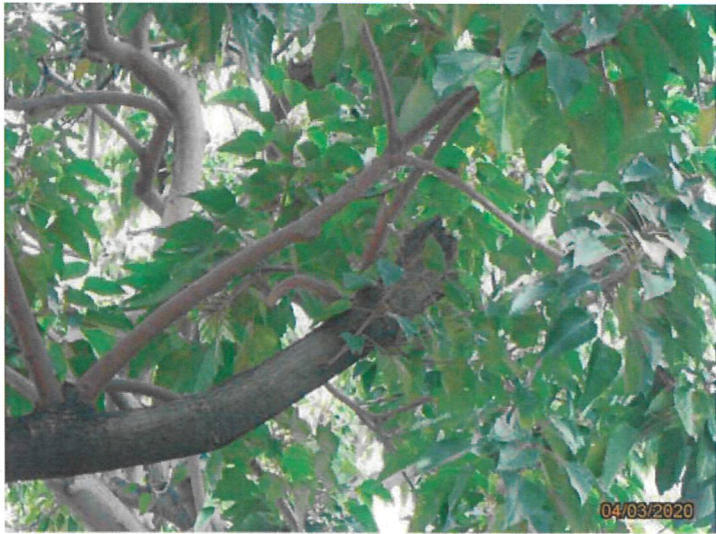
0508 - Broken branch (2)

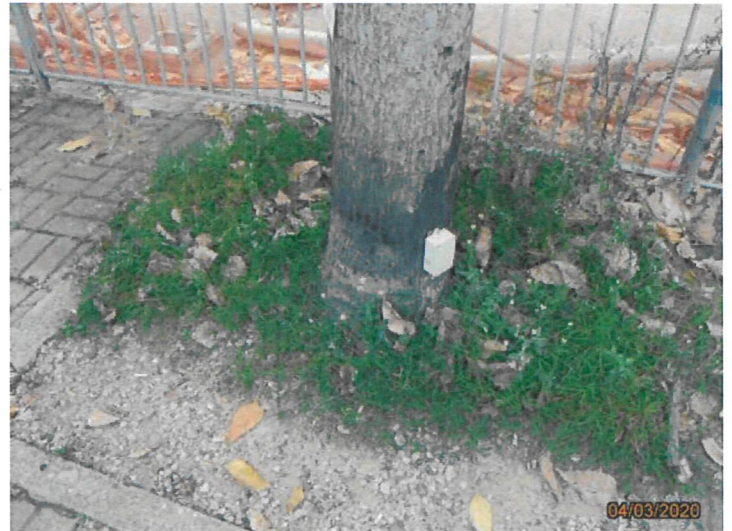
0508 - Restricted rooting area

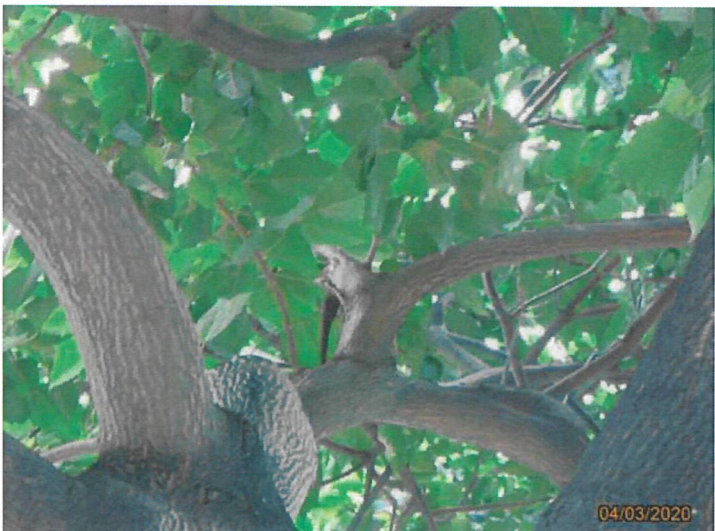
0509 - Broken branch (3)

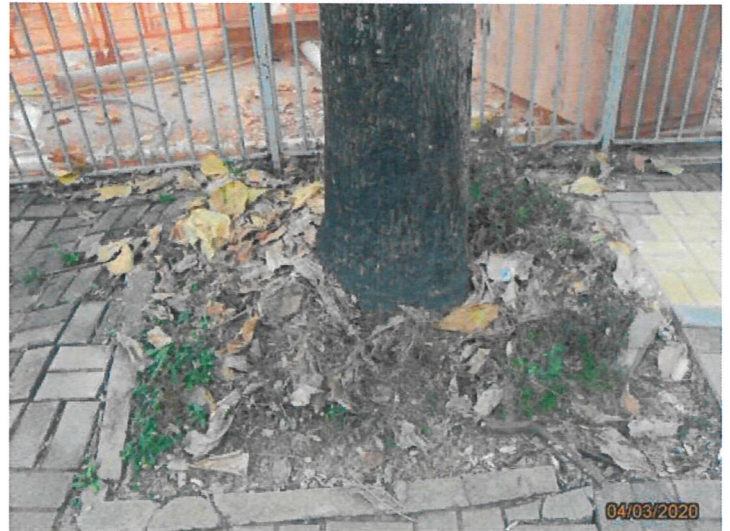
0509 - Restricted rooting area

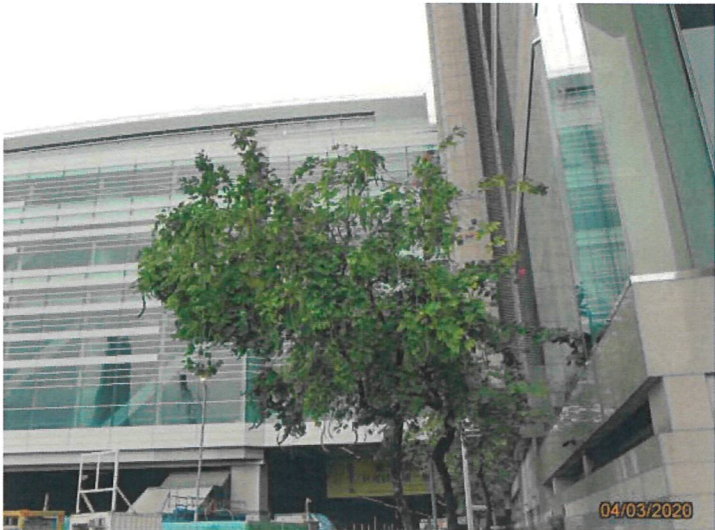
A154 - Crown condition

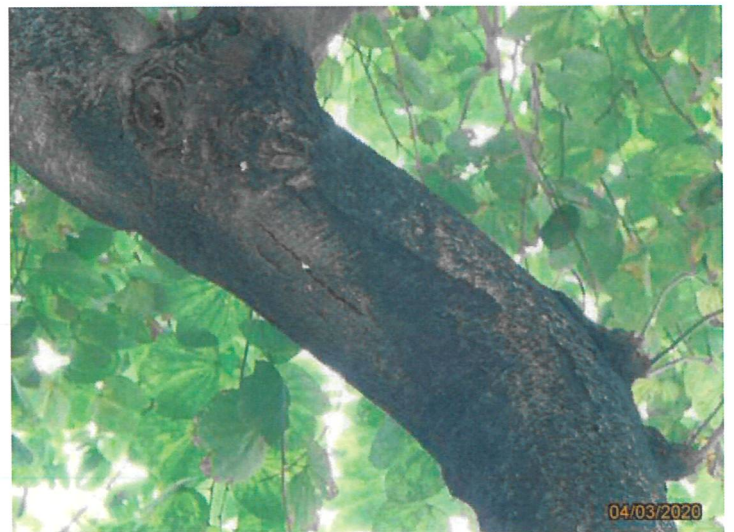
A155 - Crack on trunk

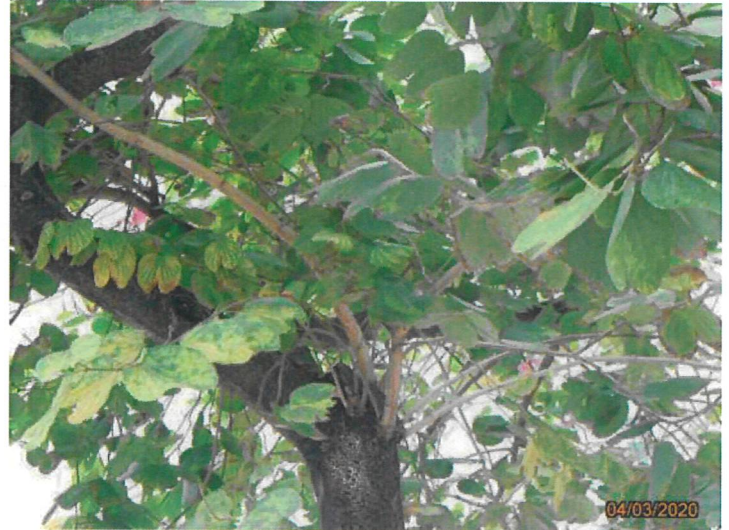
A155 - Epicormics (2)

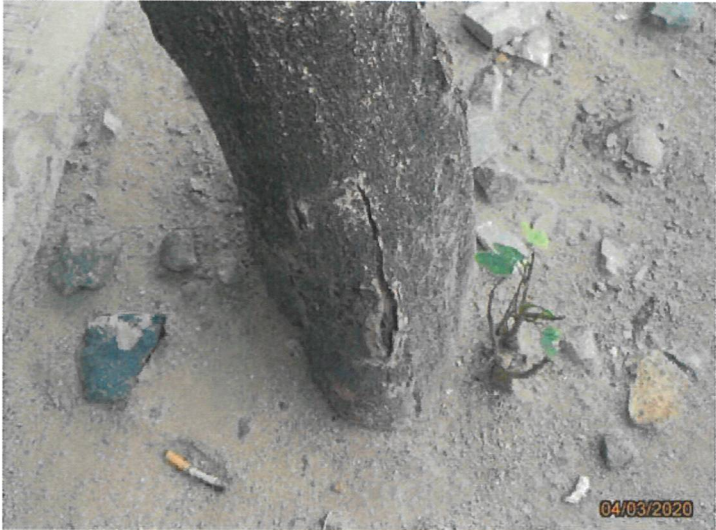
A156 - Crack on root collar

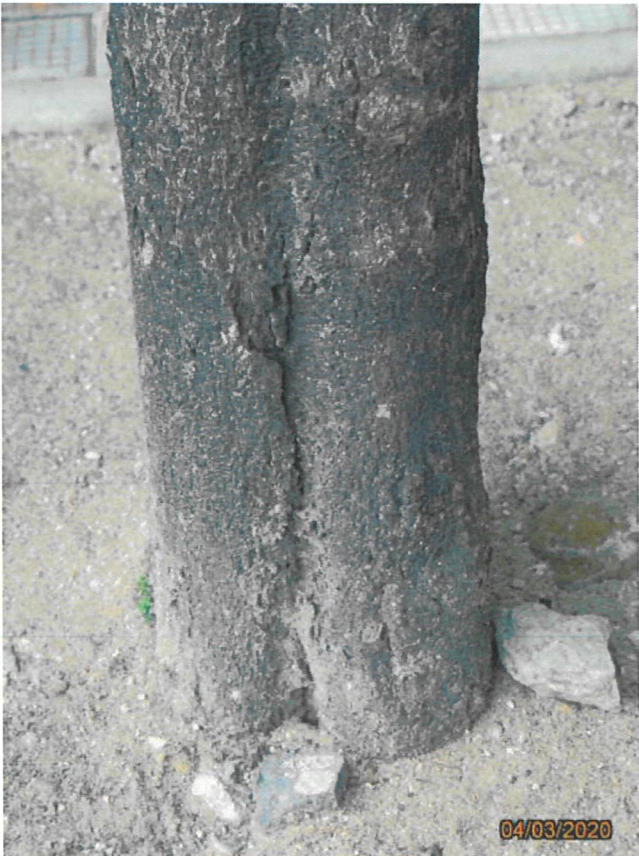
A159 - Crack on root collar

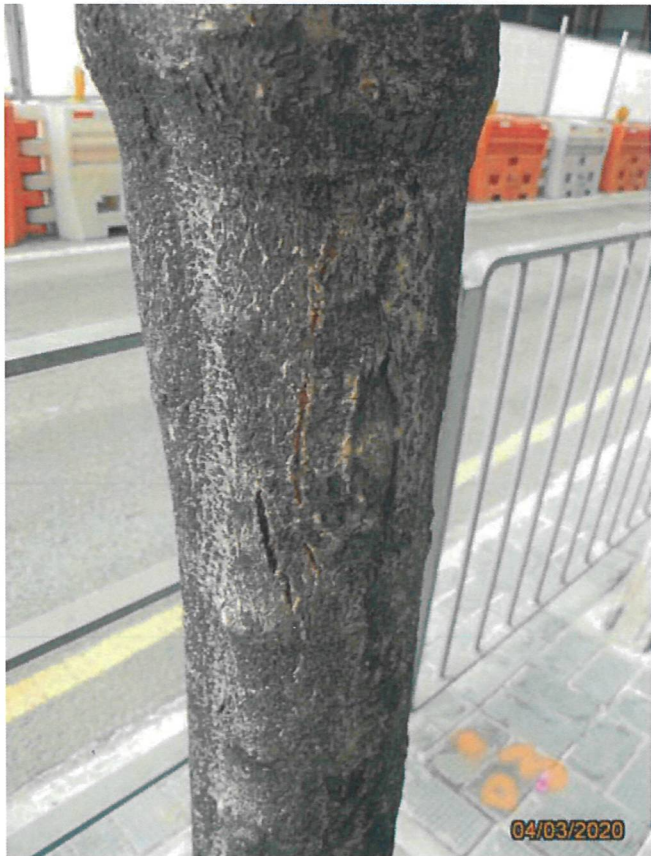
A159 - Cracks on trunk (1)

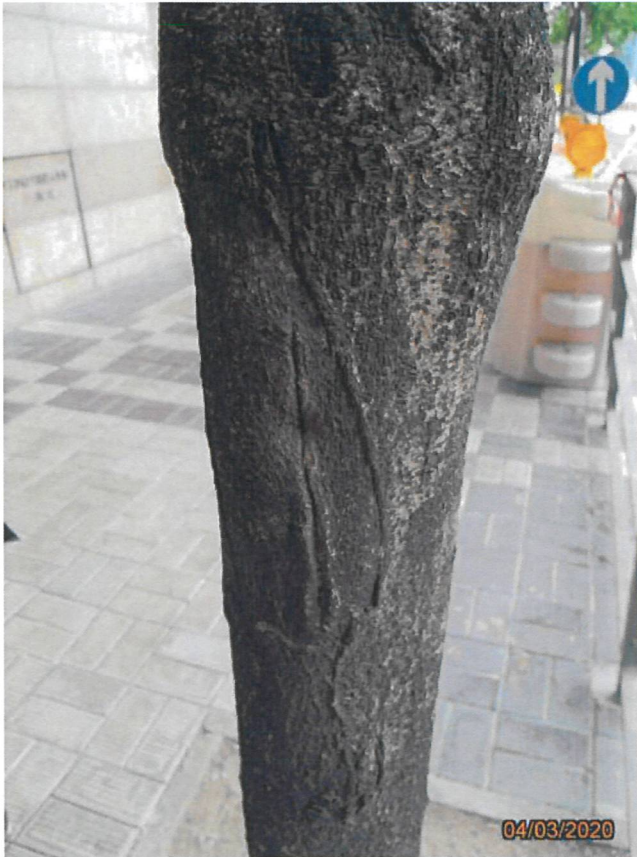
A159 - Cracks on trunk (2)

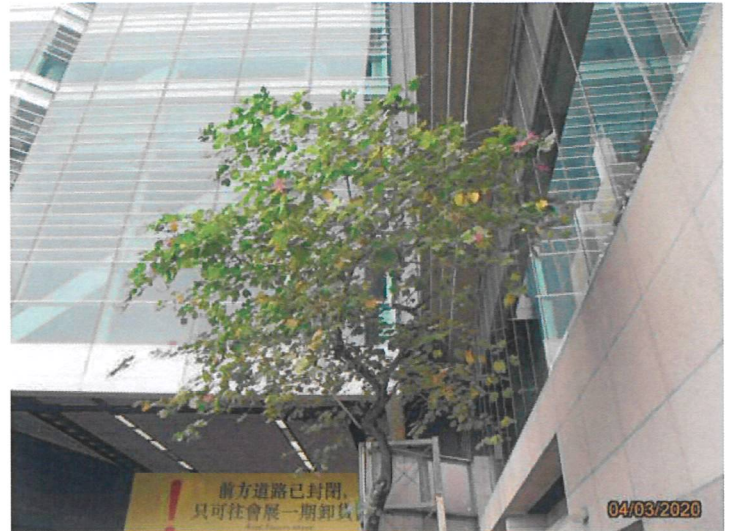
A159 - Crown condition

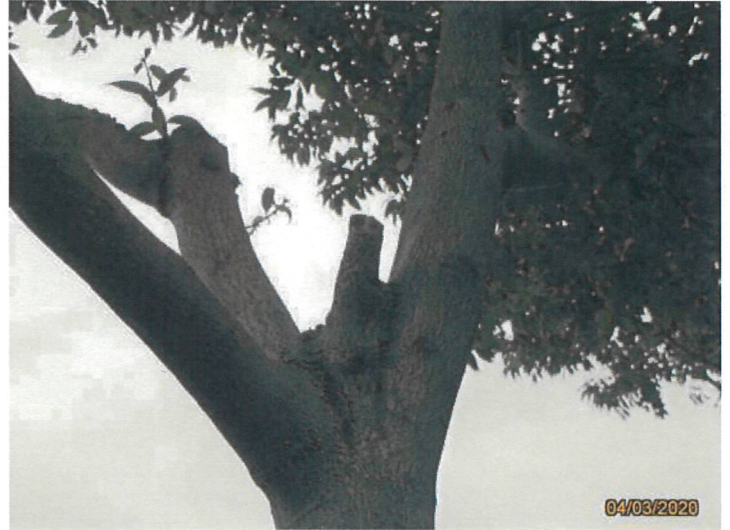
S002 - Broken branch

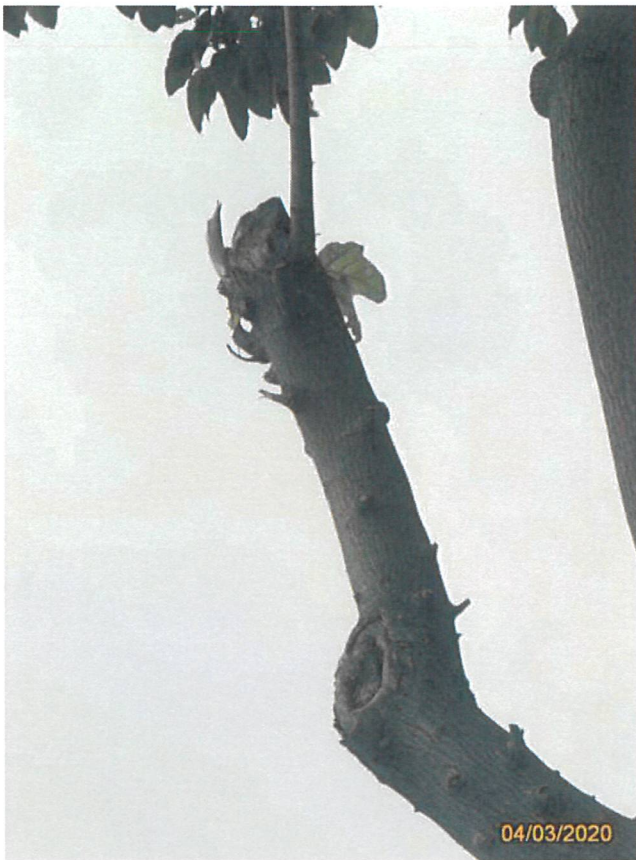
S004 - Broken branch

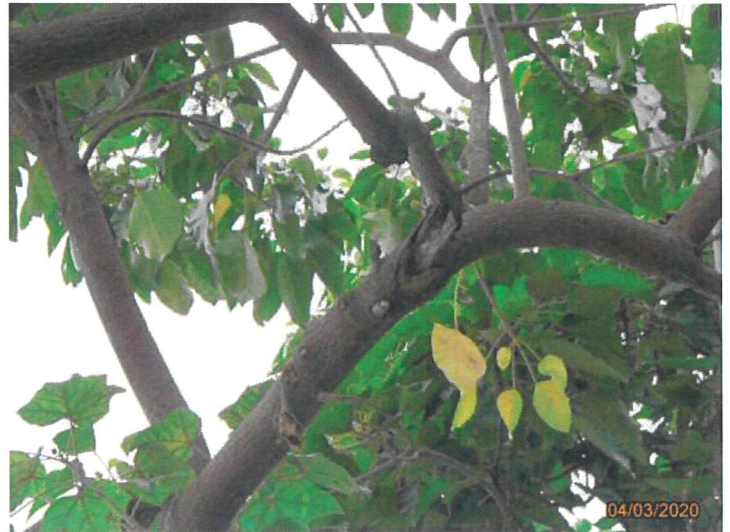
S004 - wound on branch

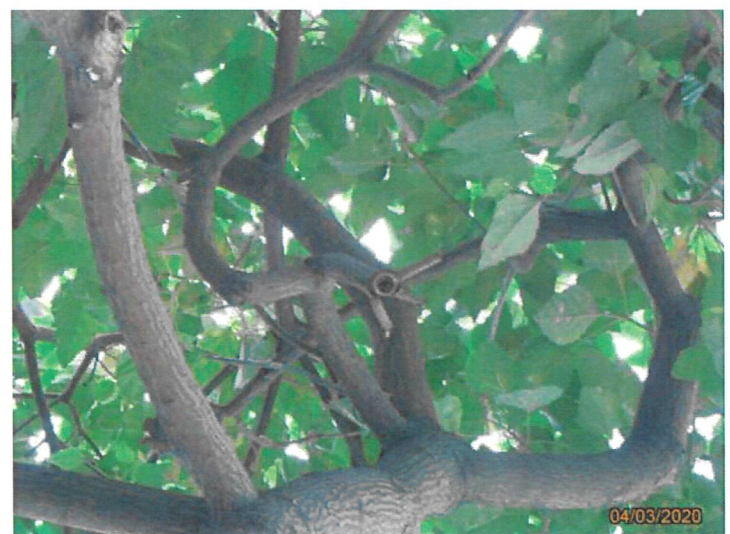
S005 - Broken branch and dead branch

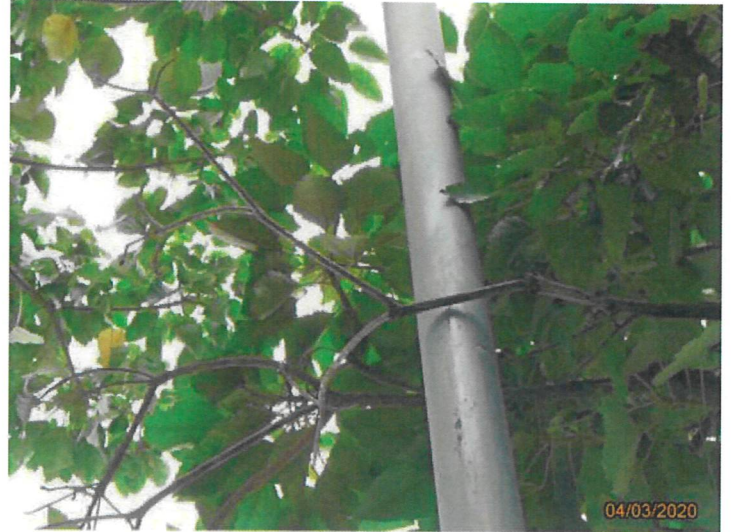
S005 - Conflict with lightpole

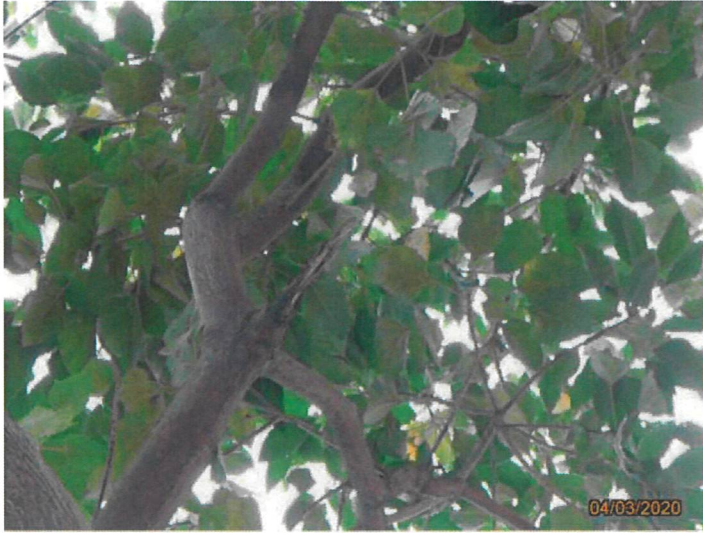
S009 - Broken branch ((2)

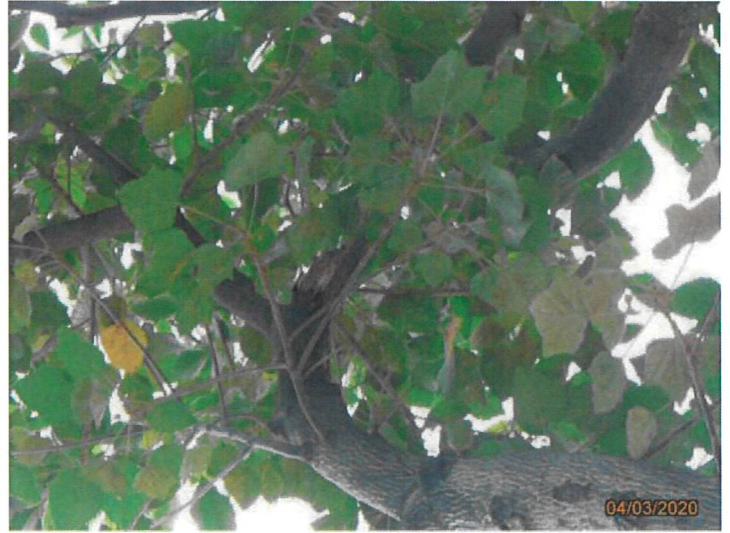
S009 - Broken branch

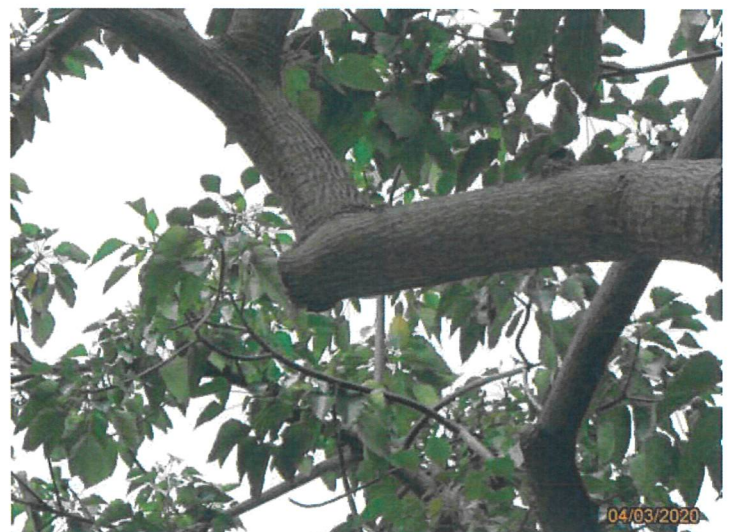
S015 - Broken branch (2)

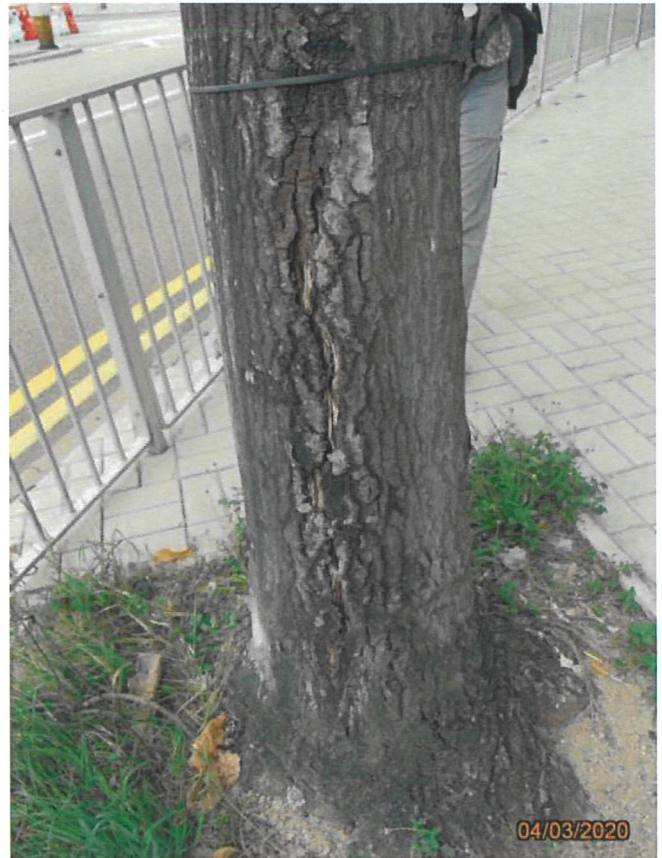
S015 - Crack on trunk

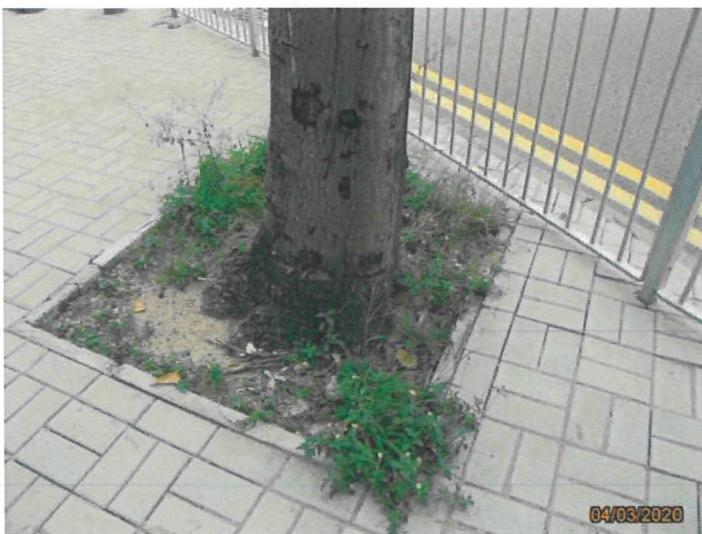
S015 - Restricted rooting area

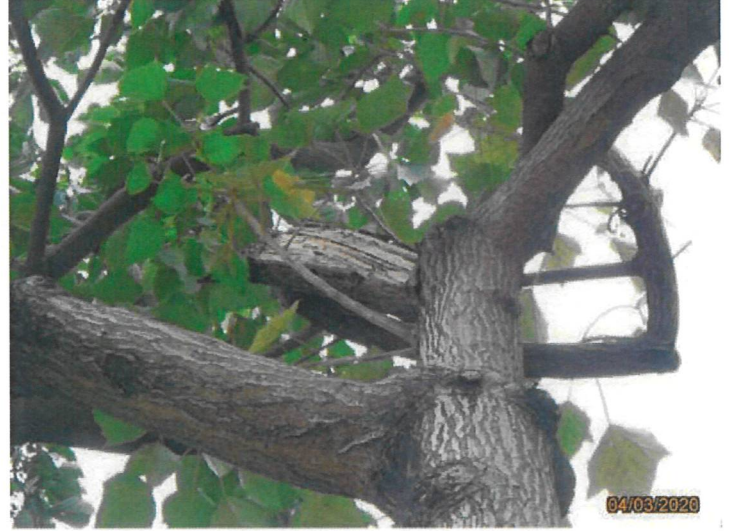
S016 - Broken branch

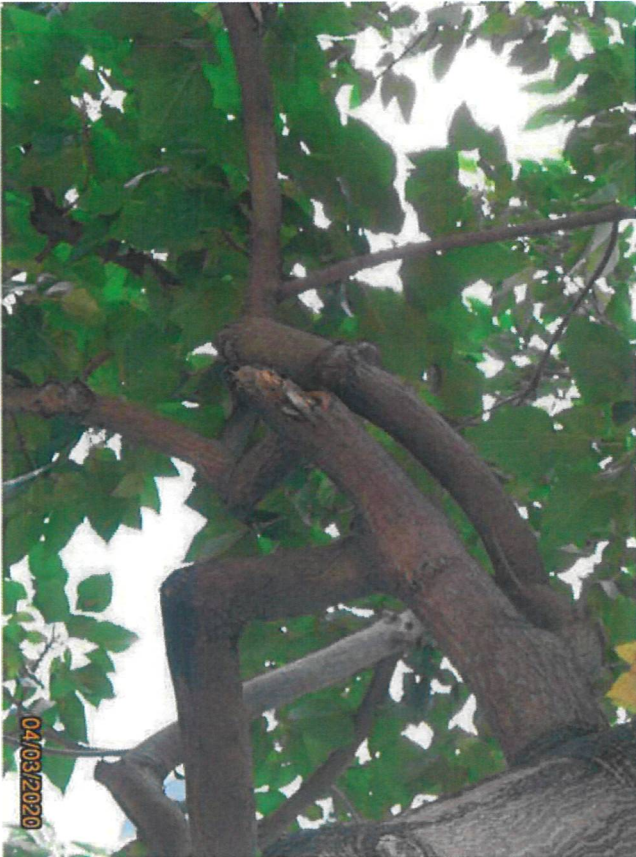
S017 - Broken and crossed branch

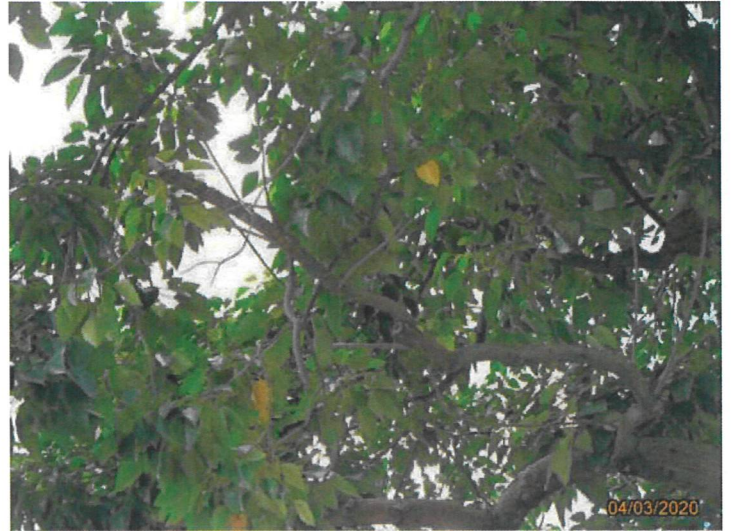
S017 - Dead branch

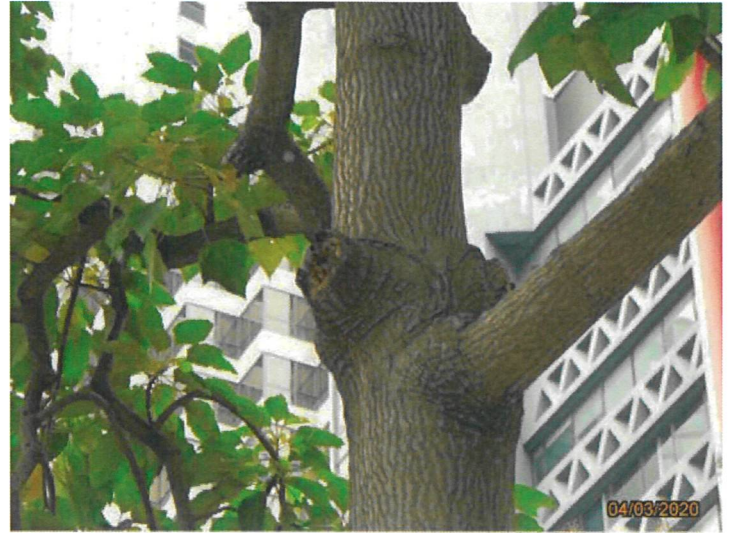
S018 - Broken branch

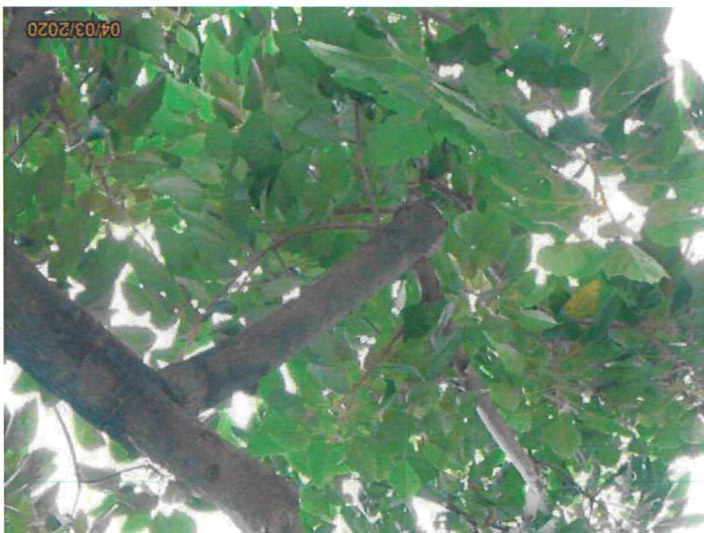
S018 - Pruned wound and epicormics

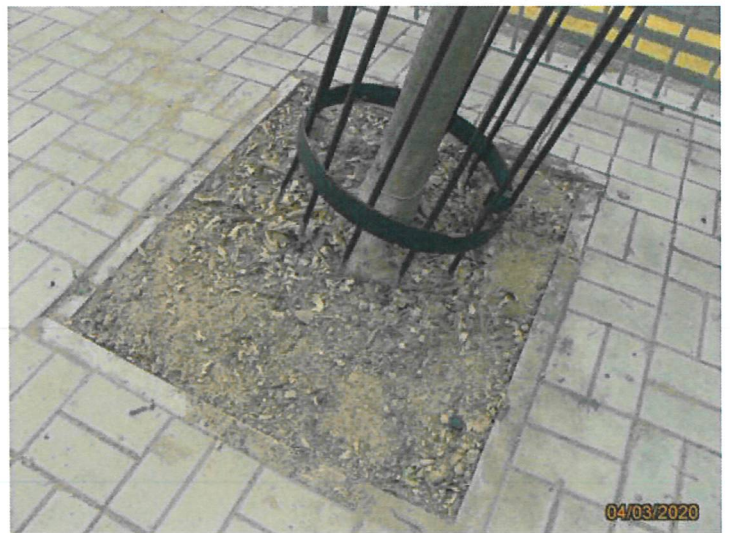
S023 - Restricted rooting area

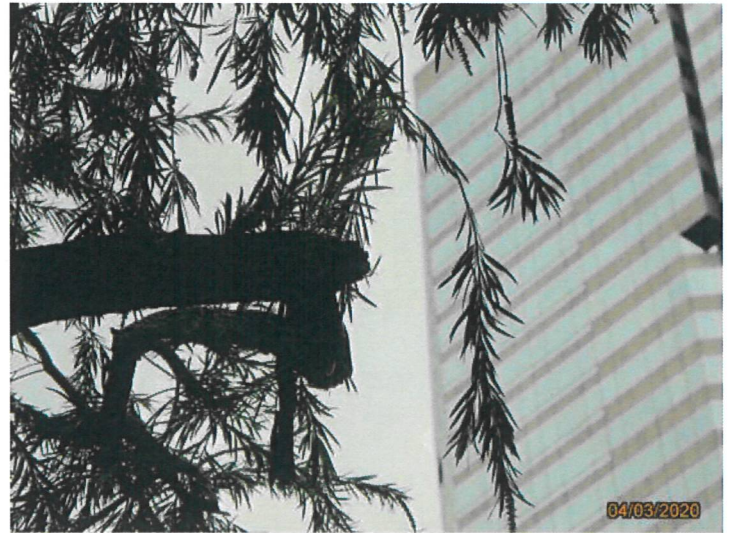
S026 - Broken branch

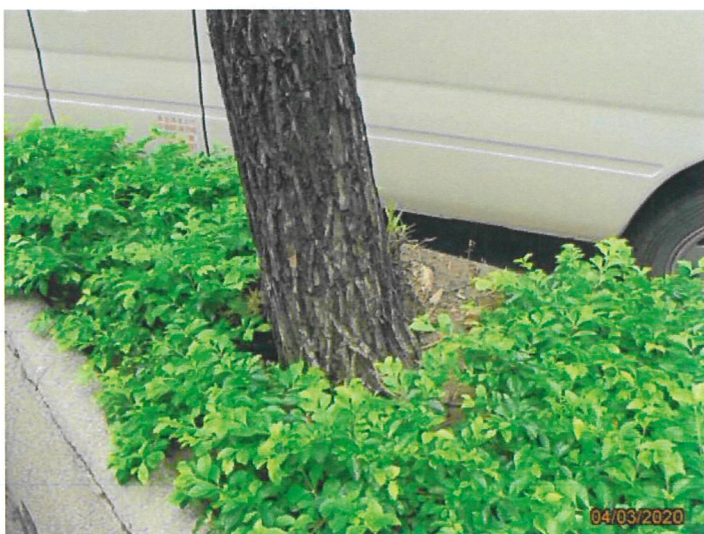
S026 - Planted in raised planter

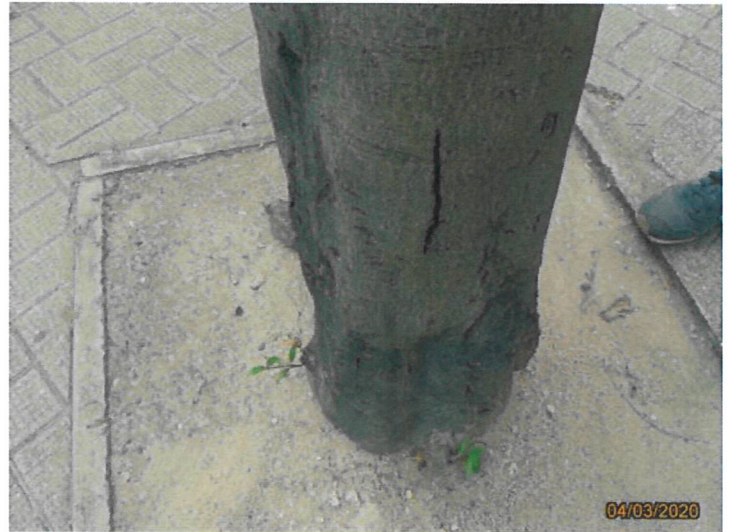
S028 - Crack on trunk (2)

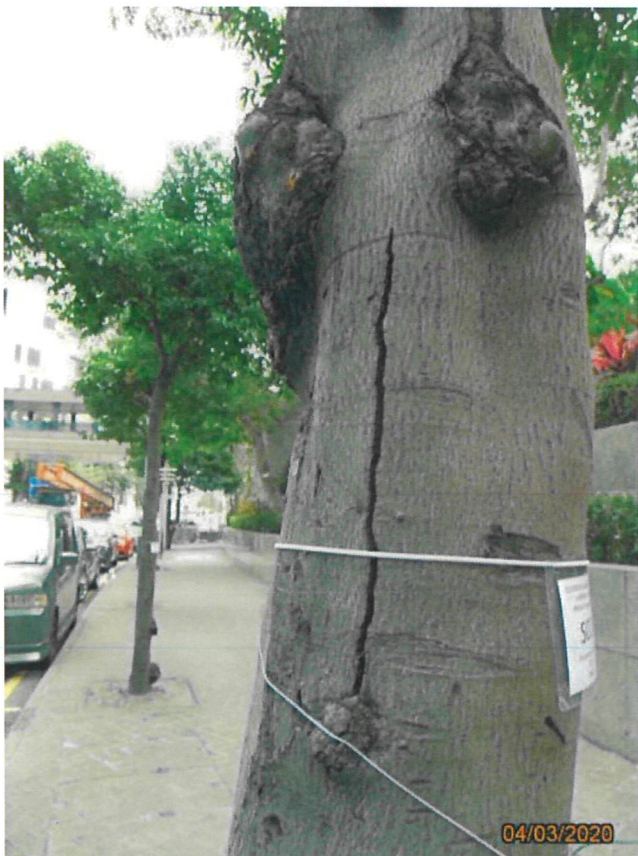
S028 - Crack on trunk (3)

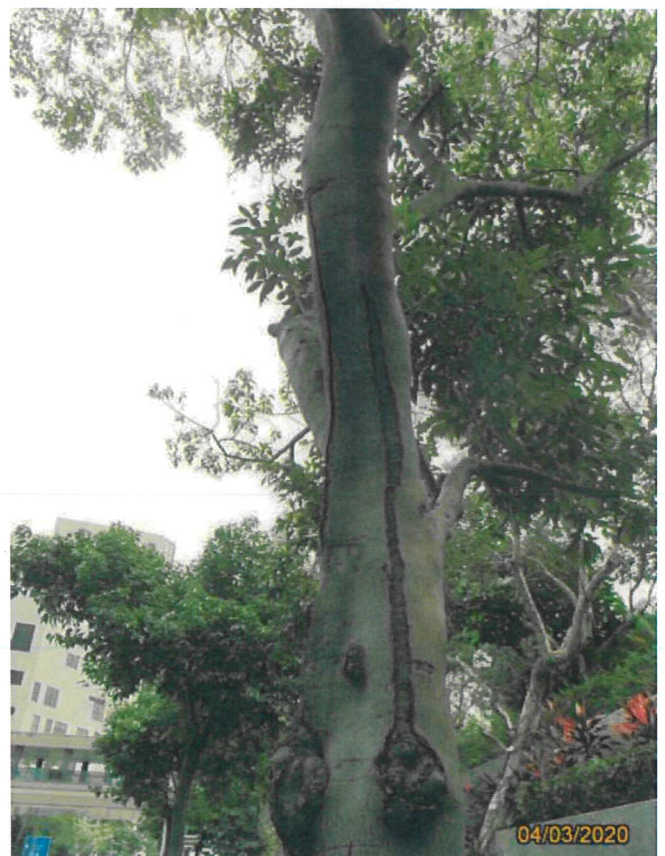
S028 - Crack on trunk (4)
