**Shatin to Central Link
Contract 1123 – Exhibition Station and Western Approach Tunnel
Submission of Landscape Plan for Further Environmental Permit No. FEP-13/364/2009/H
and FEP-03/376/2009**

**Shatin to Central Link –
Exhibition Station & Western Approach
Tunnel**

Landscape Plan
for
FEP-13/364/2009/H & FEP-03/376/2009

LS/20426 Contract 1123_H2624 - Exhibition Station and Western Approach Runnel
Initial Tree Survey Report

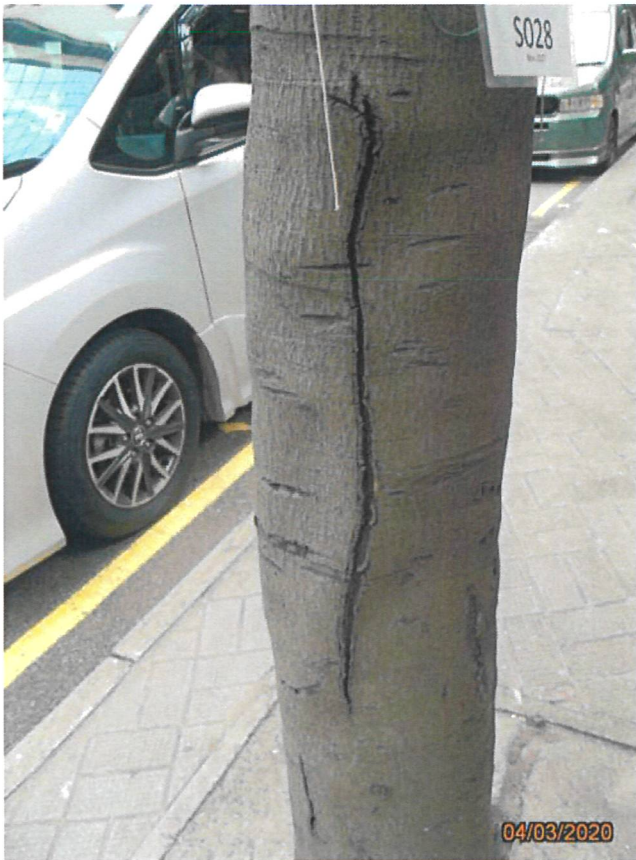
S028 - Crack on trunk

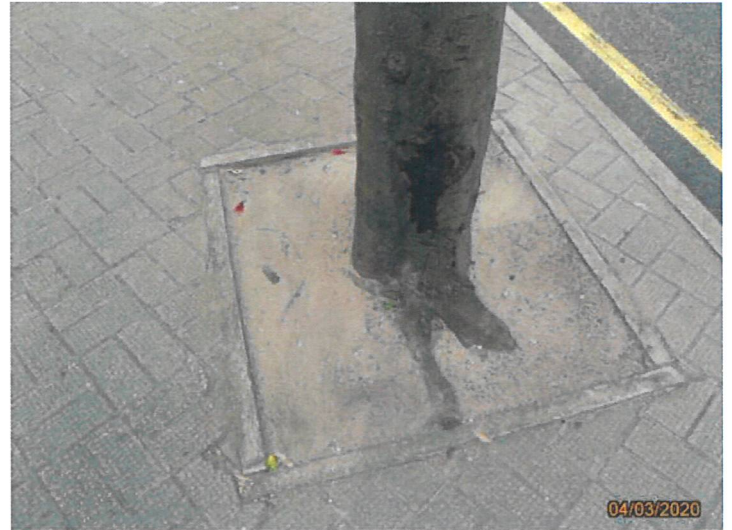
S028 - Restricted rooting area

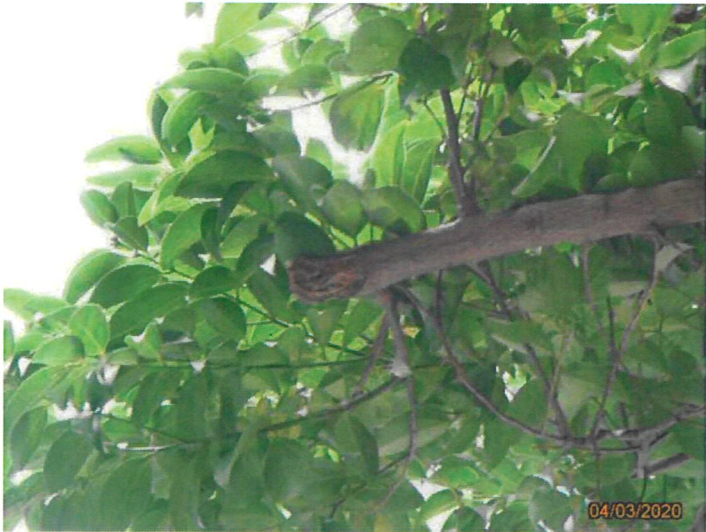
S029 - Broken branch (2)

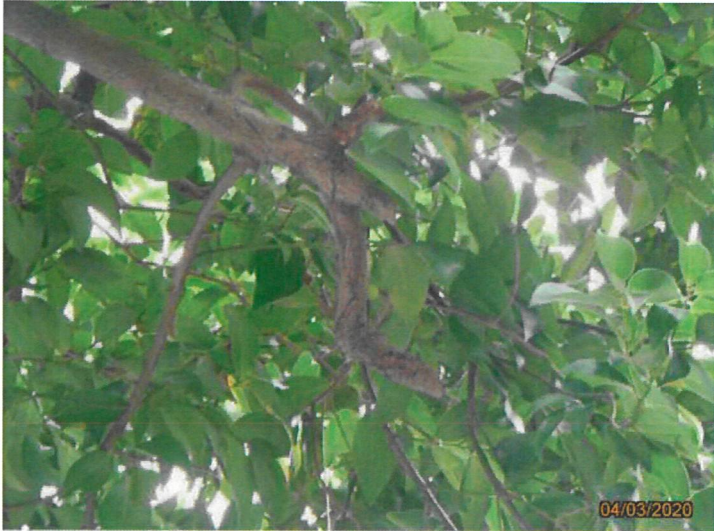
S029 - Broken branch (3)

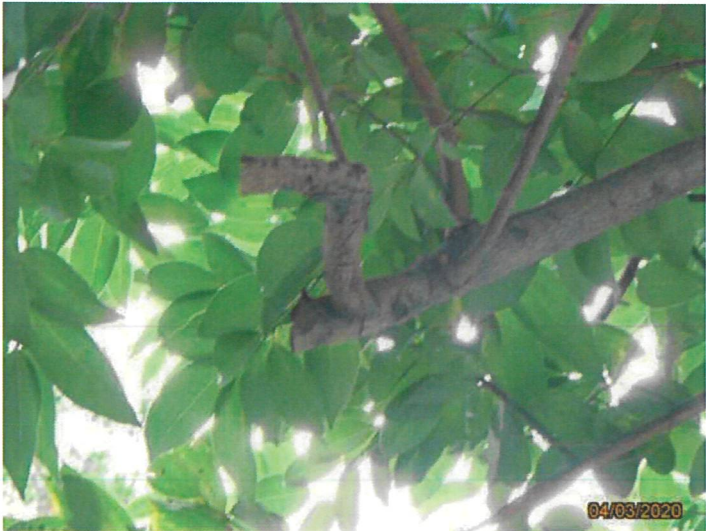
S029 - Broken branch

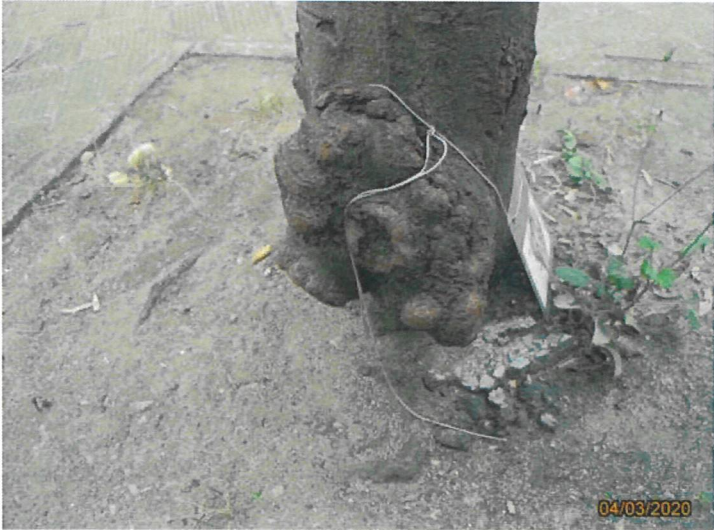
S029 - Bulge (2)

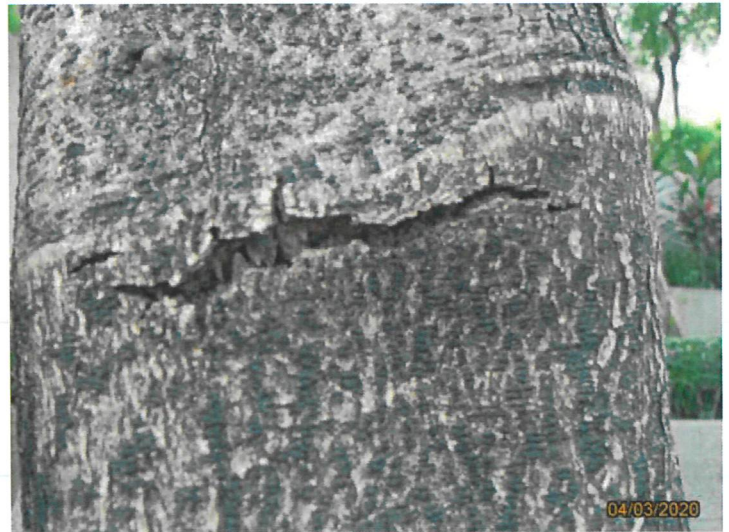
S031 - Crack on trunk

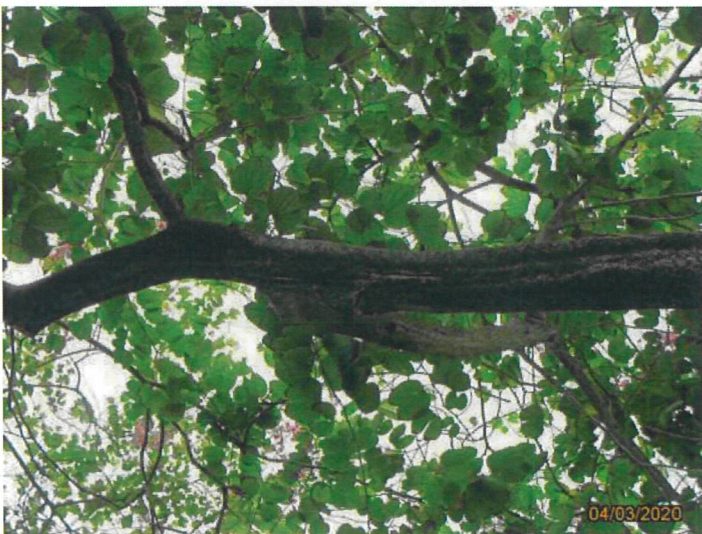
S034 - Crack on branch

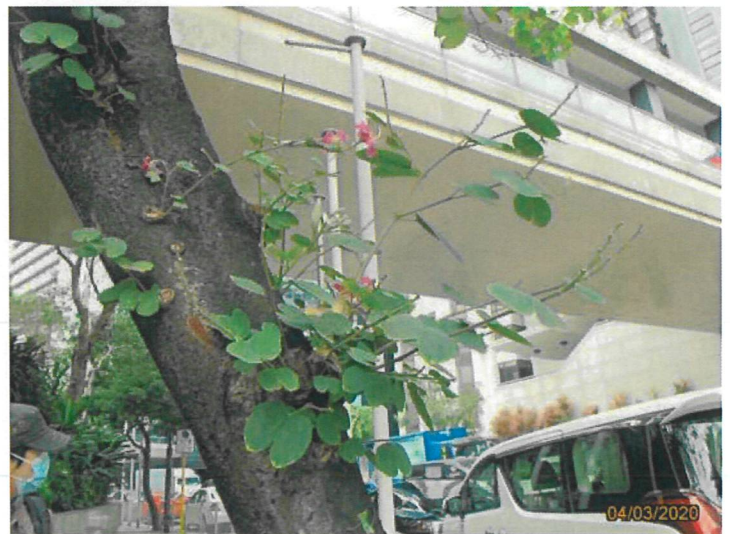
S034 - Epicormics

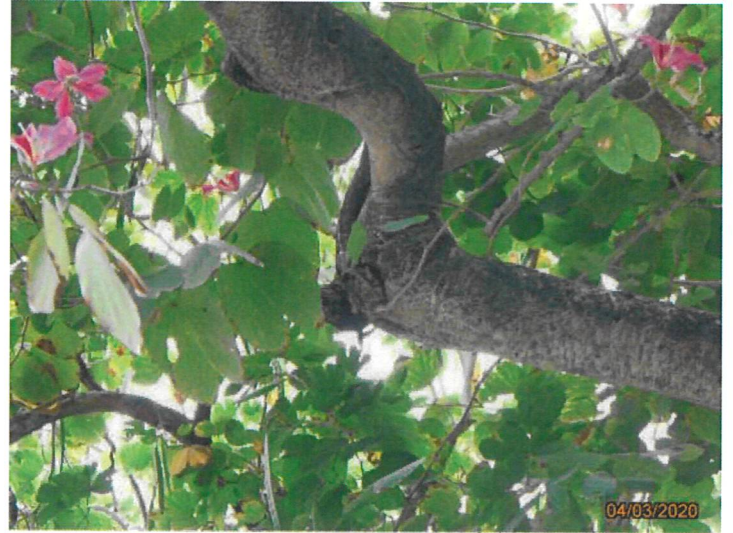
S035 - Broken branch

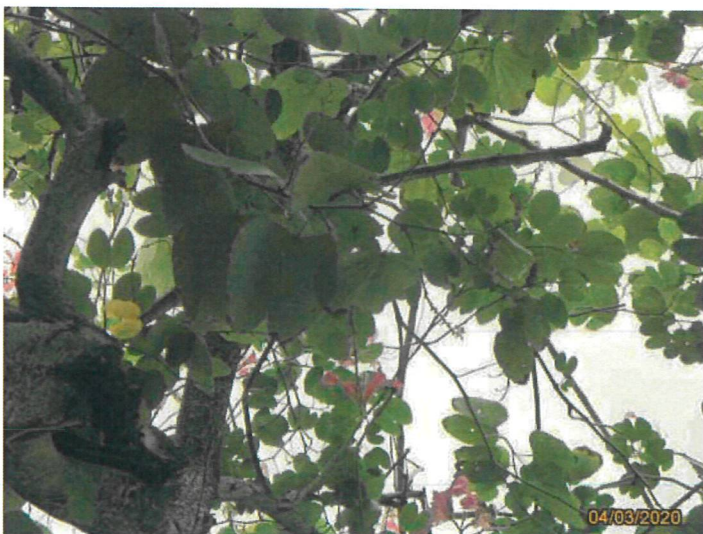
S035 - Dead branch

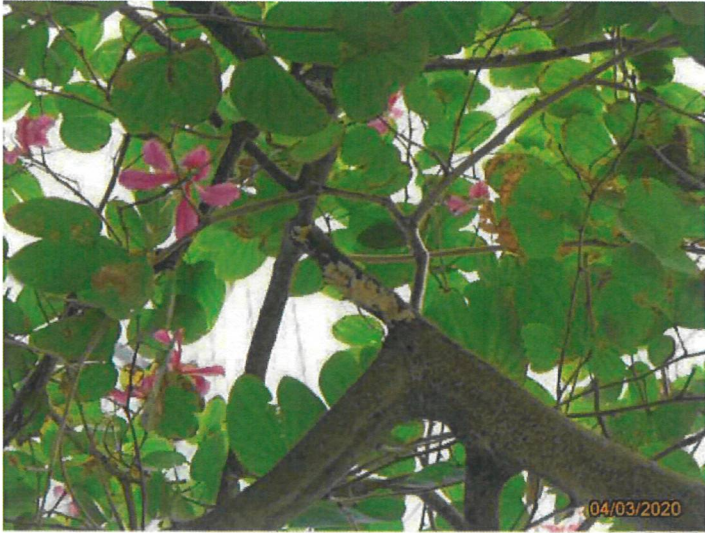
S039 - Broken branch

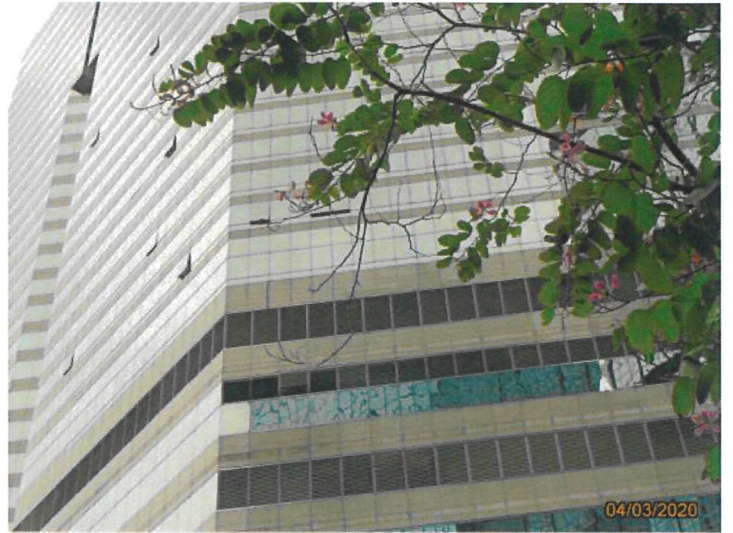
S039 - Dieback

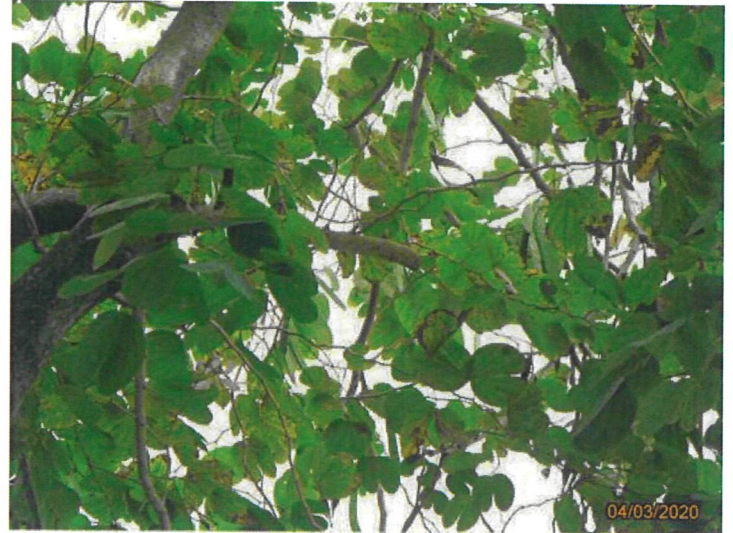
S043 - Broken branch

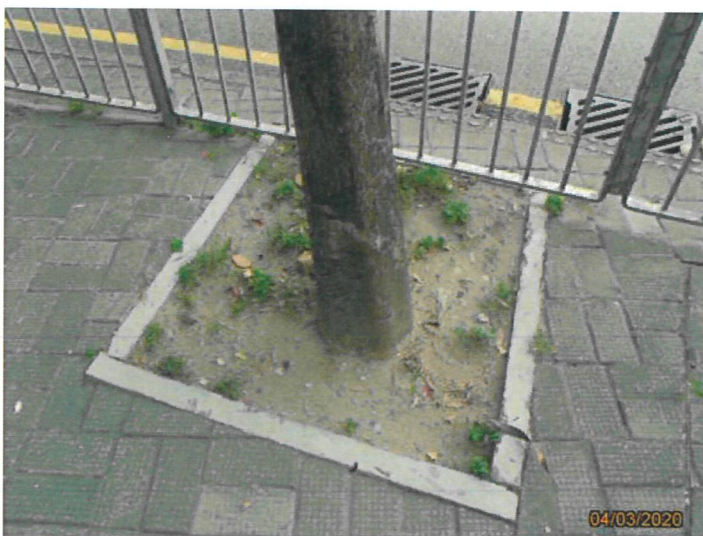
S043 - Invisible root collar and restricted rooting area
