Contract No. CV/2007/03

**Development at Anderson Road –  
Site Formation and Associated  
Infrastructure Works****Monthly EM&A Report for  
October 2015**

November 2015

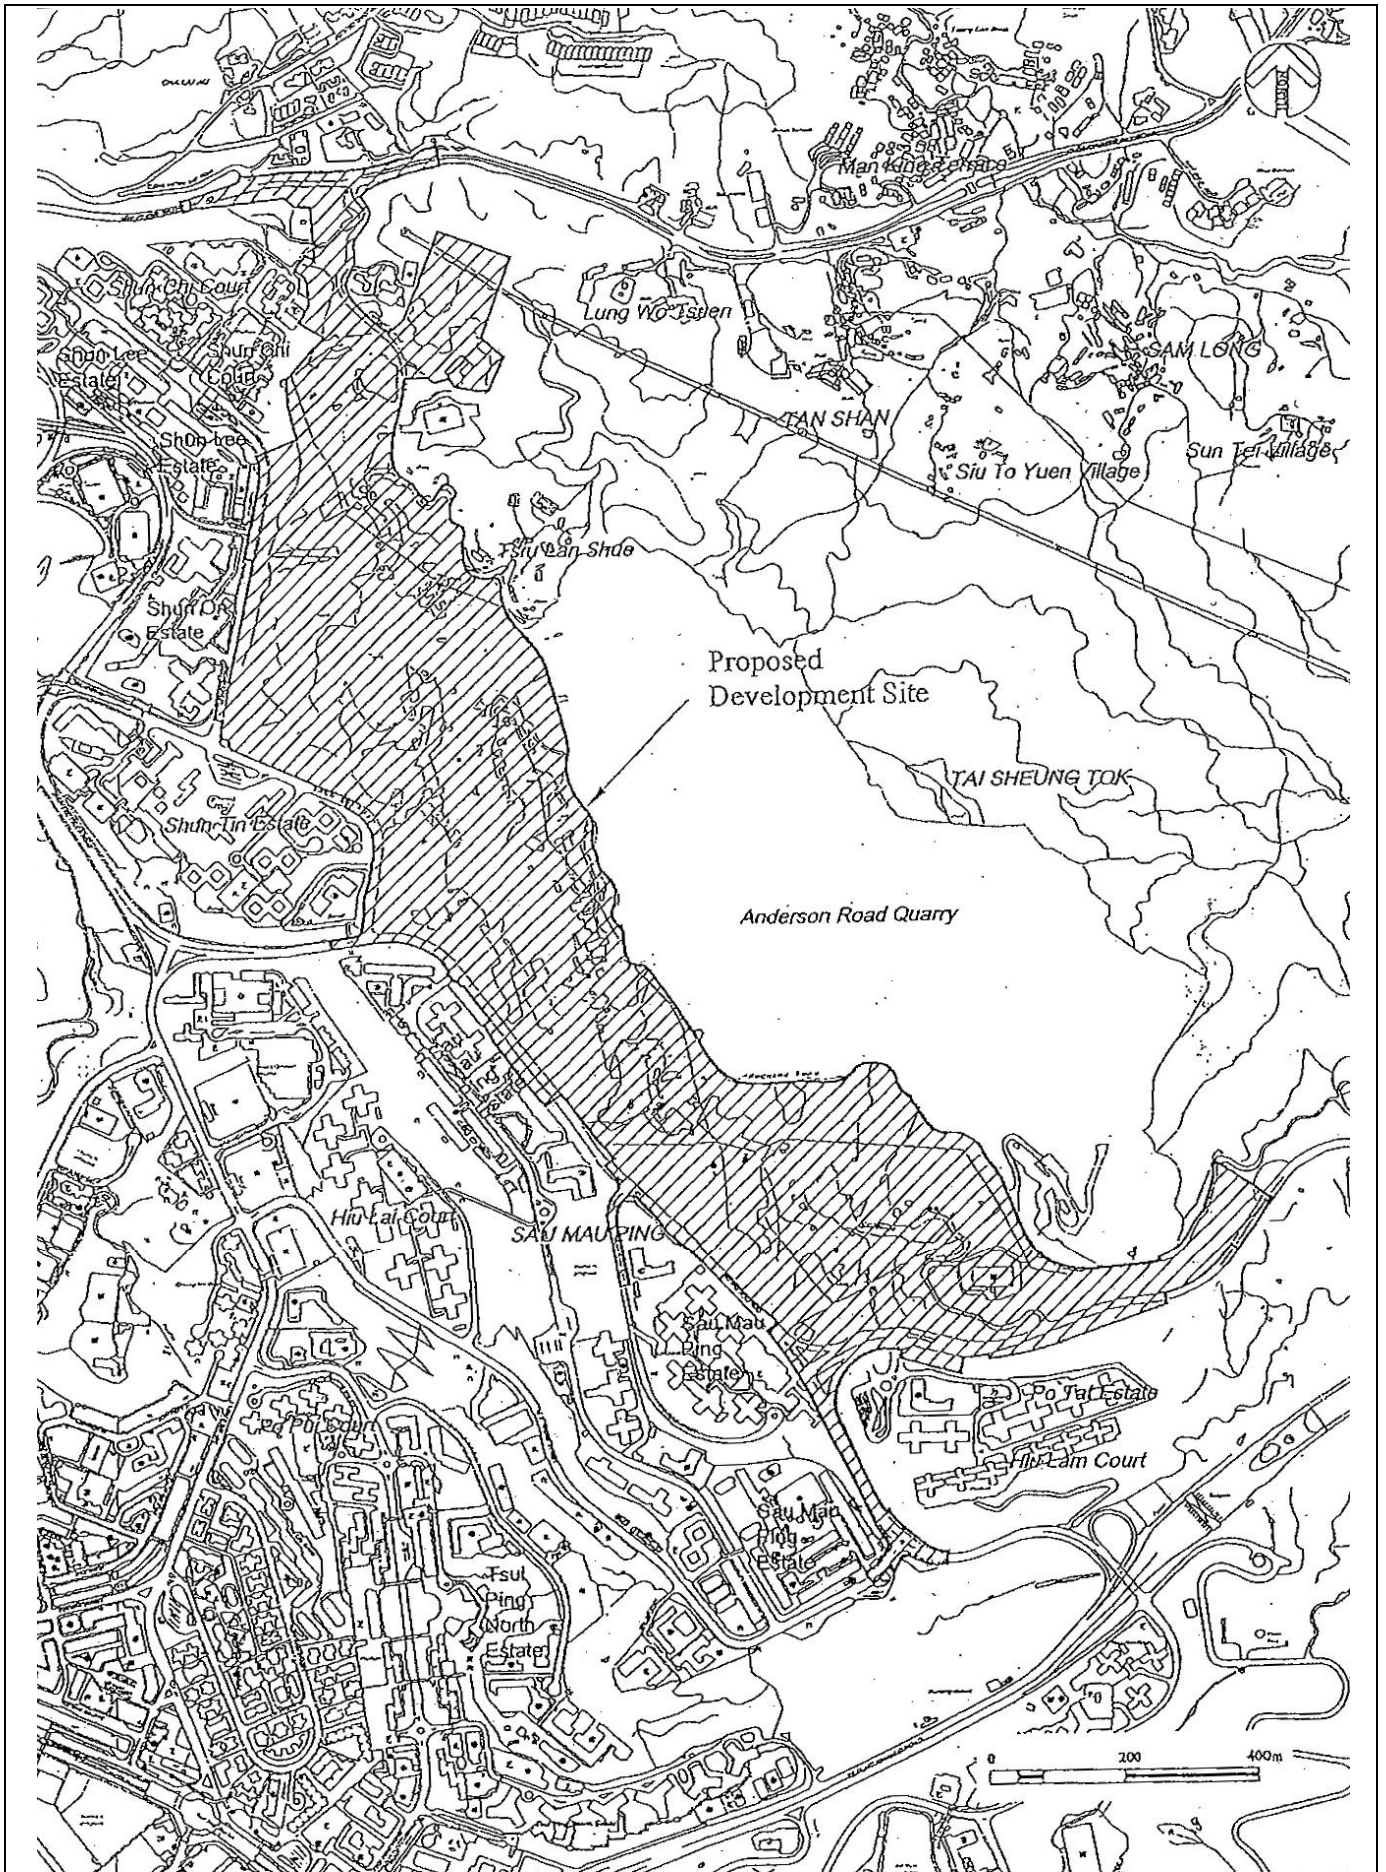
SCALE	N.T.S.	DATE	Nov-09
CHECK	ENFL	DRAWN	LCHC
JOB NO.	60043155	DRAWING No.	Rev.
		FIG 1.1	-

**GENERAL LAYOUT PLAN**
