Contract No. CV/2007/03

**Development at Anderson Road –
Site Formation and Associated
Infrastructure Works****Quarterly EM&A Summary Report for
March 2016 to May 2016**

June 2016

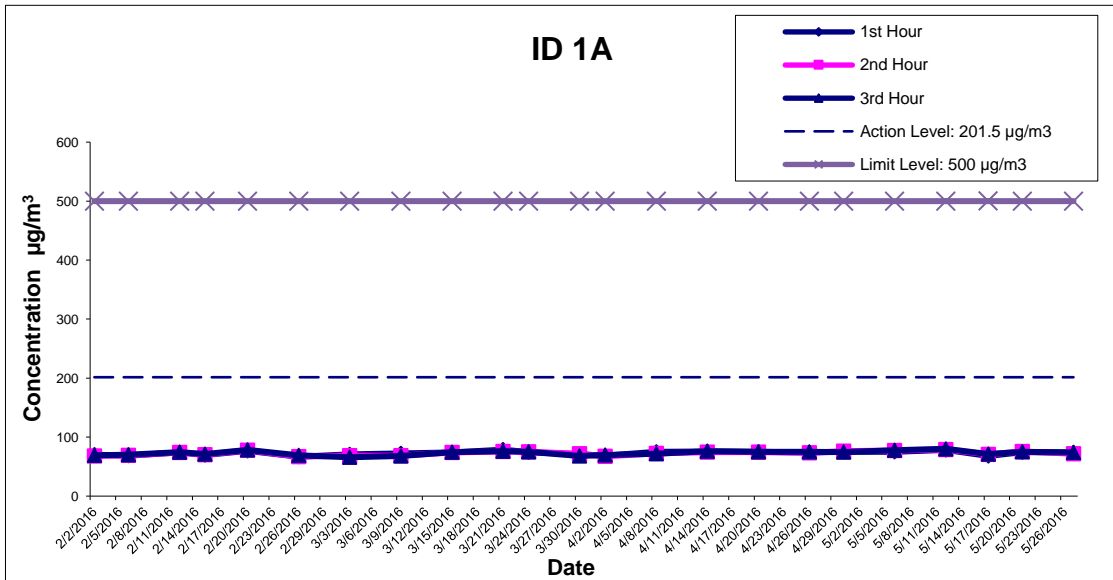
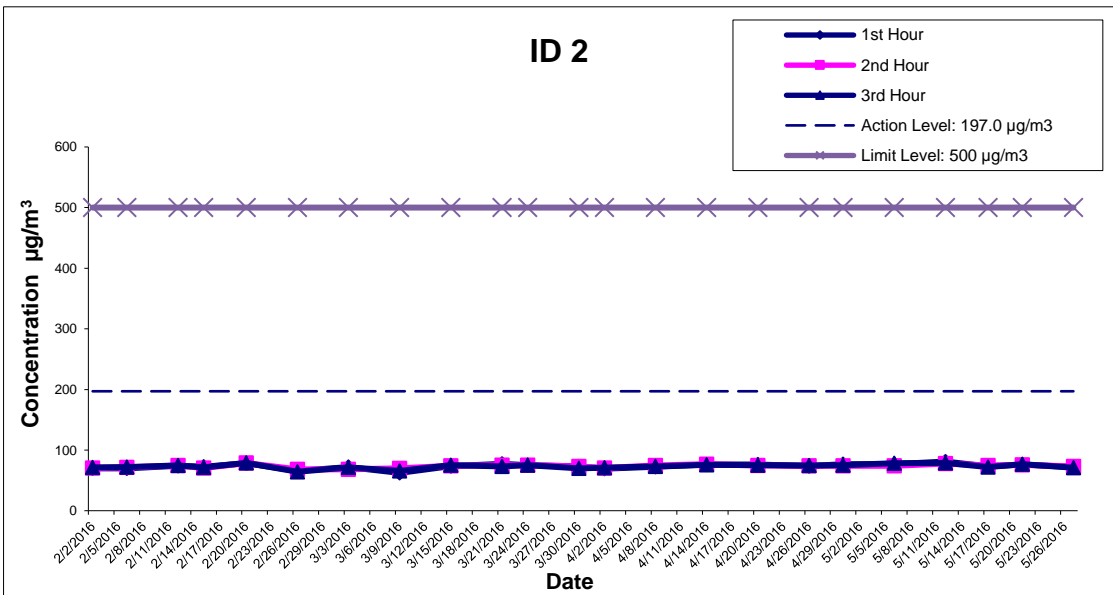
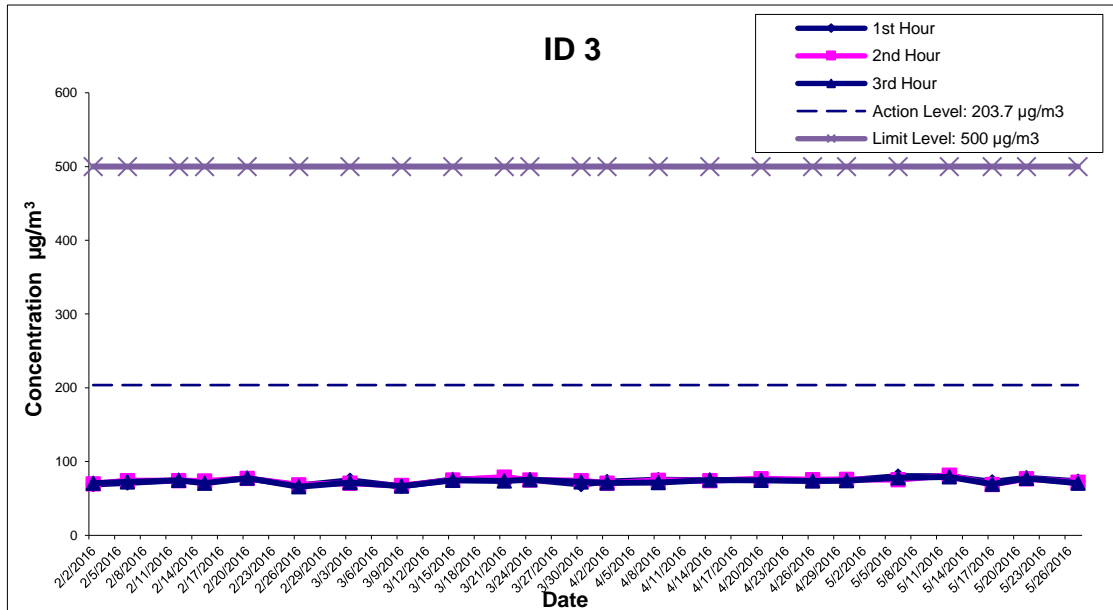
**Graphical Presentations of Impact 1-hour TSP
 Monitoring Results**

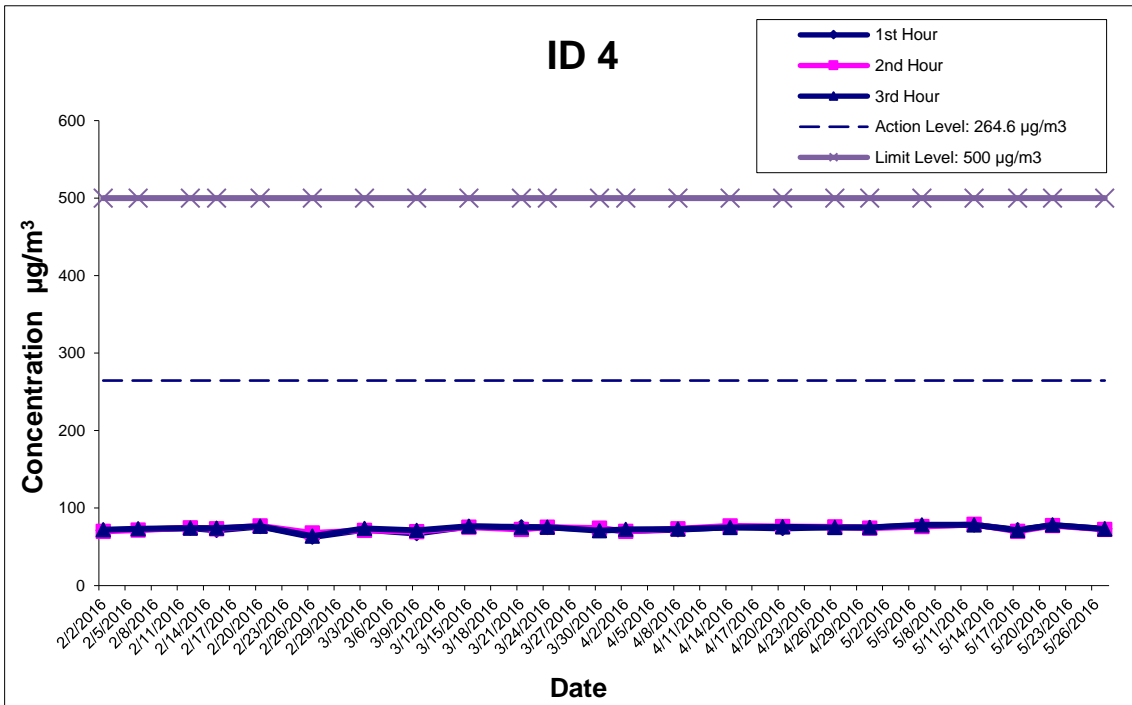
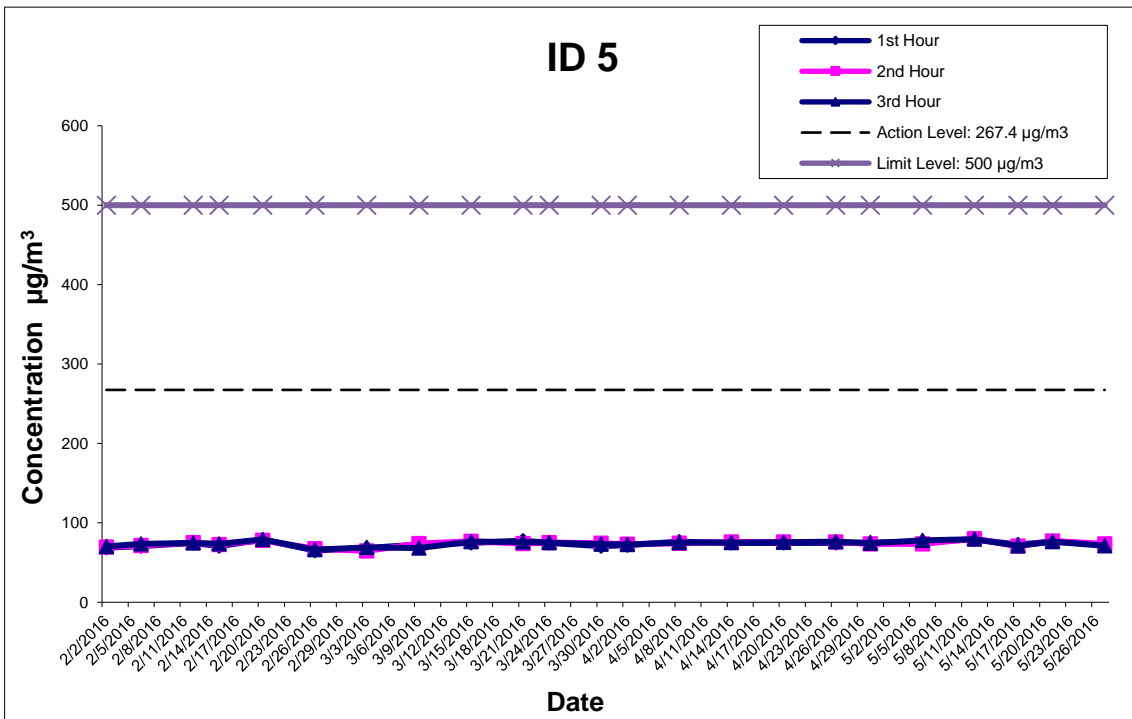
**Graphical Presentations of Impact 1-hour TSP
Monitoring Results**

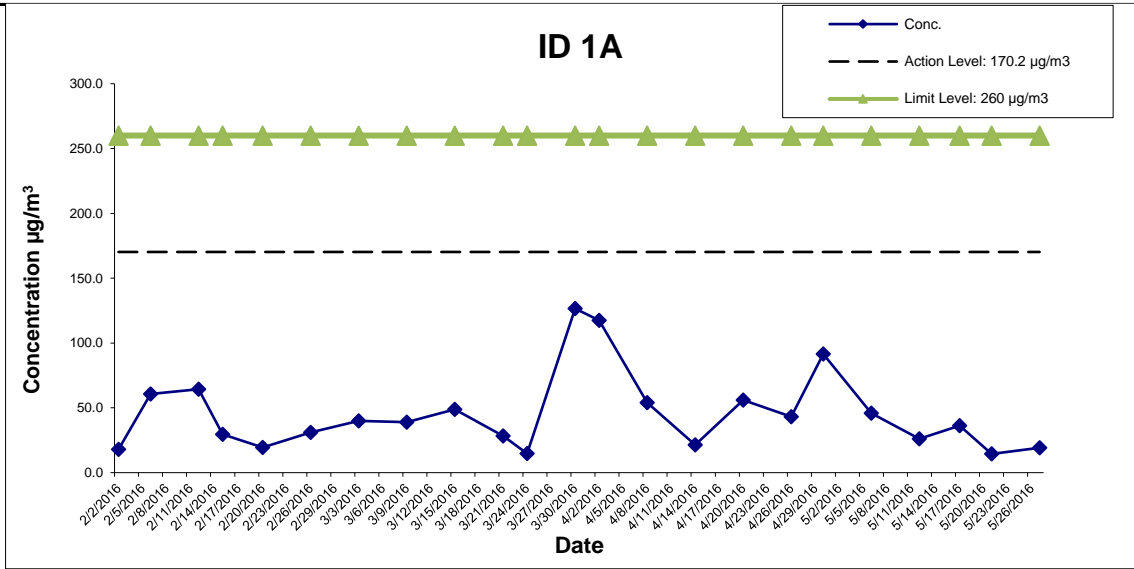
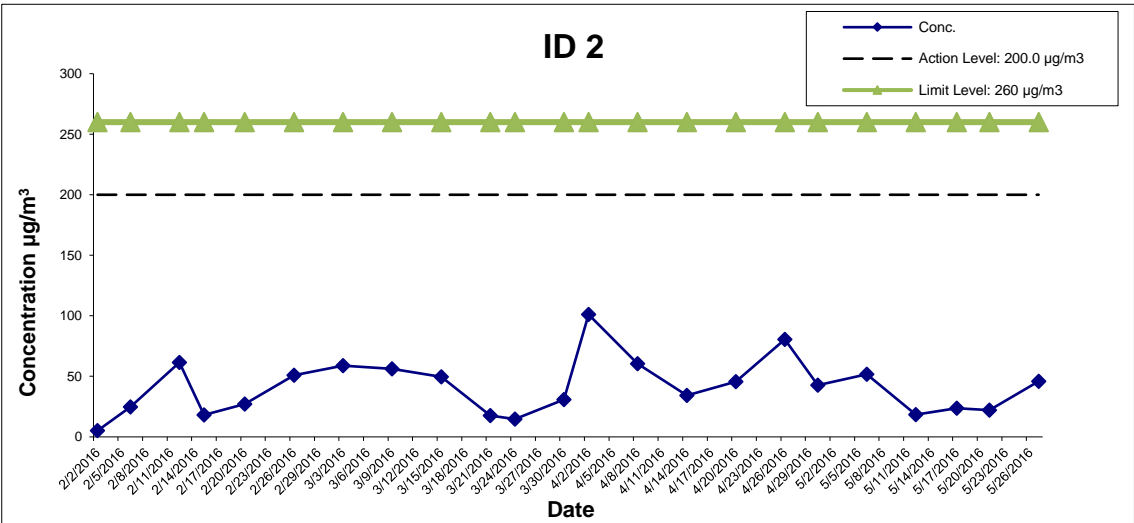
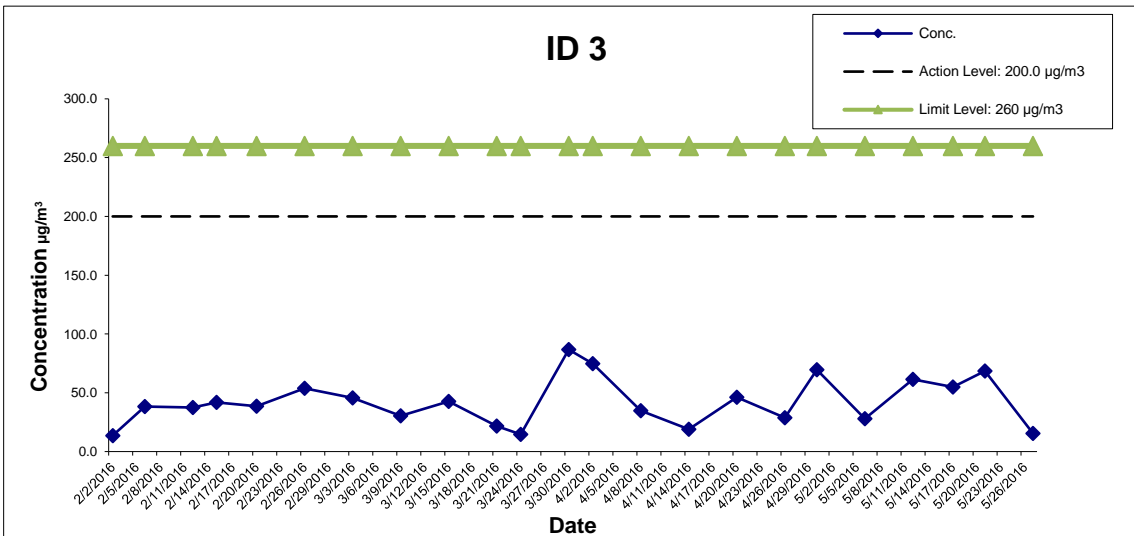
**Development at Anderson Road - Site Formation
and Associated Infrastructure Works**
Graphical Presentations of Impact 24-hour TSP
Monitoring Results

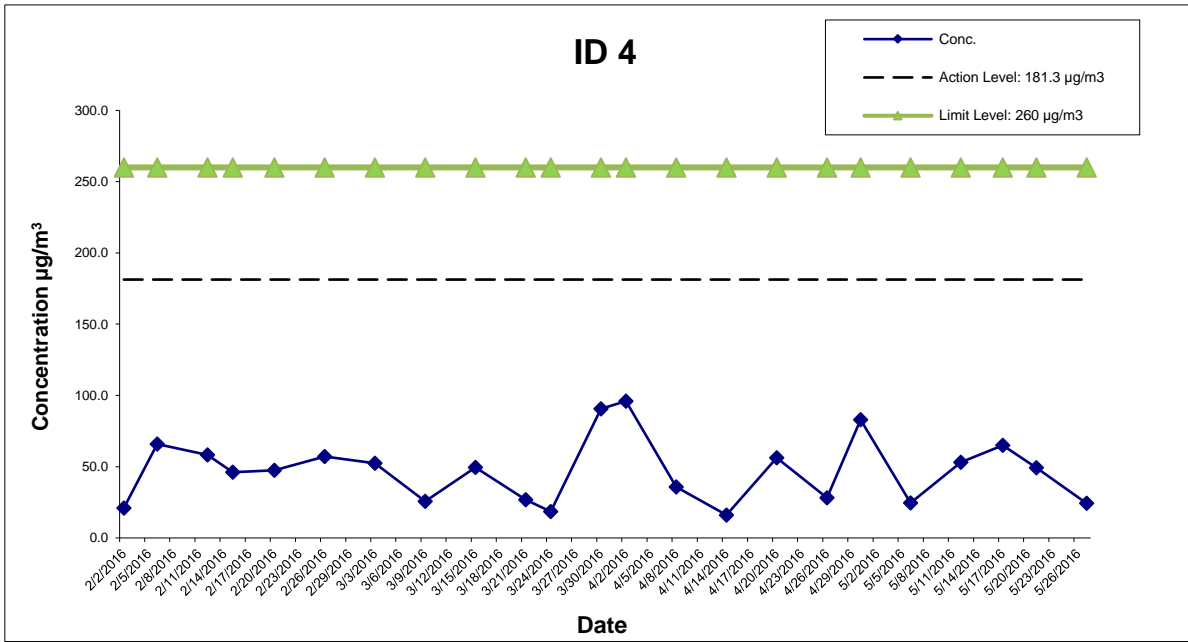
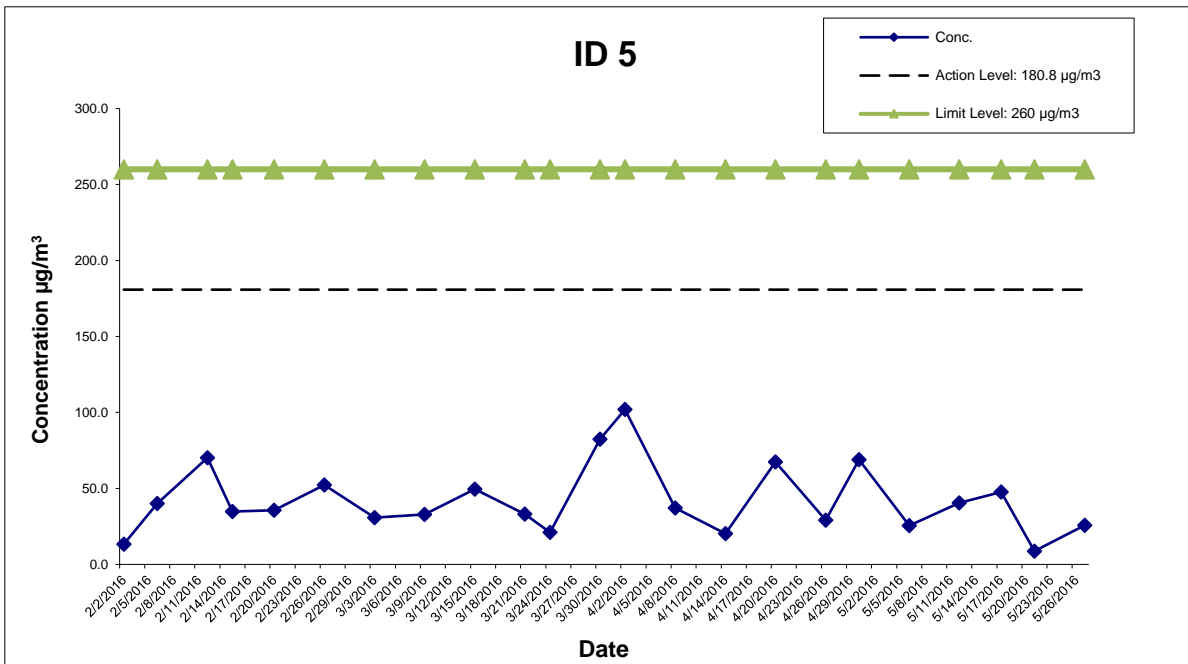
**Graphical Presentations of Impact 24-hour TSP
Monitoring Results**

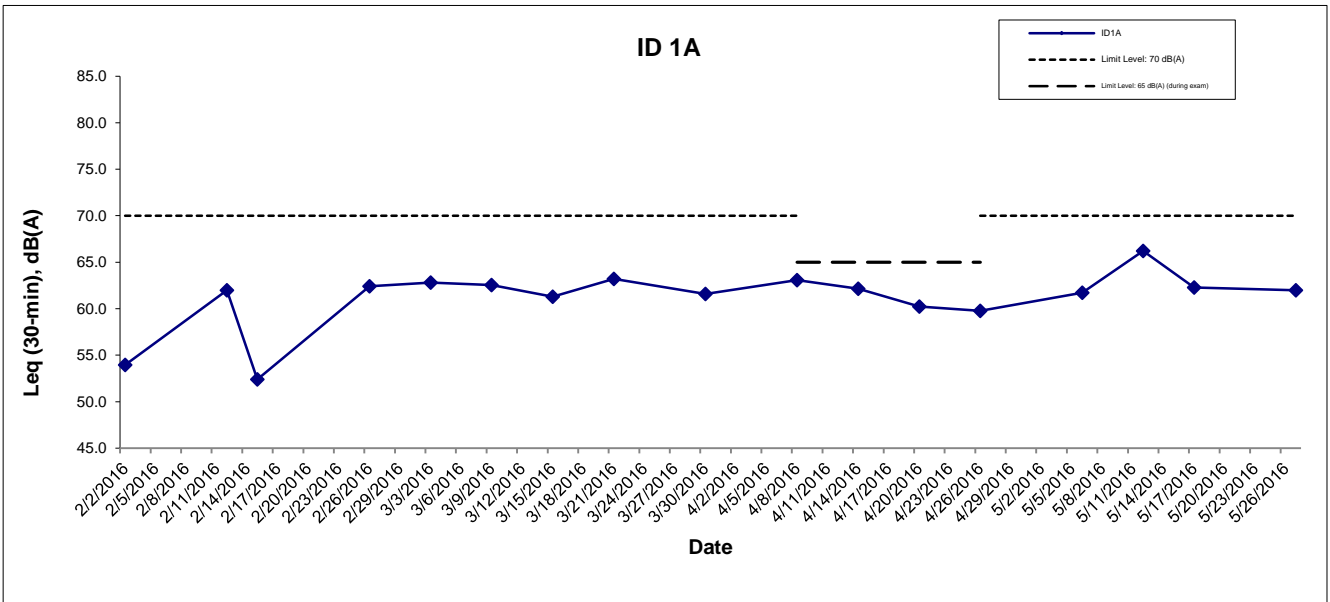
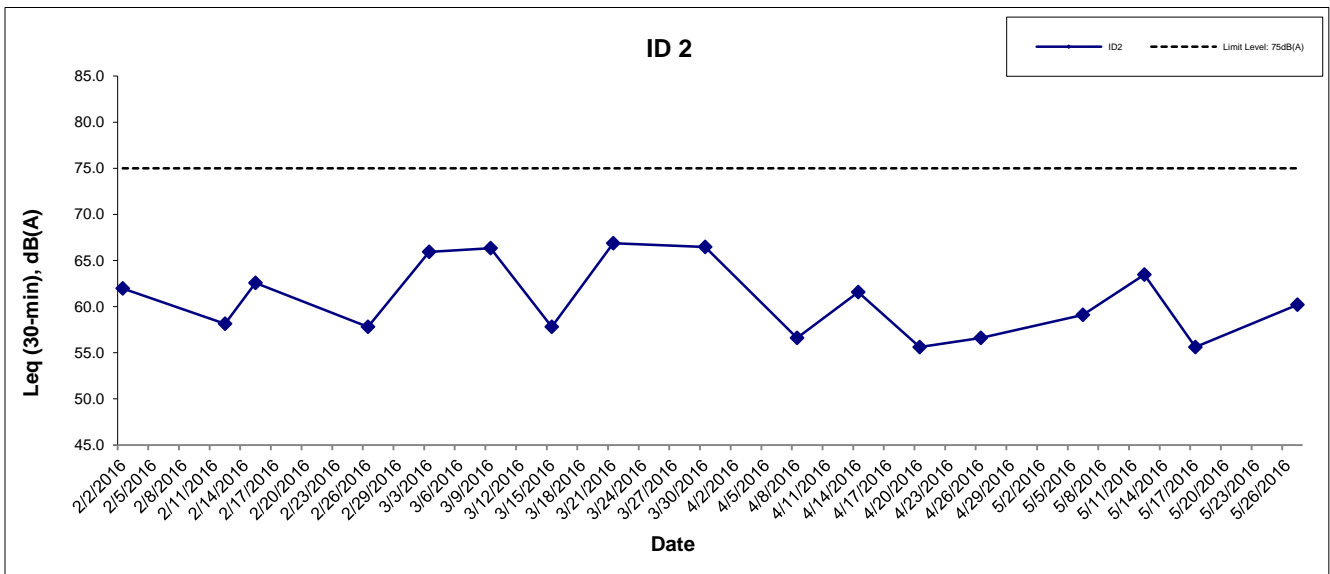
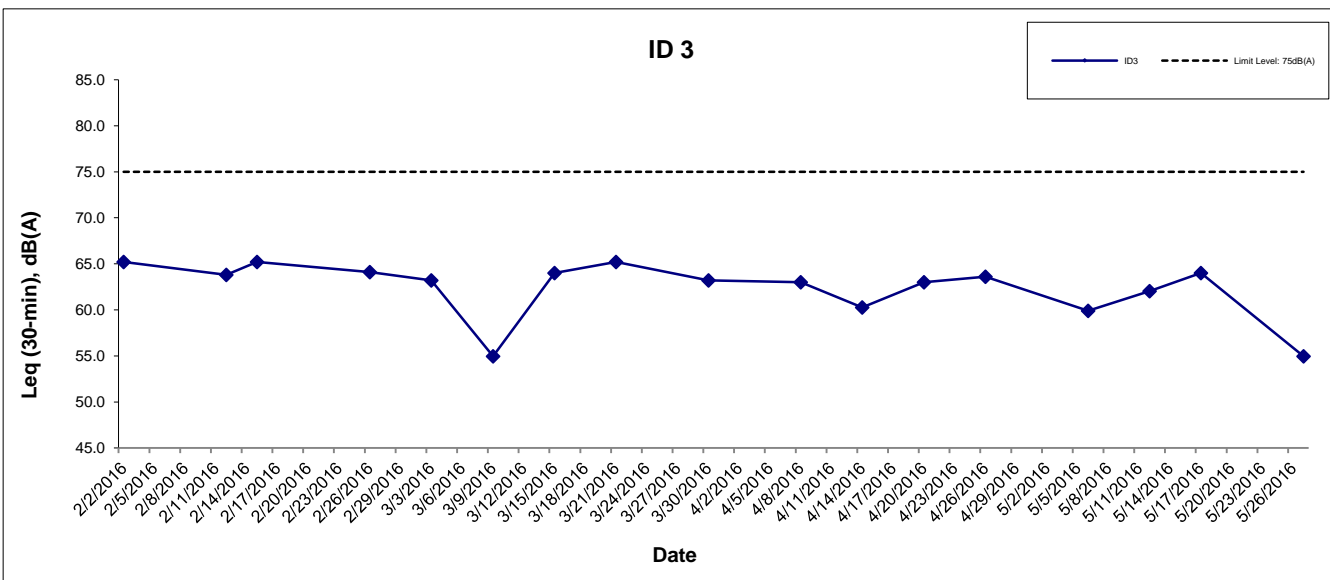
Development at Anderson Road - Site Formation and Associated Infrastructure Works	SCALE	N.T.S.	DATE	Jun-16
	Graphical Presentations of Noise Monitoring Results	CHECK	FYW	DRAWN	DTTW
		JOB NO.	60043155	APPENDIX	G
					-

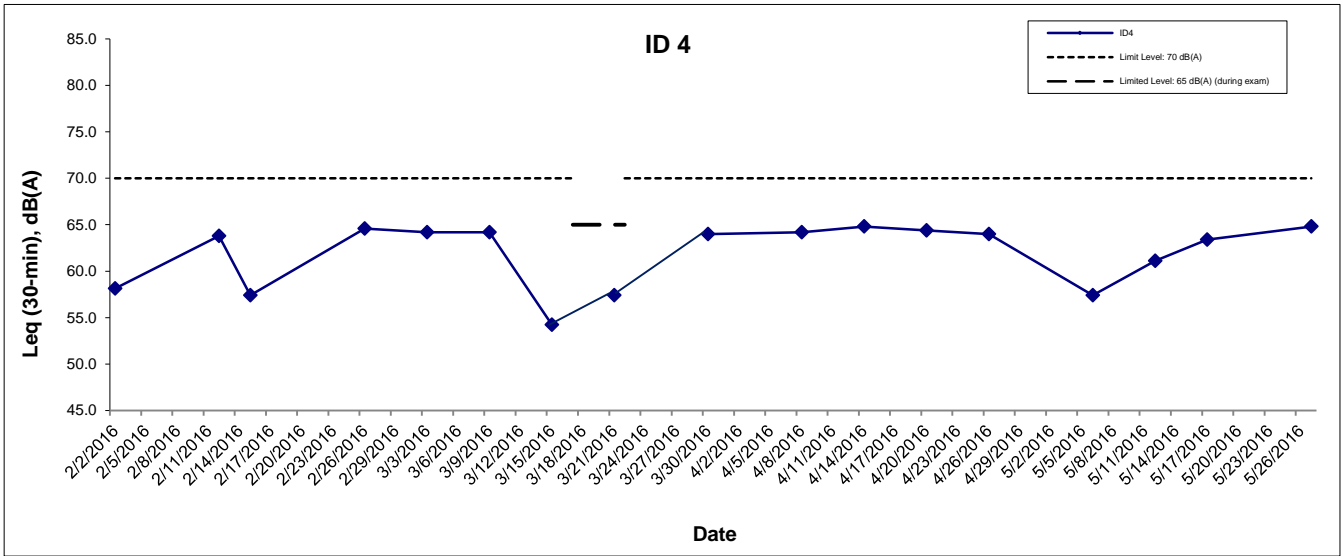
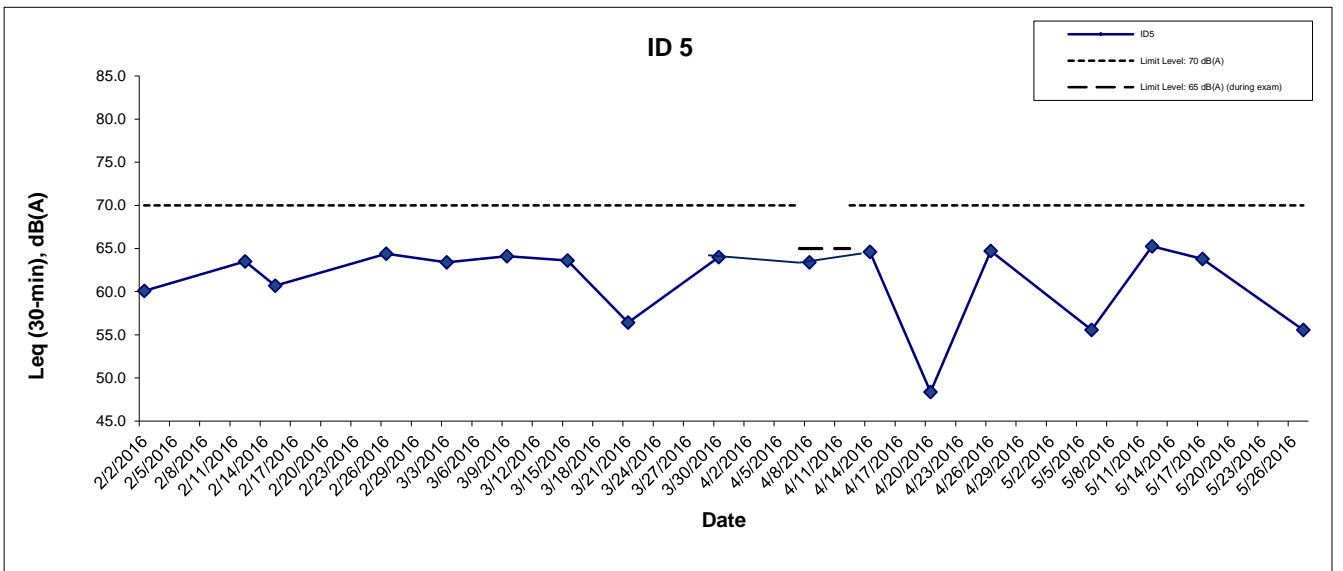
Graphical Presentations of Noise Monitoring Results
