Contract No. CV/2007/03

**Development at Anderson Road –
Site Formation and Associated
Infrastructure Works****Monthly EM&A Report for
May 2016**

June 2016

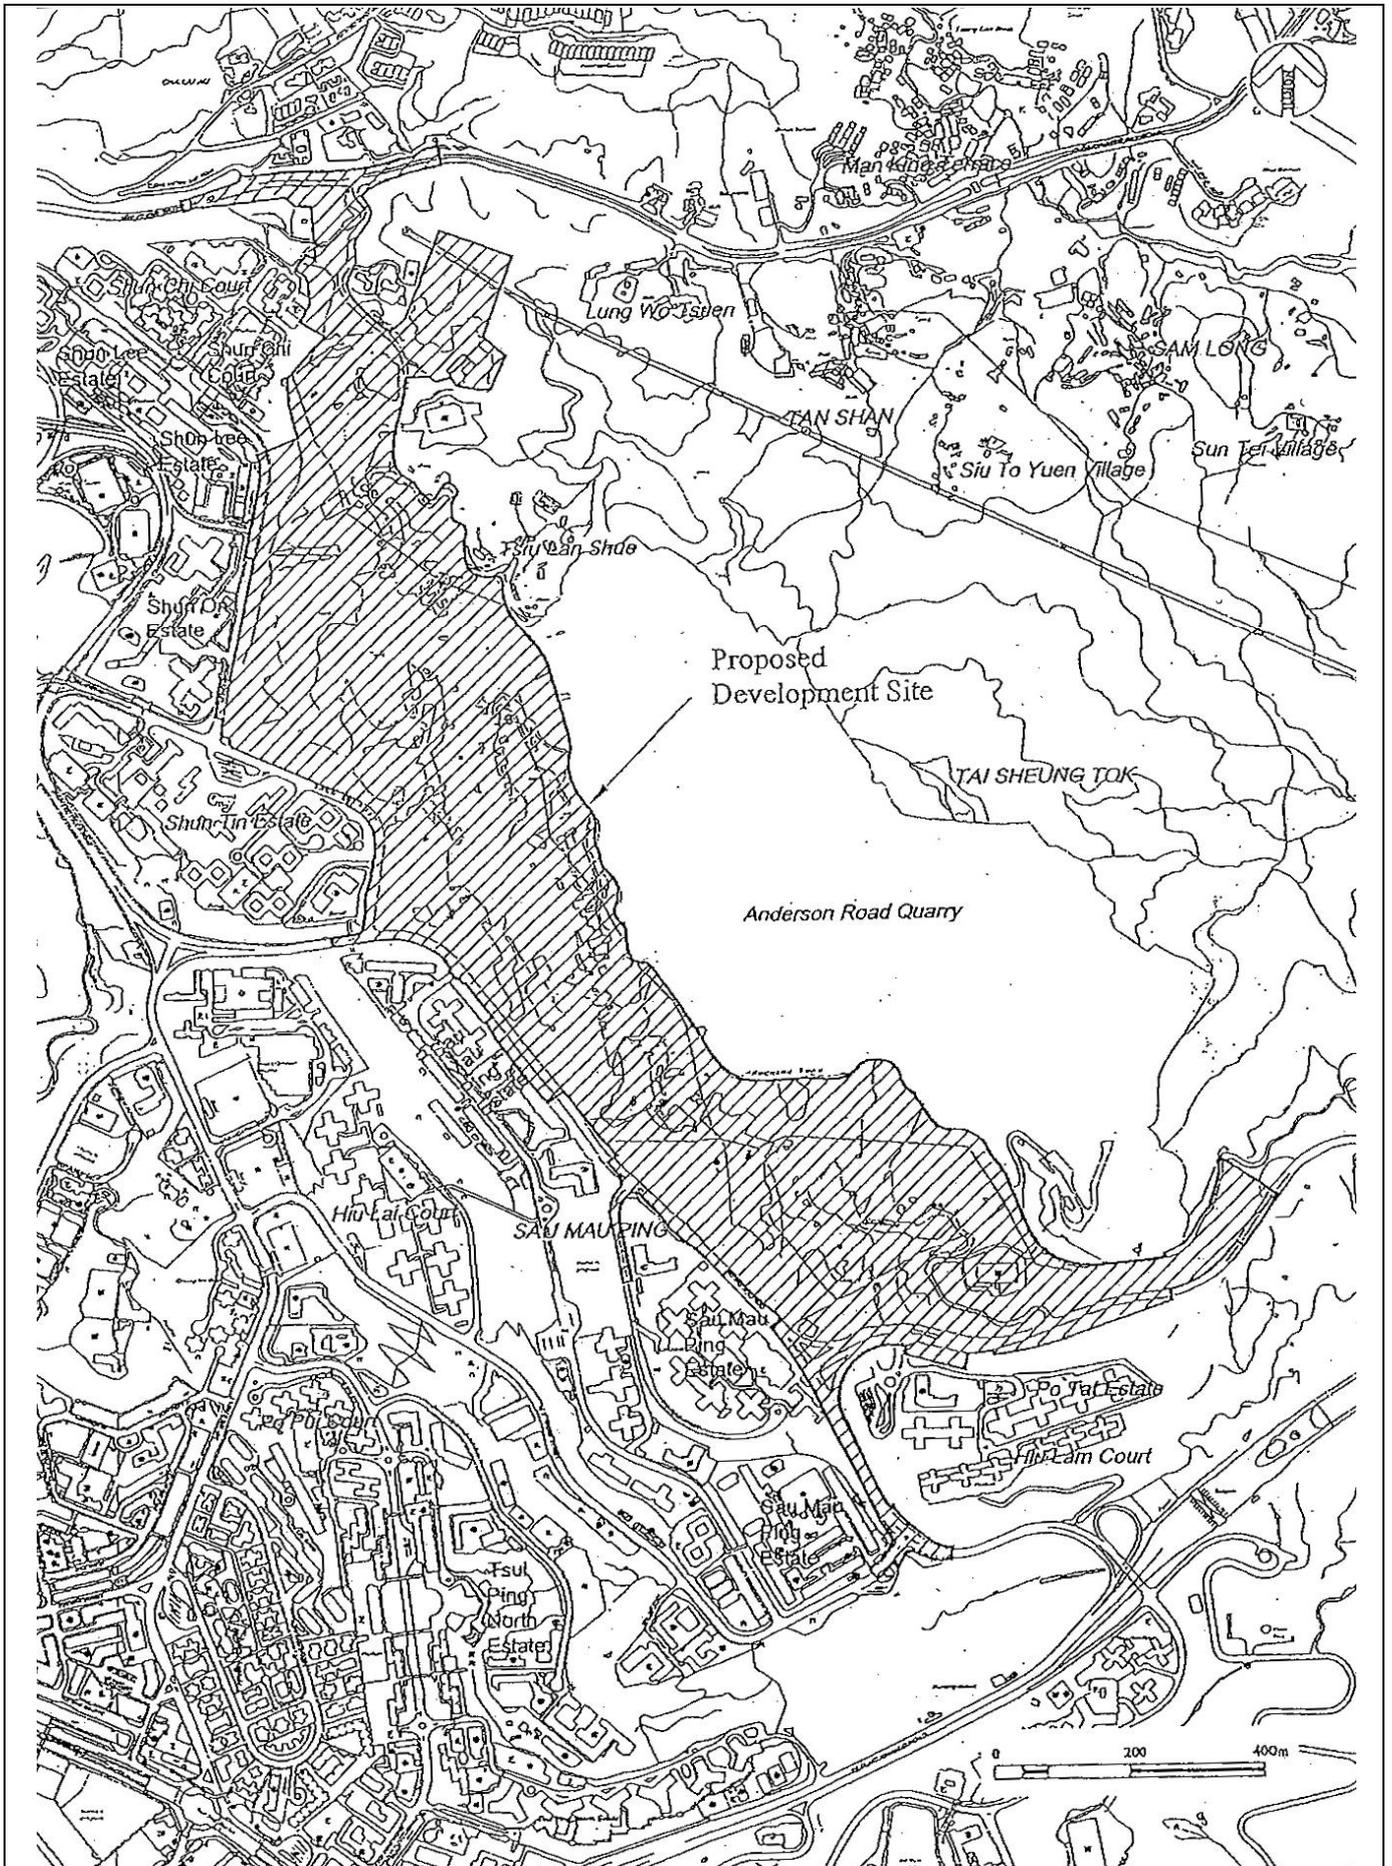
SCALE	N.T.S.	DATE	Nov-09
CHECK	ENFL	DRAWN	LCHC
JOB NO.	60043155	DRAWING No.	Rev.
		FIG 1.1	-

GENERAL LAYOUT PLAN

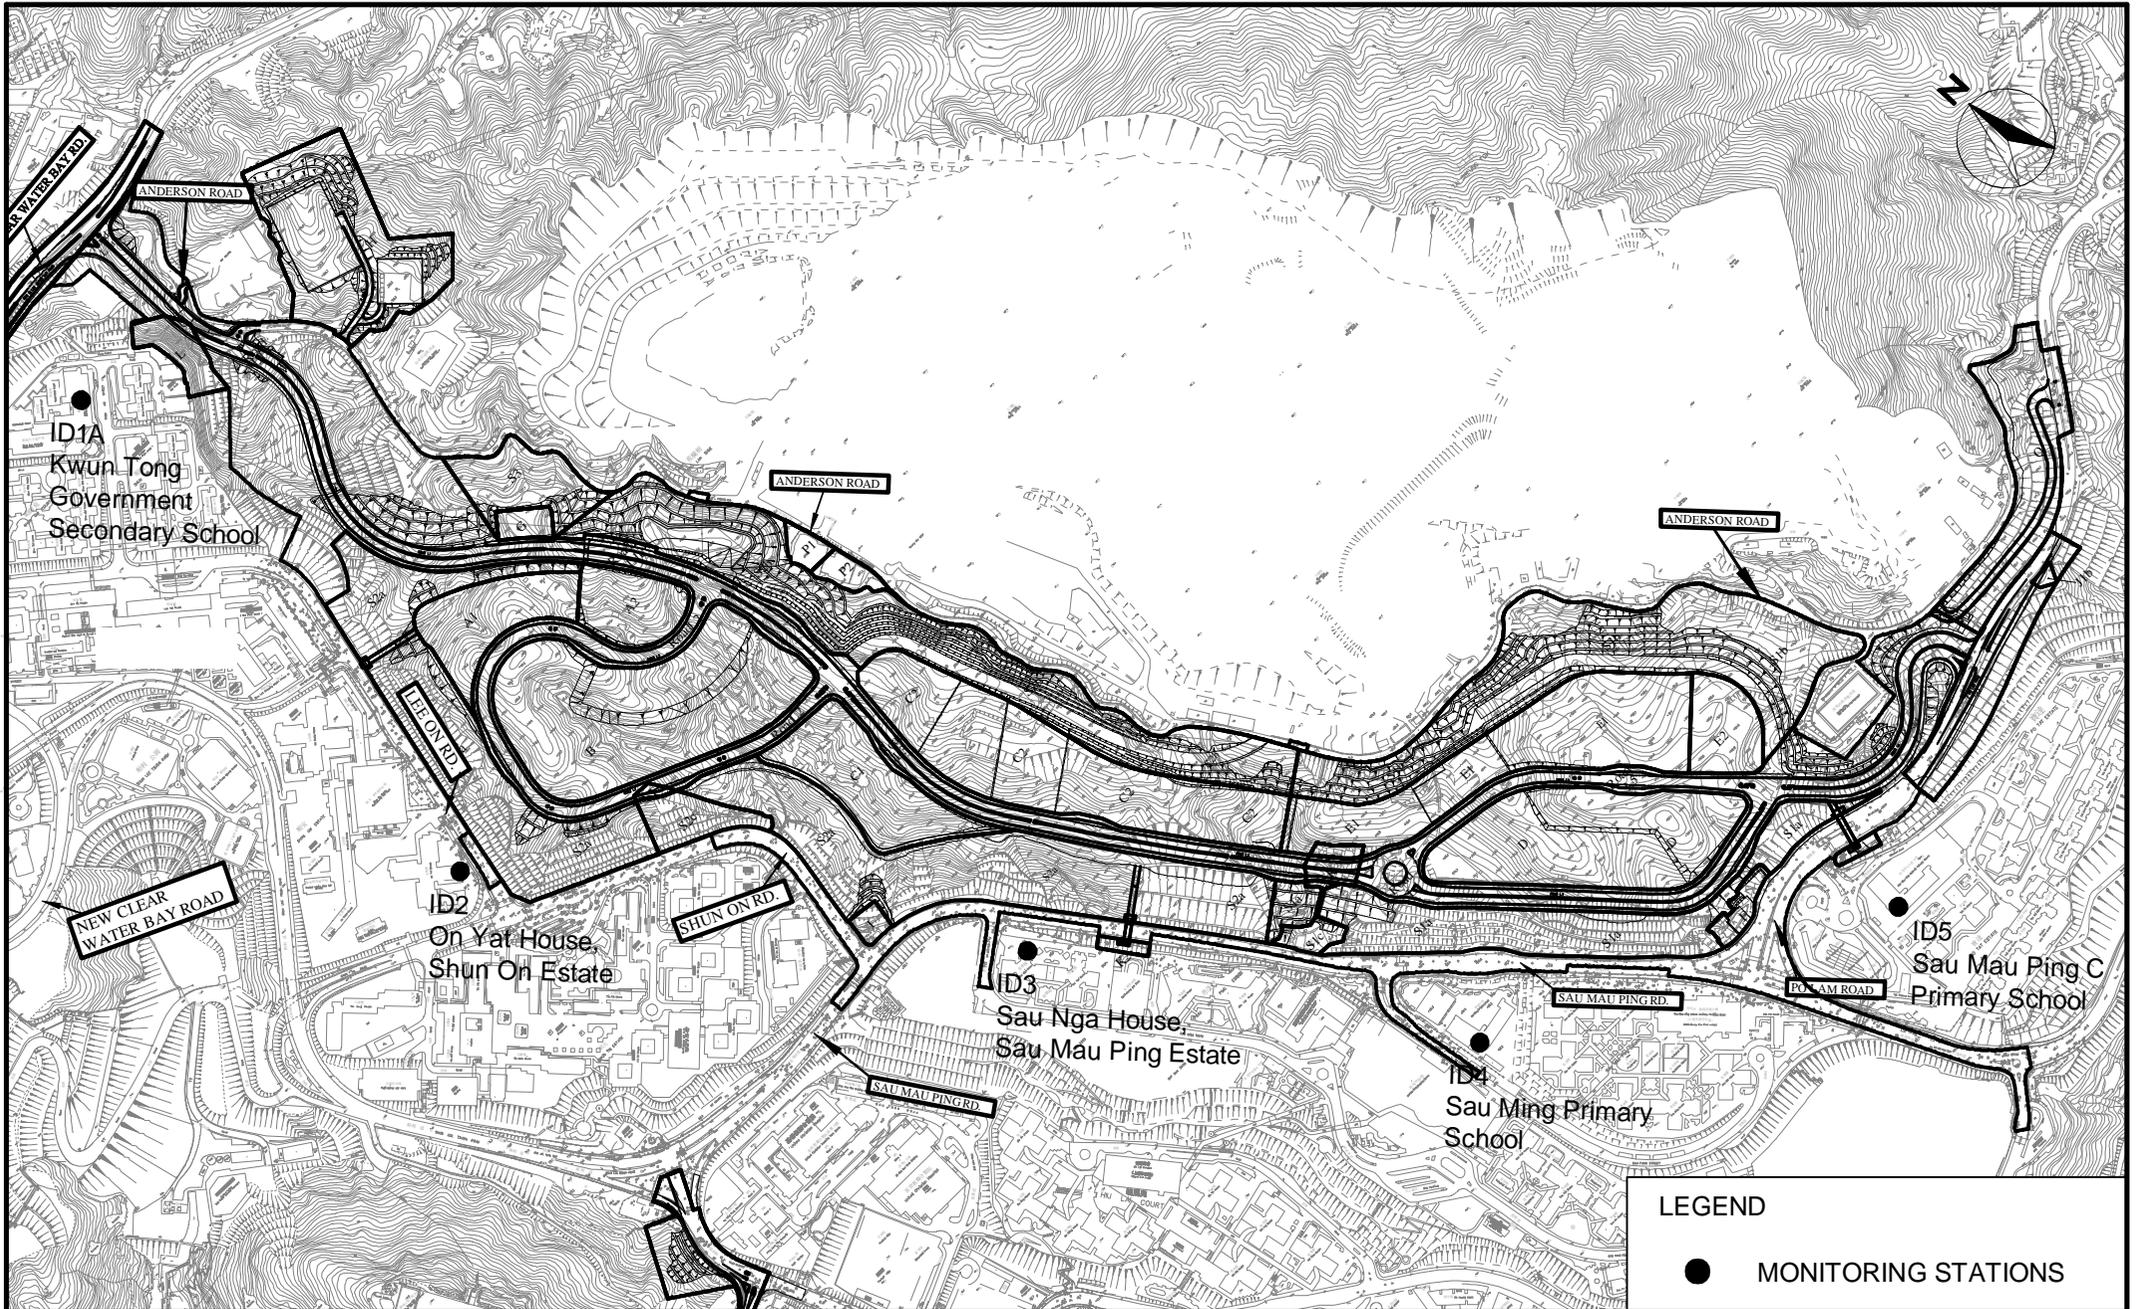
LEGEND			
●	MONITORING STATIONS

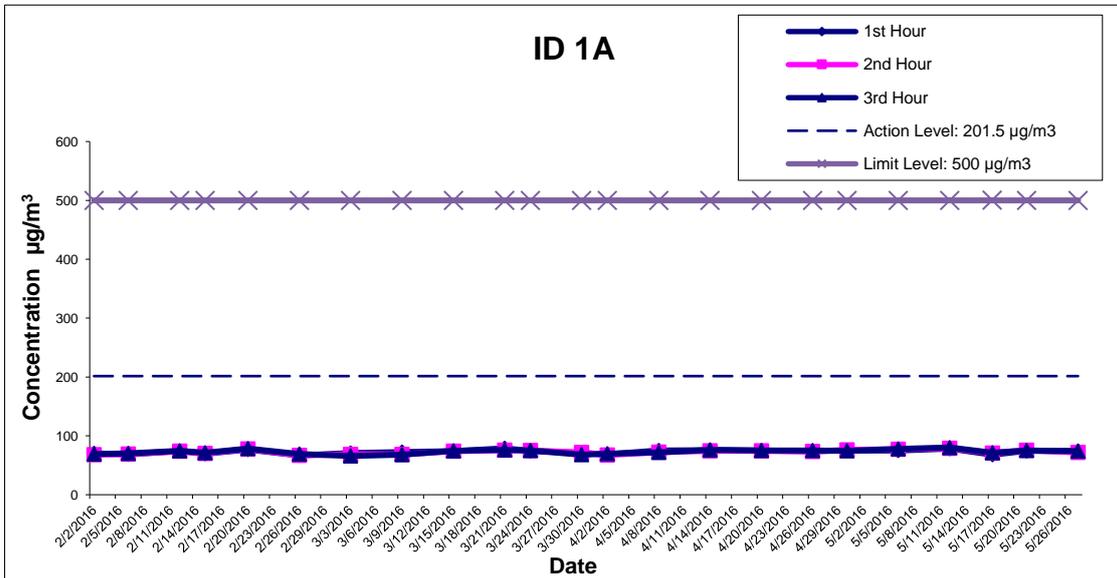
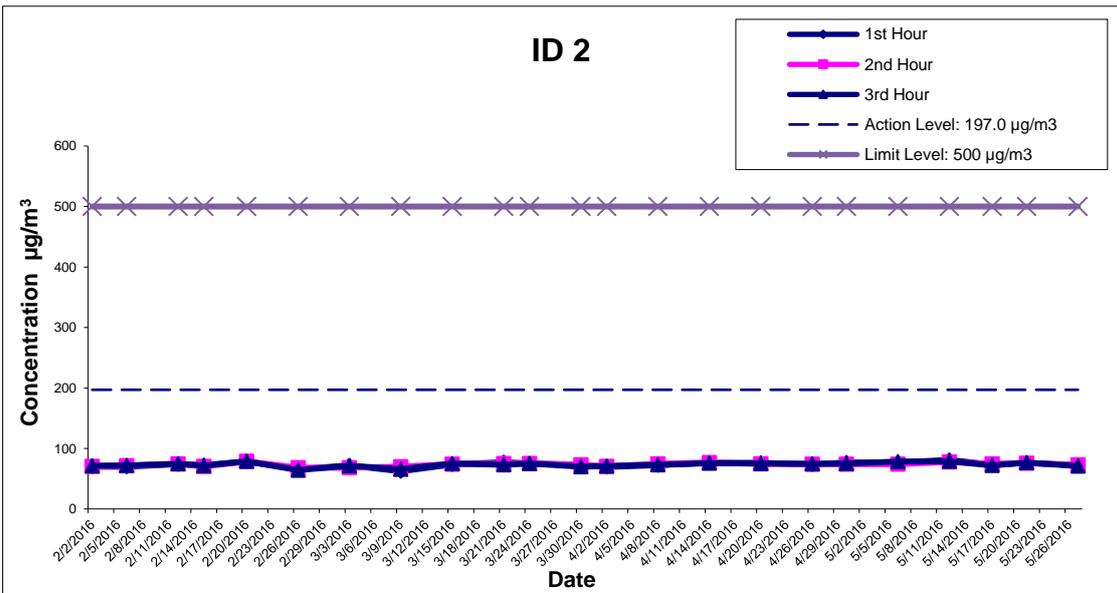
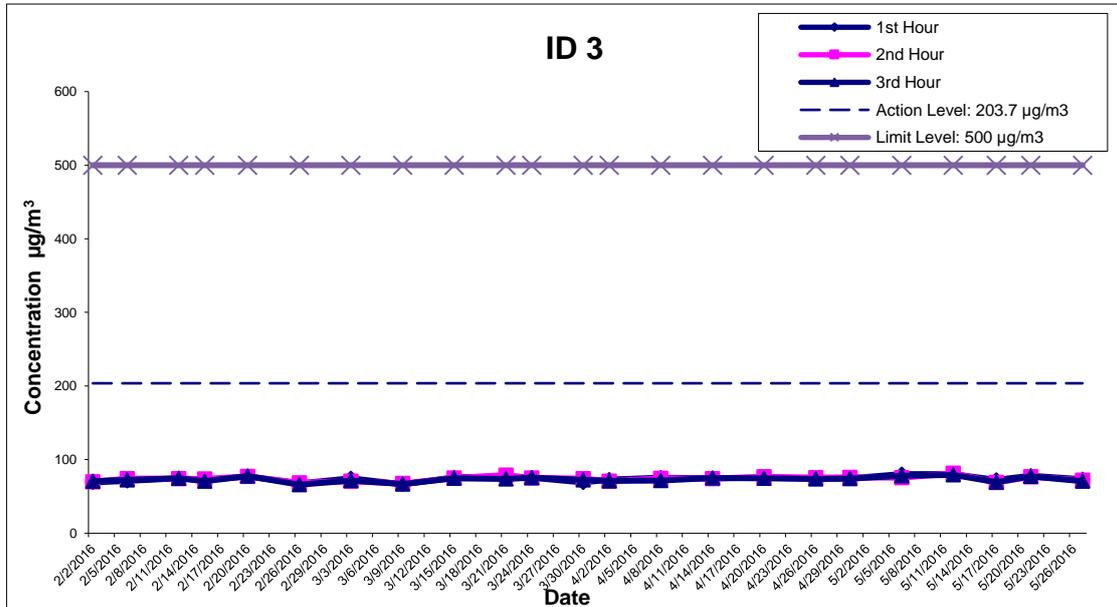
SCALE	N.T.S.	DATE	Jun-16
CHECK	FYW	DRAWN	DTTW
JOB NO.	60043155	APPENDIX No.	Rev.
		F	-

**Graphical Presentations of Impact 1-hour TSP
Monitoring Results**

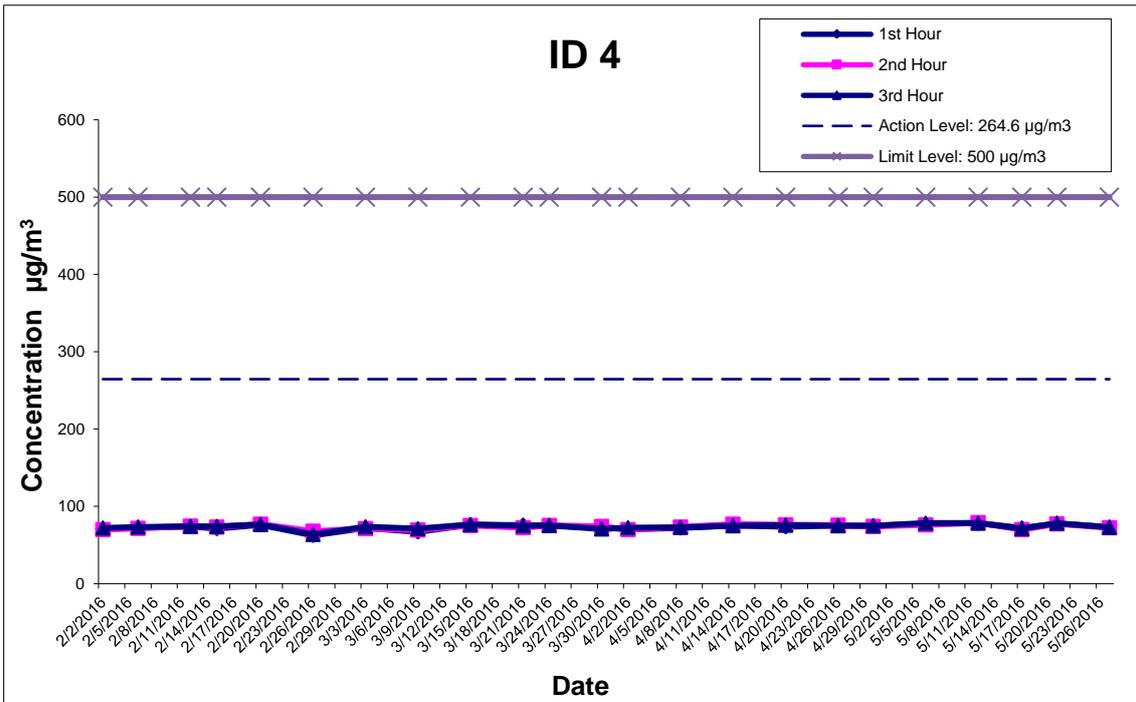
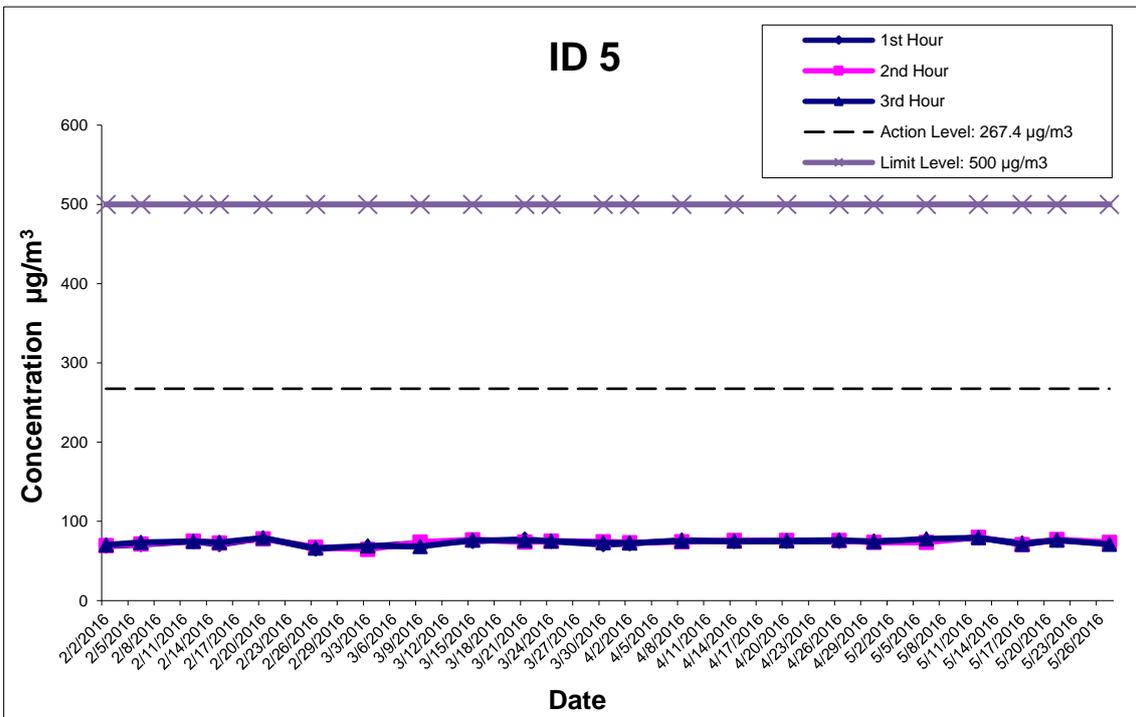
SCALE	N.T.S.	DATE	Jun-16
CHECK	FYW	DRAWN	DTTW
JOB NO.	60043155	APPENDIX No.	Rev.
		F	-

**Graphical Presentations of Impact 1-hour TSP
Monitoring Results**

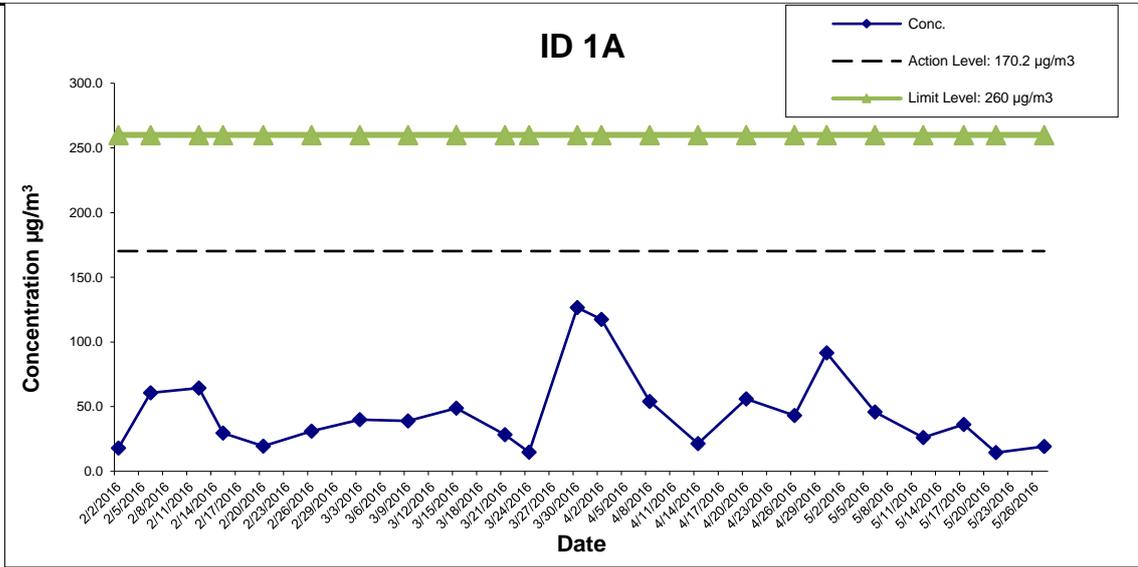
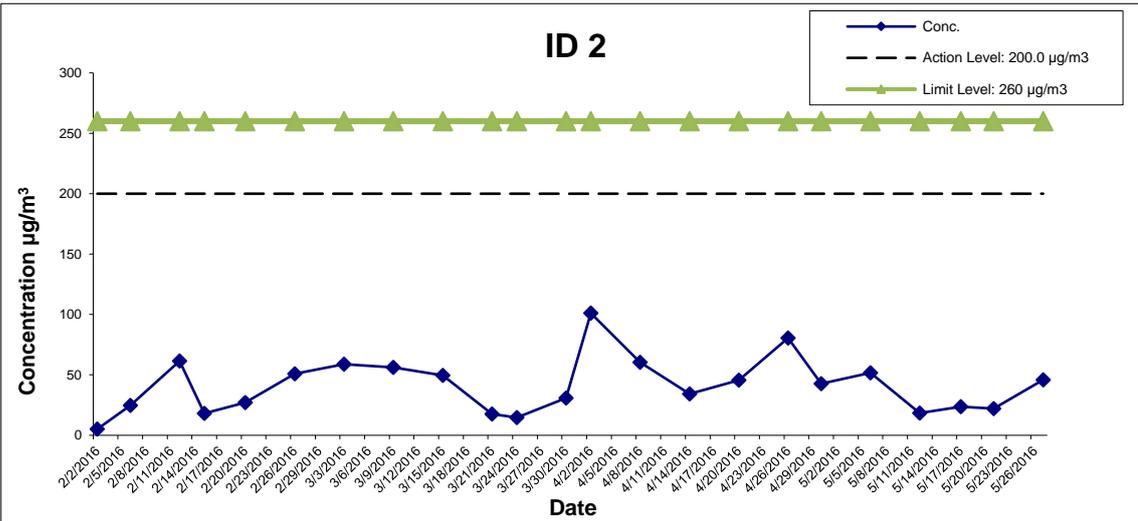
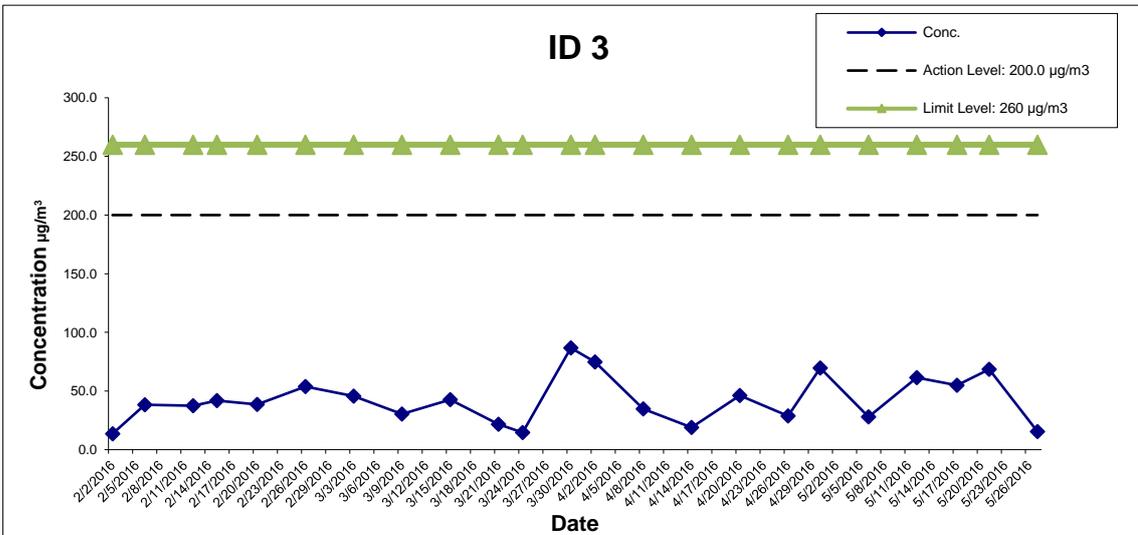
SCALE	N.T.S.	DATE	Jun-16
CHECK	FYW	DRAWN	DTTW
JOB NO.	60043155	APPENDIX No.	Rev.
		F	-

**Development at Anderson Road - Site Formation
and Associated Infrastructure Works**
Graphical Presentations of Impact 24-hour TSP
Monitoring Results

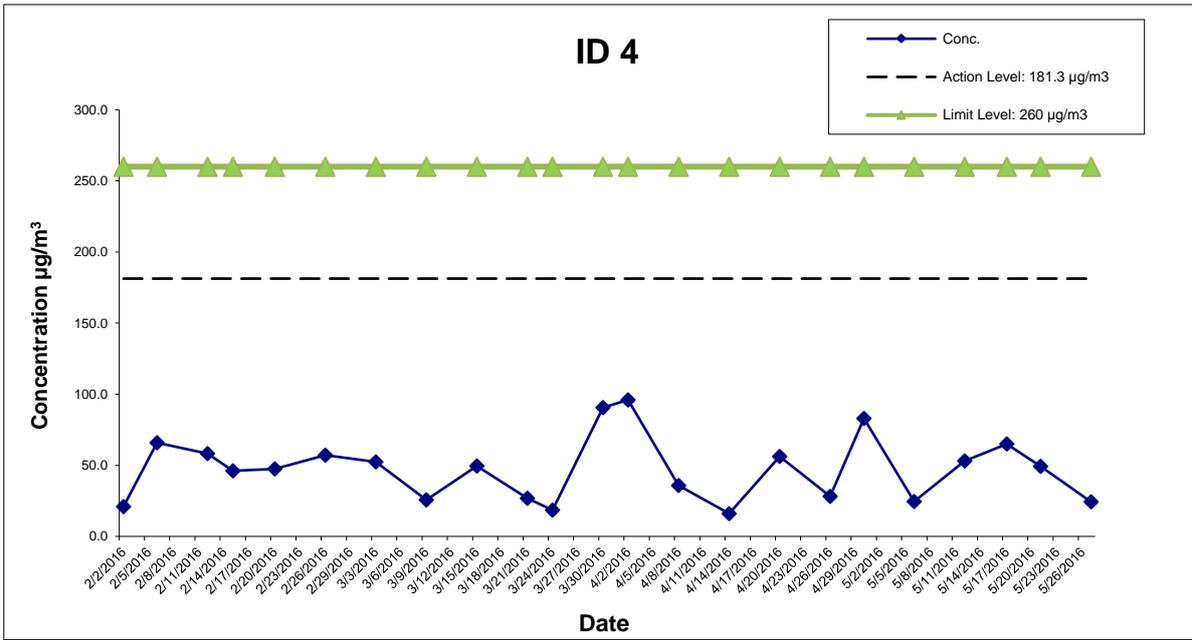
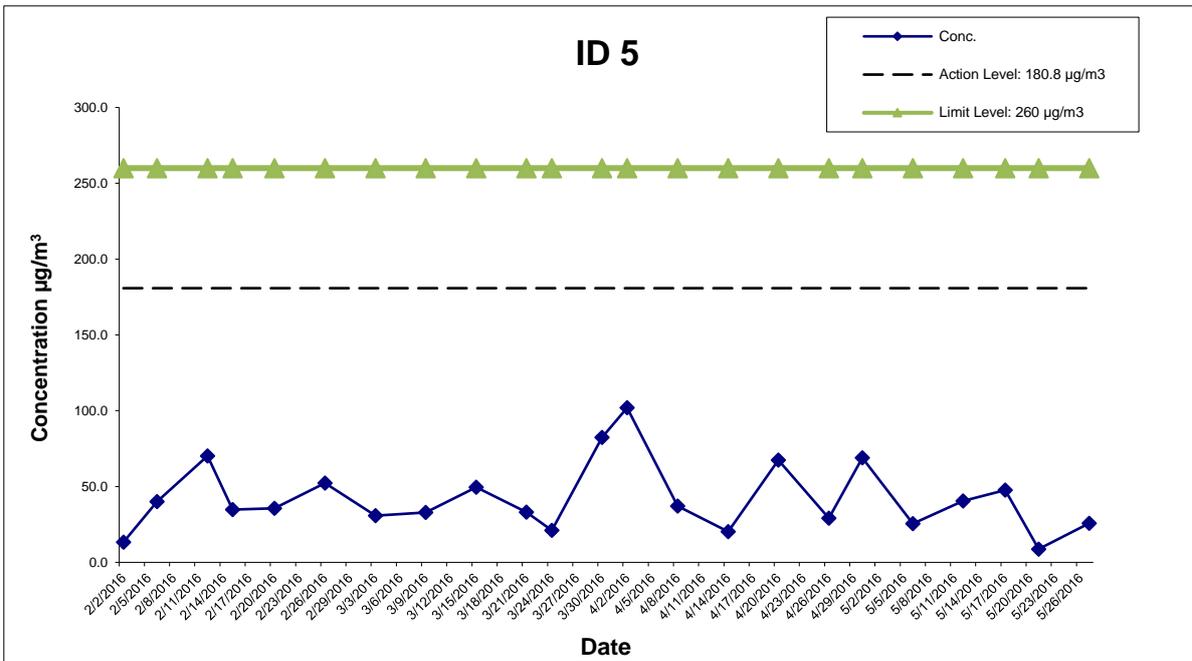
**Graphical Presentations of Impact 24-hour TSP
Monitoring Results**

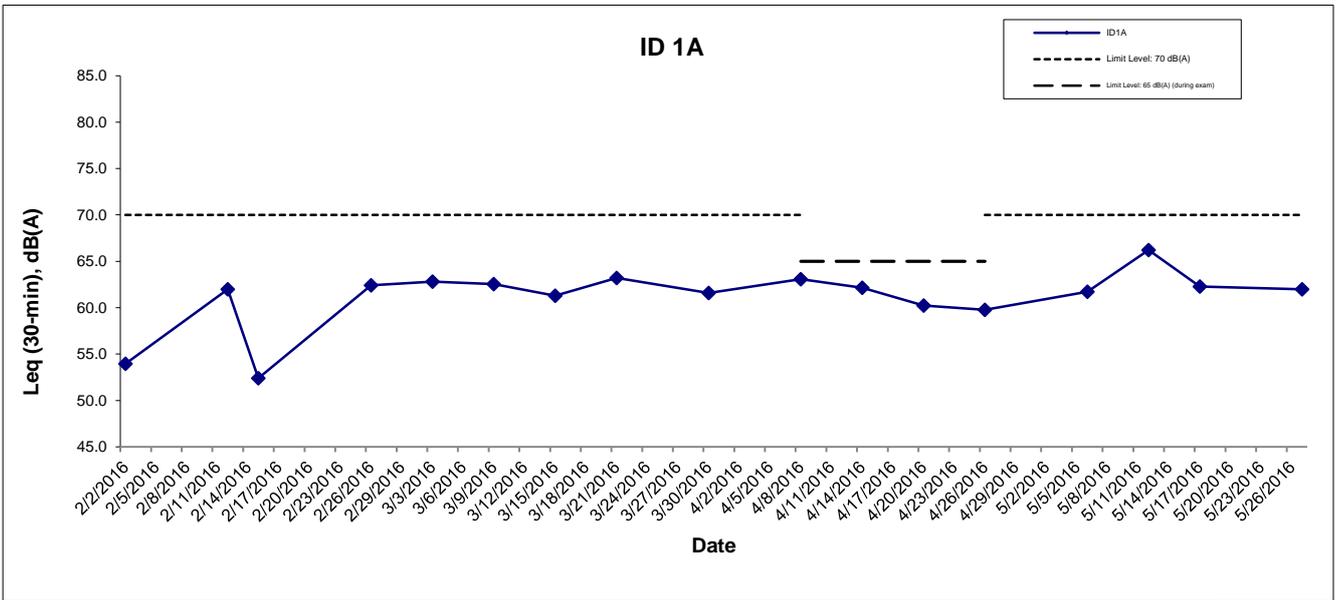
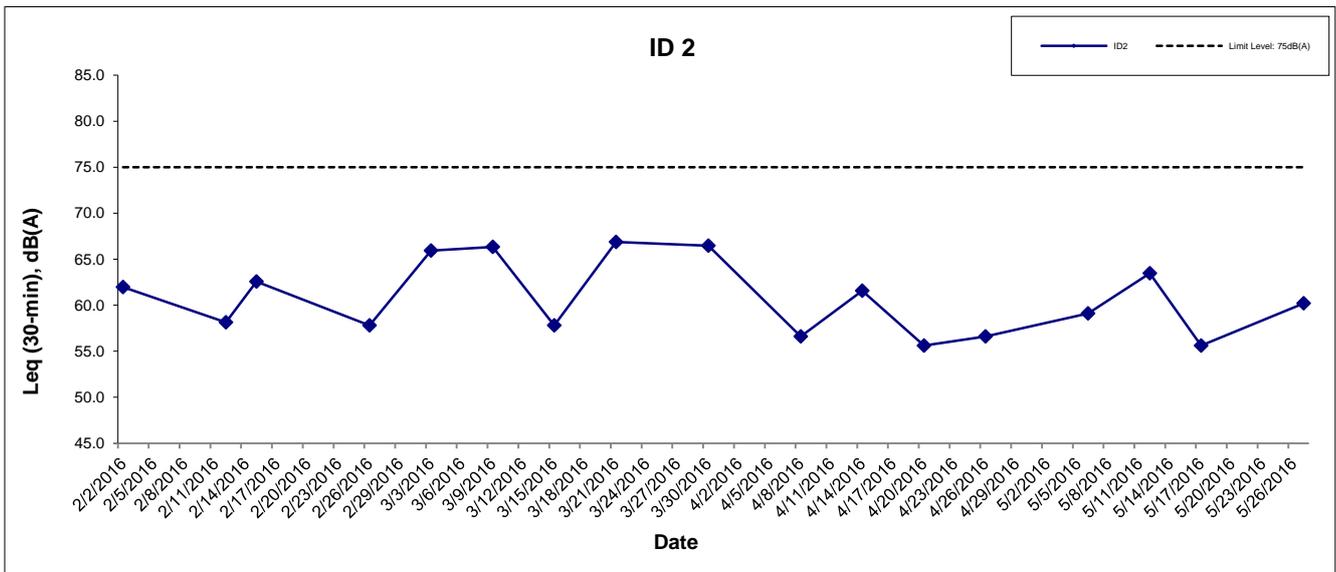
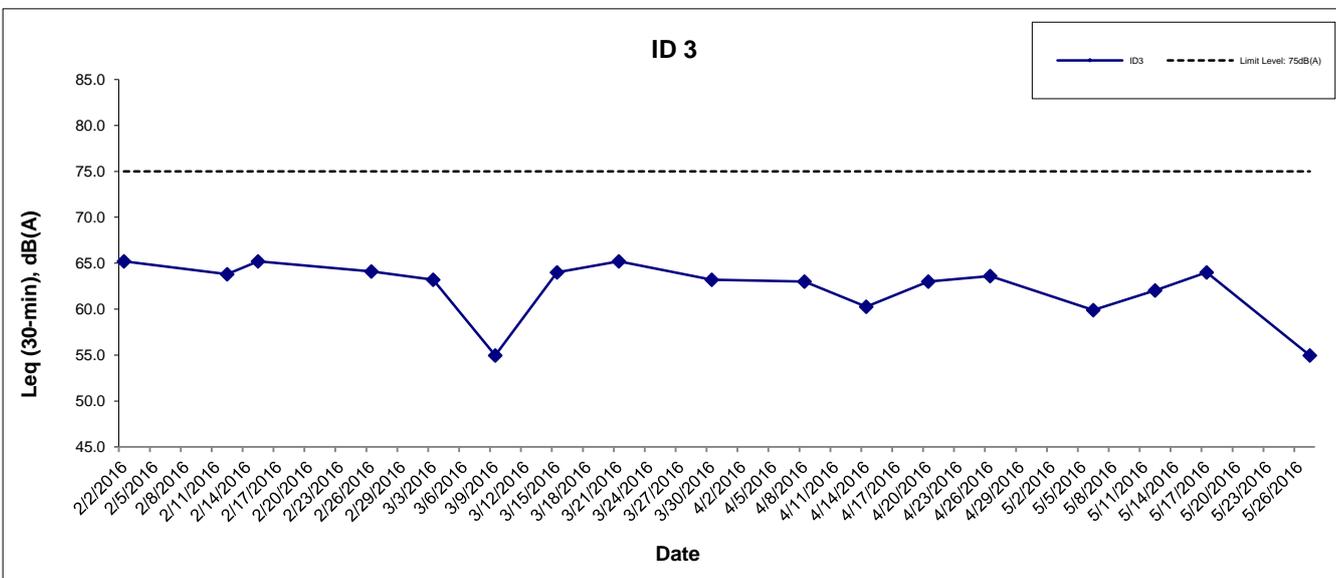
Development at Anderson Road - Site Formation and Associated Infrastructure Works	SCALE	N.T.S.	DATE	Jun-16
	Graphical Presentations of Noise Monitoring Results	CHECK	FYW	DRAWN	DTTW
		JOB NO.	60043155	APPENDIX	G
					-

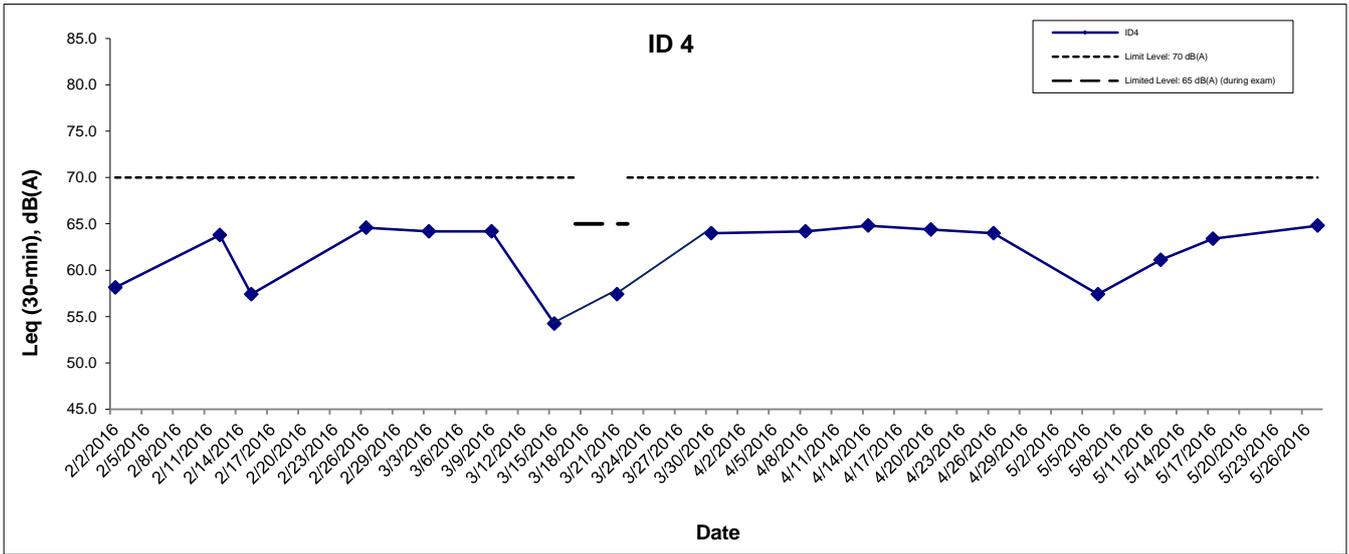
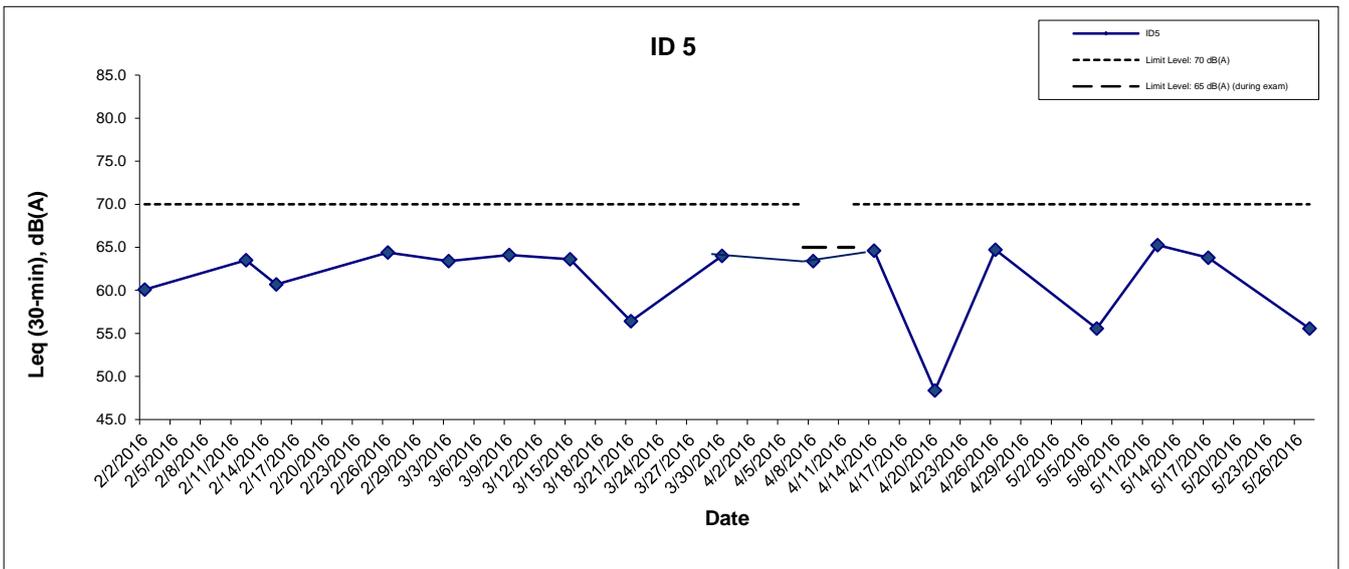
Development at Anderson Road - Site Formation and Associated Infrastructure Works	SCALE	N.T.S.	DATE	Jun-16
	Graphical Presentations of Noise Monitoring Results	CHECK	FYW	DRAWN	DTTW
		JOB NO.	60043155	APPENDIX	G
