Contract No. CV/2007/03

**Development at Anderson Road –
Site Formation and Associated
Infrastructure Works****Monthly EM&A Report for
March 2017**

April 2017

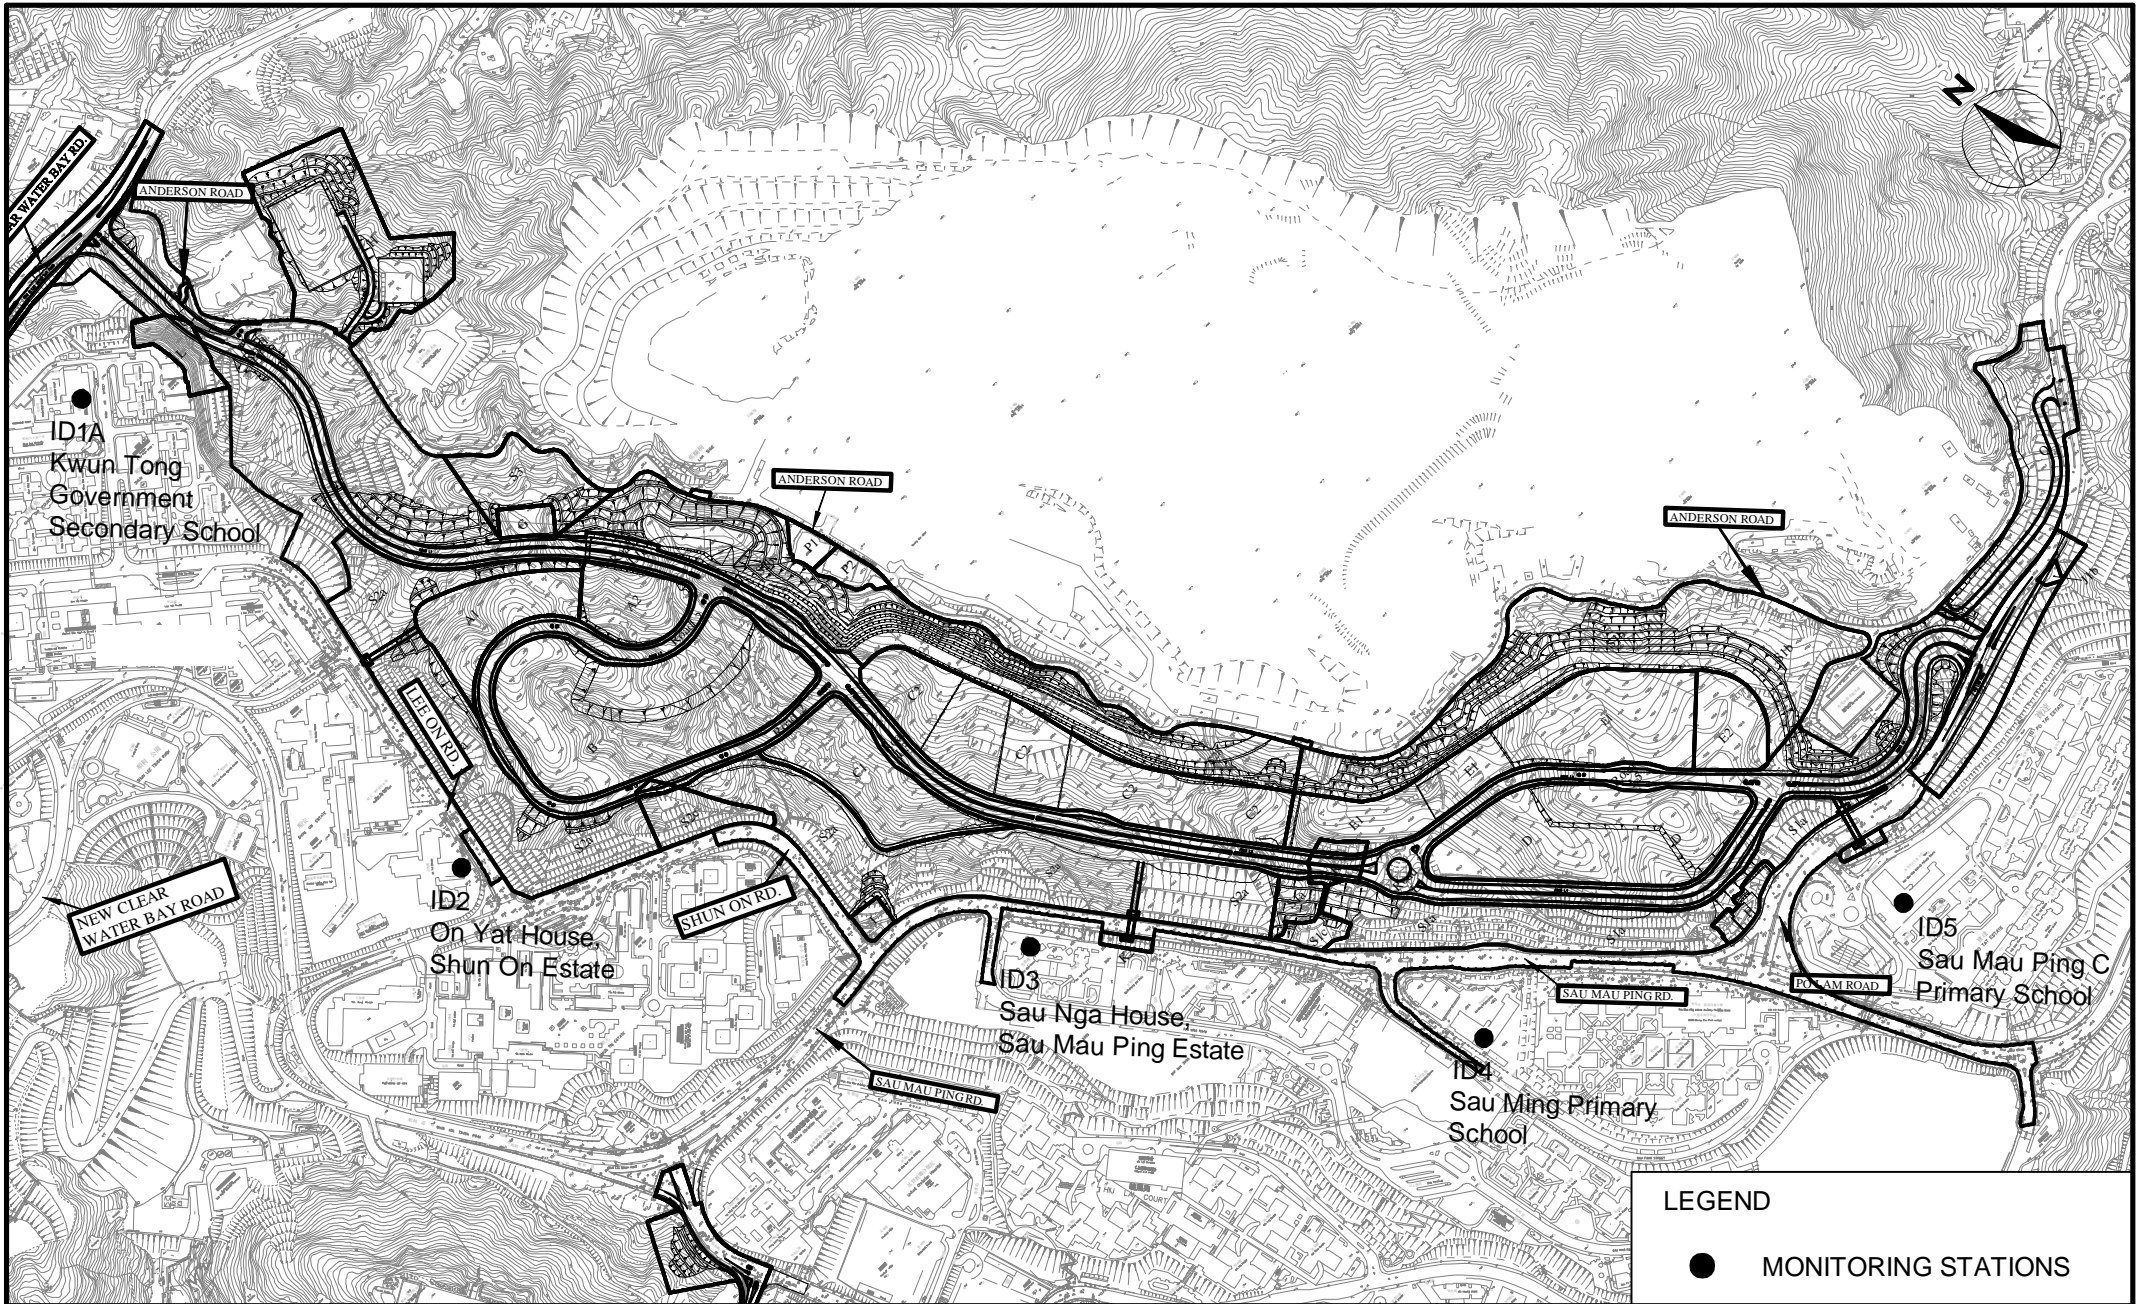
Development at Anderson Road - Site Formation and Associated Infrastructure Works	SCALE	N.T.S.	DATE	Nov-09	
	GENERAL LAYOUT PLAN	CHECK	ENFL	DRAWN	LCHC	
		JOB NO.	60043155	DRAWING No.	Rev.	-
				FIG 1.1

LEGEND			
●	MONITORING STATIONS

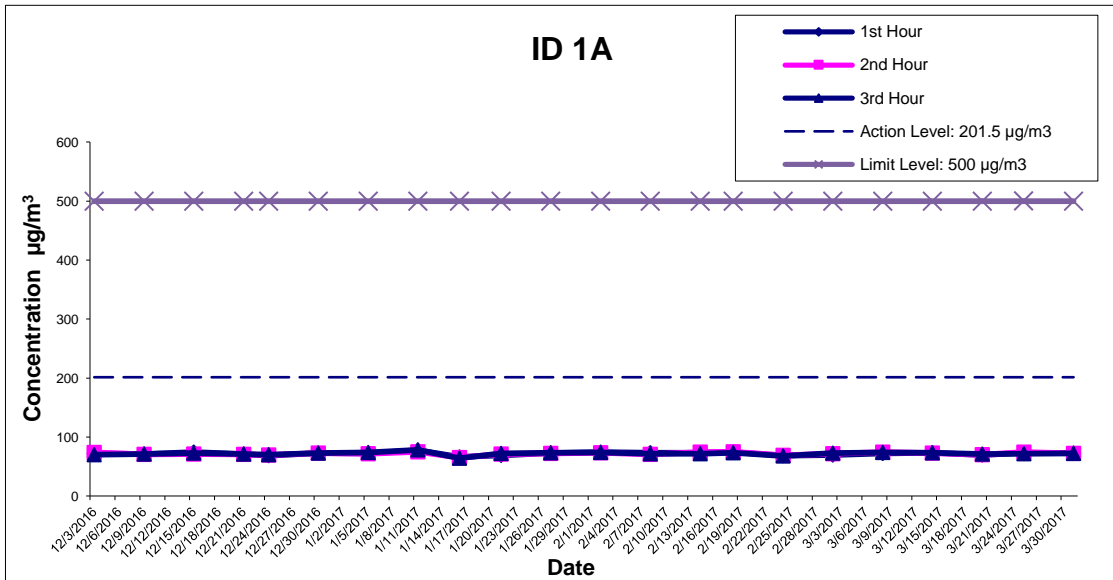
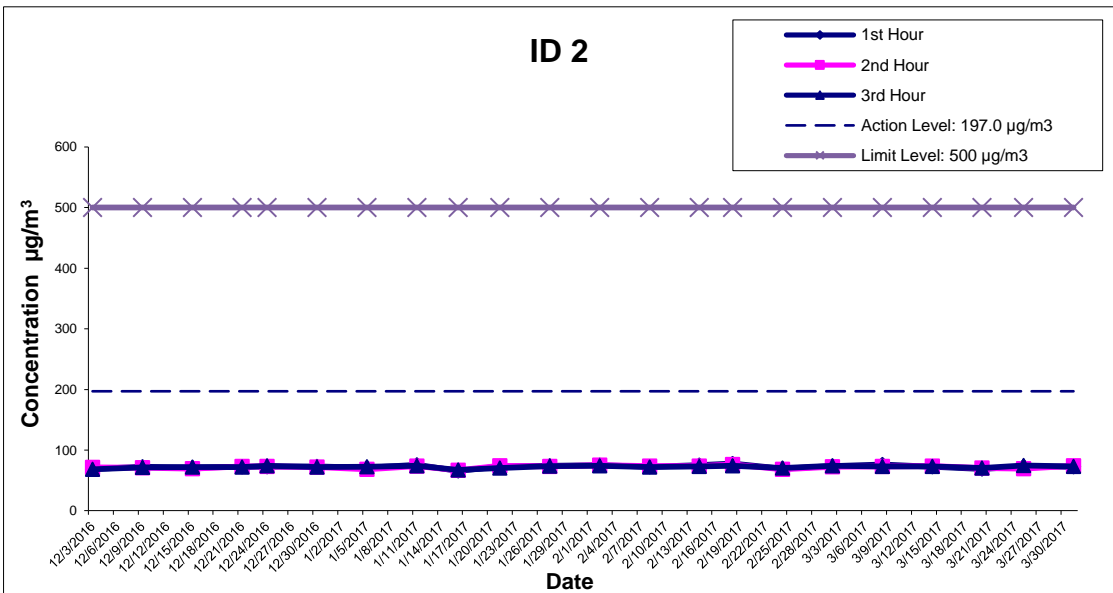
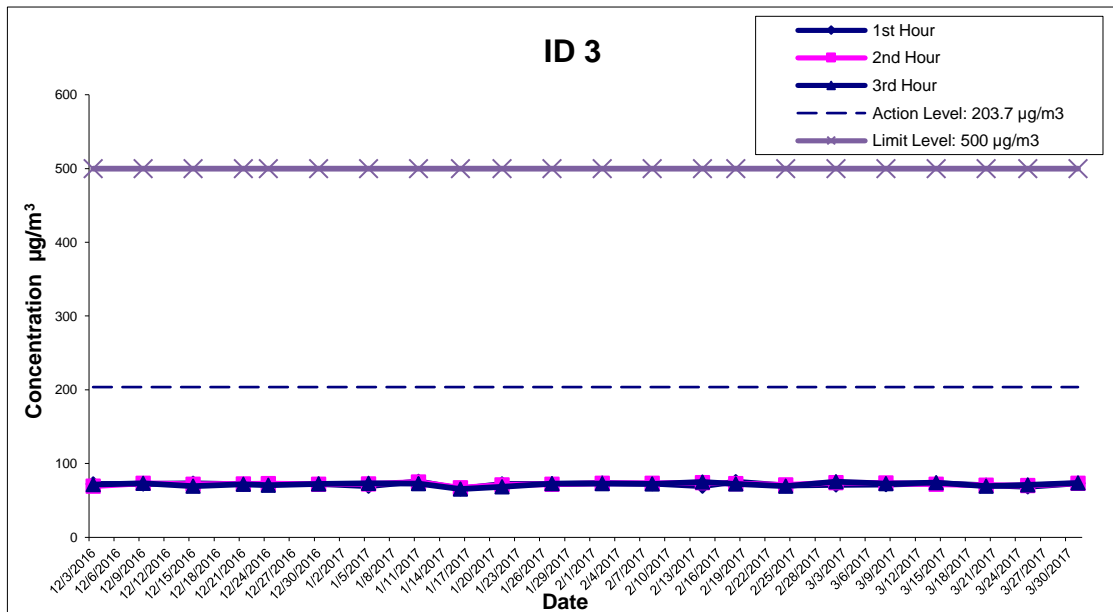
**Graphical Presentations of Impact 1-hour TSP
Monitoring Results**

1-hour TSP Monitoring Results at Station ID 5 (Sau Mau Ping Catholic Primary School)

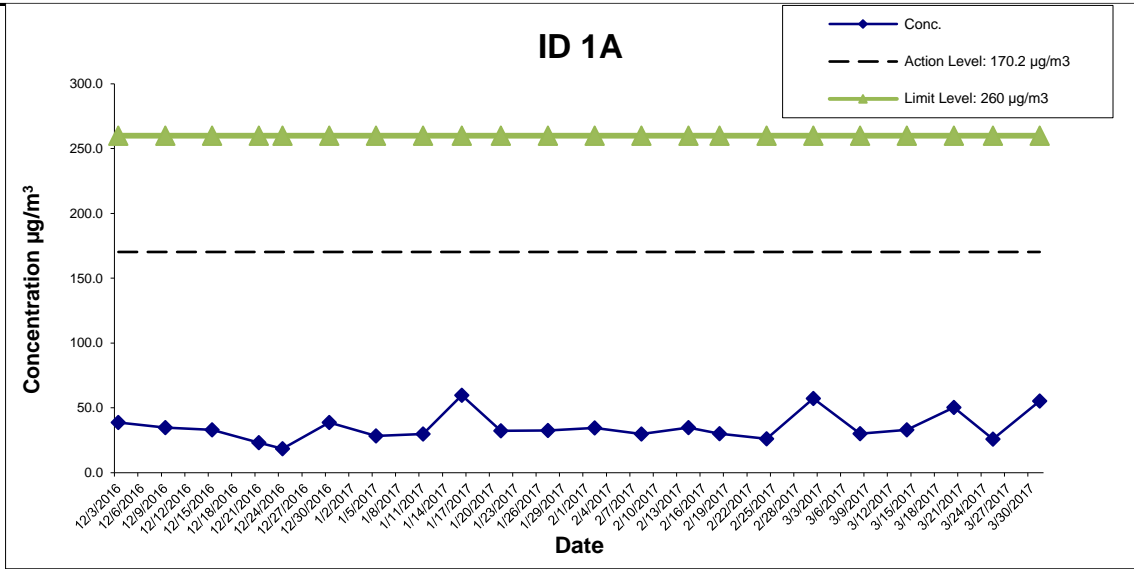
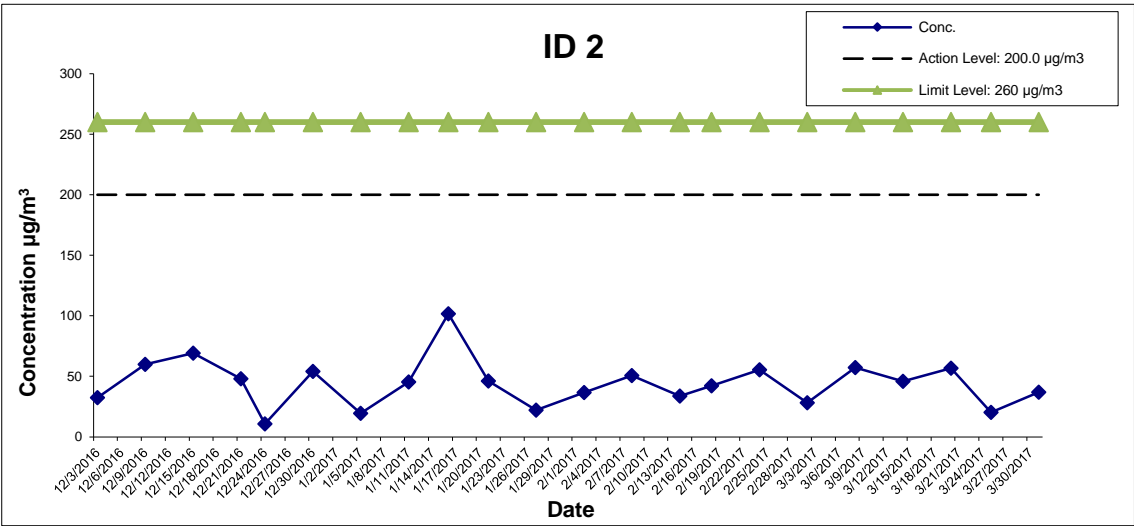
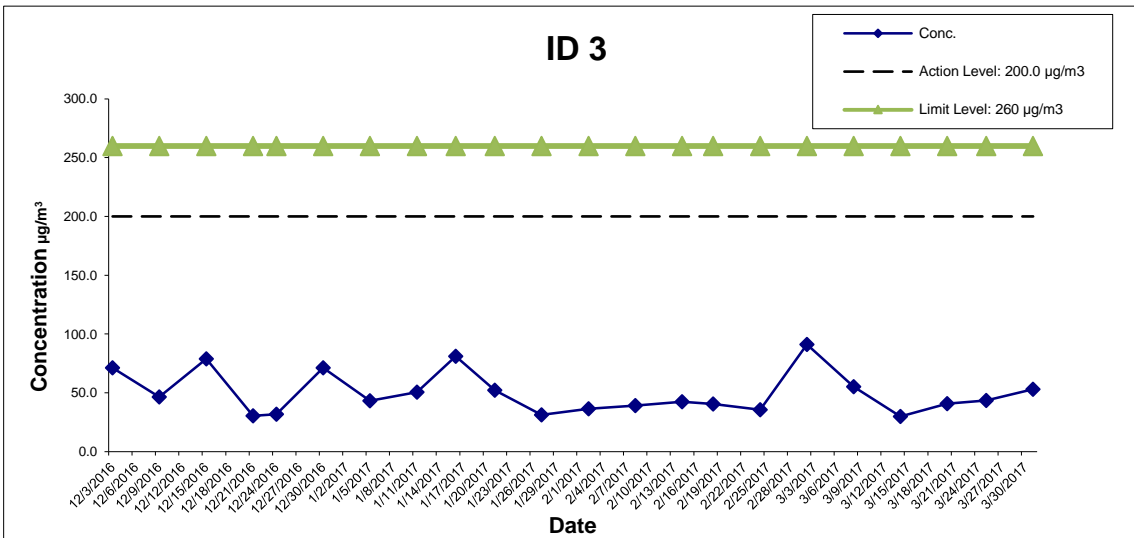
**Graphical Presentations of Impact 24-hour TSP
Monitoring Results**

24-hour TSP Monitoring Results at Station ID 5 (Sau Mau Ping Catholic Primary School)

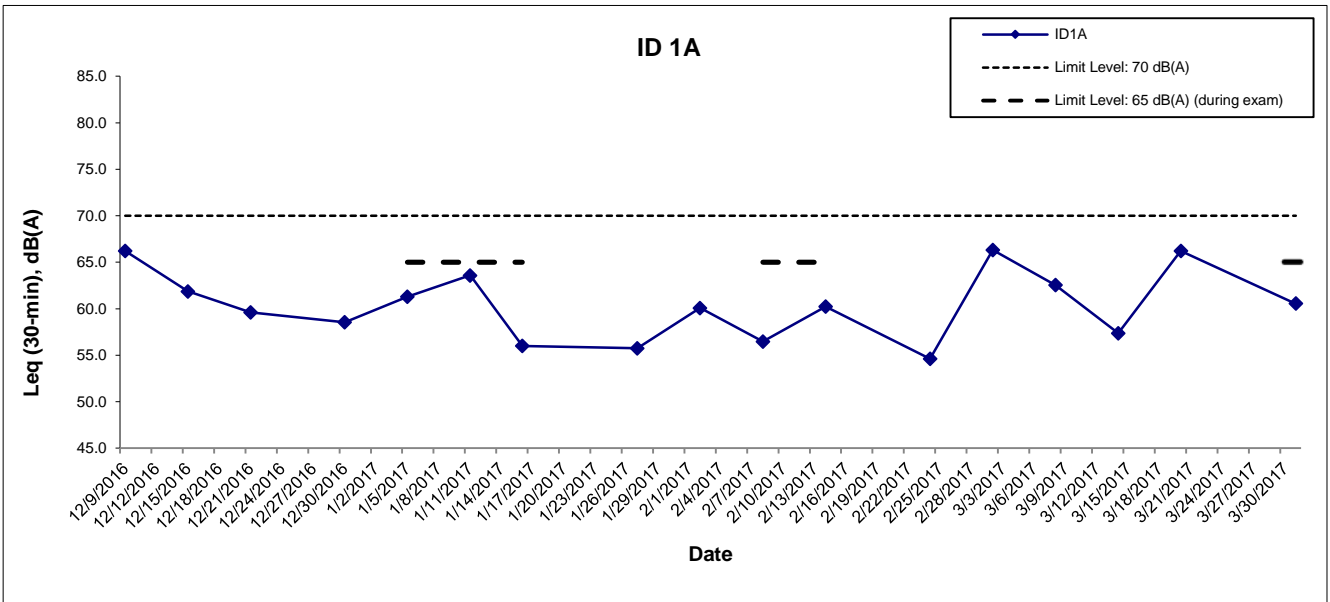
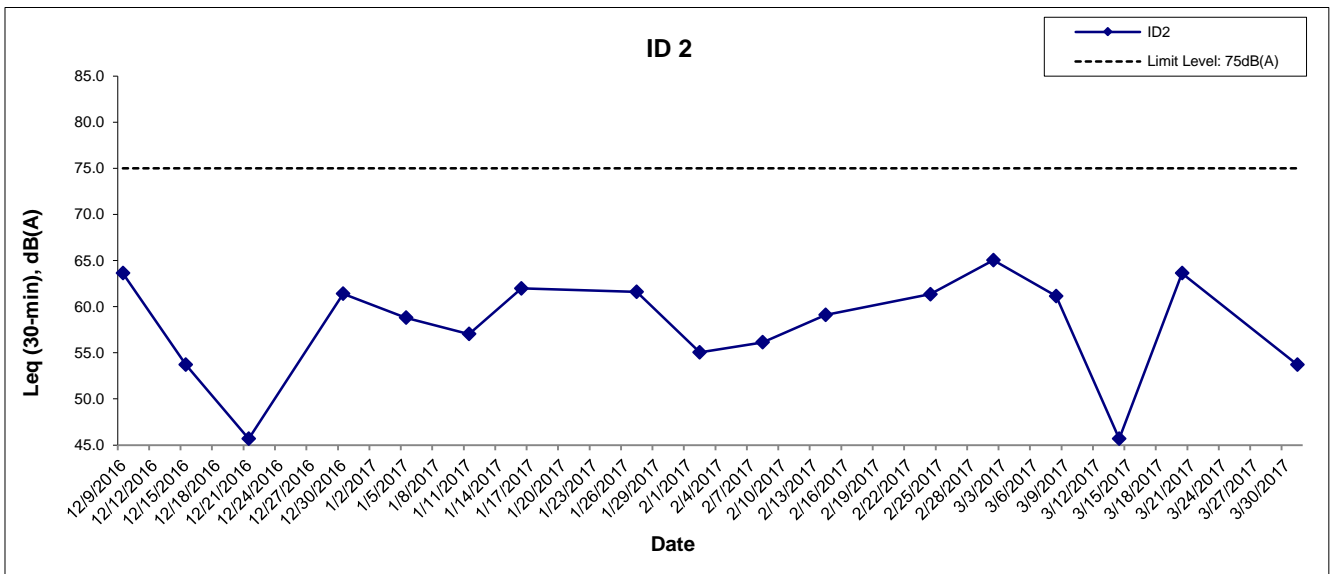
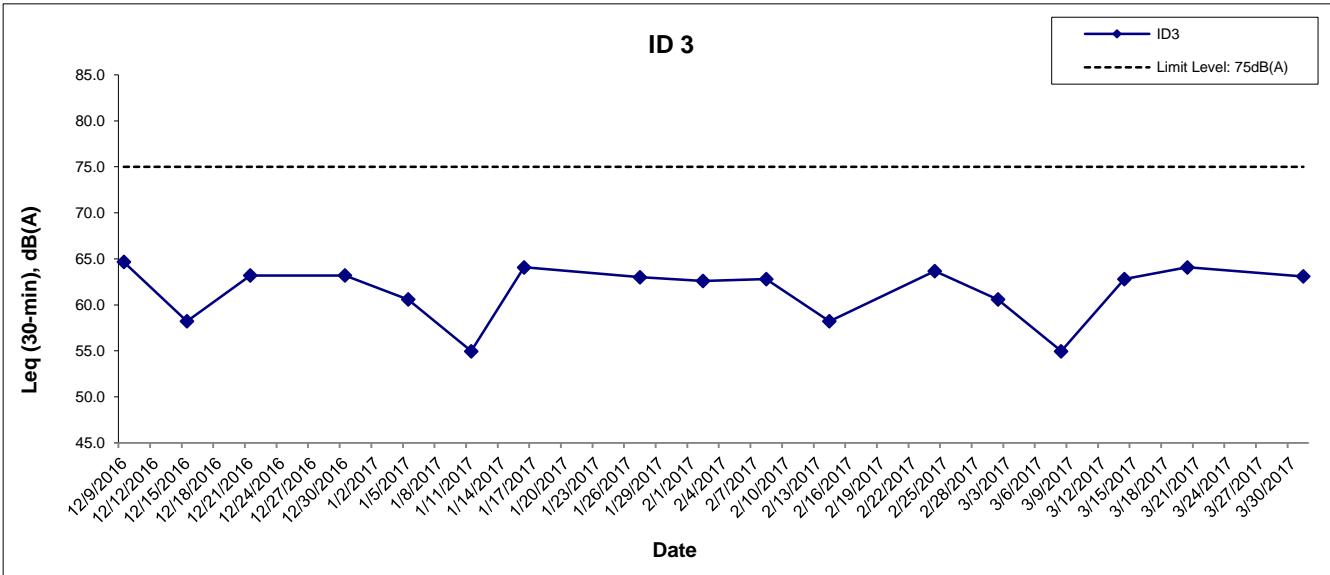
Graphical Presentations of Noise Monitoring Results

^{**} - Limit Level of 70dB(A) applies to education institutes while 65dB(A) applies during school examination period.
