**Development of Lok Ma Chau Loop: Land  
Decontamination and Advance Engineering  
Works - Environmental Team**

**Monthly Environmental Monitoring and  
Audit Report for February 2019**

**(version 2.0)**

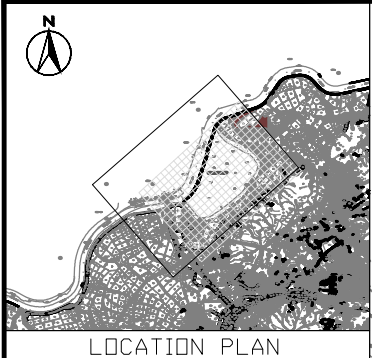
SCALE	1:500 @A4	DATE	FEB 2019
CHECK	IT	DRAWN	JW
JOB No.	WMA 18047	FIGURE NO.	Fig 5
		REV	-

COUNT LOCATION FOR FLIGHT LINES SURVEY OF ALL BIRD SPECIES  
 AND LOCATIONS OF ECOLOGICAL AREA AND ITS BUFFER ZONE

- 6.4 The flight line corridor survey work should be carried out at the LMC Lookout, according to Section 11.4.1.1 of the EM&A Manual. The location at LMC Lookout is shown in **Figure 5**.

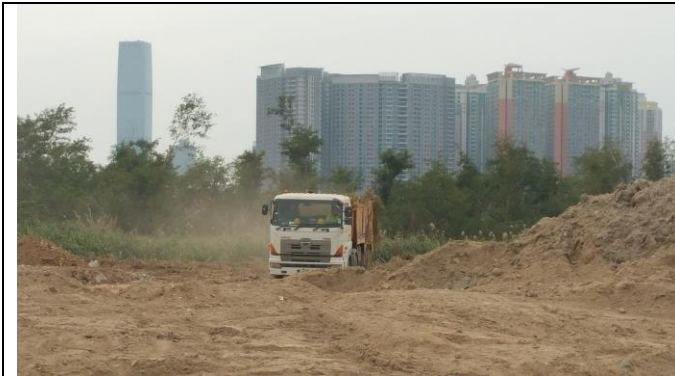
Ref No: 190201-001

**Impact:**  
Air Quality (E5)

- Details:**
- Dust generation due to the construction vehicles movement and unloading of material was observed. The Contractor should continue to implement a proper watering system for haul road and site area.

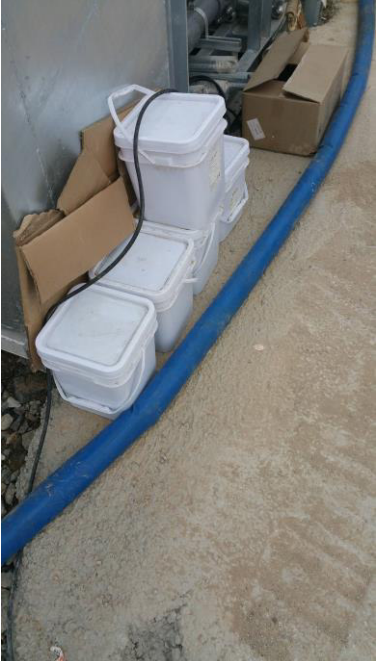
<p><b>Ref No:</b> 190125-R05</p> <p><b>Impact:</b> Waste/ Chemical Management (G3i)</p> <p><b>Details:</b></p> <ul style="list-style-type: none"><li>• Chemical containers at near the wetsep shall be stored properly</li></ul> <p><b>Follow up:</b> Item remarked as 180201-R04.</p>

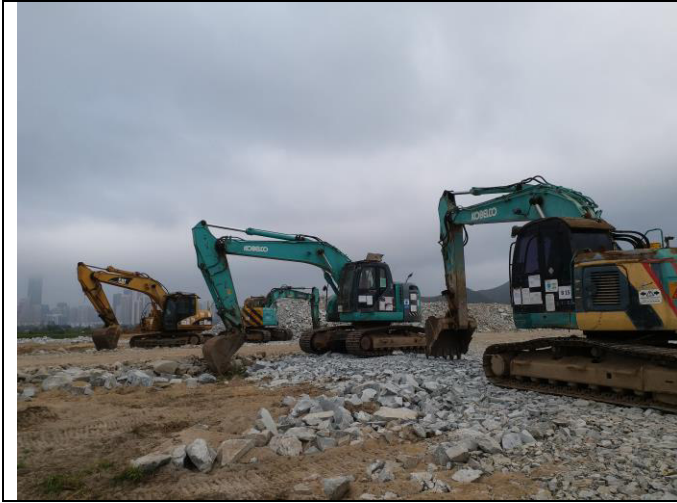
**Ref No:** 190208-R05

**Impact:**  
Ecology (B4)

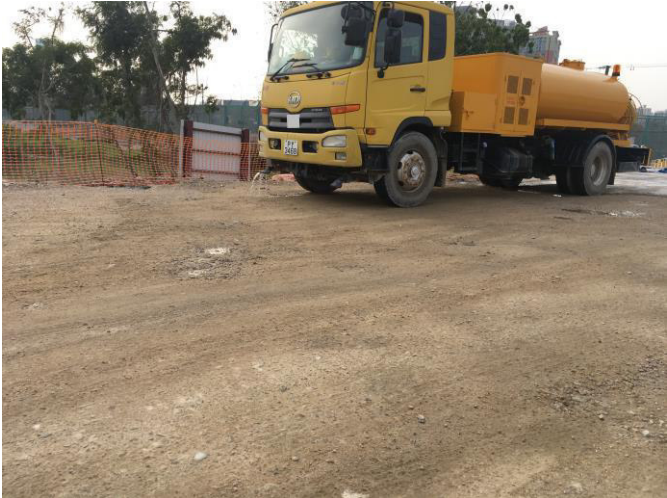
<p><b>Ref No:</b> 190222-O01</p> <p><b>Impact:</b> Air Quality (E5)</p> <p><b>Details:</b></p> <ul style="list-style-type: none"><li>• Part of the exposed site areas were observed dry. The Contractor was reminded to ensure the implementation of watering should cover all site areas.</li></ul>

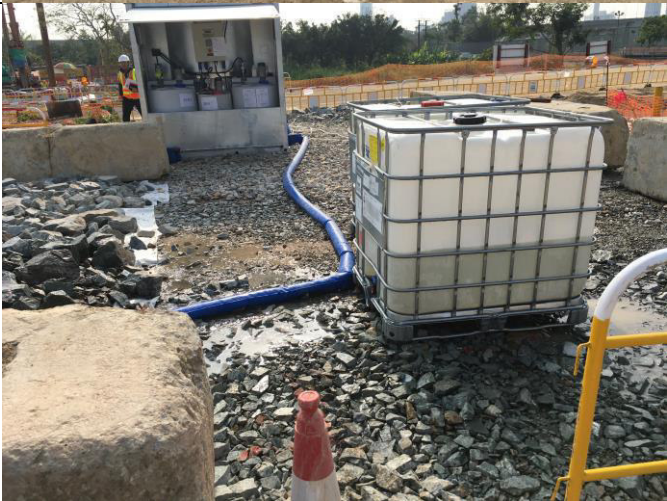
<p><b>Ref No:</b> 190222-O02</p> <p><b>Impact:</b> Water Quality (A6iii)</p> <p><b>Details:</b></p> <ul style="list-style-type: none"><li>• The soak away method from the wetset tank is not recommended, Contractor should implement an alternate system to discharge water according to discharge license.</li></ul>

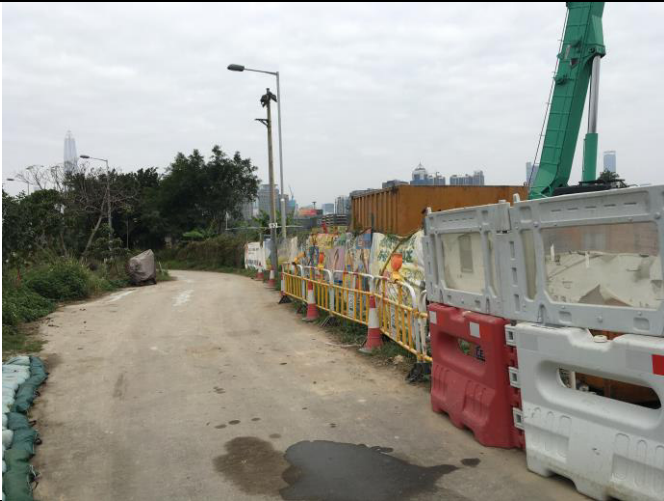
<p><b>Ref No:</b> 190222-R04</p> <p><b>Impact:</b> Air Quality (E 10)</p> <p><b>Details:</b></p> <ul style="list-style-type: none"><li>• Hoarding should be erected along the site area near the temporary bridge.</li></ul>

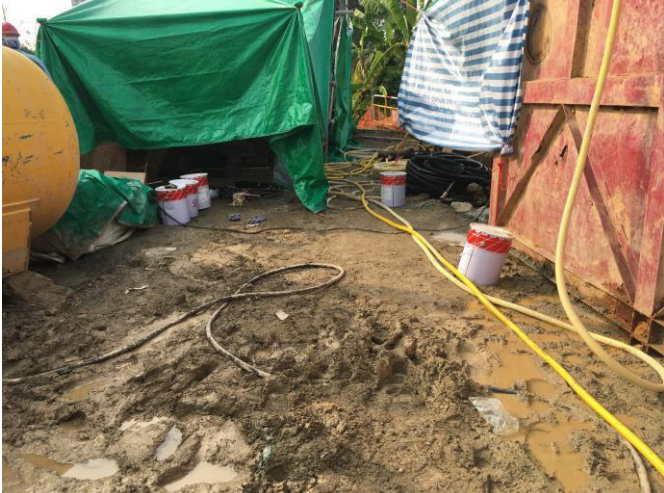
<p><b>Ref No:</b> 190222-R06</p> <p><b>Impact:</b> Waste/Chemical Management (G8)</p> <p><b>Details:</b></p> <ul style="list-style-type: none"><li>• Chemical containers should be stored properly with drip tray to avoid any on site contamination.</li></ul>

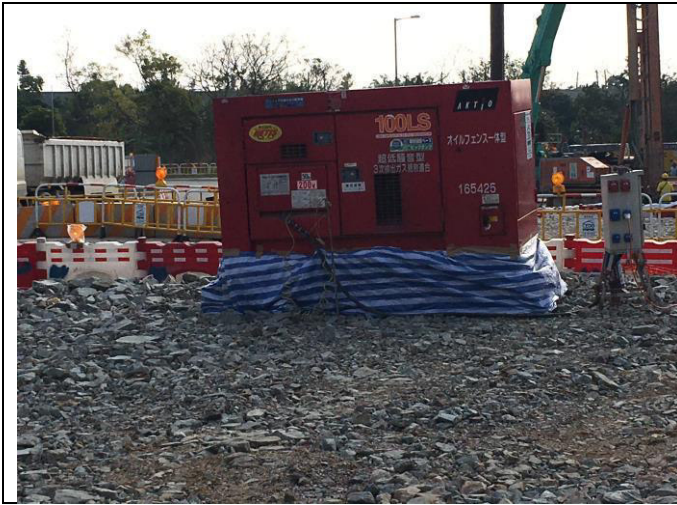
**Ref No:** 190222-R07

**Impact:**  
Waste/ Chemical Management (G8)

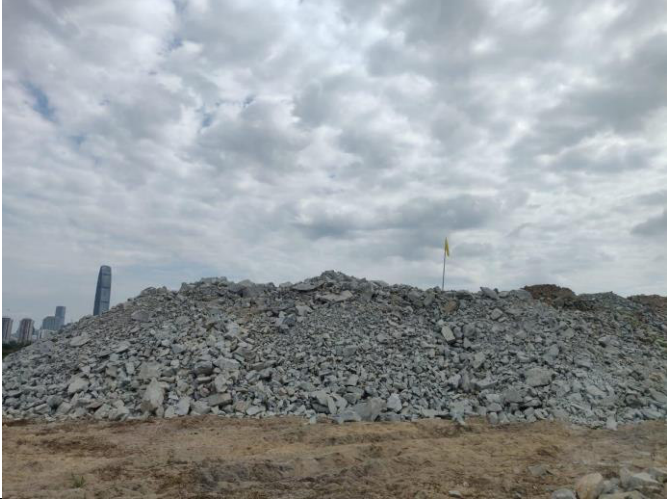
<p><b>Ref No:</b> 190213-R08</p> <p><b>Impact:</b> Ecology (B4)</p> <p><b>Details:</b></p> <ul style="list-style-type: none"><li>• A system to ensure the PMEs only operating between 0900 to 1700 hours should be implemented for all site area within 100 m of Meander</li></ul> <p><b>Follow up:</b></p> <ul style="list-style-type: none"><li>• A flag of yellow and red to indicate the operation time was erected.</li></ul>
