Expansion of Hong Kong International Airport into a Three-Runway System

Construction Phase Quarterly EM&A Report
No.34 (1 April to 30 June 2024)

August 2024

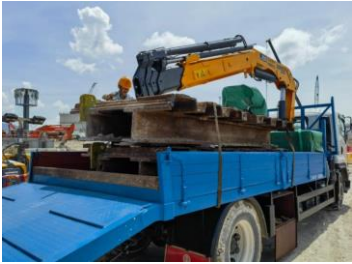
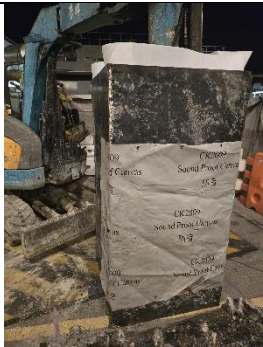
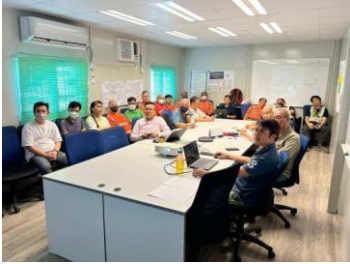
1. Metals including iron and steel generated were segregated to improve material reuse and recycling by contractor.
2. Erection of acoustic barrier around the breaker part of excavator mounted breaker to enhance the noise mitigation measures.
3. Environmental training was provided by contractor to site personnel for proper waste management and chemical waste handling procedures.

<p>Metal recycling by contractor</p>	<p>Erection of acoustic barrier</p>	<p>Provision of environmental training for site personnel by contractor</p>
