CONTRACT NO. 1/WSD/19 & 6/WSD/21

**IN-SITU REPROVISIONING OF SHA TIN WATER
TREATMENT WORKS (SOUTH WORKS) – WATER TREATMENT WORKS AND
ANCILLARY FACILITIES
Environmental Permit EP-494/2015**

**In-Situ Re provisioning of Sha Tin Water Treatment Works (South Works) – Water Treatment Works and Ancillary Facilities
Environmental Permit EP-494/2015
Submission of 100th monthly EM&A Report**

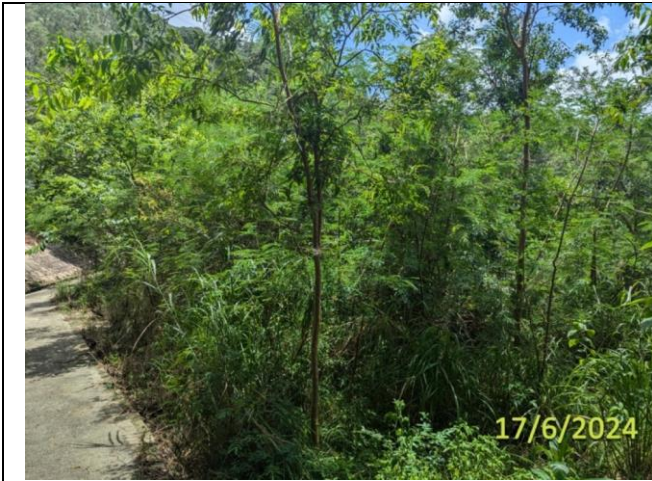
Photo 1. Protection zone of the first batch of *Cibotium barometz* have been taken out. Weeds and the invasive *Leucaena leucocephala* (銀合歡) shall be removed including the roots and seeds and packed properly during clearance.

- 2.5.6 Weeding by hand held tools within protection zone of *Cibotium barometz* is urgently needed.
- 2.5.7 Root ball of TA572 and TA327 tree should be kept moisture especially during dry and non-raining day.

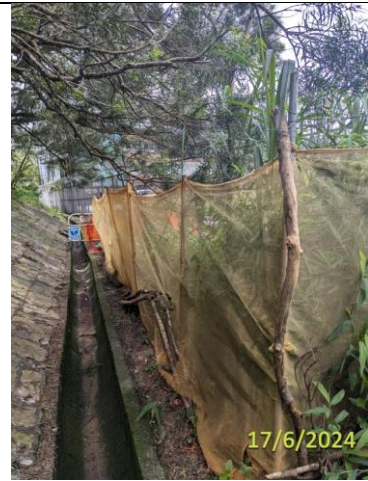
Photo 2. Metal rods of protective fence for another patch of *Cibotium barometz* has been taken out. Wooden stand has been used temporarily.

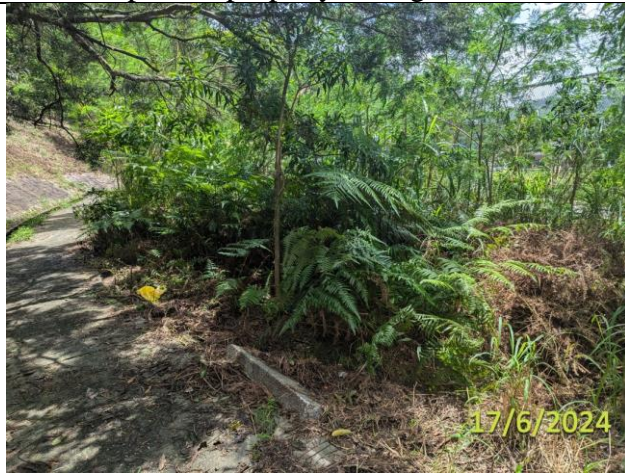
Photo 3. *Cibotium barometz* in good condition

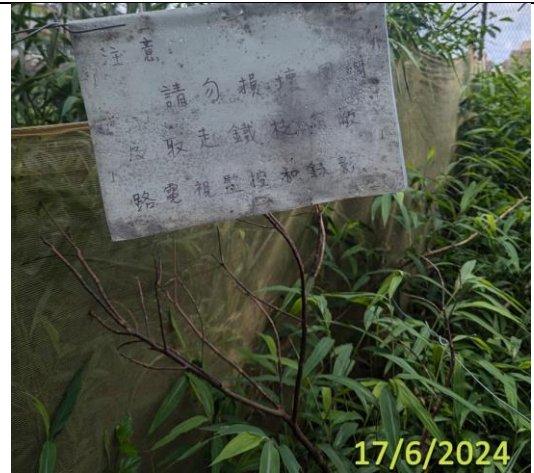
Photo 4. Warning sign for the damaged protection zone.

- 2.5.8 Signs of ploughed soil by wild boar(s) at the two groups of transplanted *Cibotium barometz* were reported in previous monitoring. A robust fencing was recently installed to protect the group of *Cibotium barometz* from further damage caused by wild boars. However, the protection zones were damaged by unknown persons recently. They should be repaired and secured as soon as possible. Surveillance cameras has been installed for any suspicious persons.

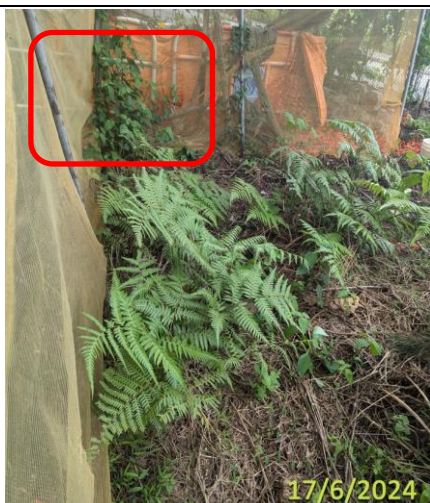
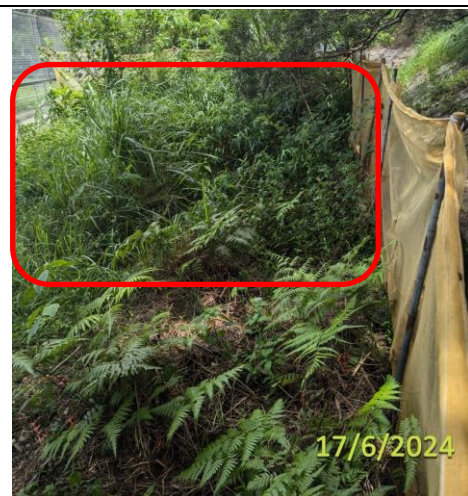
Photo 5 & 6. Weeds and climbers were observed occupying growing space of *Cibotium barometz* at the second patch (in red), which may deplete their health/ growth condition.

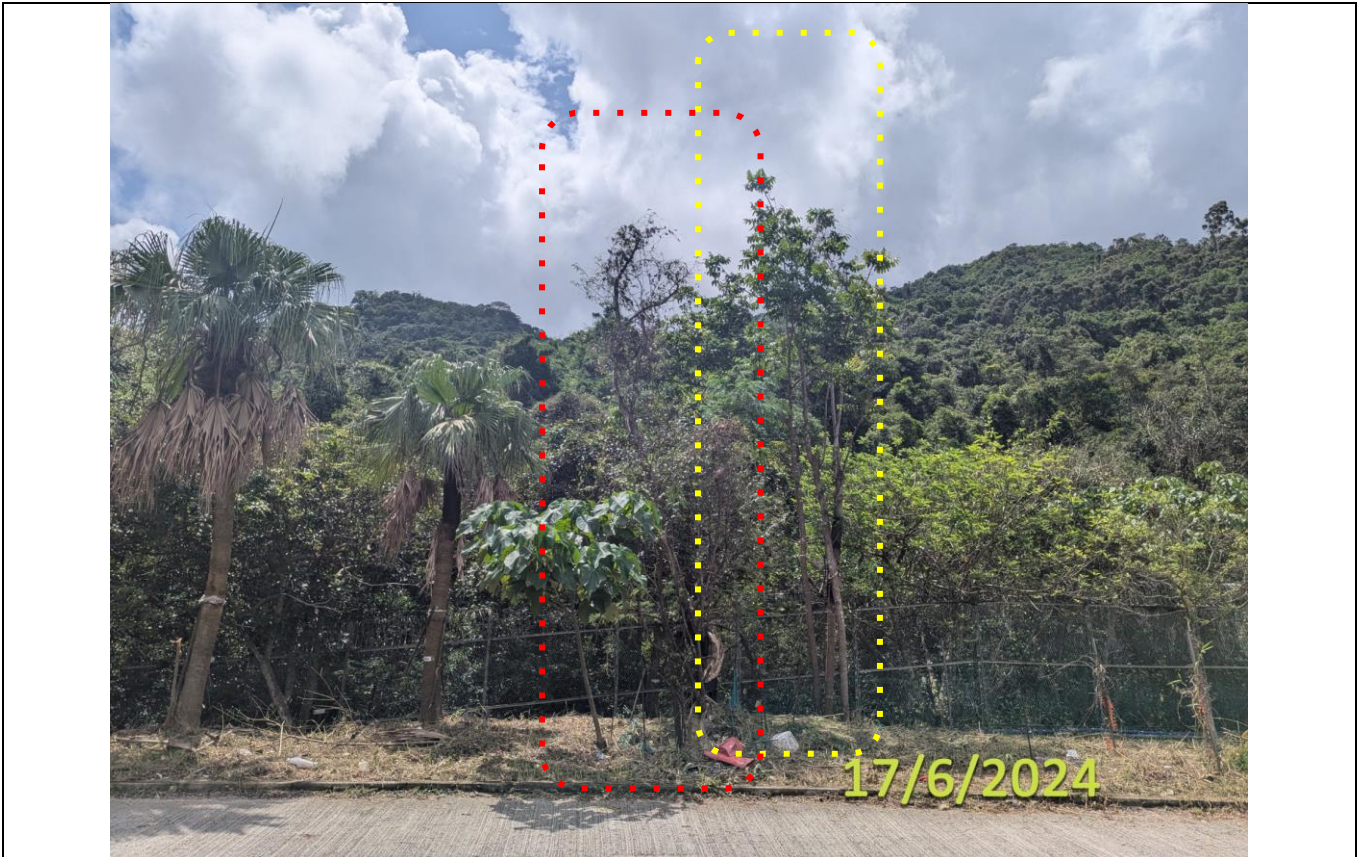
Photo 7. Transplanted Incense Tree (*Aquilaria sinensis*) – TA327 (red); and Ailanthus (*Ailanthus fordii*) – TA572 (yellow). Weeding has been completed.

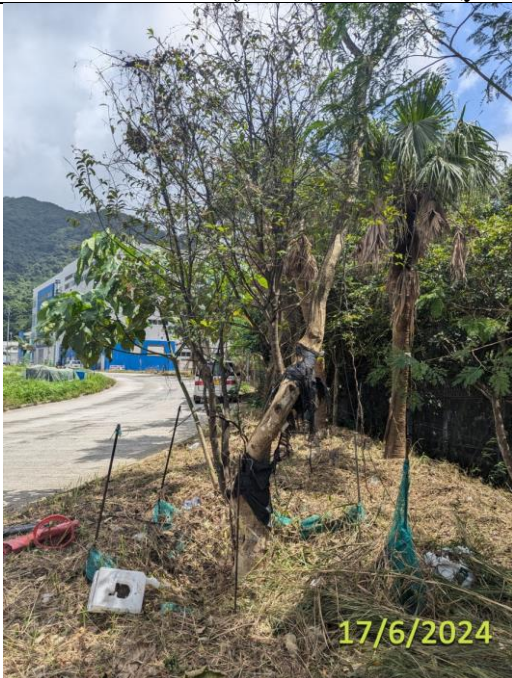
Photo 8. Sprouts at lower trunk of TA327 (*Aquilaria sinensis*). Protection zone shall be rectified.

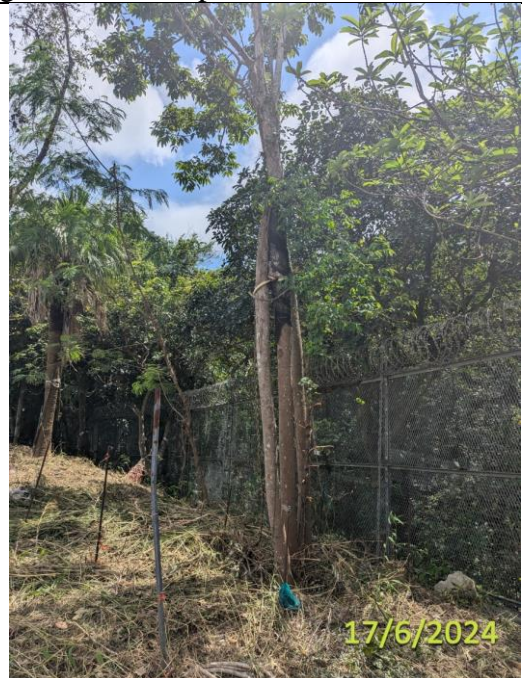
Photo 9. TA572 (*Ailanthus fordii*) was found vigorous and in generally good condition. Protection zone shall be rectified.

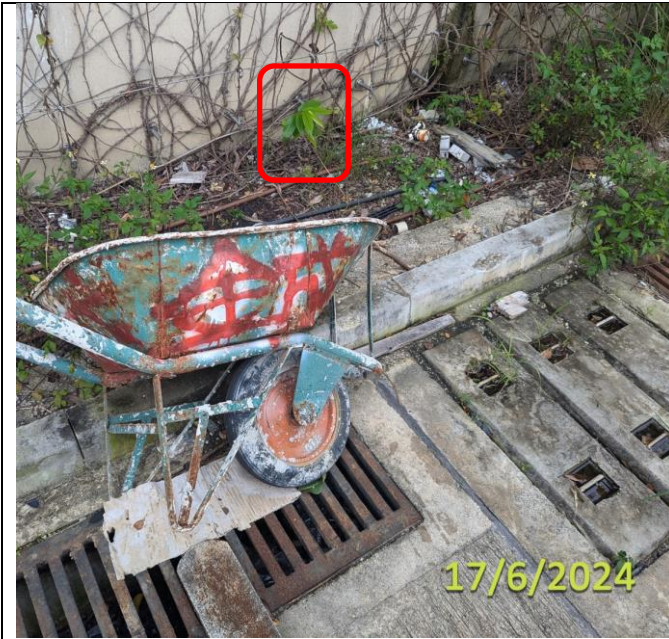
Photo 10. No materials or equipment should put near the *Desmos chinensis* (red). Rubbish should be cleared.

- 2.5.4 New small sprouts keep emerging from the two *Desmos chinensis* that have been reported dead previously. Construction materials was also found too close to the planter. An eye-catching protective fence shall be set up as a protection zone. No construction materials shall be placed near/ within the protection zone.

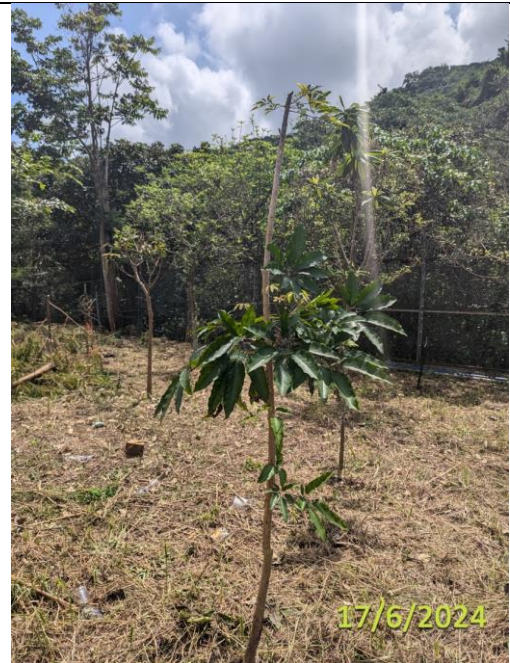
Photo 11. *Schefflera heptaphylla* as compensatory planting of TA326.

- 2.5.2 Compensatory planting of TA326 has been completed on 25 March 2020 by planting two *Syzygium levinei* and one *Schefflera heptaphylla*. However, the two native *Syzygium levinei* were mis-planted by two exotic *Syzygium jambos*, which has been replaced by another native tree species *Celtis sinensis* on 31 May 2021. Climbing vines on one of the *Celtis sinensis* should be removed, including the roots, to reduce rapid colonization covering the canopy.

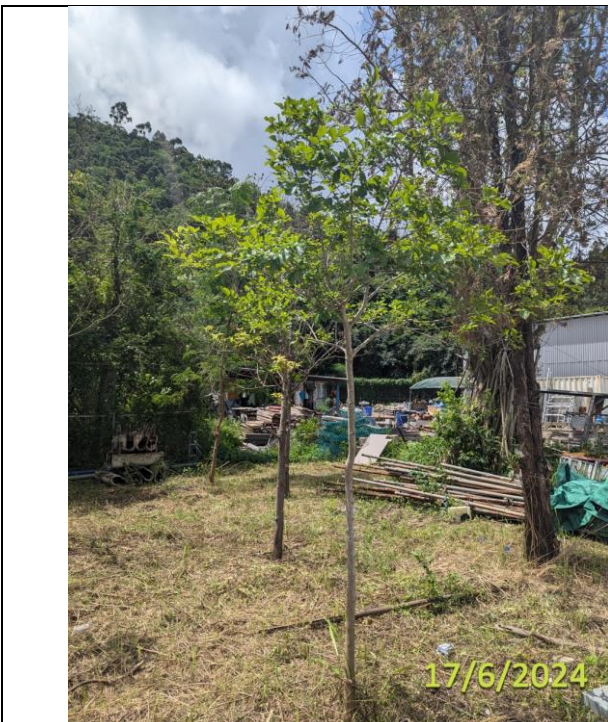
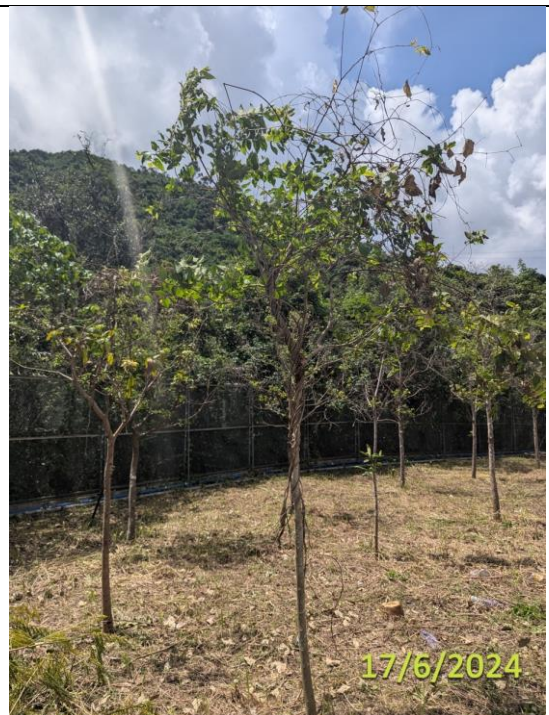
Photo 12 and 13. The two exotic *Syzygium jambos* (mis-treated as the native *Syzygium levinei*) are replaced by another native tree *Celtis sinensis* (due to market availability) as compensatory planting of TA326. Note: *Celtis sinensis* is a deciduous species. Weeding has been completed.

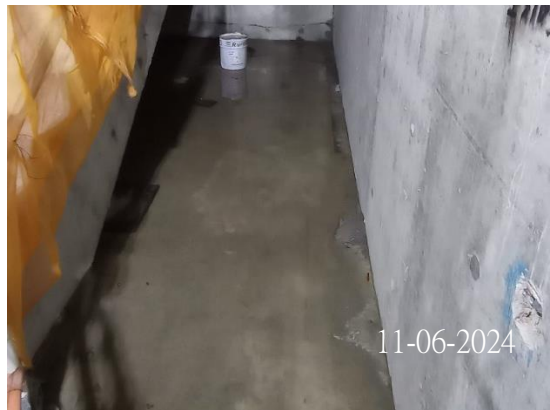
Photo 5 (Water accumulation on the site area at 6/WSD)

Date	Environmental Observations	Follow-up Status
5 June 2024	It is observed that water accumulation in the siren area. Contractor reminded to clear it.	Water accumulation has been cleaned it.
11 June 2024	It is observed that water accumulation in the siren area. Contractor reminded to clear it.	Water accumulation has been cleaned it.
19 June 2024	It is observed that water accumulation in the siren area. Contractor reminded to clear it.	Water accumulation has been cleaned it.
27 June 2024	No environmental issue was observed during the site inspection.	N/A
