CONTRACT NO. 1/WSD/19 & 6/WSD/21

**IN-SITU REPROVISIONING OF SHA TIN WATER
TREATMENT WORKS (SOUTH WORKS) – WATER TREATMENT WORKS AND
ANCILLARY FACILITIES
Environmental Permit EP-494/2015**

**In-Situ Re provisioning of Sha Tin Water Treatment Works (South Works) – Water Treatment Works and Ancillary Facilities
Environmental Permit EP-494/2015
Submission of 102nd monthly EM&A Report**

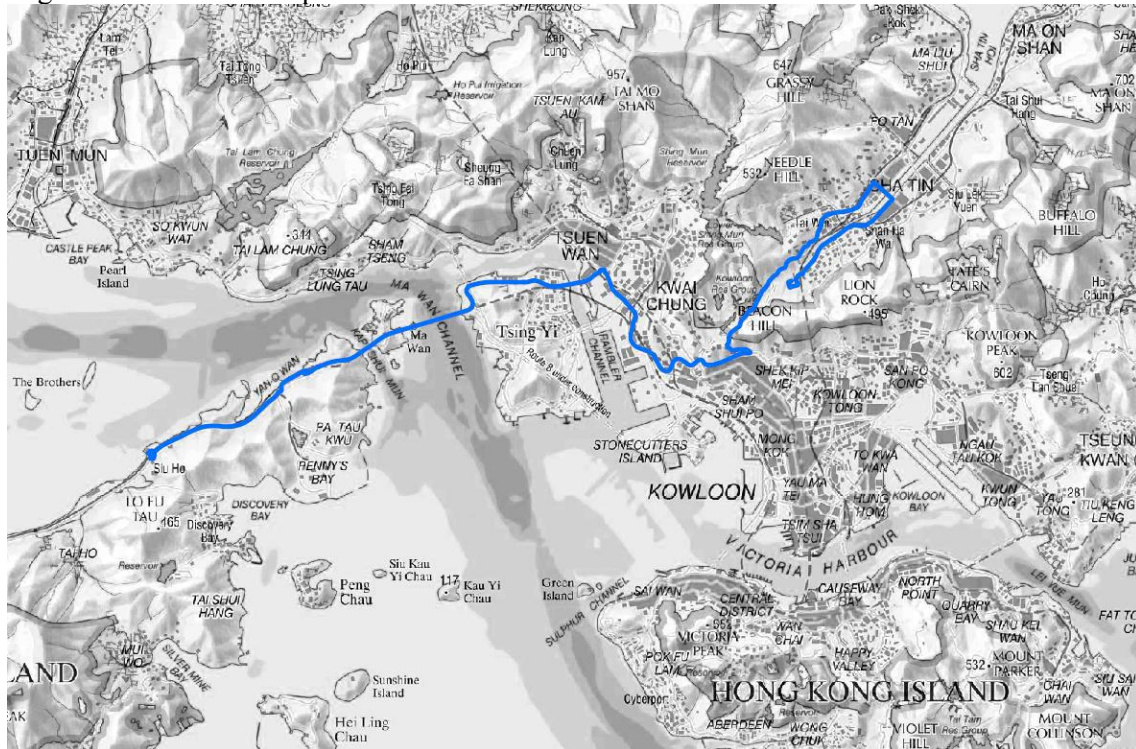
Figure 1: Chlorine Transport Route to Sha Tin Water Treatment Works

2.7.1 Chlorine is delivered to Sha Tin WTW in batches of up to 6×1-tonne drums. The transport route from Sham Shui Kok dock on North Lantau is shown in **Figure 1**. The route passes along the North Lantau Expressway, around the northern edge of Tsing Yi, through Tsuen Wan and along Tai Po Road (Piper's Hill) to Sha Tin (Table 2-15).

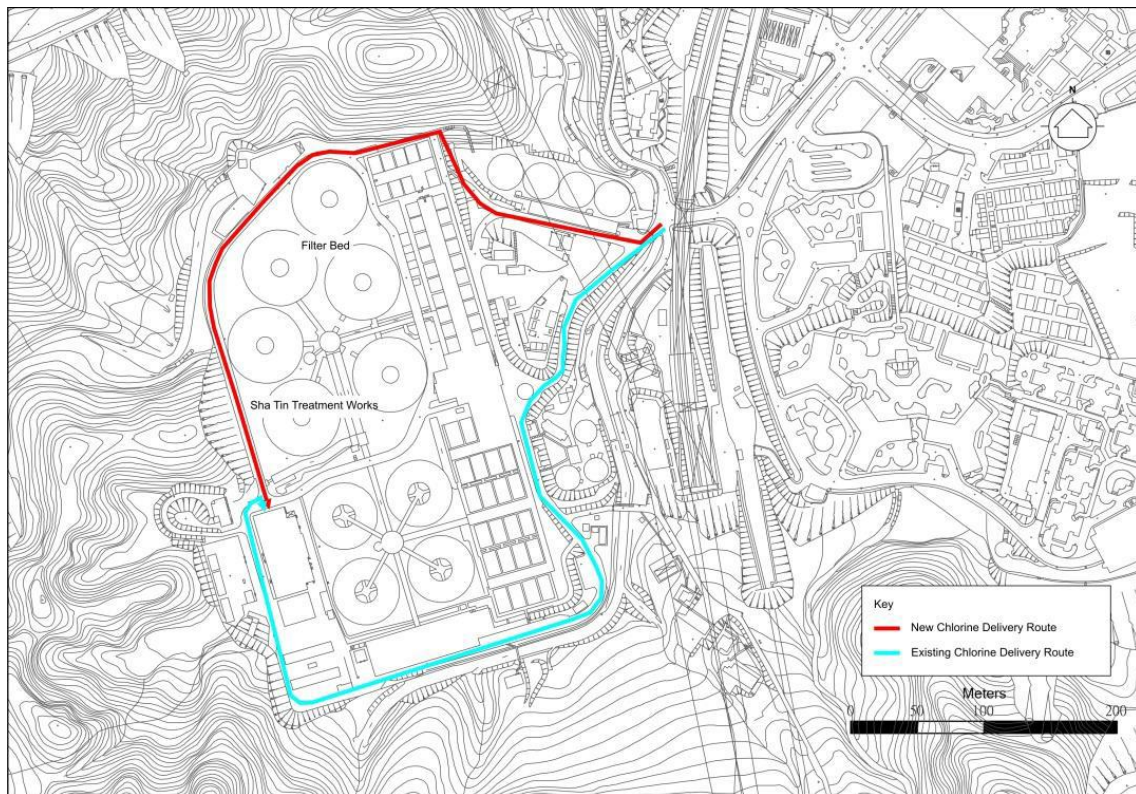
Figure 2: Chlorine Delivery Route at Sha Tin WTW

2.7.3 The on-site chlorine delivery route is shown in **Figure 2**.

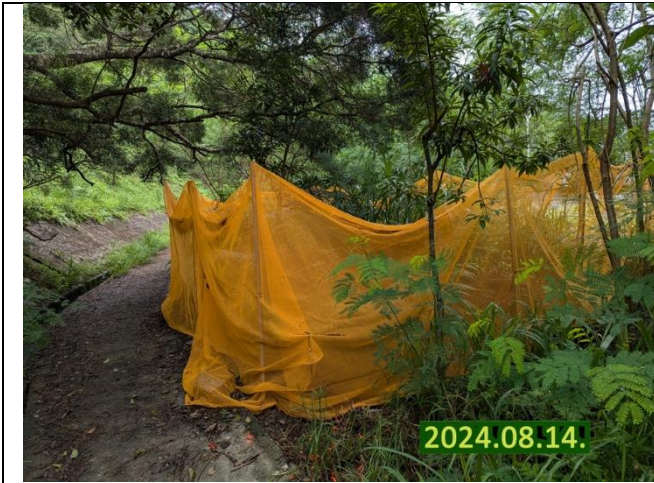
Photo 1. Protection zone of the first batch of *Cibotium barometz* have been set up again. Weeds and the invasive *Leucaena leucocephala* (銀合歡) shall be removed including the roots and seeds and packed properly during clearance.

- 2.5.6 Weeding by hand held tools within protection zone of *Cibotium barometz* is urgently needed.
- 2.5.7 Root ball of TA572 and TA327 tree should be kept moisture especially during dry and non-raining day.

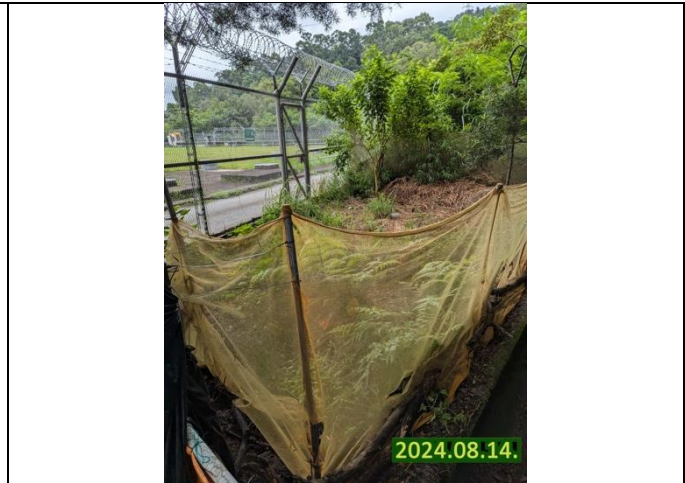
Photo 2. New metal rods of protective fence for another patch of *Cibotium barometz* has been used to replace the temporary wood sticks

- 2.5.8 Signs of ploughed soil by wild boar(s) at the two groups of transplanted *Cibotium barometz* were reported in previous monitoring. A robust fencing was recently installed to protect the group of *Cibotium barometz* from further damage caused by wild boars. However, the protection zones were damaged by unknown persons recently. They should be repaired and secured as soon as possible. Surveillance cameras has been installed for any suspicious persons.

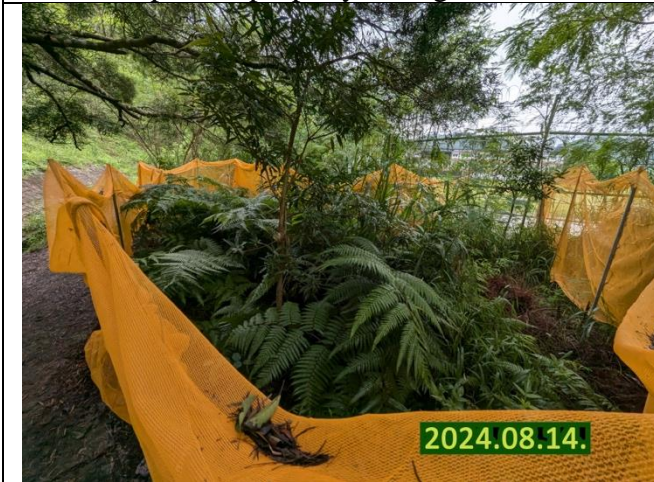
Photo 3. *Cibotium barometz* in good condition

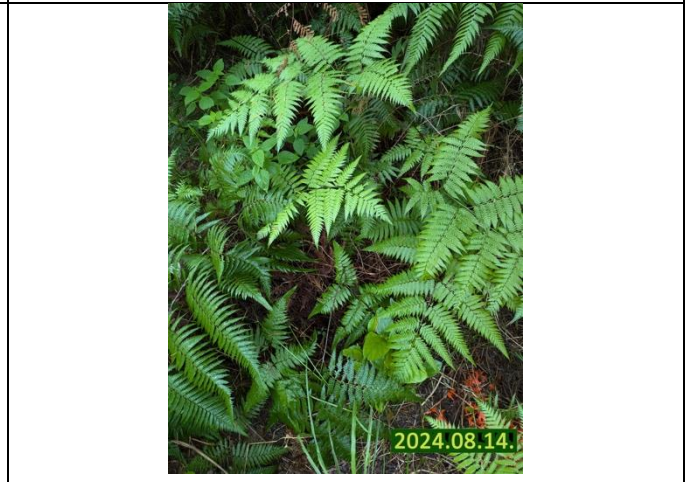
Photo 4. *Cibotium barometz* in good condition

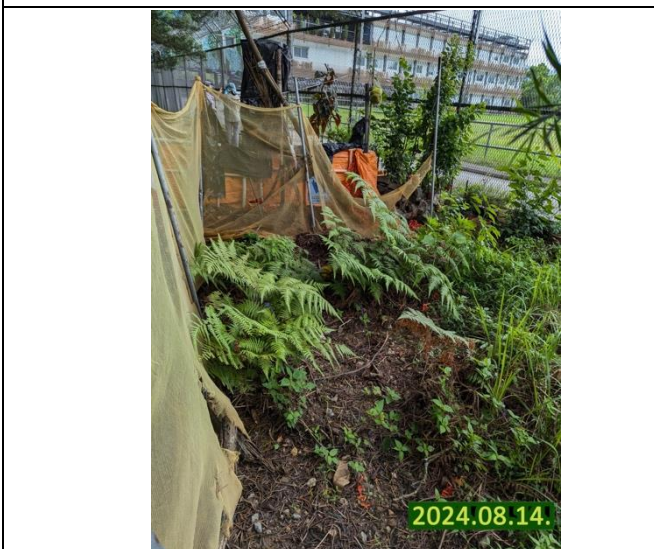
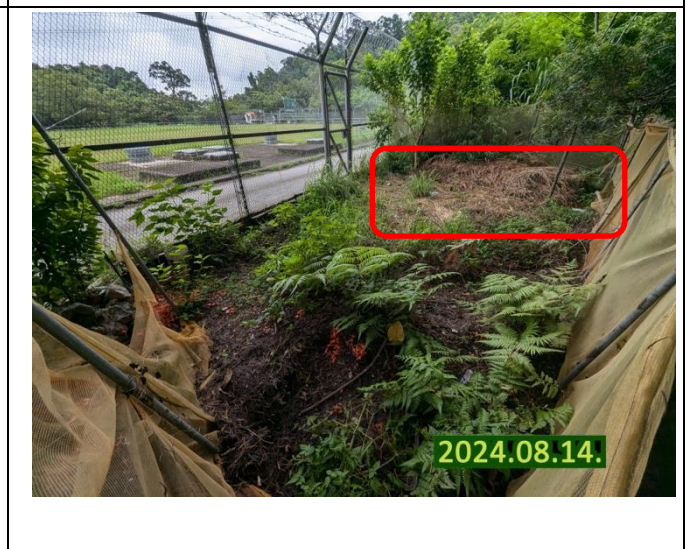
Photo 5 & 6. Weeds and climbers at the second of *Cibotium barometz* has been cleared.

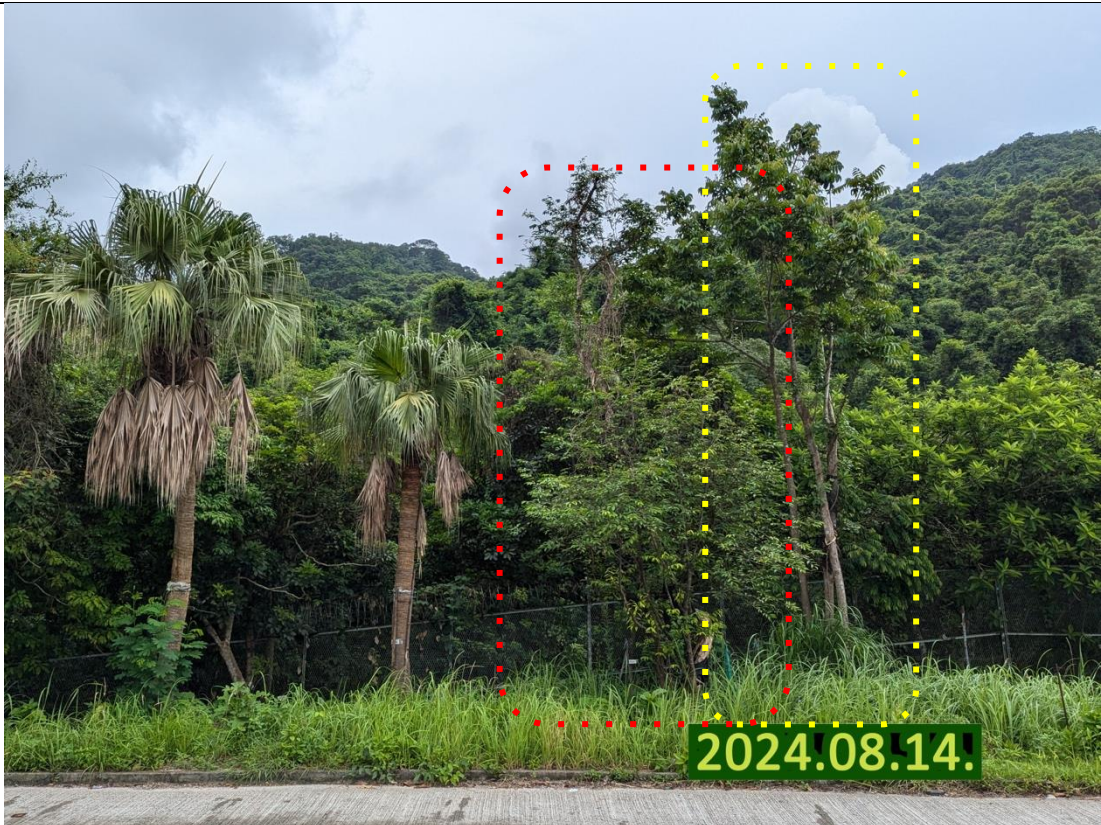
- 2.5.1 The condition of TA572 was observed in fair health despite in poor form. TA327 was in fair condition; while already dead TA326 collapsed under Signal No. 10 typhoon Mangkhut in September 2018. Tree guying cables have been installed to provide external support to the two remaining transplanted trees. Climbing vines on TA327 should be removed, including the roots, to reduce rapid colonization covering the canopy.

Photo 7. Transplanted Incense Tree (*Aquilaria sinensis*) – TA327 (red); and Ailanthus (*Ailanthus fordii*) – TA572 (yellow). Weeding has been completed.

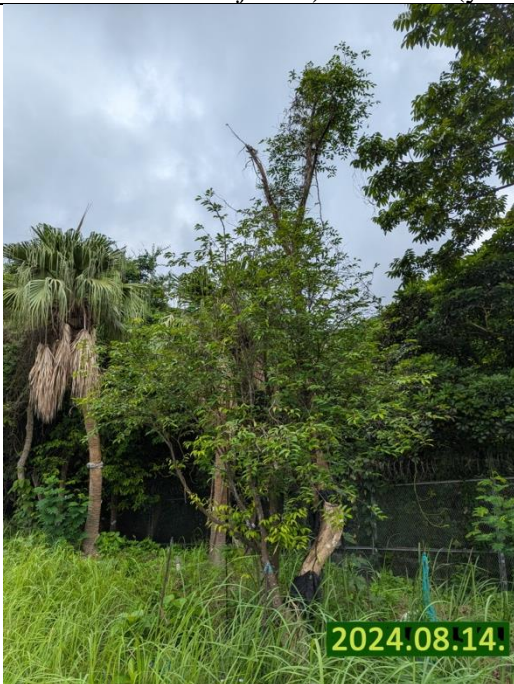
Photo 8. Sprouts at lower trunk of TA327 (*Aquilaria sinensis*). Protection zone shall be rectified.

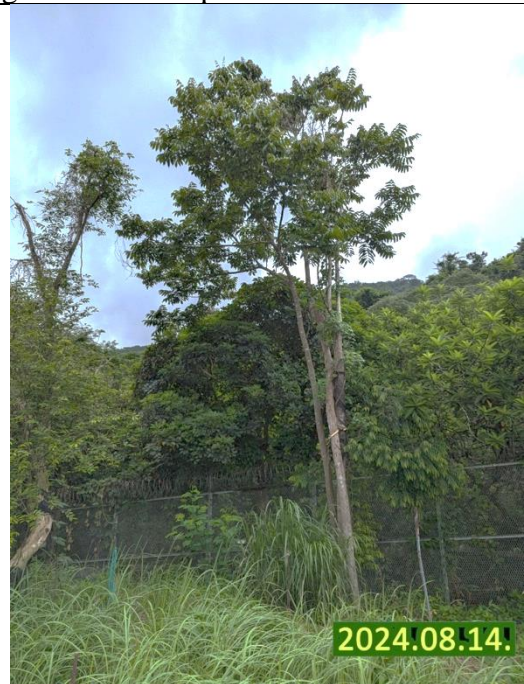
Photo 9. TA572 (*Ailanthus fordii*) was found vigorous and in generally good condition. Protection zone shall be rectified.

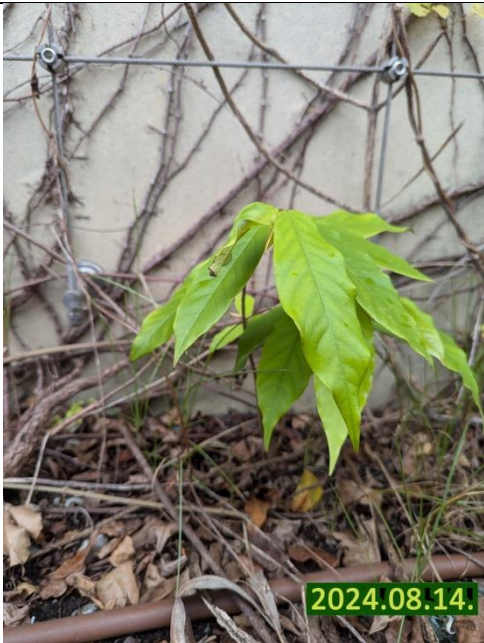
- 2.5.4 New small sprouts keep emerging from the two *Desmos chinensis* that have been reported dead previously. Construction materials was also found too close to the planter. An eye-catching protective fence shall be set up as a protection zone. No construction materials shall be placed near/ within the protection zone.

Photo 10. No materials or equipment should put near the *Desmos chinensis*. Rubbish should be cleared.

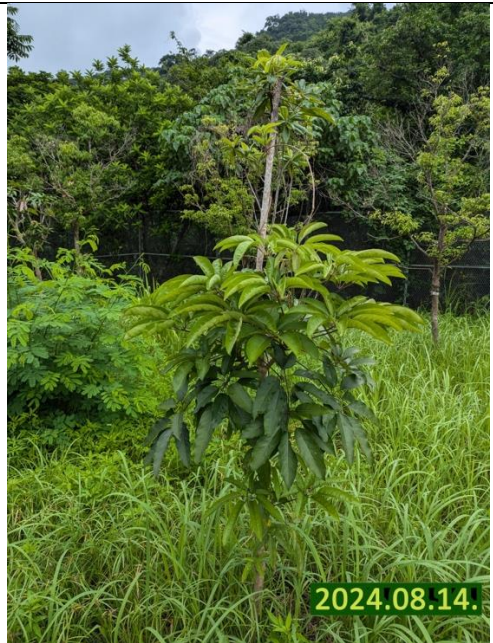
- 2.5.2 Compensatory planting of TA326 has been completed on 25 March 2020 by planting two *Syzygium levinei* and one *Schefflera heptaphylla*. However, the two native *Syzygium levinei* were mis-planted by two exotic *Syzygium jambos*, which has been replaced by another native tree species *Celtis sinensis* on 31 May 2021. Climbing vines on one of the *Celtis sinensis* should be removed, including the roots, to reduce rapid colonization covering the canopy.

Photo 11. *Schefflera heptaphylla* as compensatory planting of TA326.

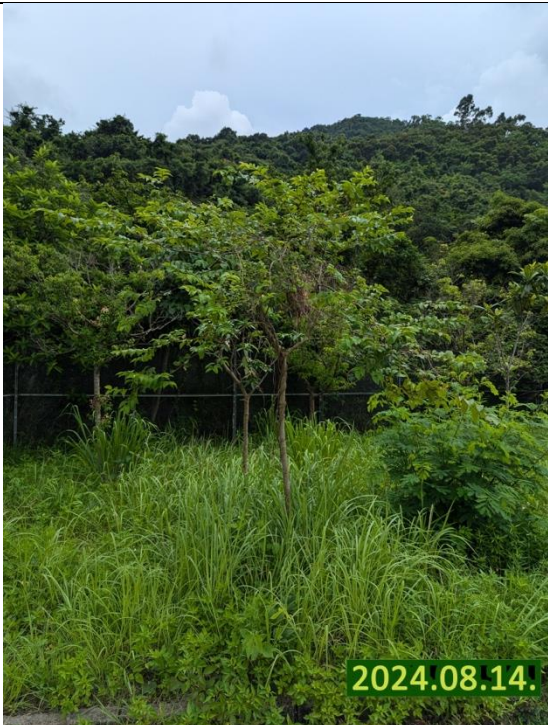
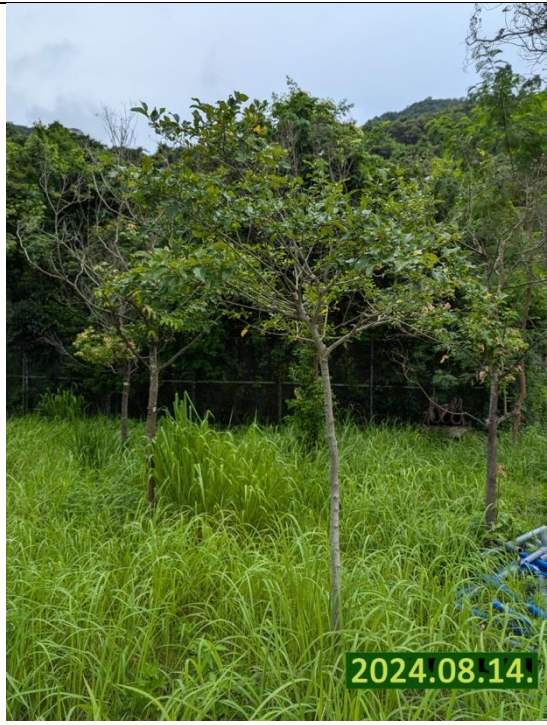
Photo 12 and 13. The two exotic *Syzygium jambos* (mis-treated as the native *Syzygium levinei*) are replaced by another native tree *Celtis sinensis* (due to market availability) as compensatory planting of TA326. Note: *Celtis sinensis* is a deciduous species.
Climber on tree has been removed.

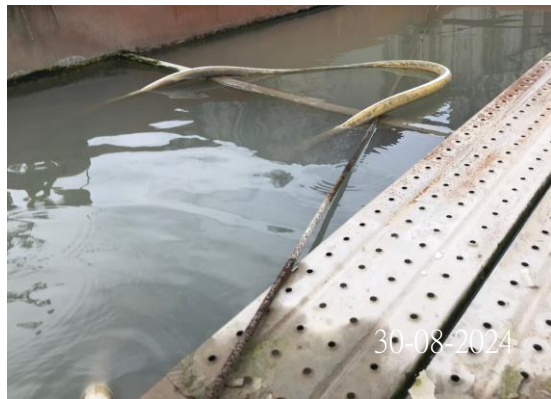
Photo 2 (Water quality of water treatment tank at 6/WSD)

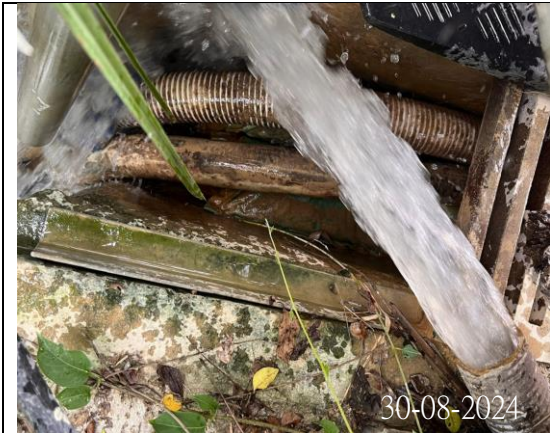
Photo 3 (Discharge point at 6/WSD)

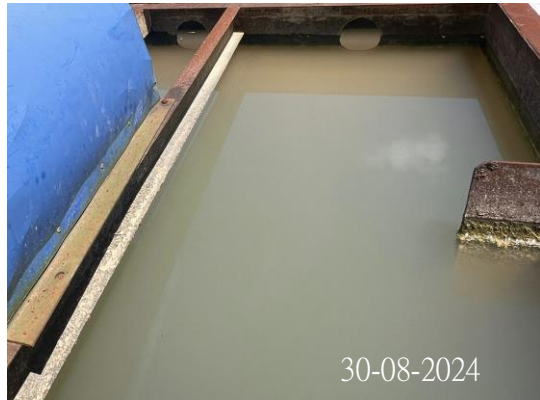
Photo 4 (Water quality of water treatment tank at 1/WSD)
