**IN-SITU REPROVISIONING OF SHA TIN WATER
TREATMENT WORKS (SOUTH WORKS) – WATER TREATMENT WORKS AND
ANCILLARY FACILITIES
Environmental Permit EP-494/2015**

- (a) Three hard copies,
- (b) Two copies of the 104th monthly Environmental Monitoring and Audit (EM&A) Report (Rev.0). (Register No.: AEIAR-187/2015)

**In-Situ Re provisioning of Sha Tin Water Treatment Works (South Works) – Water Treatment Works and Ancillary Facilities
Environmental Permit EP-494/2015
Submission of 104th monthly EM&A Report**

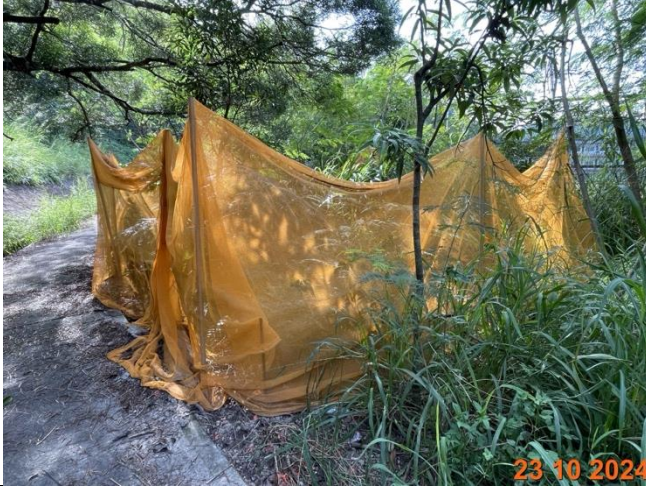
Photo 1. Protection zone of the first batch of *Cibotium barometz* have been set up again. Weeds and the invasive *Leucaena leucocephala* (銀合歡) shall be removed including the roots and seeds and packed properly during clearance.

- 2.5.6 Weeding by hand held tools within protection zone of *Cibotium barometz* is in progress.
- 2.5.7 Root ball of TA572 and TA327 tree should be kept moisture especially during dry and non-raining day.

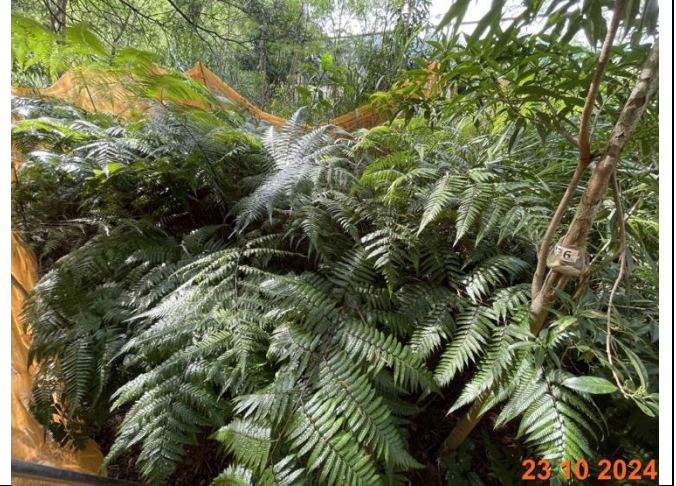
Photo 2. *Cibotium barometz* growing vigorously in sheltered condition.

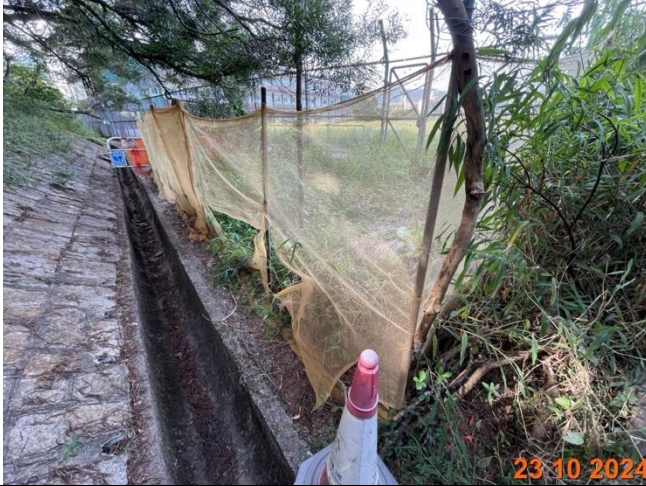
Photo 3. Second batch of *Cibotium barometz*, where the net is slightly broken.

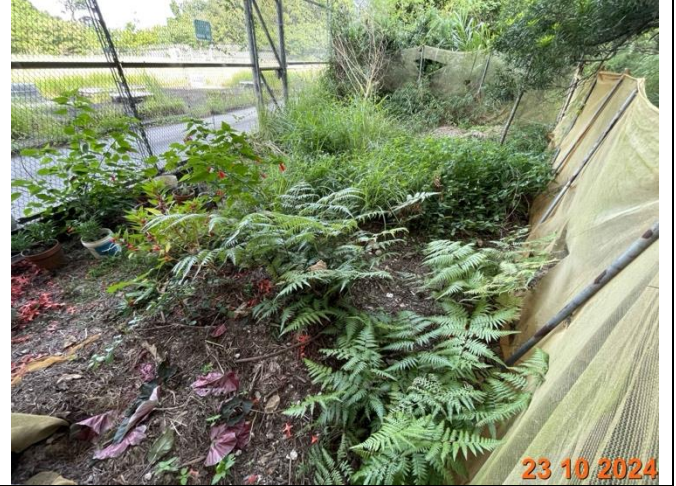
Photo 4. *Cibotium barometz* in fair condition. It is more exposed where light-demanding weed slowly becomes a problem.

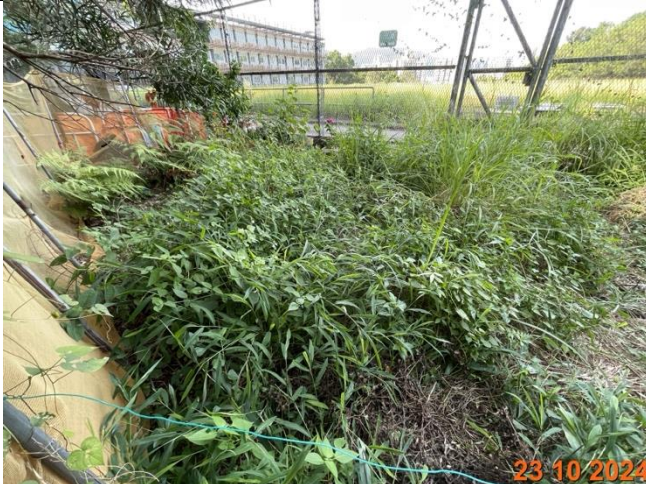
Photo 5. Weed growing around the second patch of *Cibotium barometz*.

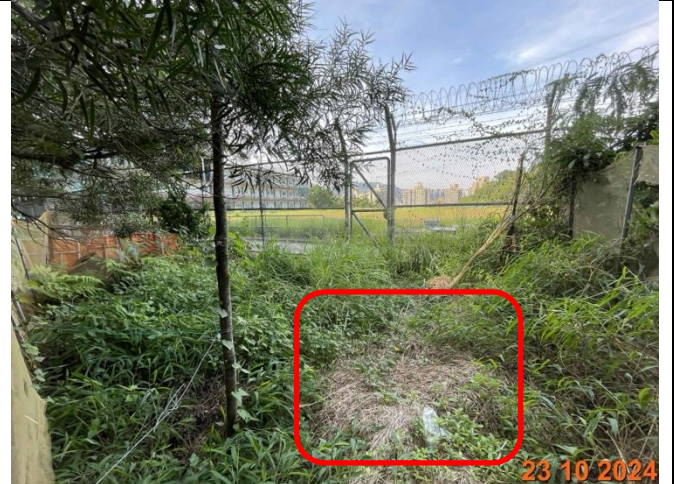
Photo 6. Rubbish was found within the protection zone of the second patch of *Cibotium barometz*.

- 2.5.9 Given that leftover/ garbage was observed nearby, illegal feeding of wild pigs or other wild animals was also suspected to occur. Warning signs of illegal feeding and plant protection zone may be put along the receptor site to remind the hikers. Reporting the case to the relevant government department, i.e. AFCD, is suggested to prevent further aggregation of wild boars in the area.

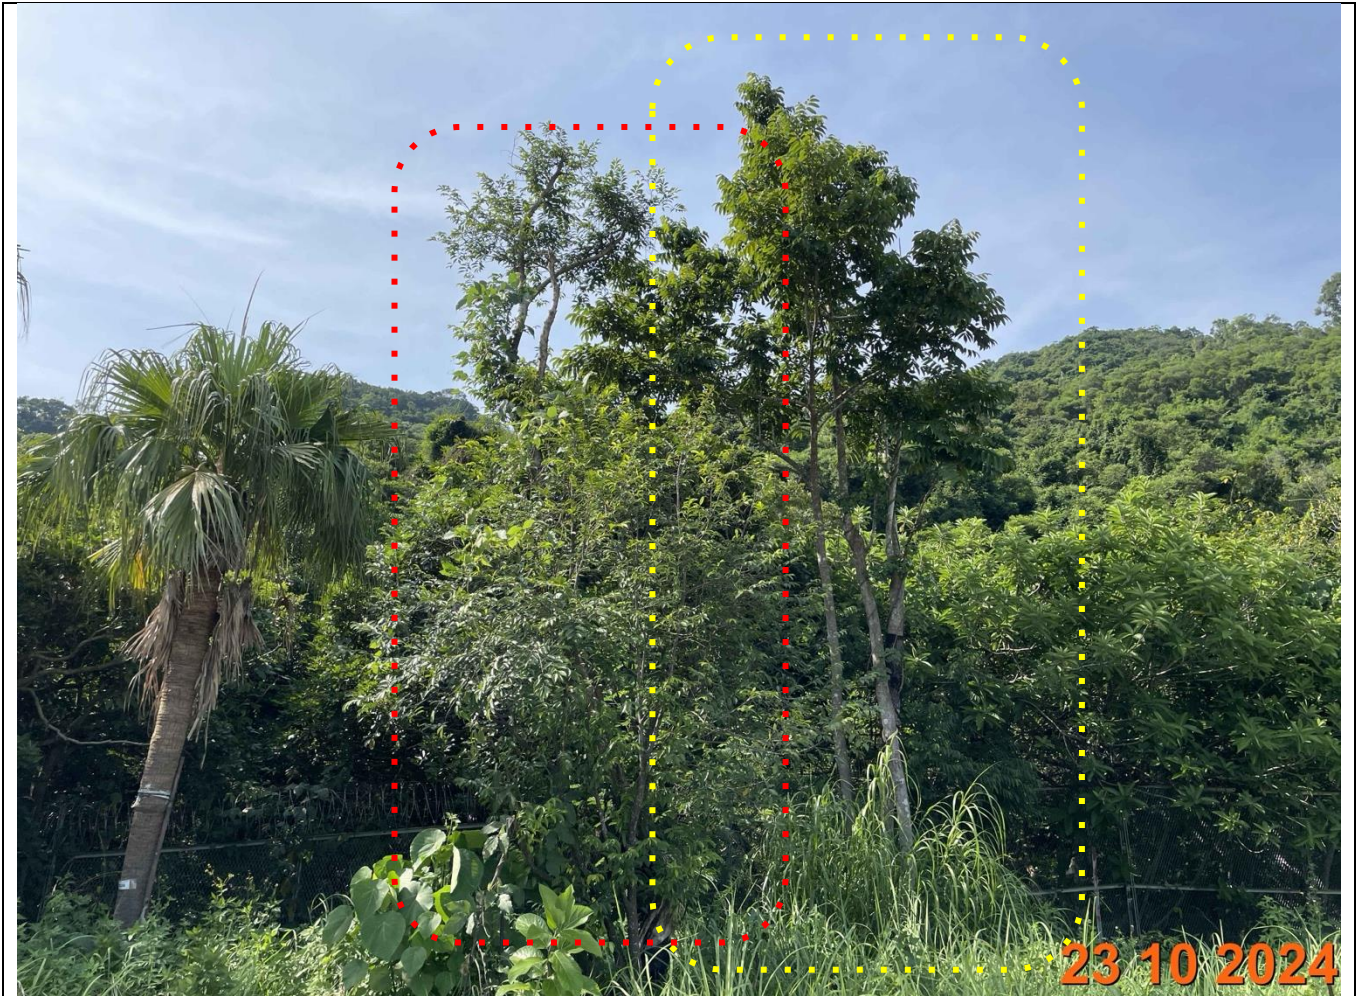
- 2.5.1 The condition of TA572 was observed in fair health despite in poor form. TA327 was in fair condition; while already dead TA326 collapsed under Signal No. 10 typhoon Mangkhut in September 2018. Tree guying cables have been installed to provide external support to the two remaining transplanted trees. Weeding has been completed in this area

Photo 7. Transplanted Incense Tree (*Aquilaria sinensis*) – TA327 (red); and Ailanthus (*Ailanthus fordii*) – TA572 (yellow). Weeds grew vigorously around the two trees.

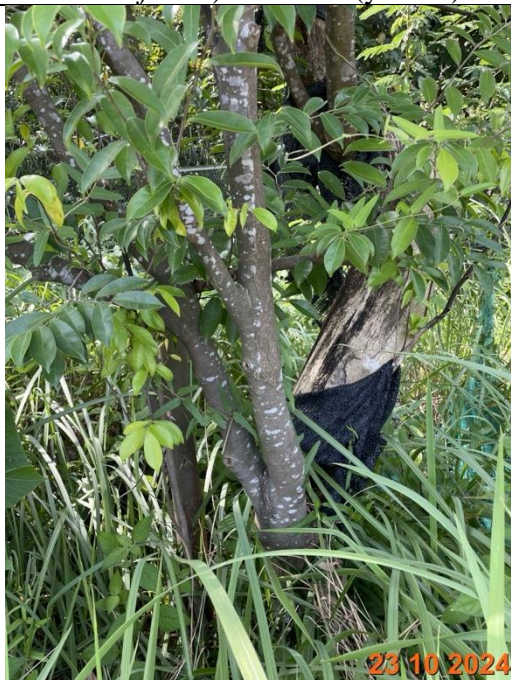
Photo 8. Sprouts at lower trunk of TA327 (*Aquilaria sinensis*). Protection zone shall be rectified.

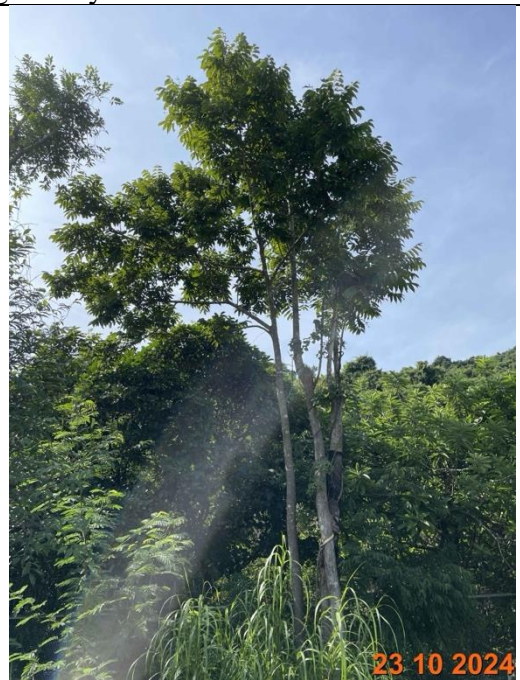
Photo 9. TA572 (*Ailanthus fordii*) was found vigorous and in generally good condition. Protection zone shall be rectified.

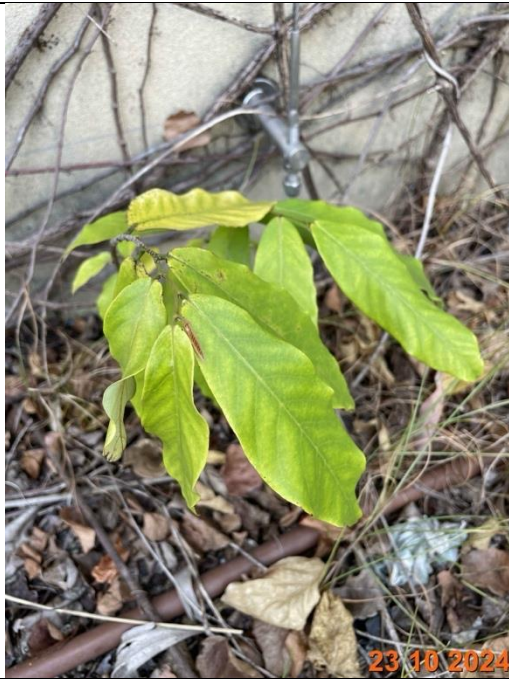
- 2.5.4 New small sprouts keep emerging from the two *Desmos chinensis* that have been reported dead previously. Construction materials was also found too close to the planter. An eye-catching protective fence shall be set up as a protection zone. No construction materials shall be placed near/ within the protection zone.

Photo 10. No construction material or equipment should put near the *Desmos chinensis*. Rubbish should be cleared.

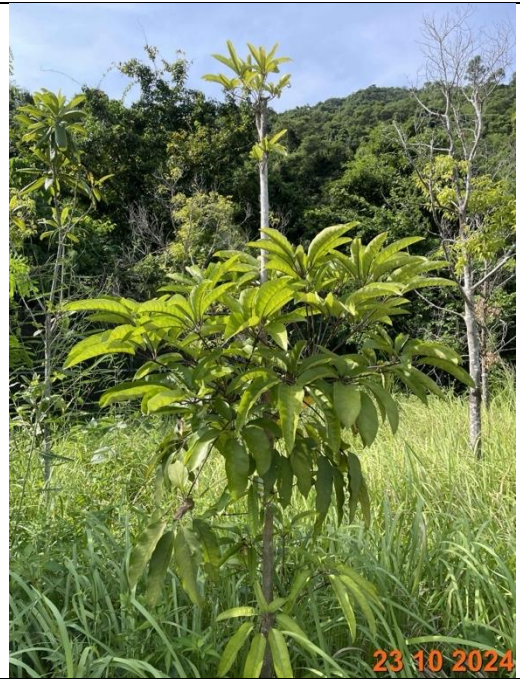
Photo 11. *Schefflera heptaphylla* as compensatory planting of TA326.

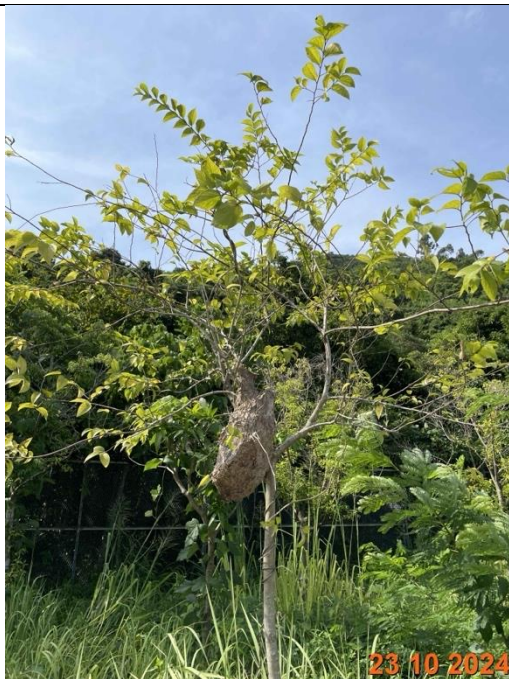
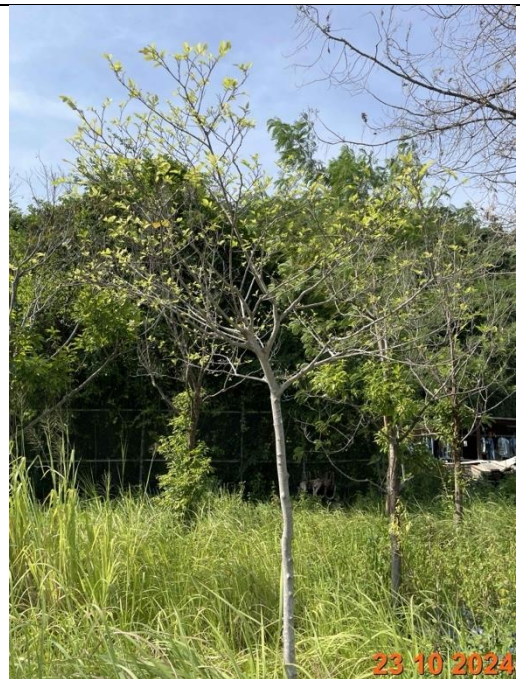
- 2.5.2 Compensatory planting of TA326 has been completed on 25 March 2020 by planting two *Syzygium levinei* and one *Schefflera heptaphylla*. However, the two native *Syzygium levinei* were mis-planted by two exotic *Syzygium jambos*, which have been replaced by another native tree species *Celtis sinensis* on 31 May 2021. Weeding was completed in this area.

Photo 12 and 13. The two exotic *Syzygium jambos* (mis-treated as the native *Syzygium levinei*) were replaced by another native tree species *Celtis sinensis* (due to market availability) as compensatory planting of TA326. Note: *Celtis sinensis* is a deciduous species. Weeds grew vigorously around two trees.
