**CONTRACT NO. 1/WSD/19 & 6/WSD/21**

**IN-SITU REPROVISIONING OF SHA TIN WATER  
TREATMENT WORKS (SOUTH WORKS) – WATER TREATMENT WORKS AND  
ANCILLARY FACILITIES  
Environmental Permit EP-494/2015**

**In-Situ Re provisioning of Sha Tin Water Treatment Works (South Works) – Water Treatment Works and Ancillary Facilities  
Environmental Permit EP-494/2015  
Submission of 105<sup>th</sup> monthly EM&A Report**

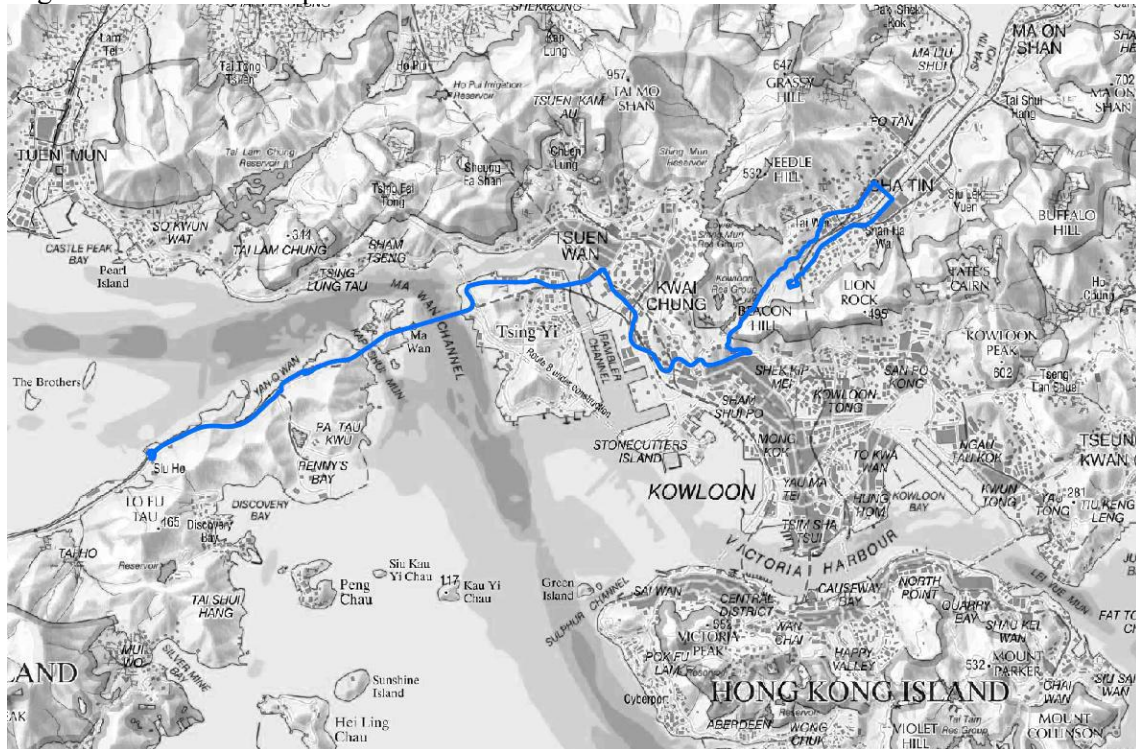
Figure 1: Chlorine Transport Route to Sha Tin Water Treatment Works

2.7.1 Chlorine is delivered to Sha Tin WTW in batches of up to 6×1-tonne drums. The transport route from Sham Shui Kok dock on North Lantau is shown in **Figure 1**. The route passes along the North Lantau Expressway, around the northern edge of Tsing Yi, through Tsuen Wan and along Tai Po Road (Piper's Hill) to Sha Tin (Table 2-15).

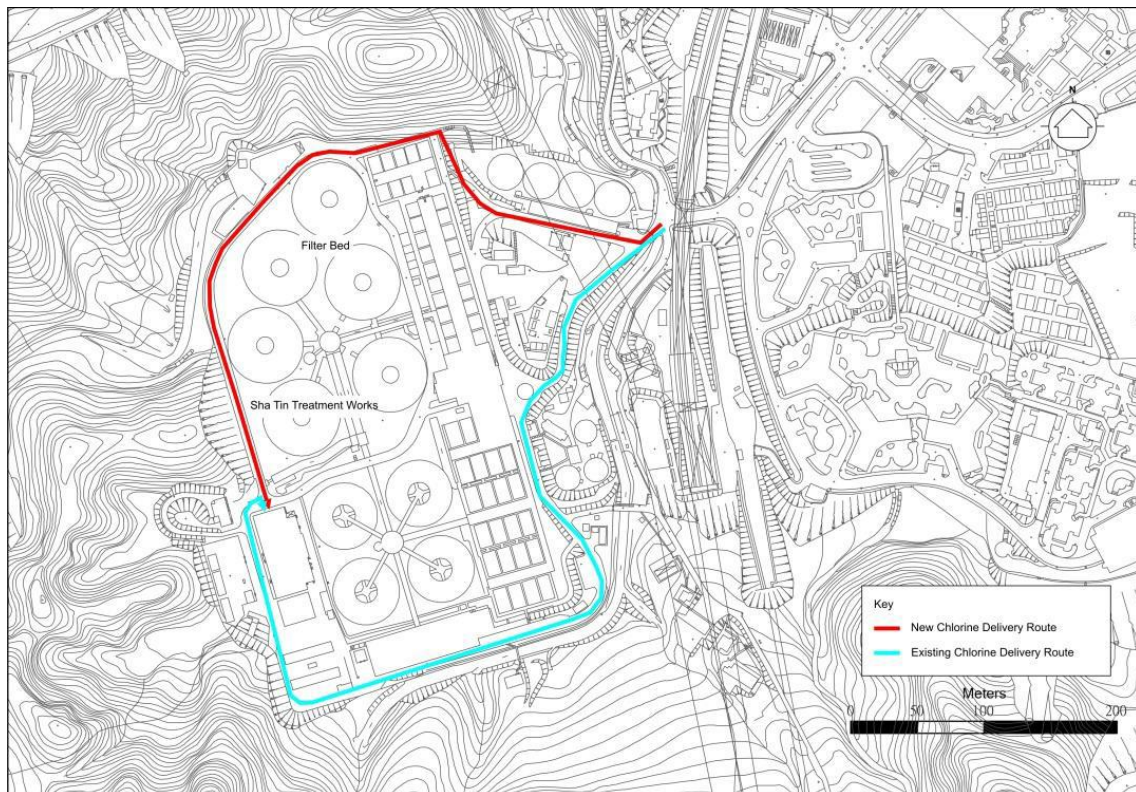
Figure 2: Chlorine Delivery Route at Sha Tin WTW

2.7.3 The on-site chlorine delivery route is shown in **Figure 2**.

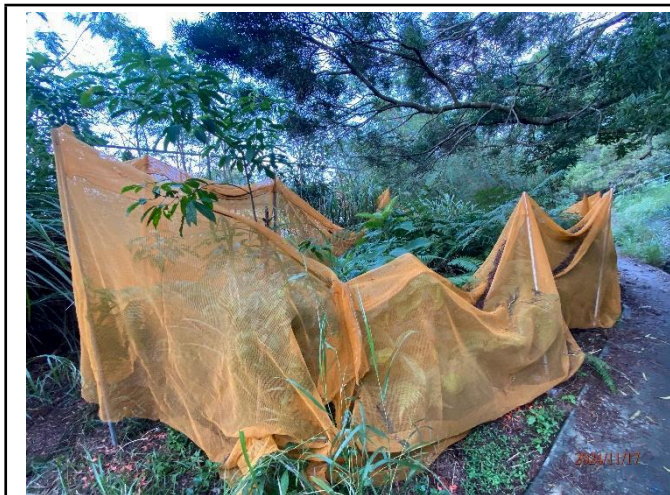
Photo 1. Protection zone of the first batch of *Cibotium barometz* have been set up again. Weeds and the invasive *Leucaena leucocephala* (銀合歡) shall be removed and packed properly during weeding.

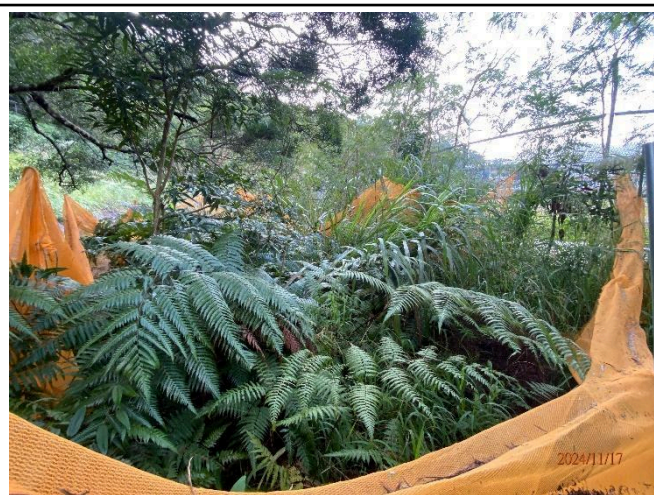
Photo 2. *Cibotium barometz* growing vigorously in sheltered condition.

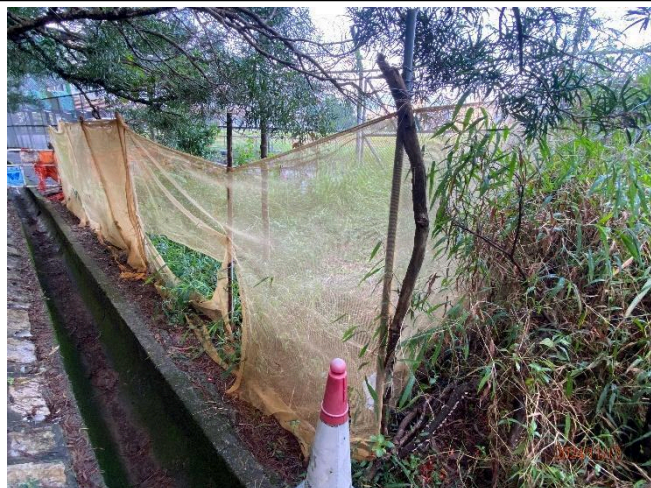
Photo 3. Second batch of *Cibotium barometz*, where the net is slightly broken.

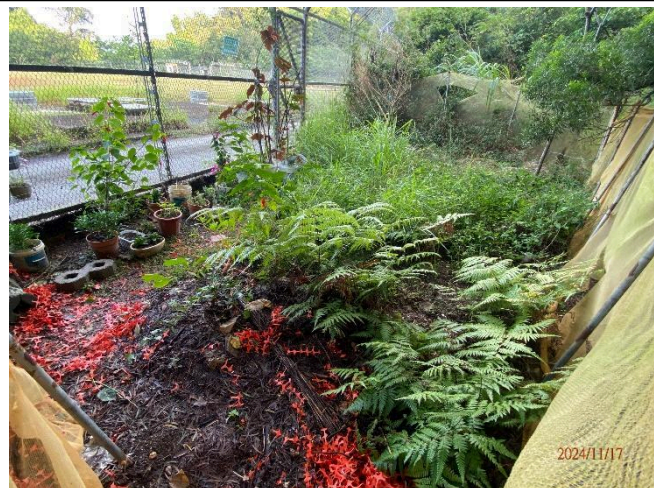
Photo 4. *Cibotium barometz* in fair condition. It is more exposed where light-demanding weed gradually takes over the planting site.

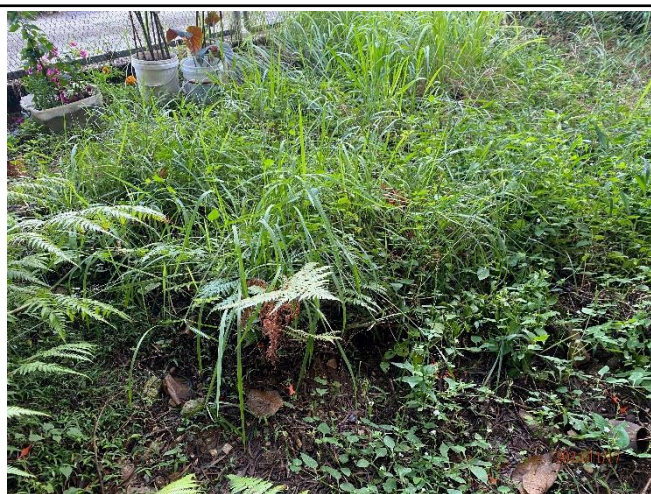
Photo 5. Weed growing around the second patch of *Cibotium barometz*

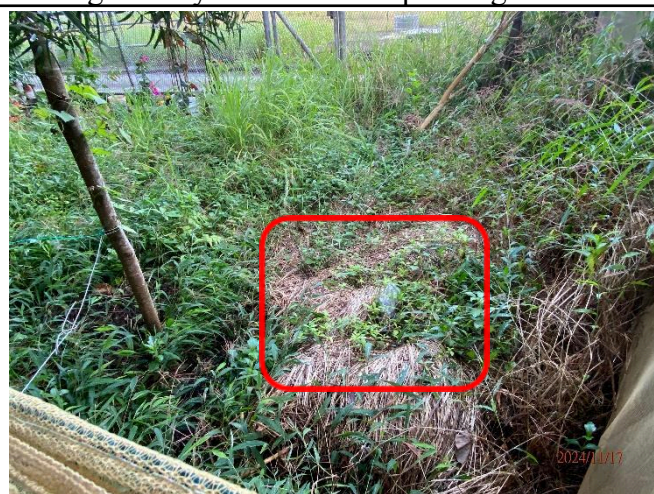
Photo 6. Rubbish was found within the protection zone of the second patch of *Cibotium barometz*

- 2.5.9 Given that leftover/ garbage was observed near the planting area of *Cibotium barometz*, illegal feeding of wild pigs or other wild animals was suspected to occur. Warning signs of illegal feeding and plant protection zone are recommended to put along the receptor site to remind the public in order to prevent further aggregation of wild boars in the area. Reporting the case to the relevant government

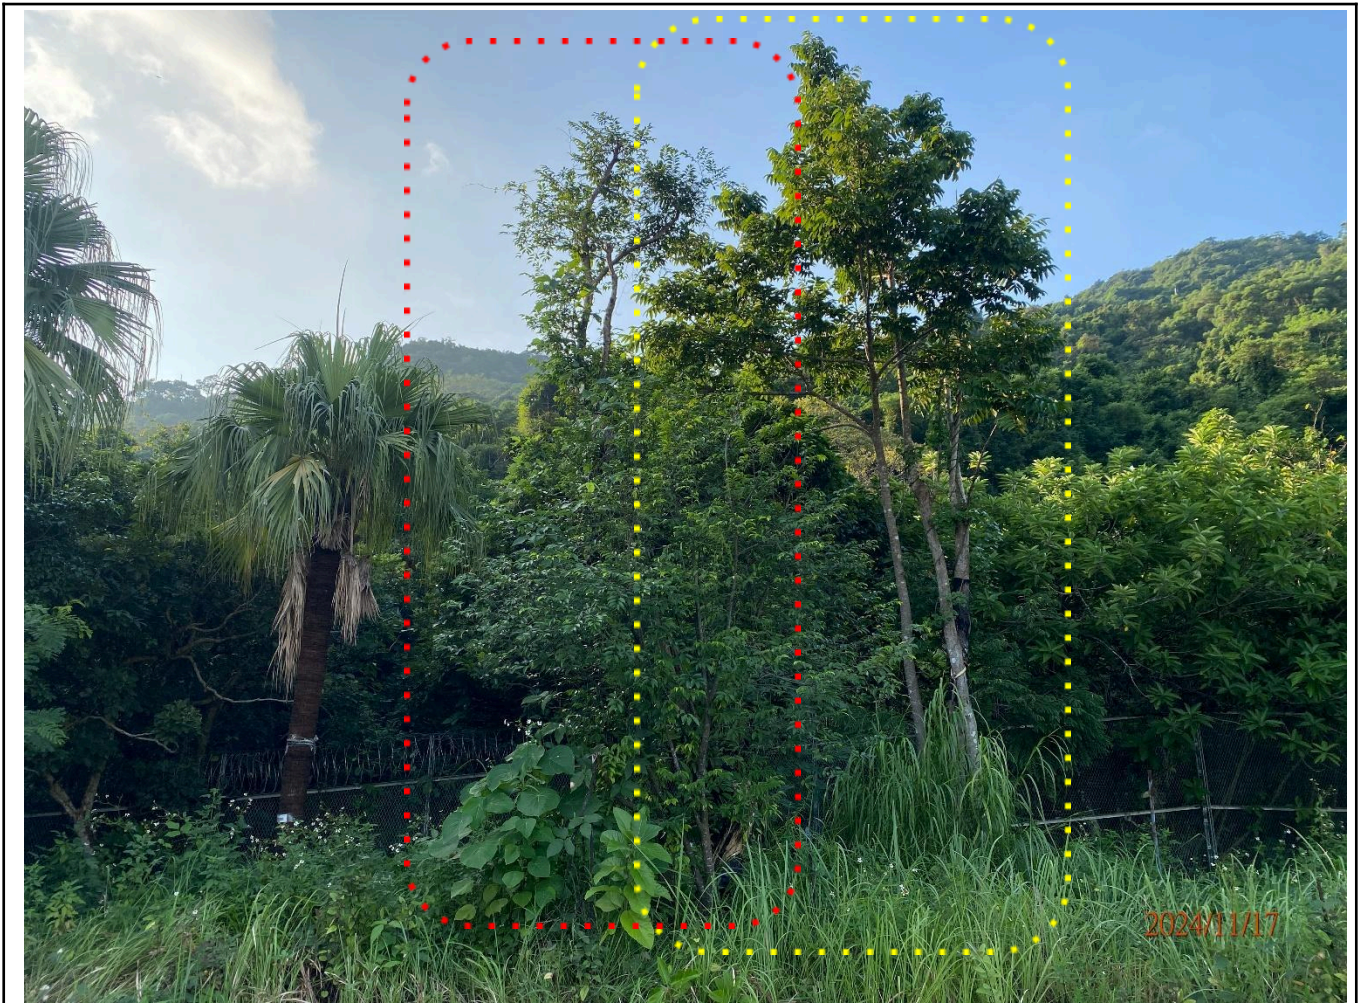
- 2.5.1 The condition of TA572 was observed in fair health despite in poor form. TA327 was in fair condition; while already dead TA326 collapsed under Signal No. 10 typhoon Mangkhut in September 2018. Tree guying cables have been installed to provide external support to the two remaining transplanted trees. Weeding has been completed in this area

Photo 7. Transplanted Incense Tree (*Aquilaria sinensis*) – TA327 (red); and Ailanthus (*Ailanthus fordii*) – TA572 (yellow). Weeds grew vigorously around the two trees.

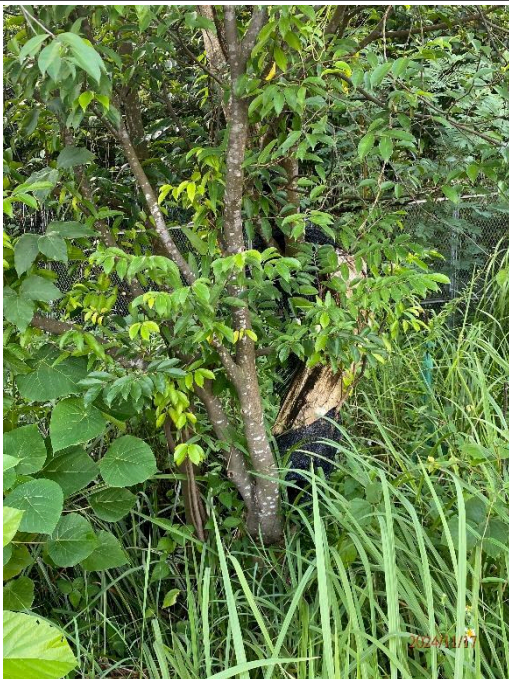
Photo 8. Sprouts growing at the wound in the lower trunk of TA327 (*Aquilaria sinensis*). Protection zone shall be rectified.

- 2.5.6 Weeding by hand held tools within protection zone of *Cibotium barometz* is in progress.
- 2.5.7 Root ball of TA572 and TA327 tree should be kept moisture especially during dry and non-raining day.

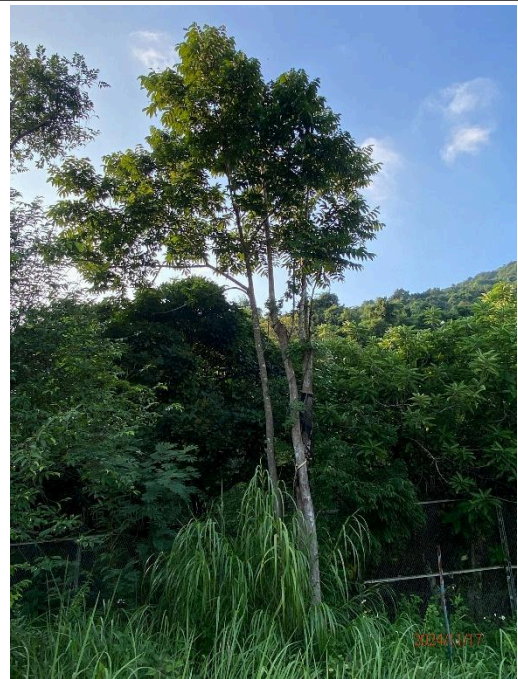
Photo 9. TA572 (*Ailanthus fordii*) was found vigorous and in generally good condition. Protection zone shall be rectified.

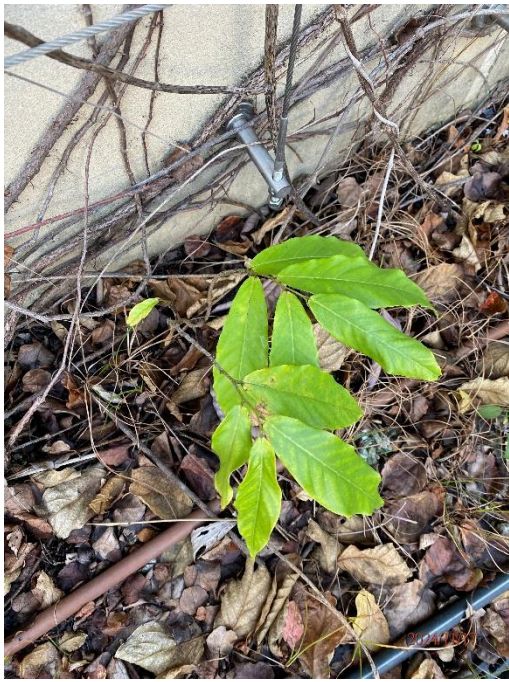
- 2.5.3 *Desmos chinensis* has been finalized as the candidate to compensate the loss of *Artabotrys hongkongensis*. Two individuals were planted at Wall C in STWTW on 1 April 2021, but one of them was found to be dead on 30 November 2022.

Photo 10. No construction material or equipment should put near the *Desmos chinensis*. Rubbish should be cleared.

- 2.5.4 Construction material was found too close to the planter of climber *Desmos chinensis*. An eye-catching protective fence shall be set up as a protection zone. No construction material shall be placed near/within the protection zone.

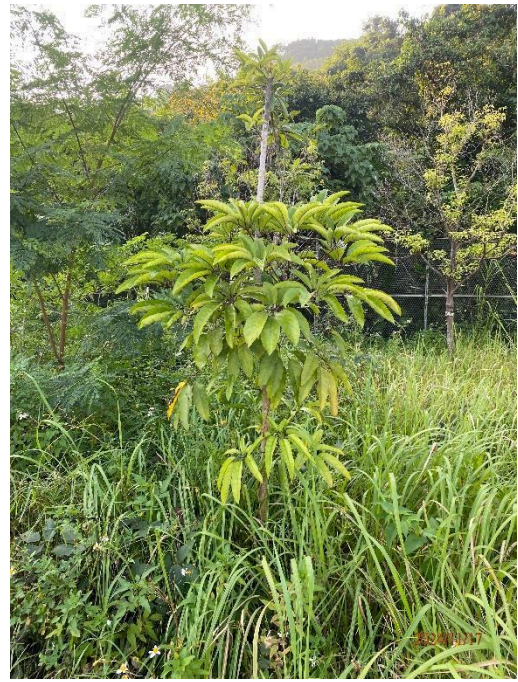
Photo 11. *Schefflera heptaphylla* as compensatory planting of TA326; selective weeding around the planted individual suggested.

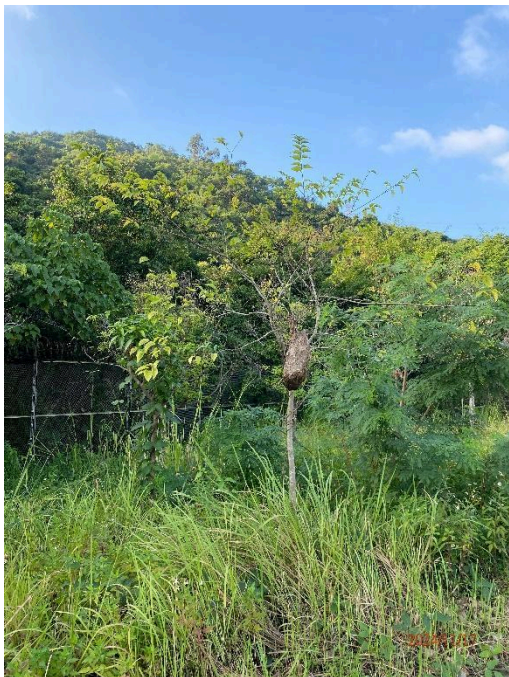
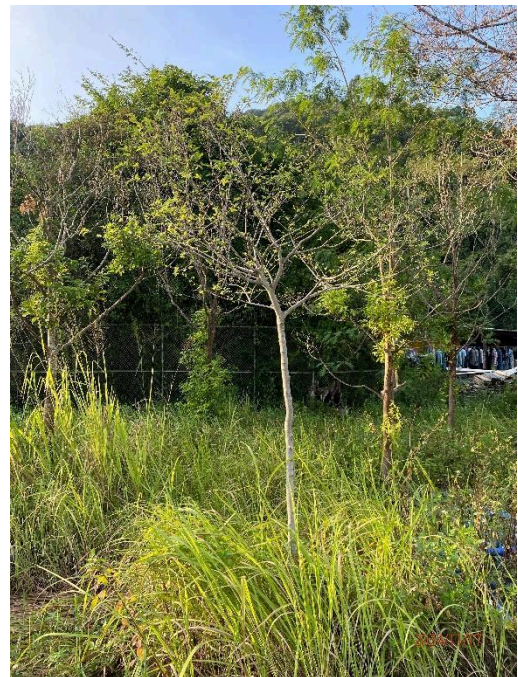
- 2.5.2 Compensatory planting of TA326 has been completed on 25 March 2020 by planting two *Syzygium levinei* and one *Schefflera heptaphylla*. However, the two native *Syzygium levinei* were mis-planted by two exotic *Syzygium jambos*, which have been replaced by another native tree species *Celtis sinensis* on 31 May 2021. Weeding was completed in this area.

Photo 12 and 13. The two exotic *Syzygium jambos* (mis-treated as the native *Syzygium levinei*) were replaced by another native tree species *Celtis sinensis* (due to market availability) as compensatory planting of TA326. Note: *Celtis sinensis* is a deciduous species. Weeds grew vigorously around two trees; selective weeding around the planted individual suggested.

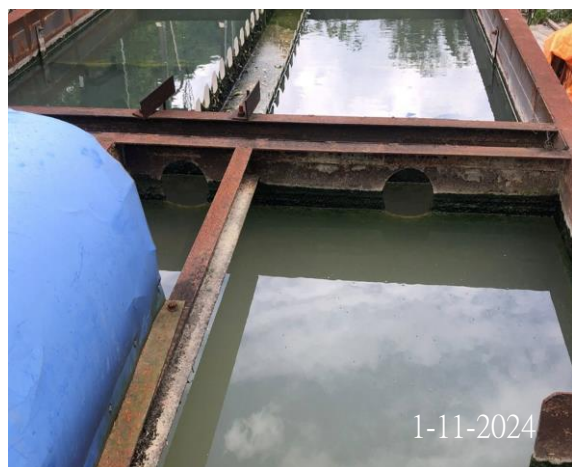
Photo 2 (Water quality of water treatment tank at 6/WSD)

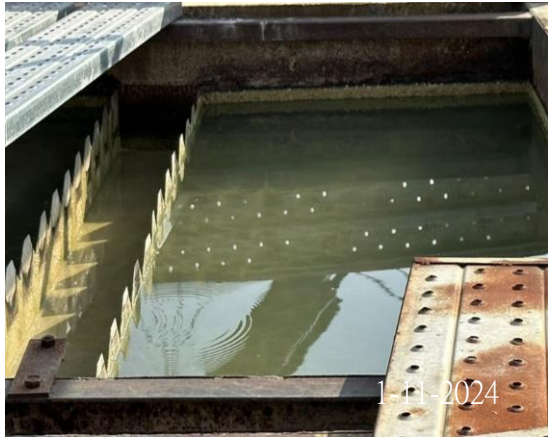
Photo 4 (Water quality of water treatment tank at 1/WSD)

- 3) In our investigation on 1 November 2024, the Contractor had implemented water quality mitigation measures (eg. sandbags were put within the site to avoid wastewater from leaking out of the site) and wastewater have been properly treated (Photo 2 & 4). No adverse water quality impact was observed during the site inspection (Photo 3). The water accumulation was observed on the 6/WSD site area (Photo 5). Based on the site observation, it is concluded that the exceedance of limit level was non-project related.

- 4) Nevertheless, the Contractor should continually fully implement the water mitigation measures as recommended in the implementation schedule for environmental mitigation measures in the EM&A Manual.

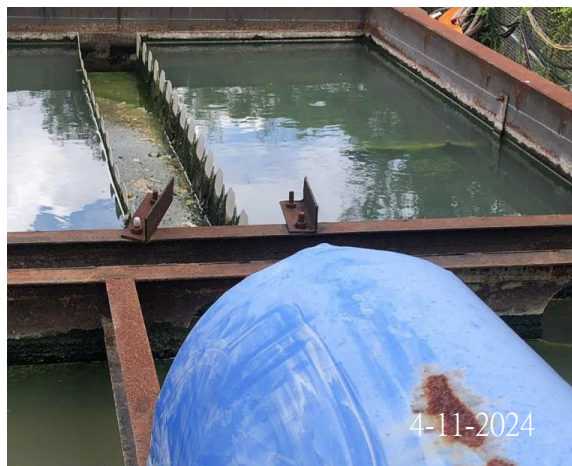
Photo 2 (Water quality of water treatment tank at 6/WSD)

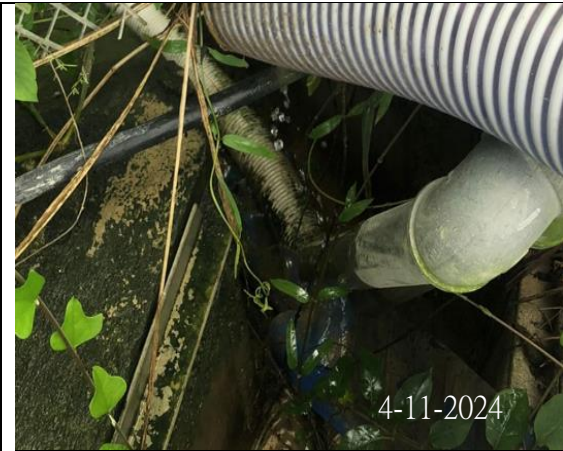
Photo 3 (Discharge point at 6/WSD)

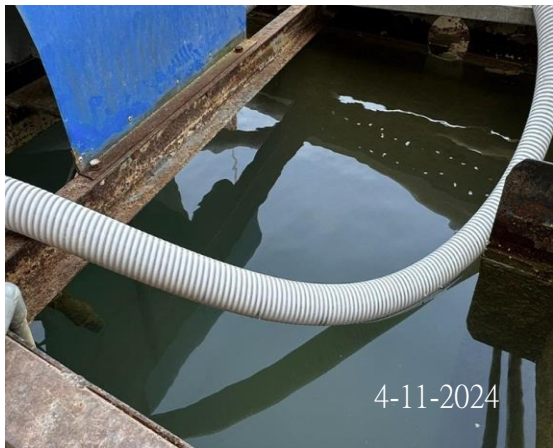
Photo 4 (Water quality of water treatment tank at 1/WSD)

- 3) In our investigation on 4 November 2024, the Contractor had implemented water quality mitigation measures (eg. sandbags were put within the site to avoid wastewater from leaking out of the site) and wastewater have been properly treated (Photo 2 & 4). No adverse water quality impact was observed during the site inspection (Photo 3). The water accumulation was observed on the 6/WSD site area (Photo 5). Based on the site observation, it is concluded that the exceedance of limit level was non-project related.

- 4) Nevertheless, the Contractor should continually fully implement the water mitigation measures as recommended in the implementation schedule for environmental mitigation measures in the EM&A Manual.

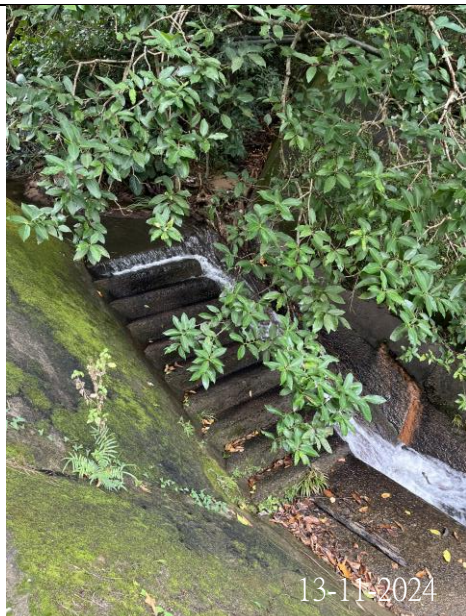
Photo 1 (C1)

- 1) According to the field observation from the Environmental Team (ET) on 13 November 2024, no polluted discharge made from construction site to the Control Station C1 (Photo 1), since C1 is a control station upstream of Impact Monitoring Station M1. Moreover, the construction of Logistic center (next to C1, Photo 5) have been completed in December 2020, no construction work was conducted nearby C1. In general, the condition of water at Control Station C1 was in order and no discharge from construction was observed (Photo 1). The water quality monitoring locations and contract site area are illustrated in Figure 1.

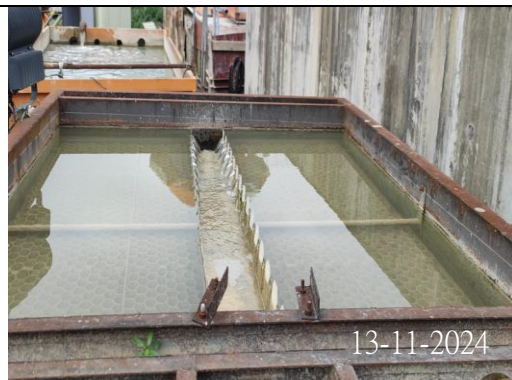
Photo 6 (Water quality of water treatment tank at 6/WSD)

- I. It is observed that chemical storage is uncovered. Contractor reminded to cover it.
  - II. It is observed that concrete materials is uncovered. Contractor reminded to cover it.
- 6) In our investigation on 13 November 2024, the Contractor had implemented water quality mitigation measures (eg. sandbags were put within the site to avoid wastewater from leaking out of the site) and wastewater have been properly treated (Photo 6 & 8). No adverse water quality impact was observed during the site inspection (Photo 7). Based on the site observation, it is concluded that the exceedance of limit level was non-project related.
- 7) Nevertheless, the Contractor should continually fully implement the water mitigation measures as recommended in the implementation schedule for environmental mitigation measures in the EM&A Manual.

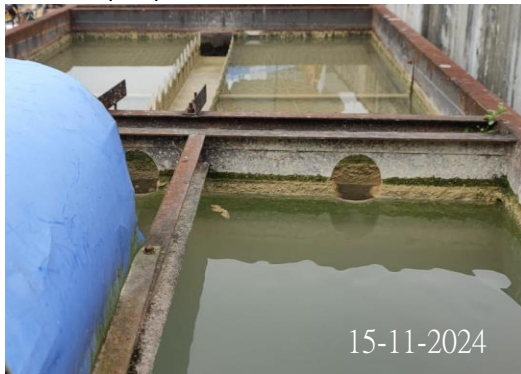
Photo 4 (Water quality of water treatment tank at 6/WSD)

mitigation measures (eg. sandbags were put within the site to avoid wastewater from leaking out of the site) and wastewater have been properly treated (Photo 4 & 6). No adverse water quality impact was observed during the site inspection (Photo 5). Based on the site observation, it is concluded that the exceedance of limit level was non-project related.

- 6) Nevertheless, the Contractor should continually fully implement the water mitigation measures as recommended in the implementation schedule for environmental mitigation measures in the EM&A Manual.

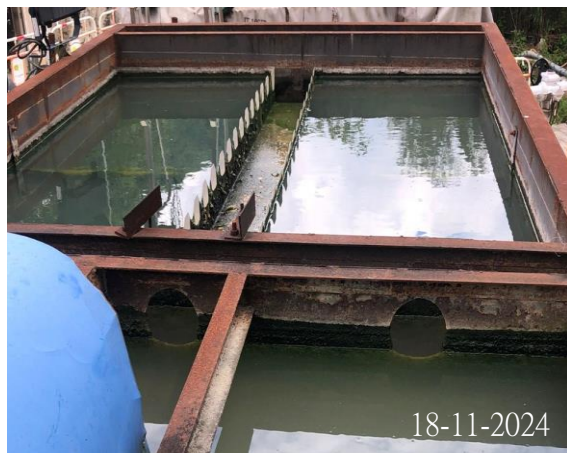
Photo 2 (Water quality of water treatment tank at 6/WSD)

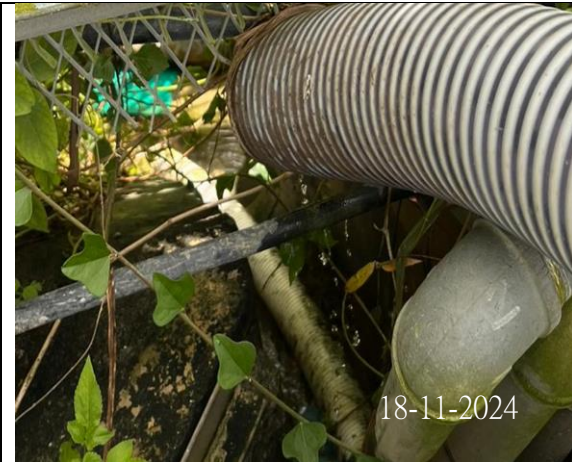
Photo 3 (Discharge point at 6/WSD)

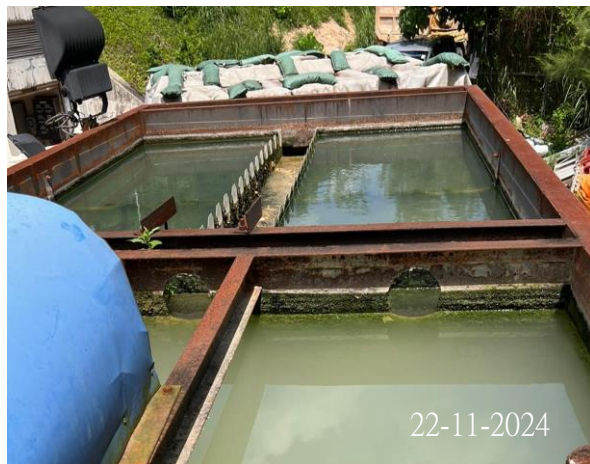
Photo 2 (Water quality of water treatment tank at 6/WSD)

In our investigation on 22 November 2024, the Contractor had implemented water quality mitigation measures (eg. sandbags were put within the site to avoid wastewater from leaking out of the site) and wastewater have been properly treated (Photo 2 & 4). No adverse water quality impact was observed during the site inspection (Photo 3). Based on the site observation, it is concluded that the exceedance of limit level was non-project related.

- 3) Nevertheless, the Contractor should continually fully implement the water mitigation measures as recommended in the implementation schedule for environmental mitigation measures in the EM&A Manual.

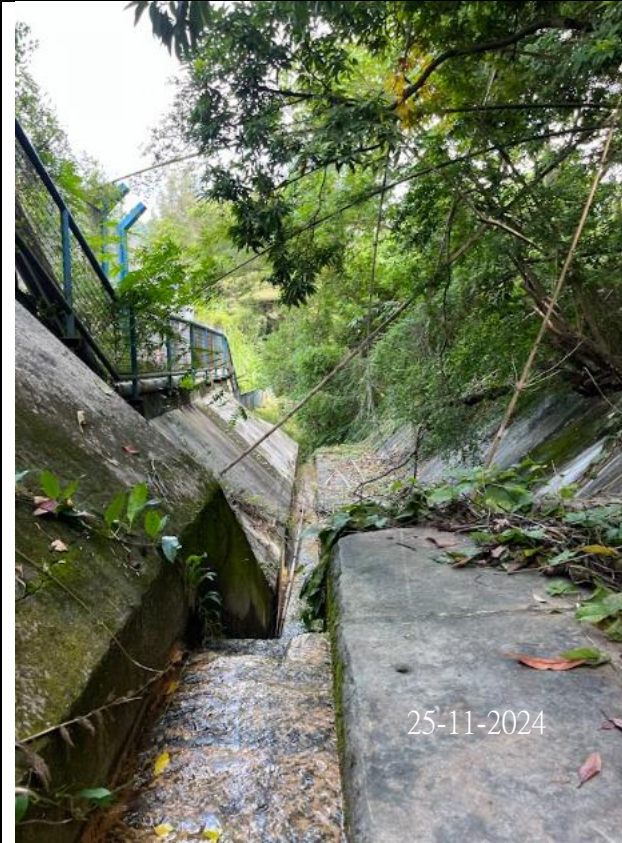
Photo 1 (M3)

- 1) According to the field observation from the Environmental Team (ET) on 25 November 2024, no polluted discharge was made from construction site to the Impact Monitoring Station M3 (Photo 1). In general, the condition of water at Impact Station M3 was in order and no discharge from construction was observed (Photo 1). The water quality monitoring locations and contract site area are illustrated in Figure 1.
- 2) Weekly site inspection by the Contractor and ET was conducted on 28 November 2024 to audit the site environmental performance. The overall condition was in compliance.

- 3) Nevertheless, the Contractor should continually fully implement the water mitigation measures as recommended in the implementation schedule for environmental mitigation measures in the EM&A Manual.

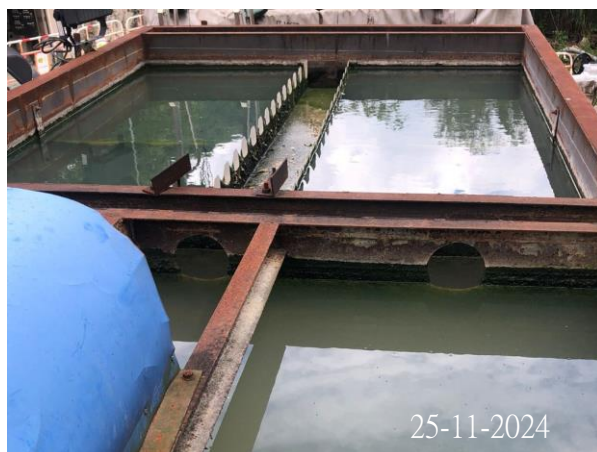
Photo 2 (Water quality of water treatment tank at 6/WSD)

In our investigation on 25 November 2024, the Contractor had implemented water quality mitigation measures (eg. sandbags were put within the site to avoid wastewater from leaking out of the site) and wastewater have been properly treated (Photo 2 & 4). No adverse water quality impact was observed during the site inspection (Photo 3). Based on the site observation, it is concluded that the exceedance of limit level was non-project related.

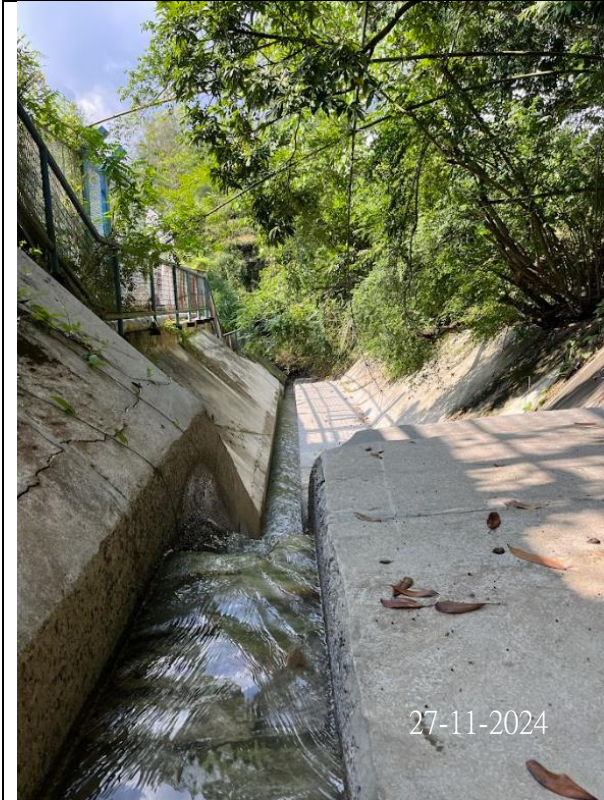
Photo 1 (M3)

- 1) According to the field observation from the Environmental Team (ET) on 27 November 2024, no polluted discharge was made from construction site to the Impact Monitoring Station M3 (Photo 1). In general, the condition of water at Impact Station M3 was in order and no discharge from construction was observed (Photo 1). The water quality monitoring locations and contract site area are illustrated in Figure 1.
- 2) Weekly site inspection by the Contractor and ET was conducted on 28 November 2024 to audit the site environmental performance. The overall condition was in compliance.

- 3) Nevertheless, the Contractor should continually fully implement the water mitigation measures as recommended in the implementation schedule for environmental mitigation measures in the EM&A Manual.

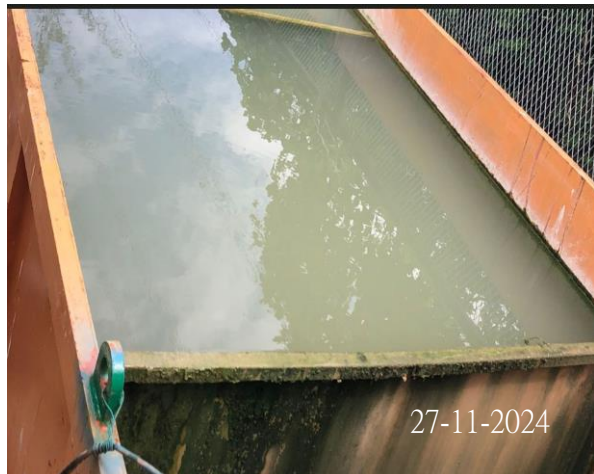
Photo 2 (Water quality of water treatment tank at 6/WSD)

In our investigation on 27 November 2024, the Contractor had implemented water quality mitigation measures (eg. sandbags were put within the site to avoid wastewater from leaking out of the site) and wastewater have been properly treated (Photo 2 & 4). No adverse water quality impact was observed during the site inspection (Photo 3). Based on the site observation, it is concluded that the exceedance of limit level was non-project related.

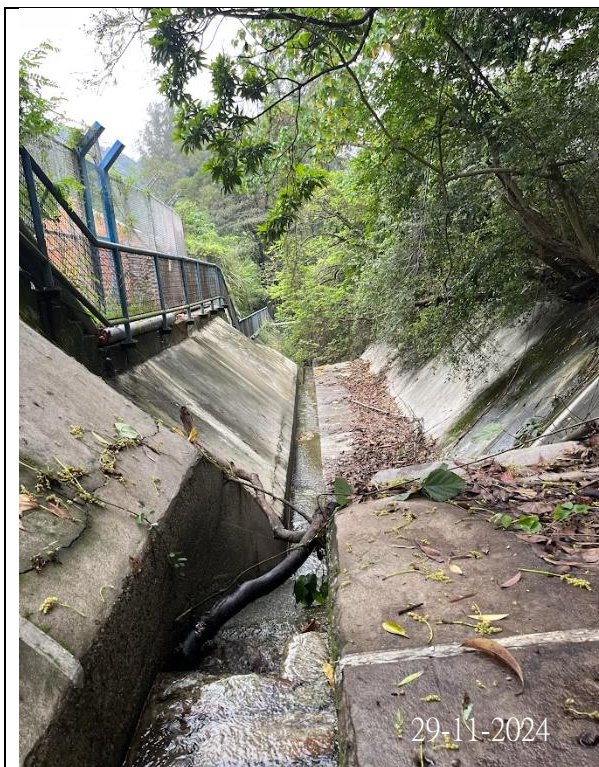
Photo 1 (M3)

- 1) According to the field observation from the Environmental Team (ET) on 29 November 2024, no polluted discharge was made from construction site to the Impact Monitoring Station M3 (Photo 1). In general, the condition of water at Impact Station M3 was in order and no discharge from construction was observed (Photo 1). The water quality monitoring locations and contract site area are illustrated in Figure 1.
- 2) Weekly site inspection by the Contractor and ET was conducted on 28 November 2024 to audit the site environmental performance. The overall condition was in compliance.

- 3) Nevertheless, the Contractor should continually fully implement the water mitigation measures as recommended in the implementation schedule for environmental mitigation measures in the EM&A Manual.

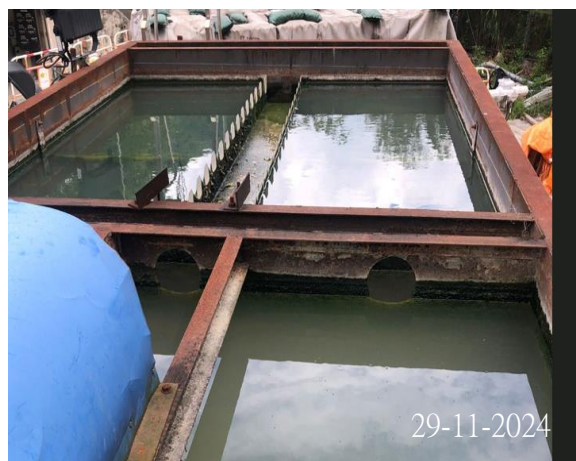
Photo 2 (Water quality of water treatment tank at 6/WSD)

In our investigation on 29 November 2024, the Contractor had implemented water quality mitigation measures (eg. sandbags were put within the site to avoid wastewater from leaking out of the site) and wastewater have been properly treated (Photo 2 & 4). No adverse water quality impact was observed during the site inspection (Photo 3). Based on the site observation, it is concluded that the exceedance of limit level was non-project related.
