**CONTRACT NO. 1/WSD/19 & 6/WSD/21**

**IN-SITU REPROVISIONING OF SHA TIN WATER  
TREATMENT WORKS (SOUTH WORKS) – WATER TREATMENT WORKS AND  
ANCILLARY FACILITIES  
Environmental Permit EP-494/2015**

**In-Situ Re provisioning of Sha Tin Water Treatment Works (South Works) – Water Treatment Works and Ancillary Facilities  
Environmental Permit EP-494/2015  
Submission of 106<sup>th</sup> monthly EM&A Report**

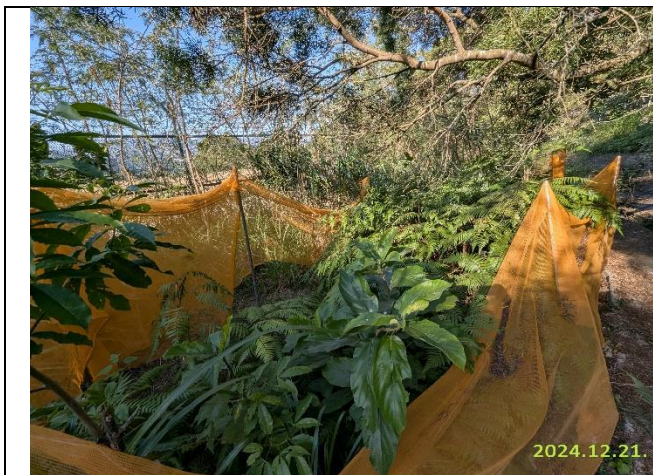
Photo 1. Protection zone of the first batch of *Cibotium barometz* has been established. Weeds and the invasive *Leucaena leucocephala* (銀合歡) shall be removed and packed properly during weeding.

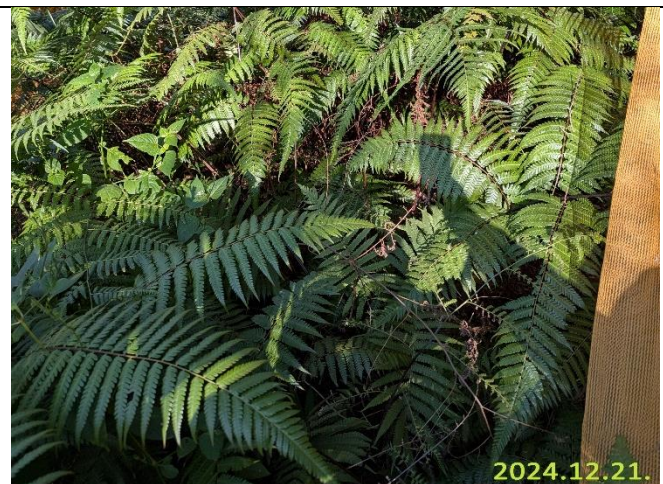
Photo 2. *Cibotium barometz* growing vigorously in sheltered condition.

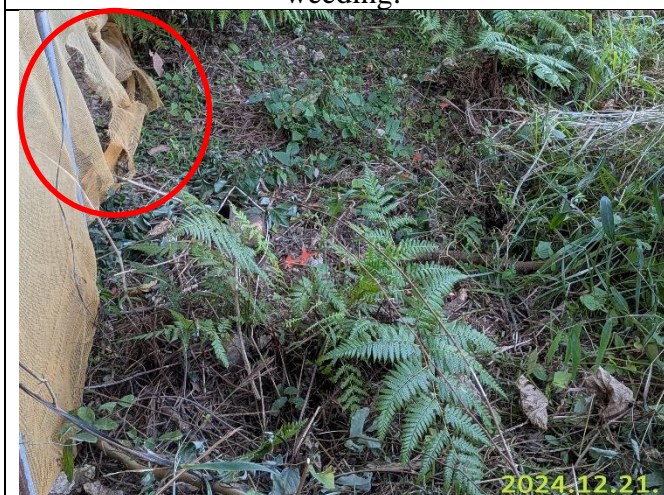
Photo 3. Second batch of *Cibotium barometz*, where the net is slightly broken.

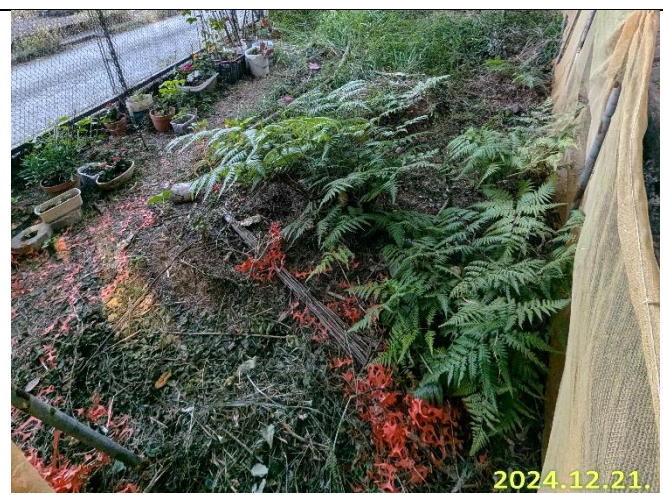
Photo 4. *Cibotium barometz* in fair condition. It is more exposed where light-demanding weed gradually takes over the planting site.

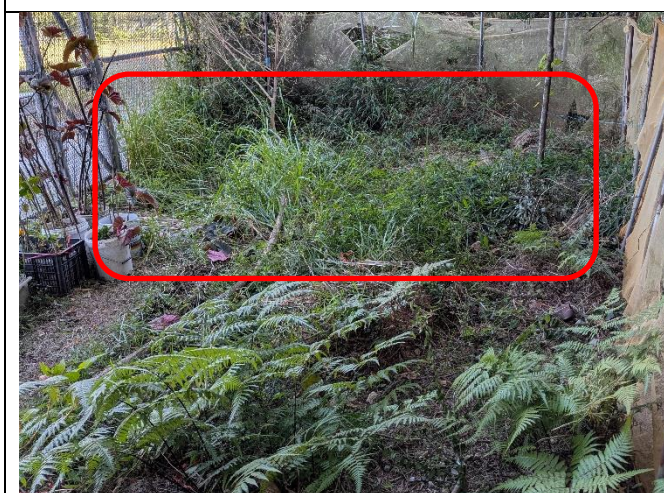
Photo 5. Weed growing around the second patch of *Cibotium barometz*

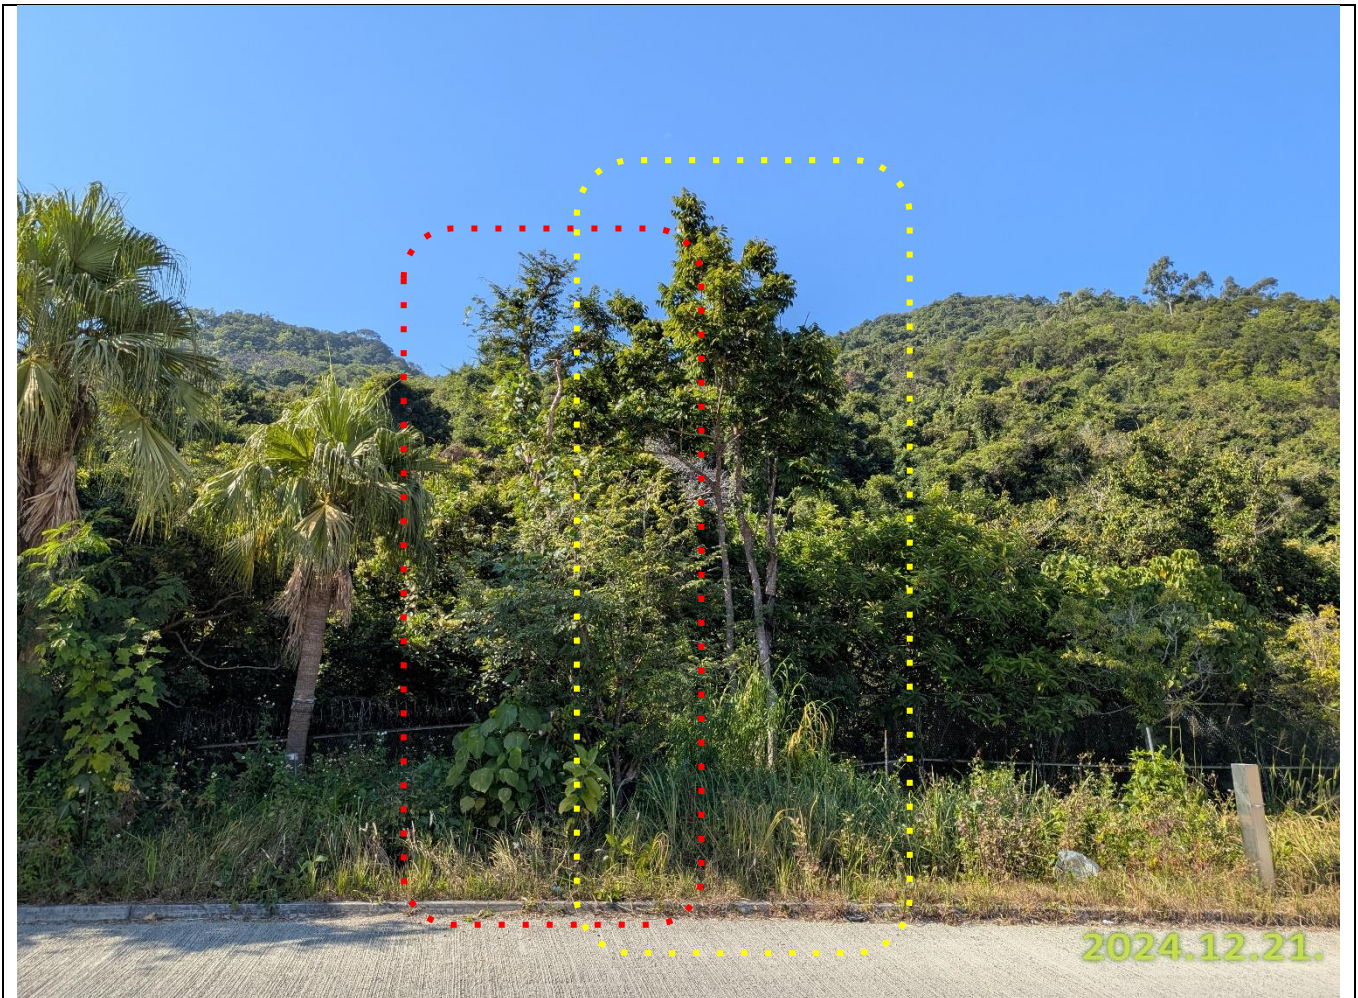
Photo 7. Transplanted Incense Tree (*Aquilaria sinensis*) – TA327 (red); and Ailanthus (*Ailanthus fordii*) – TA572 (yellow). Weeds grew vigorously around the two trees.

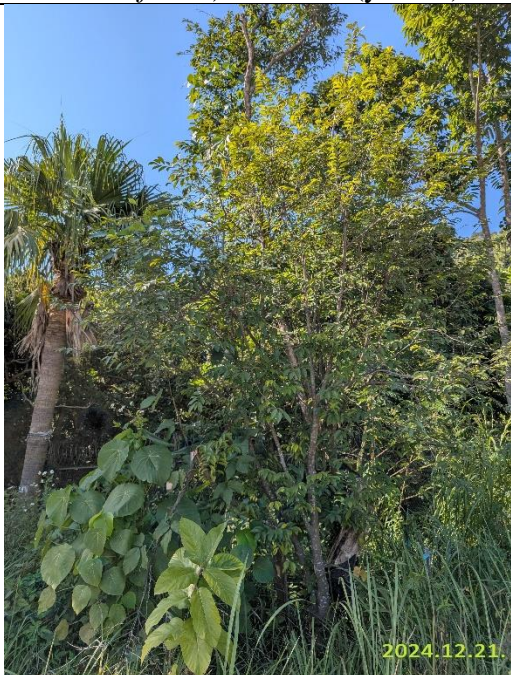
Photo 8. Close-up of TA327 (*Aquilaria sinensis*). Protection zone shall be rectified.

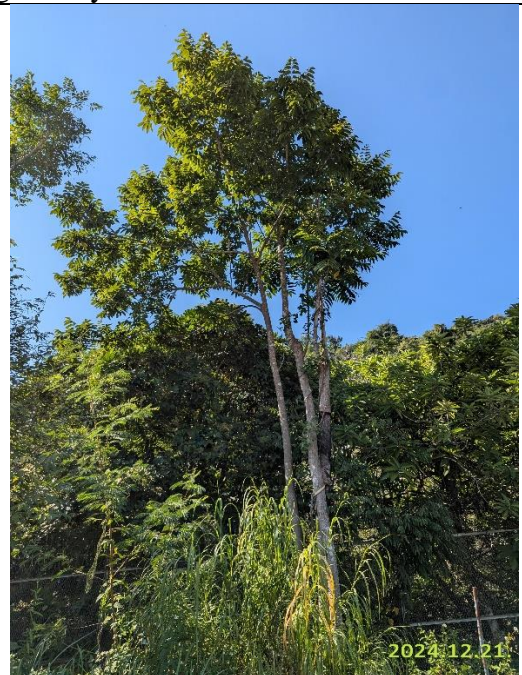
Photo 9. TA572 (*Ailanthus fordii*) was found vigorous and in generally good condition. Protection zone shall be rectified.

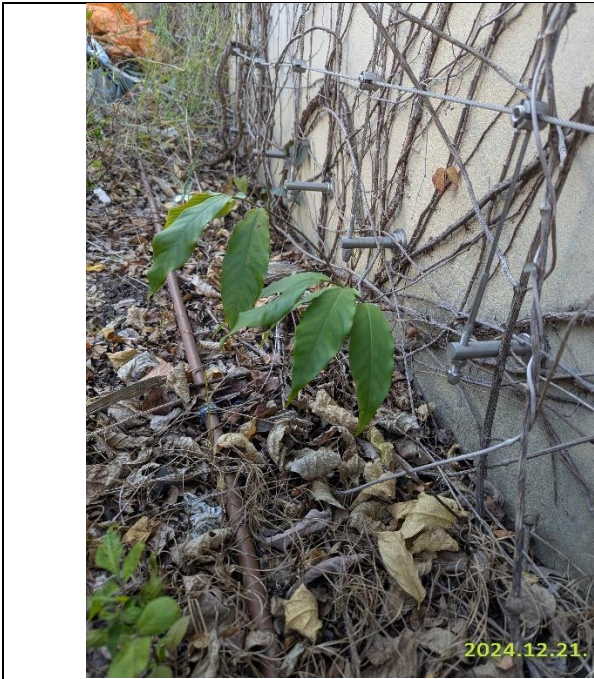
Photo 10. No construction material or equipment should put near the *Desmos chinensis*. Rubbish should be cleared.

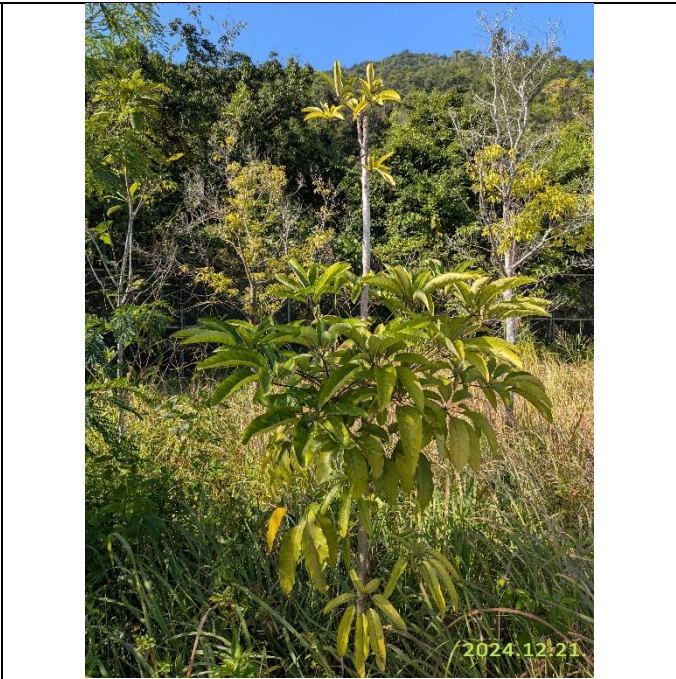
Photo 11. *Schefflera heptaphylla* as compensatory planting of TA326; selective weeding around the planted individual suggested.

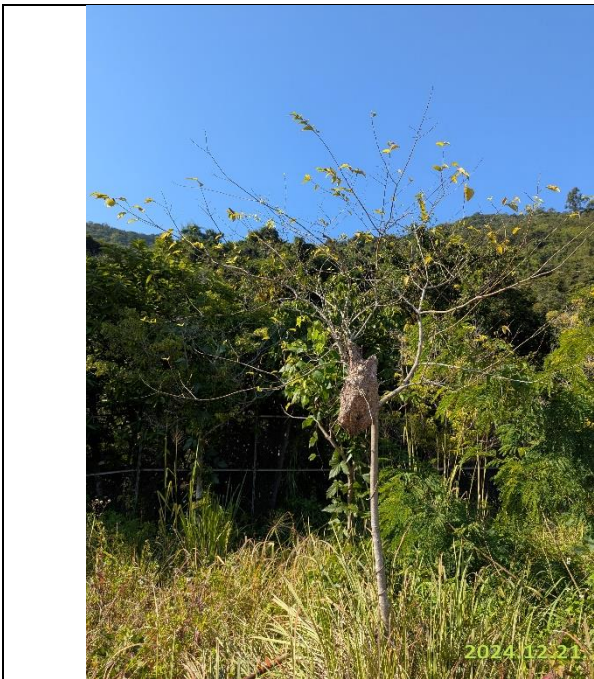
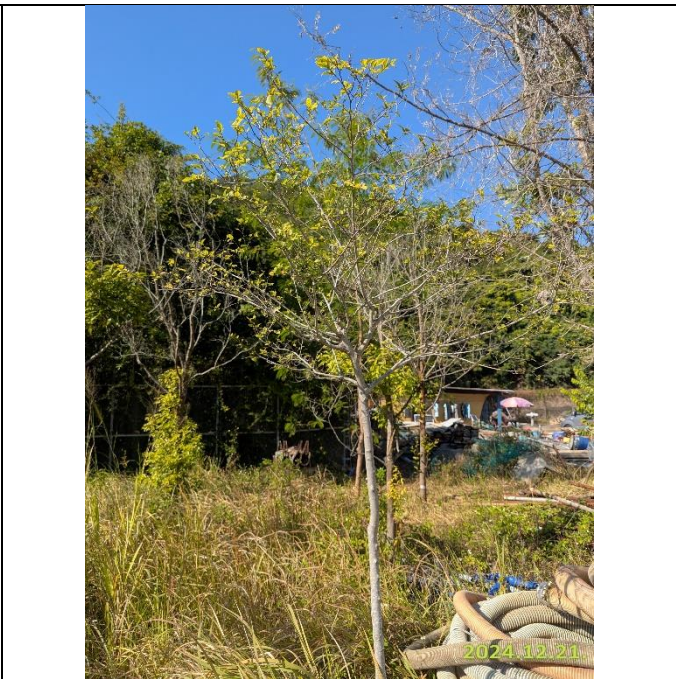
Photo 12 and 13. The two exotic *Syzygium jambos* (mis-treated as the native *Syzygium levinei*) were replaced by another native tree species *Celtis sinensis* (due to market availability) as compensatory planting of TA326. Note: *Celtis sinensis* is a deciduous species. Weeds grew vigorously around two trees; selective weeding around the planted individual suggested.

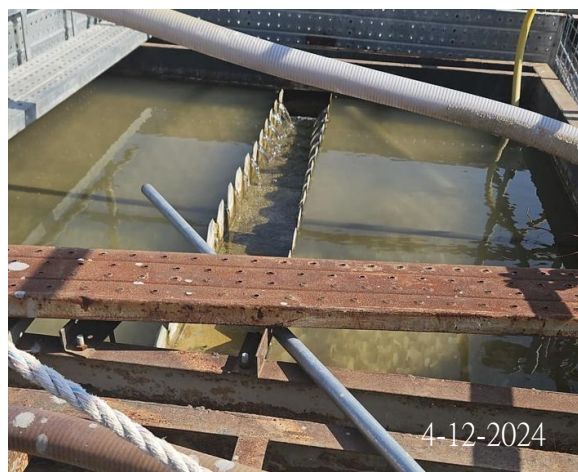
Photo 4 (Water quality of water treatment tank at 1/WSD)

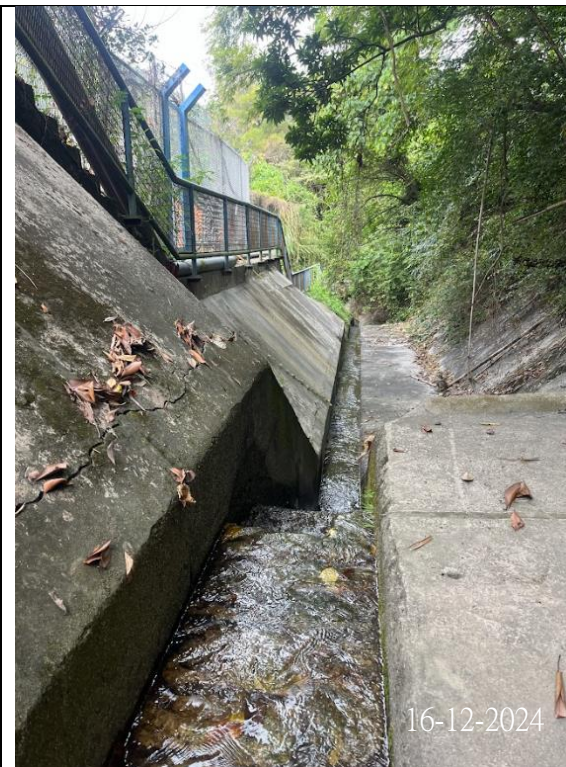
Photo 1 (M3)

- I. It is observed that chemical materials are uncovered. Contractor reminded to cover it.
- 3) In our investigation on 16 December 2024, the Contractor had implemented water quality mitigation measures (eg. sandbags were put within the site to avoid wastewater from leaking out of the site) and wastewater have been properly treated (Photo 2 & 4). No adverse water quality impact was observed during the site inspection (Photo 3). Based on the site observation, it is concluded that the exceedance of limit level was non-project related.
- 4) Nevertheless, the Contractor should continually fully implement the water mitigation measures as recommended in the implementation schedule for environmental mitigation measures in the EM&A Manual.
