EP-510/2016 – Police Facilities in Kong Nga Po

**Service Contract No. NDO 07/2019
Environmental Team for Site Formation and
Infrastructure Works for Police Facilities in
Kong Nga Po**

**Monthly Environmental Monitoring and
Audit Report for May 2024
(Version 1.0)**

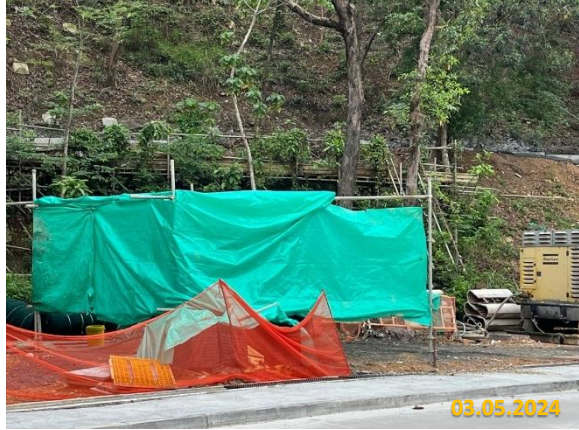
Ref*	Proposed Construction Method**	Location/Working Period	Anticipated Major Impacts	Recommended Mitigation Measures	Photo Records (Partial)
EIA 3.91; EM&A Log 2.2	Slope Upgrading Works	Kong Nga Po Main Site Kong Nga Po Road	Dust impact from soil nail works	<ul style="list-style-type: none"> • Three side enclosure with top shelter for cement mixing works • Water spraying on soil nailing works • Dusty materials exceeding 20 bags shall be stored in area sheltered on top and the three sides or covered entirely by impervious sheeting

<p>By sub-contractor at KNP Road</p>
EIA 5.6.1.2; EM&A Log 4.2			Water	<ul style="list-style-type: none"> • Deploy desilting/sedimentation devices for wastewater treatment prior to discharge • Establish soil berm with retention pit to control water outflow

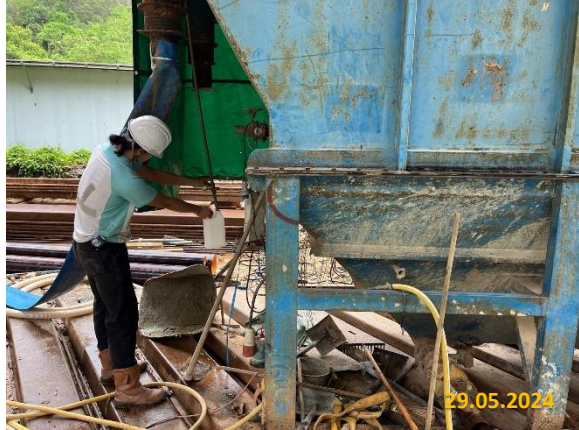
<p>By main contractor at KNP Road</p>

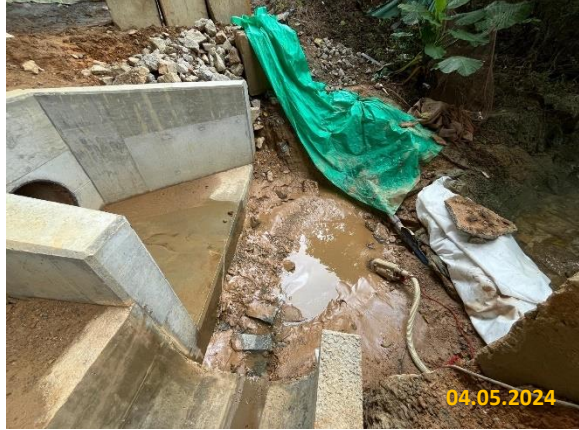
Ref*	Proposed Construction Method**	Location/Working Period	Anticipated Major Impacts	Recommended Mitigation Measures	Photo Records (Partial)
	(Cont') Slope Upgrading Works	(Cont') Kong Nga Po Main Site Kong Nga Po Road

<p>By main contractor at KNP Road</p>
EIA 4.4.6; EM&A Log 3.2			Noise	<ul style="list-style-type: none"> Regular inspection and maintenance of plant and equipment in good condition

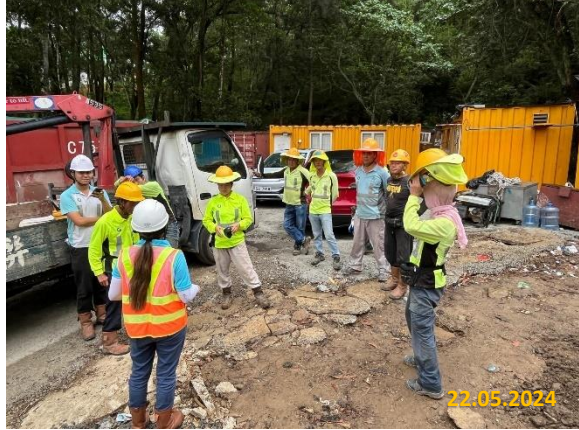
Ref*	Proposed Construction Method**	Location/Working Period	Anticipated Major Impacts	Recommended Mitigation Measures	Photo Records (Partial)
EIA 10.11, EM&A Log 9.4	(Cont') Slope Upgrading Works	(Cont') Kong Nga Po Main Site Kong Nga Po Road	Ecology Concern	<ul style="list-style-type: none"> • Provide training to frontline workers for the conservative species • Provision of protective fence for the conservative species • Regular inspection for concerned vegetation

<p>22.05.2024</p> <p>By main contractor at KNP Main Site</p>
EIA Table 10.11 EM&A Table 9.1			Landscape and visual impact	<ul style="list-style-type: none"> • Properly fenced off the conservative species • Preservation of existing trees will be undertaken in accordance with DEVB TC(W) 7/2015 and Guidelines for Tree Risk Assessment and Management Arrangement

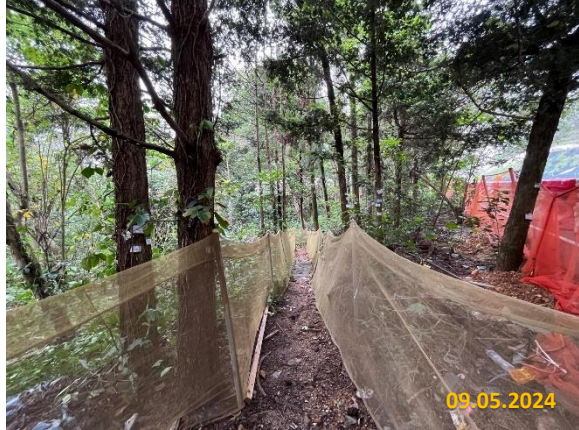
<p>09.05.2024</p> <p>By main contractor at KNP Road</p>

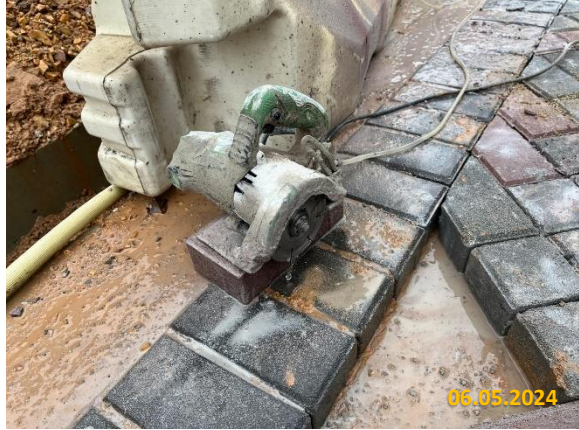
Ref*	Proposed Construction Method**	Location/Working Period	Anticipated Major Impacts	Recommended Mitigation Measures	Photo Records (Partial)
EIA 3.91; EM&A Log 2.2	Road and Associated Works	Kong Nga Po Main Site Kong Nga Po Road	Air Dust impact from excavation activities and earth moving	<ul style="list-style-type: none"> • Use of regular water spraying (once every 1.25 hours or 8 times per day) at all active works area exposed site surfaces and unpaved roads, particularly during dry weather • Regular inspection and maintenance of plant and equipment in good condition • Regularly clean up stockpiles and debris to avoid accumulation of materials

<p>By sub-contractor at KNP Road</p>
EIA 5.6.1.2; EM&A Log 4.2			Water	<ul style="list-style-type: none"> • Provide desilting/sedimentation devices for wastewater treatment before discharge

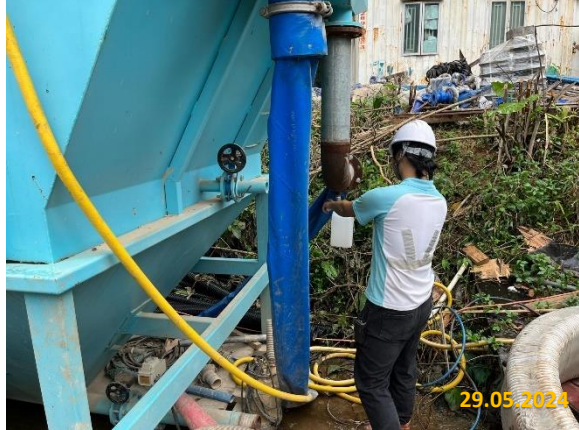
<p>By main contractor at KNP Road</p>

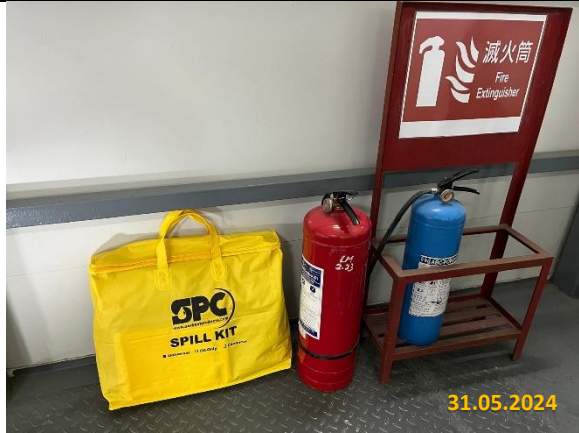
Ref*	Proposed Construction Method**	Location/Working Period	Anticipated Major Impacts	Recommended Mitigation Measures	Photo Records (Partial)
EIA 4.4.6; EM&A Log 3.2	(Con't) Road and Associated Works	(Con't) Kong Nga Po Main Site Kong Nga Po Road	Noise from roadworks	<ul style="list-style-type: none"> Enclose the noisy part of machineries with noise isolating mats during hard surface breaking / for operating plants 	N/A (No breaking works in reporting period)
EIA 7.5.1.4; EM&A Log 6.2			Chemical / Chemical Waste	<ul style="list-style-type: none"> Drip tray and chemical spillage kit shall be provided on site

<p>By main contractor at KNP Road</p>

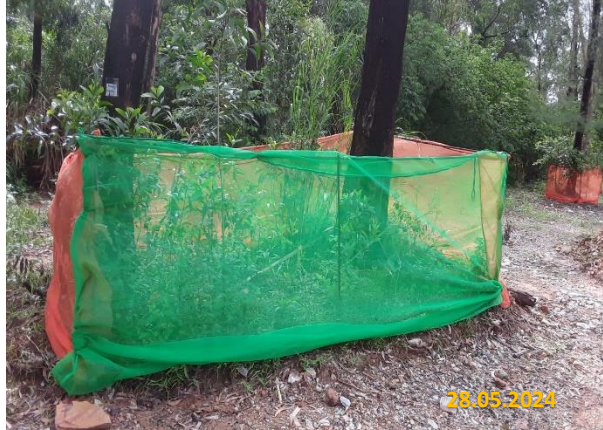
Ref*	Proposed Construction Method**	Location/Working Period	Anticipated Major Impacts	Recommended Mitigation Measures	Photo Records (Partial)
EIA Table 10.11 EM&A Table 9.1	(Con't) Road and Associated Works	(Con't) Kong Nga Po Main Site Kong Nga Po Road	Landscape and visual impact	<ul style="list-style-type: none"> • Properly fenced off the conservative species • Properly implement temporary traffic arrangement which control construction area to minimize landscape and visual impacts

<p data-bbox="1451 869 1848 896">By main contractor at KNP Road</p>
