**EP-510/2016 – Police Facilities in Kong Nga Po**

**Service Contract No. NDO 07/2019  
Environmental Team for Site Formation and  
Infrastructure Works for Police Facilities in  
Kong Nga Po**

**Monthly Environmental Monitoring and  
Audit Report for June 2024  
(Version 1.0)**

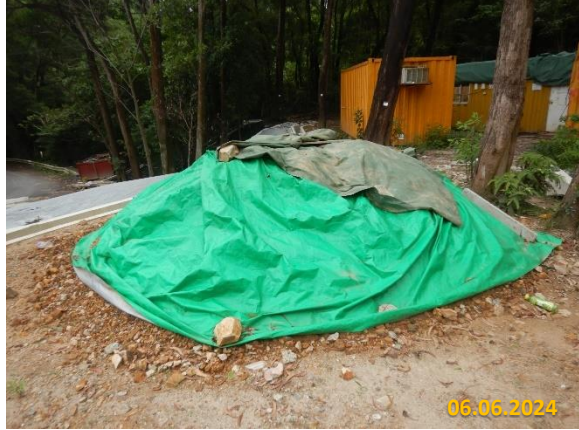
Ref*	Proposed Construction Method**	Location/Working Period	Anticipated Major Impacts	Recommended Mitigation Measures	Photo Records (Partial)
EIA 3.91; EM&A Log 2.2	Slope Upgrading Works	Kong Nga Po Road	Dust impact from soil nail works	<ul style="list-style-type: none"> <li>• Three side enclosure with top shelter for cement mixing works</li> <li>• Water spraying on soil nailing works</li> <li>• Dusty materials exceeding 20 bags shall be stored in area sheltered on top and the three sides or covered entirely by impervious sheeting</li> </ul>

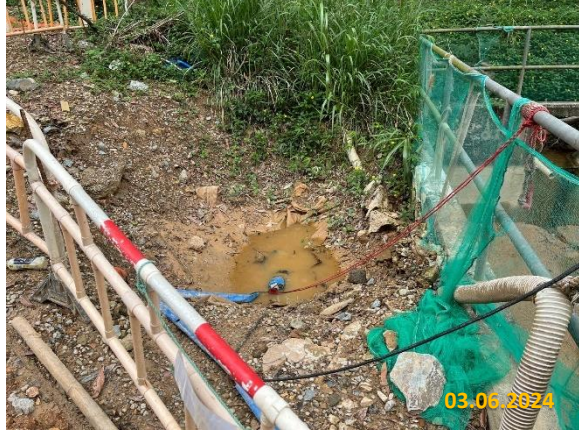
<p data-bbox="1451 1353 1848 1385">By main contractor at KNP Road</p>

<p data-bbox="1451 869 1825 901">By sub-contractor at KNP Road</p>
EIA 5.6.1.2; EM&A Log 4.2			Water	<ul style="list-style-type: none"> <li>• Deploy desilting/sedimentation devices for wastewater treatment prior to discharge</li> <li>• Establish soil berm with retention pit to control water outflow</li> </ul>

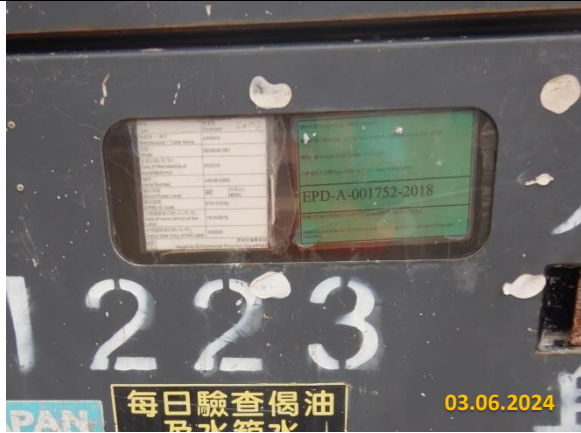
Ref*	Proposed Construction Method**	Location/Working Period	Anticipated Major Impacts	Recommended Mitigation Measures	Photo Records (Partial)
EIA 4.4.6; EM&A Log 3.2	(Cont') Slope Upgrading Works	(Cont') Kong Nga Po Road	Noise	<ul style="list-style-type: none"> <li>Regular inspection and maintenance of plant and equipment in good condition</li> </ul>

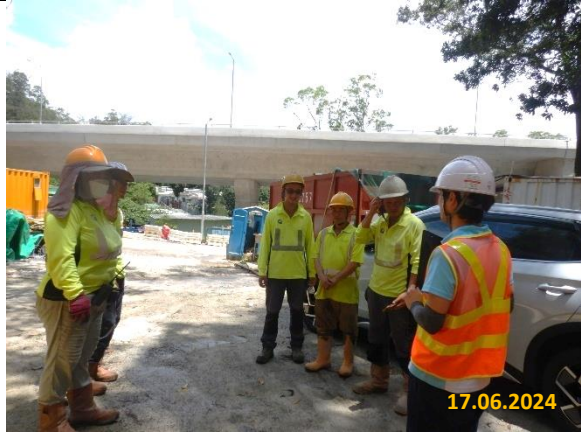
<p>By main contractor at KNP Main Site</p>

<p>By sub-contractor at KNP Road</p>
EIA 10.11, EM&A Log 9.4			Ecology Concern	<ul style="list-style-type: none"> <li>Provide training to frontline workers for the conservative species</li> <li>Provision of protective fence for the conservative species</li> <li>Regular inspection for concerned vegetation</li> </ul>

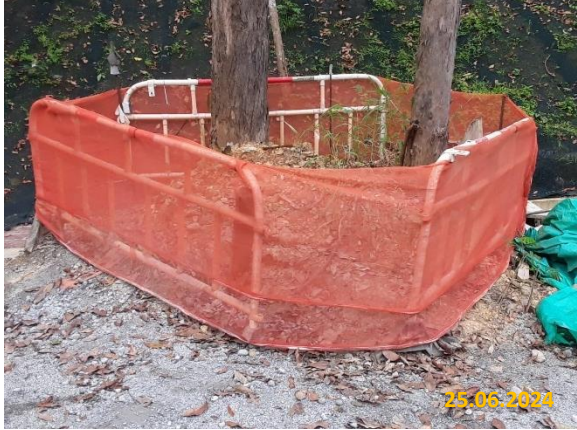
Ref*	Proposed Construction Method**	Location/Working Period	Anticipated Major Impacts	Recommended Mitigation Measures	Photo Records (Partial)
EIA Table 10.11 EM&A Table 9.1	(Cont') Slope Upgrading Works	(Cont') Kong Nga Po Road	Landscape and visual impact	<ul style="list-style-type: none"> <li>• Properly fenced off the conservative species</li> <li>• Preservation of existing trees will be undertaken in accordance with DEVB TC(W) 7/2015 and Guidelines for Tree Risk Assessment and Management Arrangement</li> </ul>

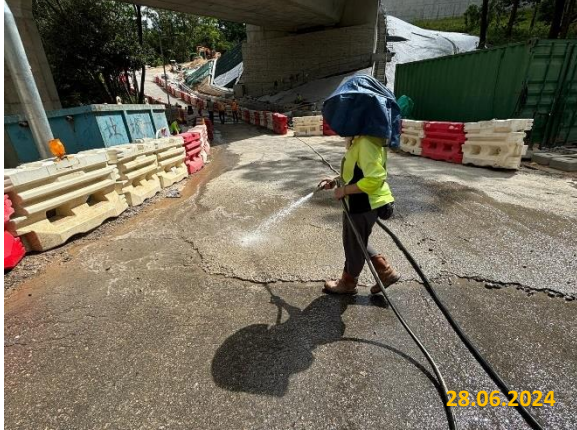
<p data-bbox="1453 1350 1830 1382">By sub-contractor at KNP Road</p>

<p data-bbox="1453 866 1845 898">By main contractor at KNP Road</p>
EIA 3.91; EM&A Log 2.2	Road and Associated Works	Kong Nga Po Road	Air Dust impact from excavation activities and earth moving	<ul style="list-style-type: none"> <li>• Use of regular water spraying (once every 1.25 hours or 8 times per day) at all active works area exposed site surfaces and unpaved roads, particularly during dry weather</li> <li>• Regular inspection and maintenance of plant and equipment in good condition</li> <li>• Regularly clean up stockpiles and debris to avoid accumulation of materials</li> </ul>

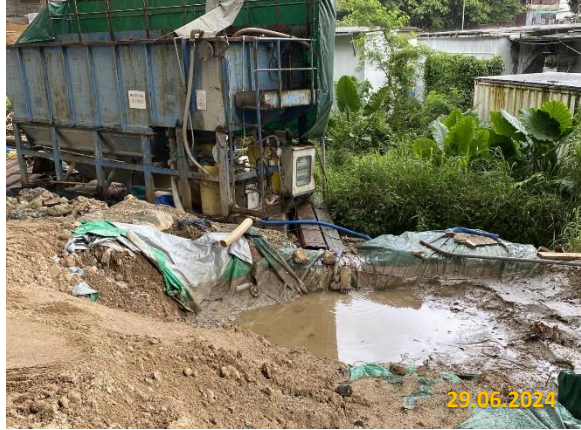
<p>By main contractor at KNP Road</p>
EIA 4.4.6; EM&A Log 3.2			Noise from roadworks	<ul style="list-style-type: none"> <li>Enclose the noisy part of machineries with noise isolating mats during hard surface breaking / for operating plants</li> </ul>	N/A (No breaking works in reporting period)

Ref*	Proposed Construction Method**	Location/Working Period	Anticipated Major Impacts	Recommended Mitigation Measures	Photo Records (Partial)
EIA 5.6.1.2; EM&A Log 4.2	(Con't) Road and Associated Works	(Con't) Kong Nga Po Road	Water	<ul style="list-style-type: none"> <li>Provide desilting/sedimentation devices for wastewater treatment before discharge</li> </ul>

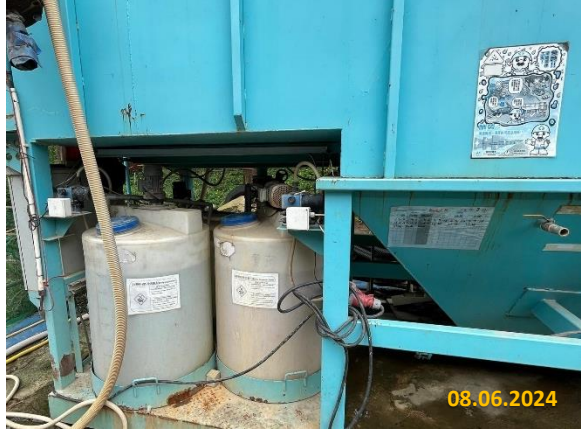
Ref*	Proposed Construction Method**	Location/Working Period	Anticipated Major Impacts	Recommended Mitigation Measures	Photo Records (Partial)
EIA 7.5.1.4; EM&A Log 6.2	(Con't) Road and Associated Works	(Con't) Kong Nga Po Road	Chemical / Chemical Waste	<ul style="list-style-type: none"> <li>Drip tray and chemical spillage kit shall be provided on site</li> </ul>
