**EP-510/2016 – Police Facilities in Kong Nga Po**

**Service Contract No. NDO 07/2019  
Environmental Team for Site Formation and  
Infrastructure Works for Police Facilities in  
Kong Nga Po**

**Monthly Environmental Monitoring and  
Audit Report for July 2024  
(Version 1.0)**

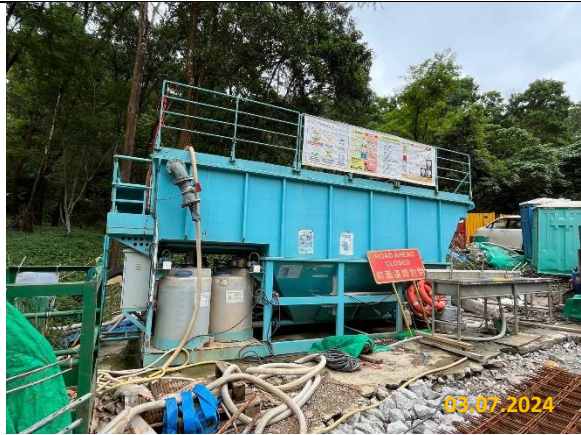
Ref*	Proposed Construction Method**	Location/Working Period	Anticipated Major Impacts	Recommended Mitigation Measures	Photo Records (Partial)
EIA 3.91; EM&A Log 2.2	Slope Upgrading Works	Kong Nga Po Road	Dust impact from soil nail works	<ul style="list-style-type: none"> <li>• Three side enclosure with top shelter for cement mixing works</li> <li>• Water spraying on soil nailing works</li> <li>• Dusty materials exceeding 20 bags shall be stored in area sheltered on top and the three sides or covered entirely by impervious sheeting</li> </ul>	N/A (No dust generating works in reporting period)
EIA 5.6.1.2; EM&A Log 4.2			Water	<ul style="list-style-type: none"> <li>• Deploy desilting/sedimentation devices for wastewater treatment prior to discharge</li> <li>• Establish soil berm with retention pit to control water outflow</li> </ul>

<p data-bbox="1451 1353 1845 1386">By main contractor at KNP Road</p>

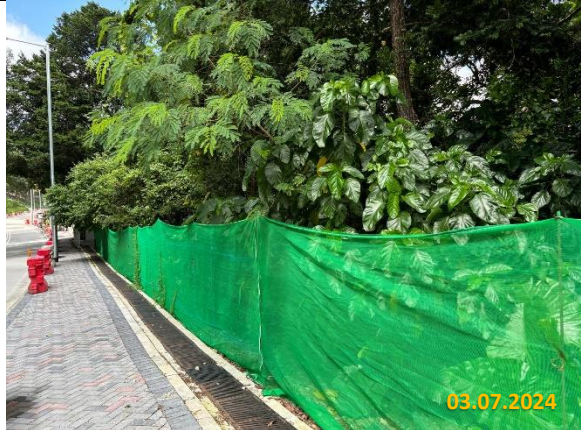
<p>By sub-contractor at KNP Road</p>
EIA 10.11, EM&A Log 9.4			Ecology Concern	<ul style="list-style-type: none"> <li>Provide training to frontline workers for the conservative species</li> <li>Provision of protective fence for the conservative species</li> <li>Regular inspection for concerned vegetation</li> </ul>

<p>By main contractor at KNP Main Site</p>

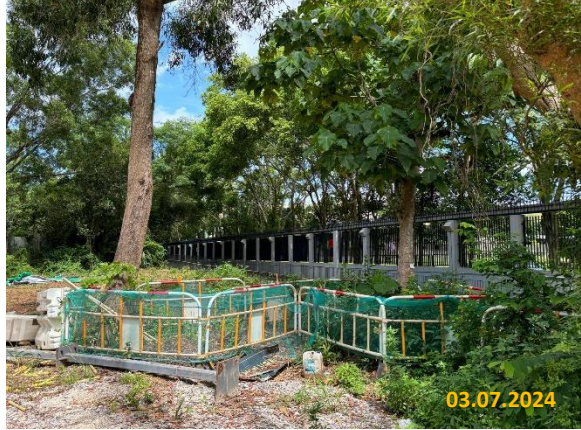
Ref*	Proposed Construction Method**	Location/Working Period	Anticipated Major Impacts	Recommended Mitigation Measures	Photo Records (Partial)
EIA Table 10.11 EM&A Table 9.1	(Cont') Slope Upgrading Works	(Cont') Kong Nga Po Road	Landscape and visual impact	<ul style="list-style-type: none"> <li>• Properly fenced off the conservative species</li> <li>• Preservation of existing trees will be undertaken in accordance with DEVB TC(W) 7/2015 and Guidelines for Tree Risk Assessment and Management Arrangement</li> </ul>

<p data-bbox="1451 866 1845 898">By main contractor at KNP Road</p>
EIA 3.91; EM&A Log 2.2	Road and Associated Works	Kong Nga Po Road	Air Dust impact from excavation activities and earth moving	<ul style="list-style-type: none"> <li>• Use of regular water spraying (once every 1.25 hours or 8 times per day) at all active works area exposed site surfaces and unpaved roads, particularly during dry weather</li> <li>• Regular inspection and maintenance of plant and equipment in good condition</li> <li>• Regularly clean up stockpiles and debris to avoid accumulation of materials</li> </ul>

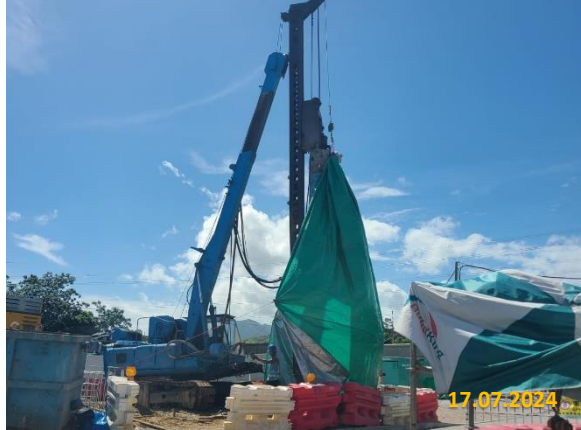
<p data-bbox="1451 1350 1830 1382">By sub-contractor at KNP Road</p>

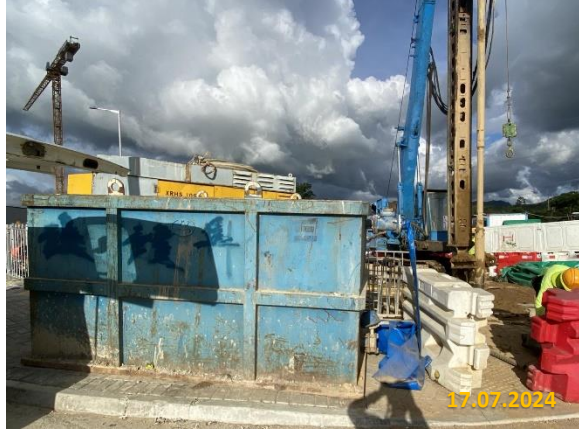
Ref*	Proposed Construction Method**	Location/Working Period	Anticipated Major Impacts	Recommended Mitigation Measures	Photo Records (Partial)
EIA 5.6.1.2; EM&A Log 4.2	(Con't) Road and Associated Works	(Con't) Kong Nga Po Road	Water	<ul style="list-style-type: none"> <li>Provide desilting/sedimentation devices for wastewater treatment before discharge</li> </ul>

<p>By main contractor at KNP Road</p>
EIA 4.4.6; EM&A Log 3.2			Noise from roadworks	<ul style="list-style-type: none"> <li>Enclose the noisy part of machineries with noise isolating mats during hard surface breaking / for operating plants</li> </ul>	N/A (No breaking works in reporting period)

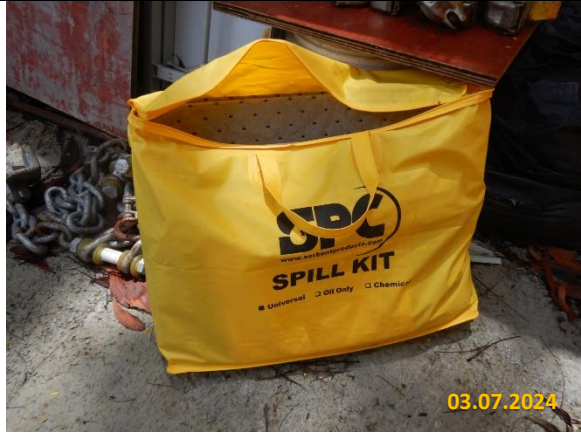
Ref*	Proposed Construction Method**	Location/Working Period	Anticipated Major Impacts	Recommended Mitigation Measures	Photo Records (Partial)
EIA 7.5.1.4; EM&A Log 6.2	(Con't) Road and Associated Works	(Con't) Kong Nga Po Road	Chemical / Chemical Waste	<ul style="list-style-type: none"> <li>• Drip tray and chemical spillage kit shall be provided on site</li> </ul>

<p>03.07.2024</p> <p>By main contractor at KNP Road</p>
EIA Table 10.11 EM&A Table 9.1			Landscape and visual impact	<ul style="list-style-type: none"> <li>• Properly fenced off the conservative species</li> <li>• Properly implement temporary traffic arrangement which control construction area to minimize landscape and visual impacts</li> </ul>
