EP-510/2016 – Police Facilities in Kong Nga Po

**Service Contract No. NDO 07/2019
Environmental Team for Site Formation and
Infrastructure Works for Police Facilities in
Kong Nga Po**

**Monthly Environmental Monitoring and
Audit Report for September 2024
(Version 1.0)**

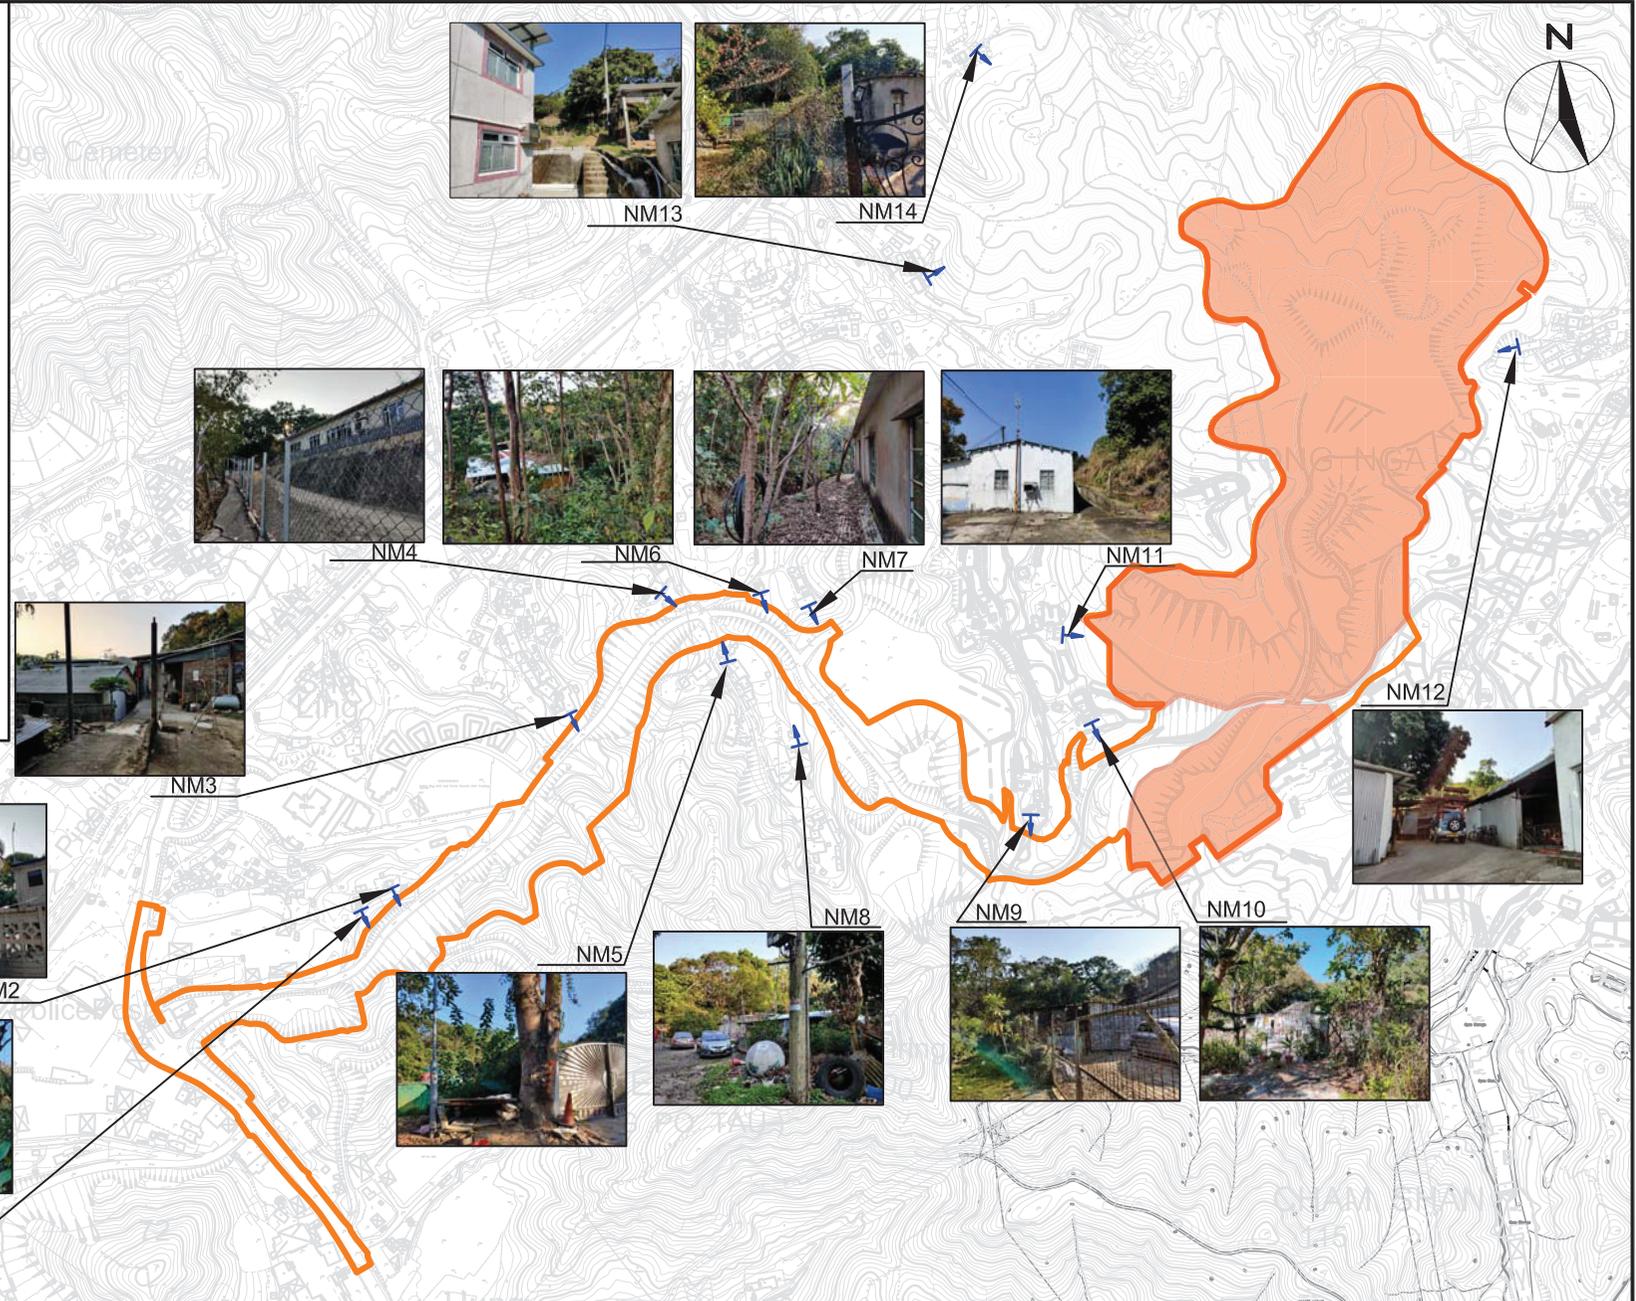
Noise Monitoring Stations	
ID	Description
NM1	Village House, Sha Ling
NM2	Village House, Sha Ling
NM3	Village House No. 248, Sha Ling
NM4	Village House, Sha Ling
NM5	Village House No. 270, Sha Ling
NM6	Village House, Sha Ling
NM7	Village House, Sha Ling
NM8	Village House, Sha Ling
NM9	Village House, Kong Nga Po
NM10	Village House, Kong Nga Po
NM11	Village House, Kong Nga Po
NM12	Village House, Kong Nga Po
NM13	Village House, Kong Nga Po
NM14	Village House, near Man Kam To Road

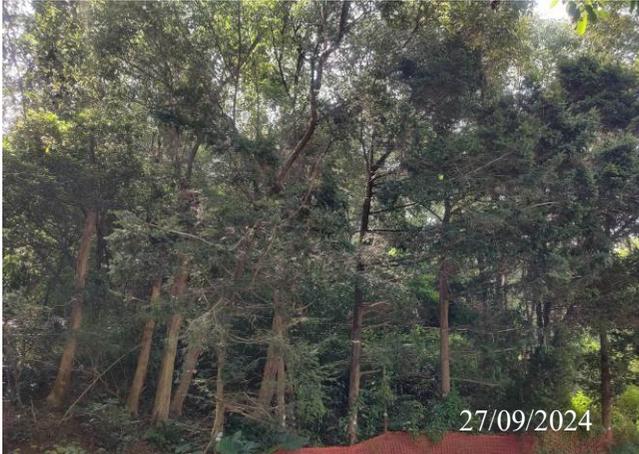
<p>Description: General view of <i>Keteleeria fortunei</i></p>	<p>Photo 4</p>

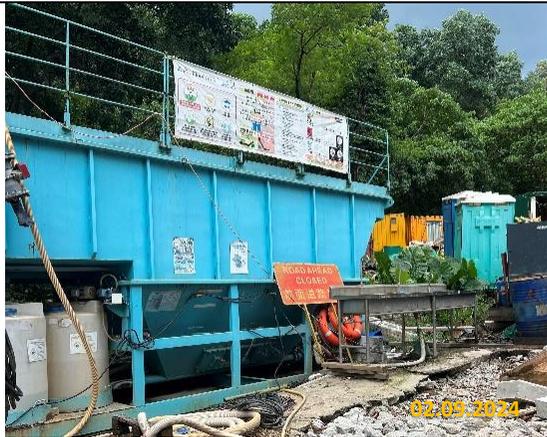
Ref*	Proposed Construction Method**	Location/Working Period	Anticipated Major Impacts	Recommended Mitigation Measures	Photo Records (Partial)
EIA 3.91; EM&A Log 2.2	Road and Associated Works (Construction works have been completed and the	Kong Nga Po Road	Air Dust impact from excavation activities and earth moving	<ul style="list-style-type: none"> Use of regular water spraying (once every 1.25 hours or 8 times per day) at all active works area exposed site surfaces and unpaved roads, particularly during dry weather Regular inspection and maintenance of plant and equipment in good condition Regularly clean up stockpiles and debris to avoid accumulation of materials 	N/A (No excavation activities and earth moving)
EIA 5.6.1.2; EM&A Log 4.2	remaining works are Establishment and defect rectification)		Water	<ul style="list-style-type: none"> Provide desilting/sedimentation devices for wastewater treatment before discharge

<p>By main contractor at KNP Road</p>

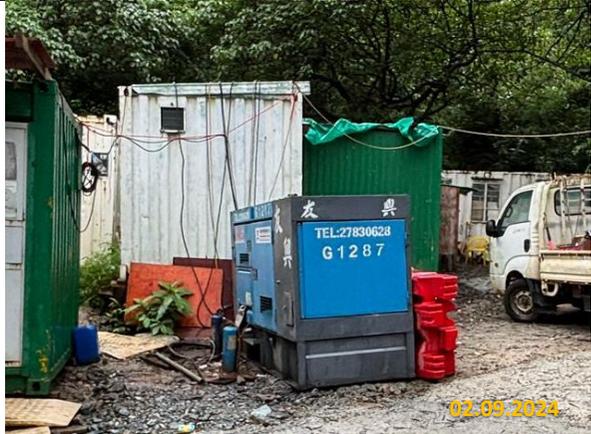
Ref*	Proposed Construction Method**	Location/Working Period	Anticipated Major Impacts	Recommended Mitigation Measures	Photo Records (Partial)
EM&A Log 3.2	(Con't) Road and Associated Works	(Con't) Kong Nga Po Road		surface breaking / for operating plants	
EIA 7.5.1.4; EM&A Log 6.2	(Construction works have been completed and the remaining works are Establishment and defect		Chemical / Chemical Waste	<ul style="list-style-type: none"> Drip tray and chemical spillage kit shall be provided on site

<p>Generator with built-in drip tray (By main contractor at KNP Road)</p>

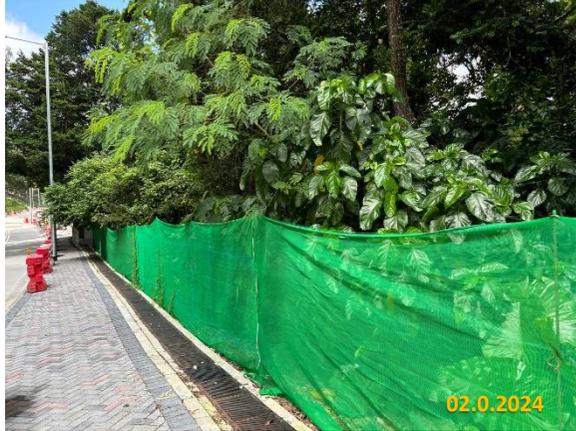
Ref*	Proposed Construction Method**	Location/Working Period	Anticipated Major Impacts	Recommended Mitigation Measures	Photo Records (Partial)
EIA Table 10.11 EM&A Table 9.1	rectification) (Con't) Road and Associated Works		Landscape and visual impact	<ul style="list-style-type: none"> • Properly fenced off the conservative species • Properly implement temporary traffic arrangement which control construction area to minimize landscape and visual impacts

<p data-bbox="1451 869 1848 901">By main contractor at KNP Road</p>
