**EP-510/2016 – Police Facilities in Kong Nga Po**

**Service Contract No. NDO 07/2019  
Environmental Team for Site Formation and  
Infrastructure Works for Police Facilities in  
Kong Nga Po**

**Monthly Environmental Monitoring and  
Audit Report for October 2024  
(Version 1.0)**

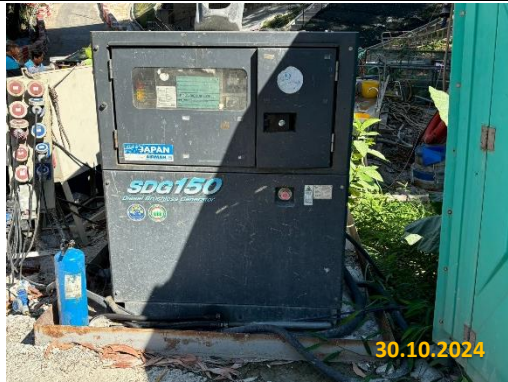
Ref*	Proposed Construction Method**	Location/Working Period	Anticipated Major Impacts	Recommended Mitigation Measures	Photo Records (Partial)
Log 3.2	(Con't) Road and	(Con't) Kong Nga Po Road			
EIA 7.5.1.4; EM&A Log 6.2	Associated Works  (Construction works have been completed and the remaining		Chemical / Chemical Waste	<ul style="list-style-type: none"> <li>Drip tray and chemical spillage kit shall be provided on site</li> </ul>

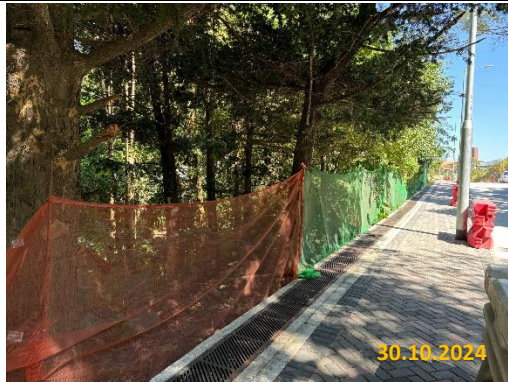
<p>By main contractor at KNP Road</p>
EIA Table 10.11 EM&A Table 9.1	works are Establishment and defect rectification) (Con't) Road and Associated Works		Landscape and visual impact	<ul style="list-style-type: none"> <li>Properly fenced off the conservative species</li> <li>Properly implement temporary traffic arrangement which control construction area to minimize landscape and visual impacts</li> </ul>
