**Service Contract No. NDO 07/2019
Environmental Team for Site Formation and
Infrastructure Works for Police Facilities in
Kong Nga Po**

**Monthly Environmental Monitoring and
Audit Report for November 2024
(Version 1.0)**

**Site Formation and Infrastructure Works for Police Facilities in Kong Nga Po
Monthly Environmental Monitoring and Audit Report for November 2024**

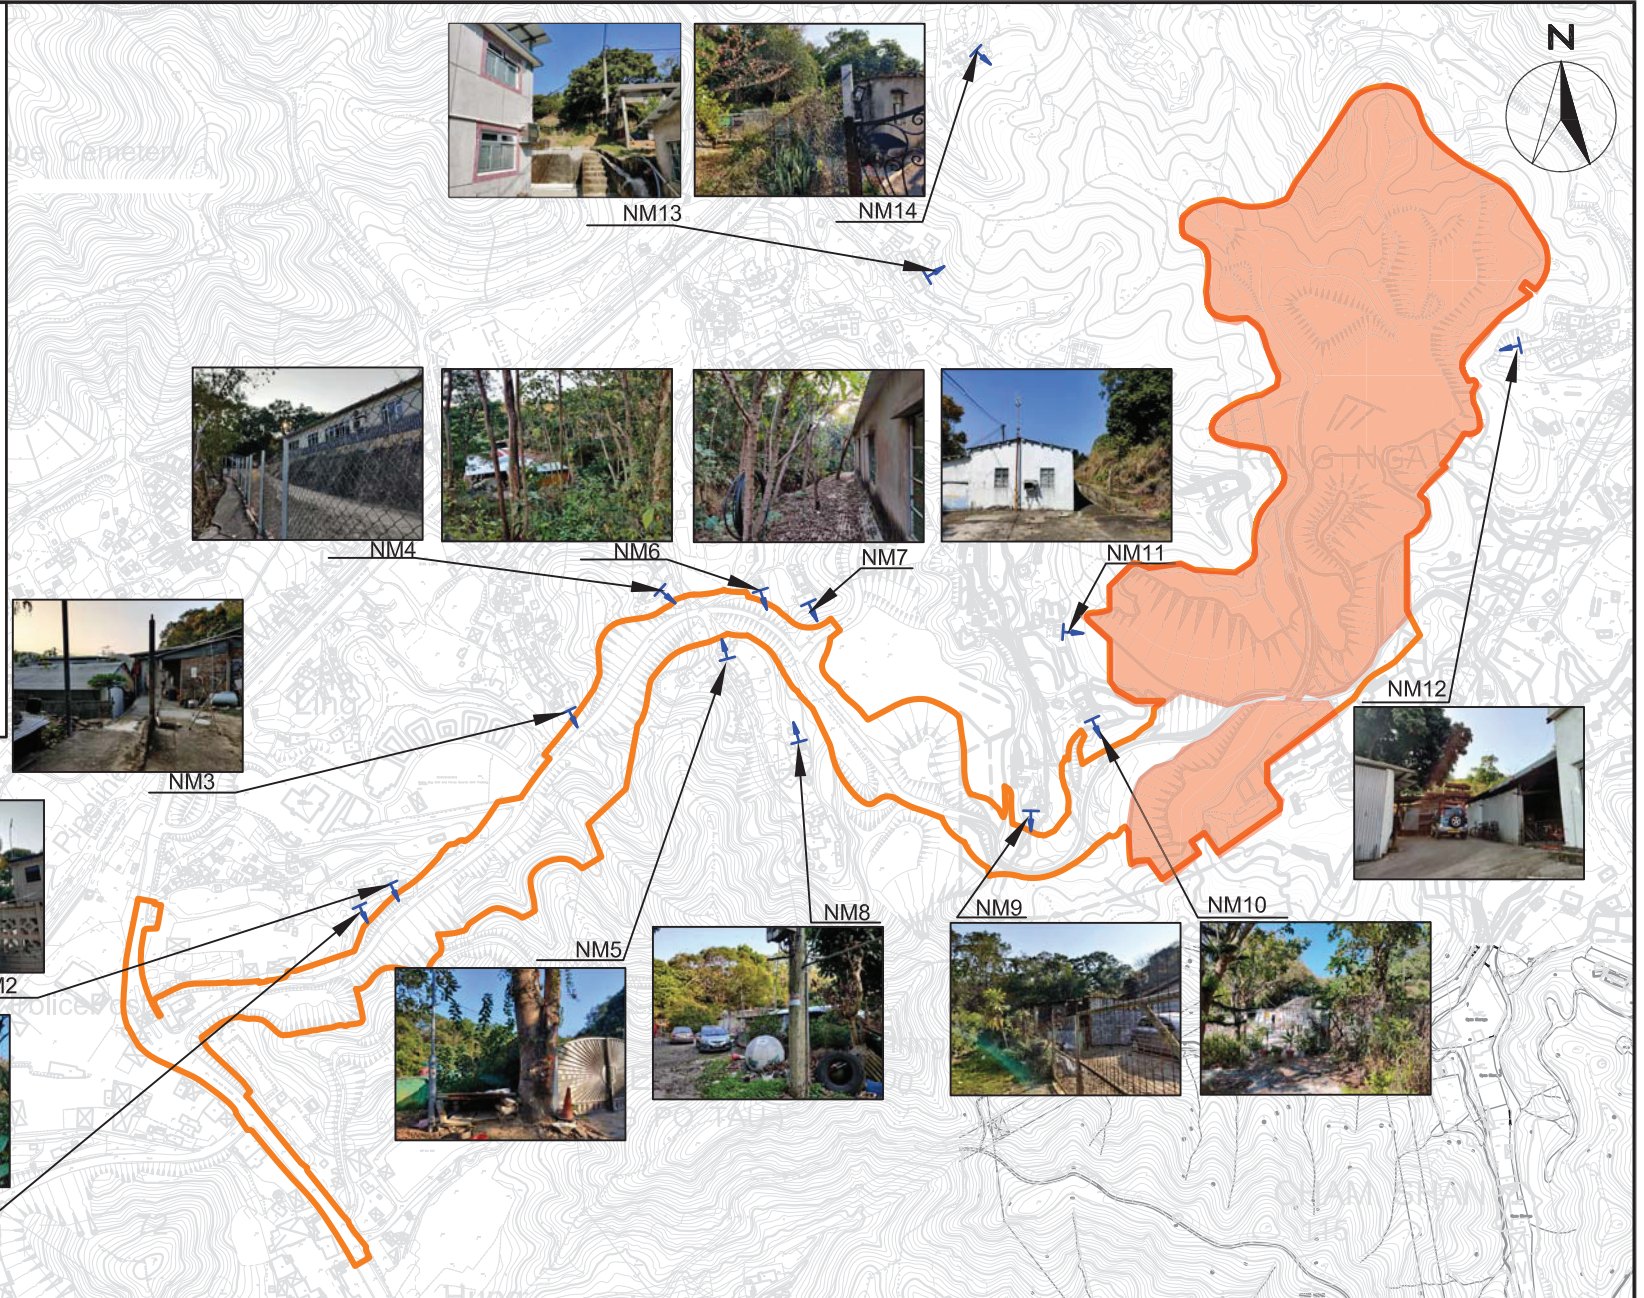
Noise Monitoring Stations	
ID	Description
NM1	Village House, Sha Ling
NM2	Village House, Sha Ling
NM3	Village House No. 248, Sha Ling
NM4	Village House, Sha Ling
NM5	Village House No. 270, Sha Ling
NM6	Village House, Sha Ling
NM7	Village House, Sha Ling
NM8	Village House, Sha Ling
NM9	Village House, Kong Nga Po
NM10	Village House, Kong Nga Po
NM11	Village House, Kong Nga Po
NM12	Village House, Kong Nga Po
NM13	Village House, Kong Nga Po
NM14	Village House, near Man Kam To Road

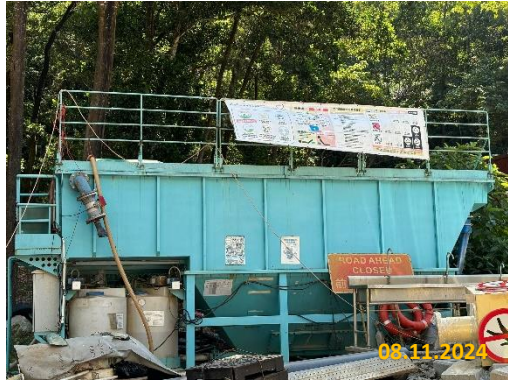
Ref*	Proposed Construction Method**	Location/Working Period	Anticipated Major Impacts	Recommended Mitigation Measures	Photo Records (Partial)
EIA 3.91; EM&A Log 2.2	Road and Associated Works (Construction works have been completed and the	Kong Nga Po Road	Air Dust impact from excavation activities and earth moving	<ul style="list-style-type: none"> Use of regular water spraying (once every 1.25 hours or 8 times per day) at all active works area exposed site surfaces and unpaved roads, particularly during dry weather Regular inspection and maintenance of plant and equipment in good condition Regularly clean up stockpiles and debris to avoid accumulation of materials 	N/A (No excavation activities and earth moving)
EIA 5.6.1.2; EM&A Log 4.2	remaining works are Establishment and defect rectification)		Water	<ul style="list-style-type: none"> Provide desilting/sedimentation devices for wastewater treatment before discharge

<p>By main contractor at KNP Road</p>

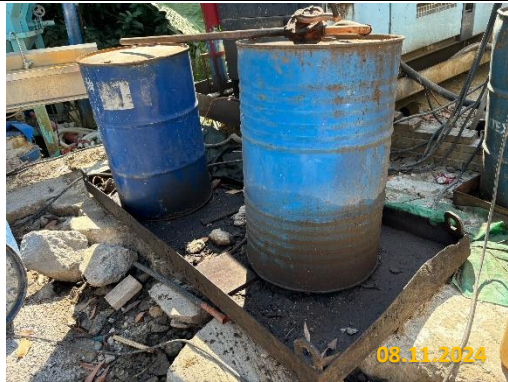
Ref*	Proposed Construction Method**	Location/Working Period	Anticipated Major Impacts	Recommended Mitigation Measures	Photo Records (Partial)
Log 3.2	(Con't) Road and	(Con't) Kong Nga Po Road			
EIA 7.5.1.4; EM&A Log 6.2	Associated Works (Construction works have been completed and the remaining		Chemical / Chemical Waste	<ul style="list-style-type: none"> Drip tray and chemical spillage kit shall be provided on site

<p>By main contractor at KNP Road</p>
EIA Table 10.11 EM&A Table 9.1	works are Establishmen t and defect rectification) (Con't) Road and Associated Works		Landscape and visual impact	<ul style="list-style-type: none"> Properly fenced off the conservative species Properly implement temporary traffic arrangement which control construction area to minimize landscape and visual impacts

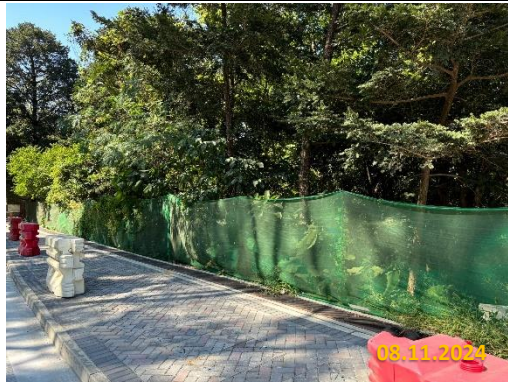
<p>By main contractor at KNP Road</p>
