EP-510/2016 – Police Facilities in Kong Nga Po

**Service Contract No. NDO 07/2019
Environmental Team for Site Formation and
Infrastructure Works for Police Facilities in
Kong Nga Po**

**Monthly Environmental Monitoring and
Audit Report for December 2024
(Version 1.0)**

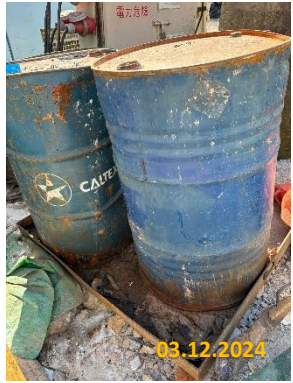
Ref*	Proposed Construction Method**	Location/ Working Period	Anticipated Major Impacts	Recommended Mitigation Measures	Photo Records (Partial)
EIA 7.5.1.4; EM&A Log 6.2	(Con't) Road and Associated Works (Construction works have been completed and the remaining	(Con't) Kong Nga Po Road	Chemical / Chemical Waste	<ul style="list-style-type: none"> Drip tray and chemical spillage kit shall be provided on site

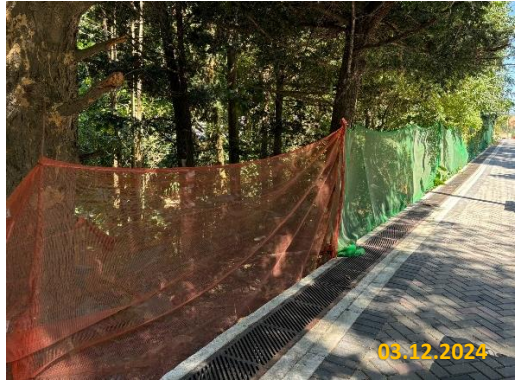
<p>By main contractor at KNP Road</p>
EIA Table 10.11 EM&A Table 9.1	works are Establishment and defect rectification)		Landscape and visual impact	<ul style="list-style-type: none"> Properly fenced off the conservative species Properly implement temporary traffic arrangement which control construction area to minimize landscape and visual impacts
