EP-510/2016 – Police Facilities in Kong Nga Po

**Service Contract No. NDO 07/2019
Environmental Team for Site Formation and
Infrastructure Works for Police Facilities in
Kong Nga Po**

**Quarterly Environmental Monitoring and
Audit Report for January to March 2024
(Version 1.0)**

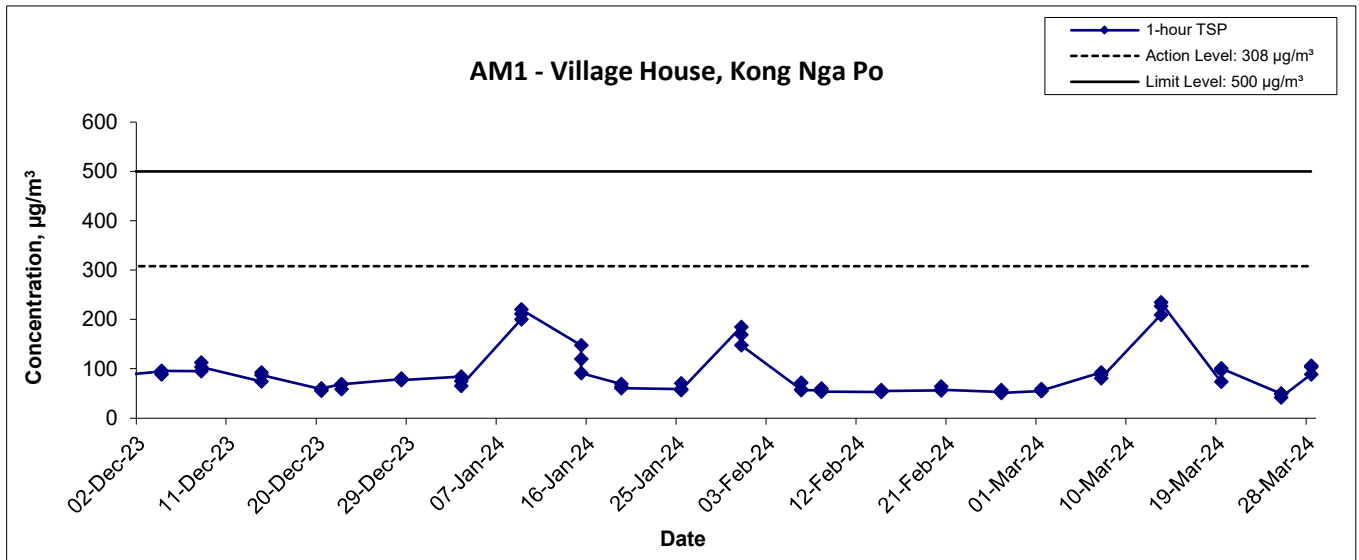
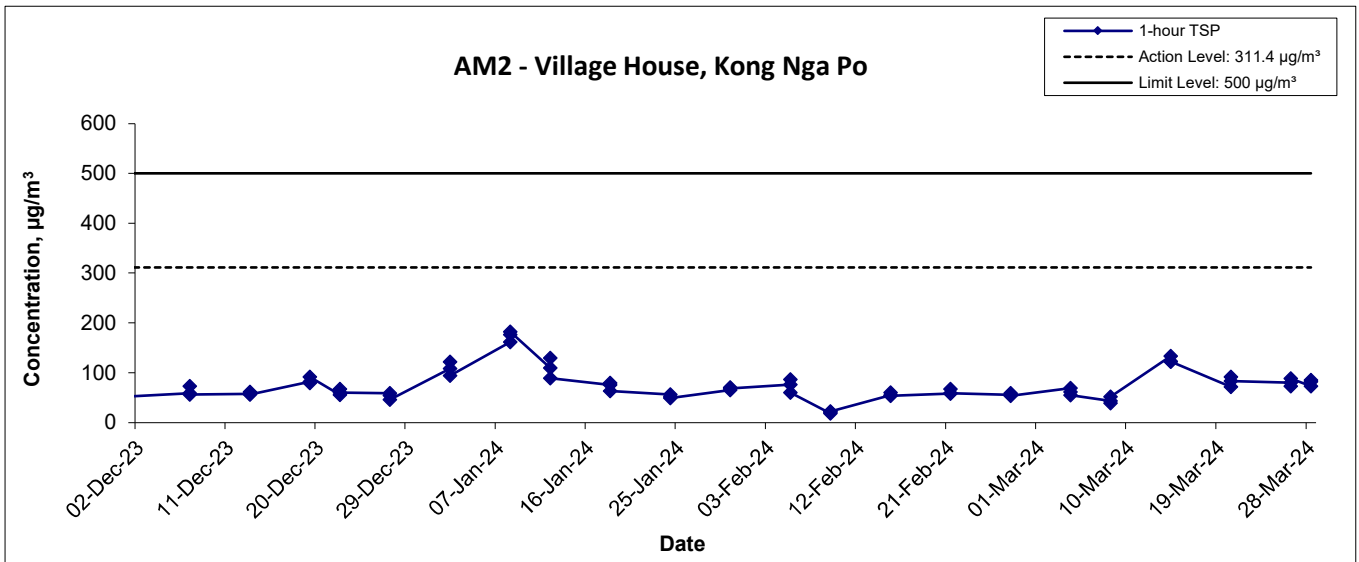
1-hr TSP Concentration Levels

Title Service Contract No. NDO 07/2019 Environmental Team for Site Formation and Infrastructure Works for Police Facilities in Kong Nga Po Graphical Presentation of 1-hour TSP Monitoring Results	Scale N.T.S	Project No. WMA20001

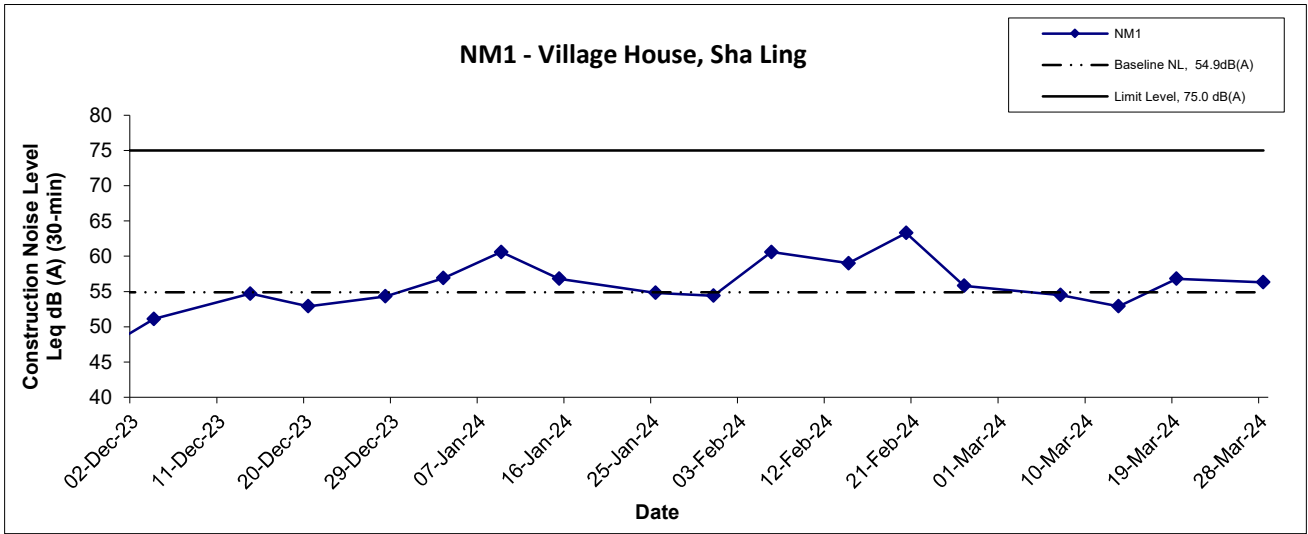
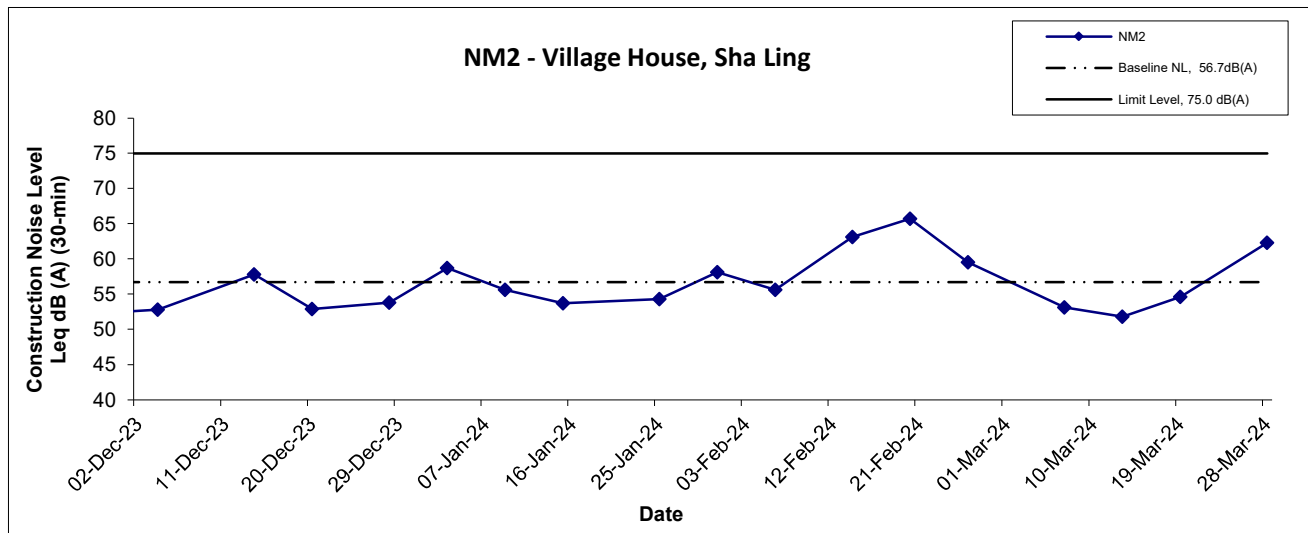
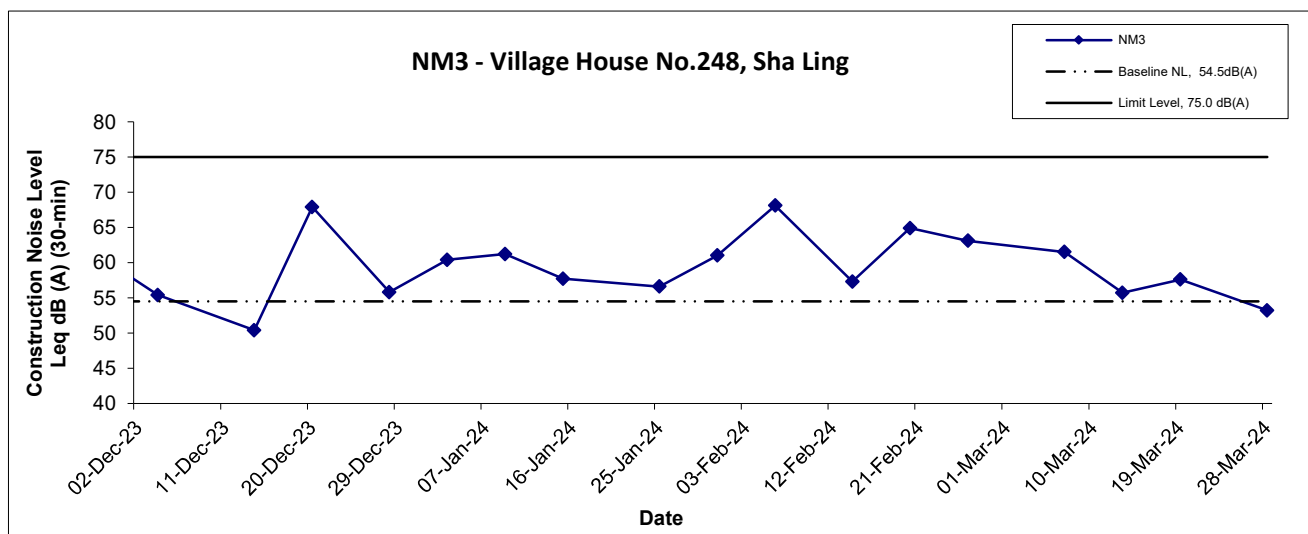
Noise Levels

Title Service Contract No. NDO 07/2019 Environmental Team for Site Formation and Infrastructure Works for Police Facilities in Kong Nga Po Graphical Presentation of Construction Noise Monitoring Results	Scale	Project No.	consulting . testing . research
	N.T.S	WMA20001	
	Date	Appendix	
	Mar 24	C

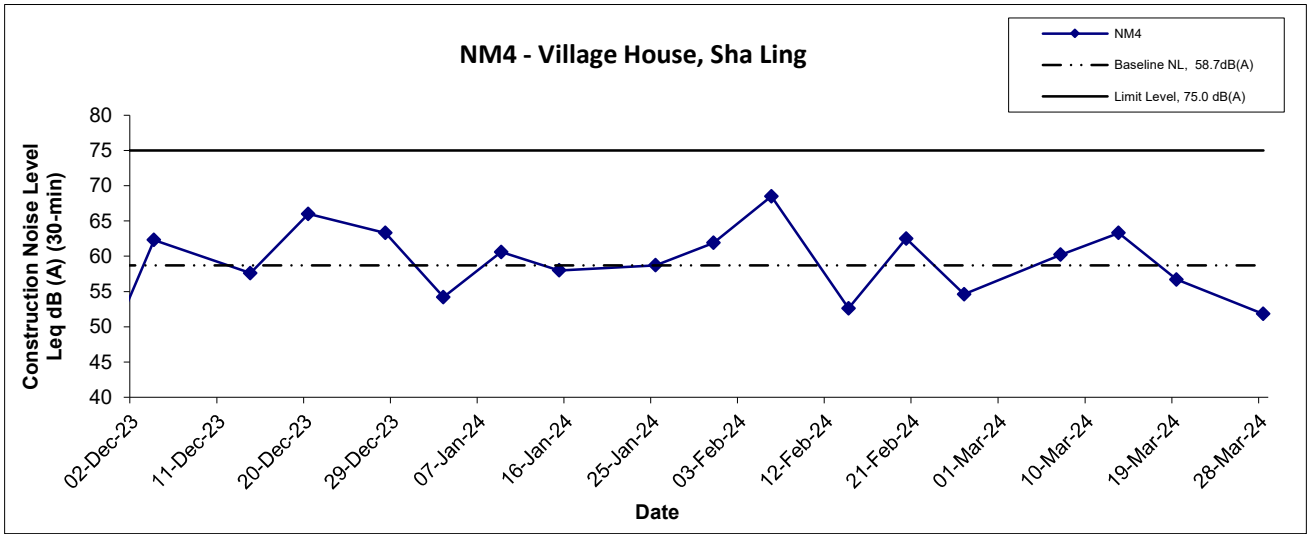
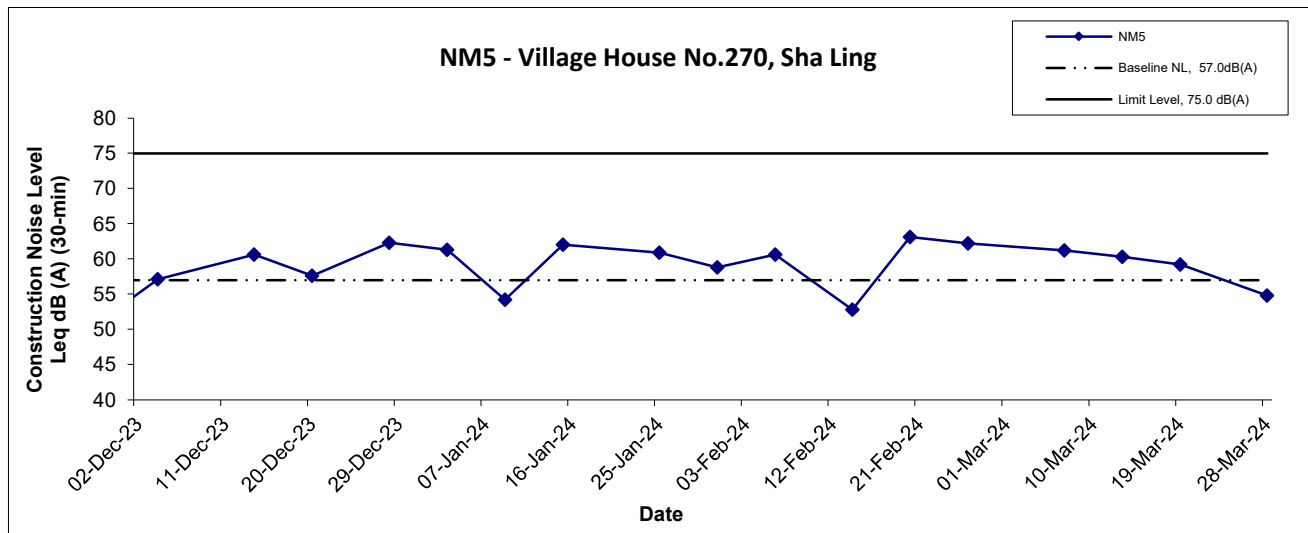
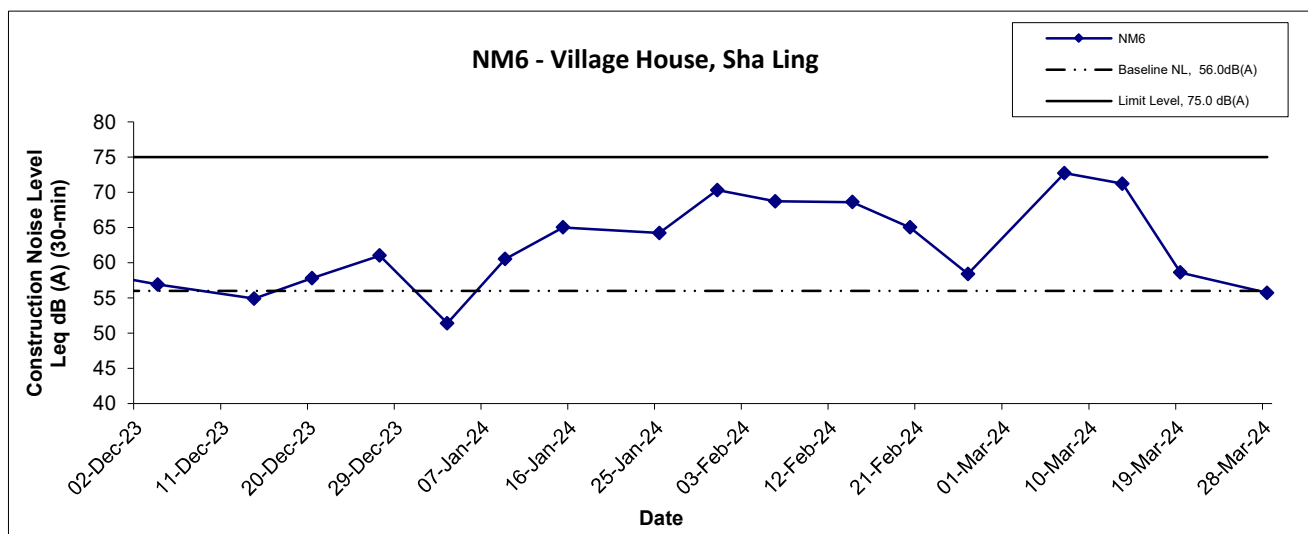
Noise Levels

Title Service Contract No. NDO 07/2019 Environmental Team for Site Formation and Infrastructure Works for Police Facilities in Kong Nga Po Graphical Presentation of Construction Noise Monitoring Results	Scale	N.T.S	Project No.	WMA20001	consulting . testing . research
	Date	Mar 24	Appendix	C

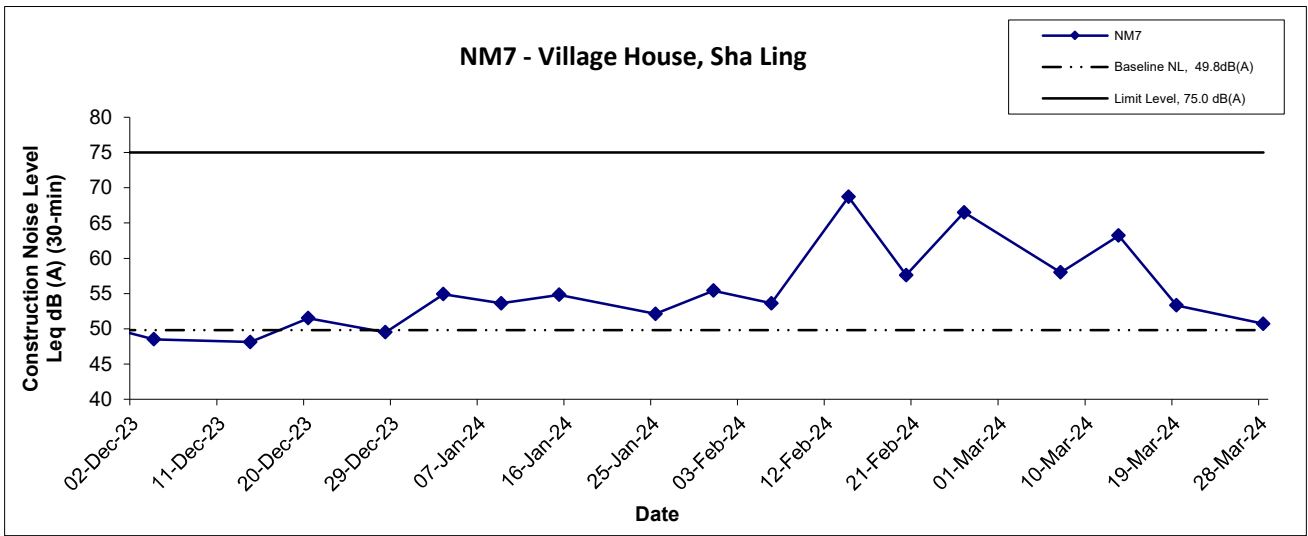
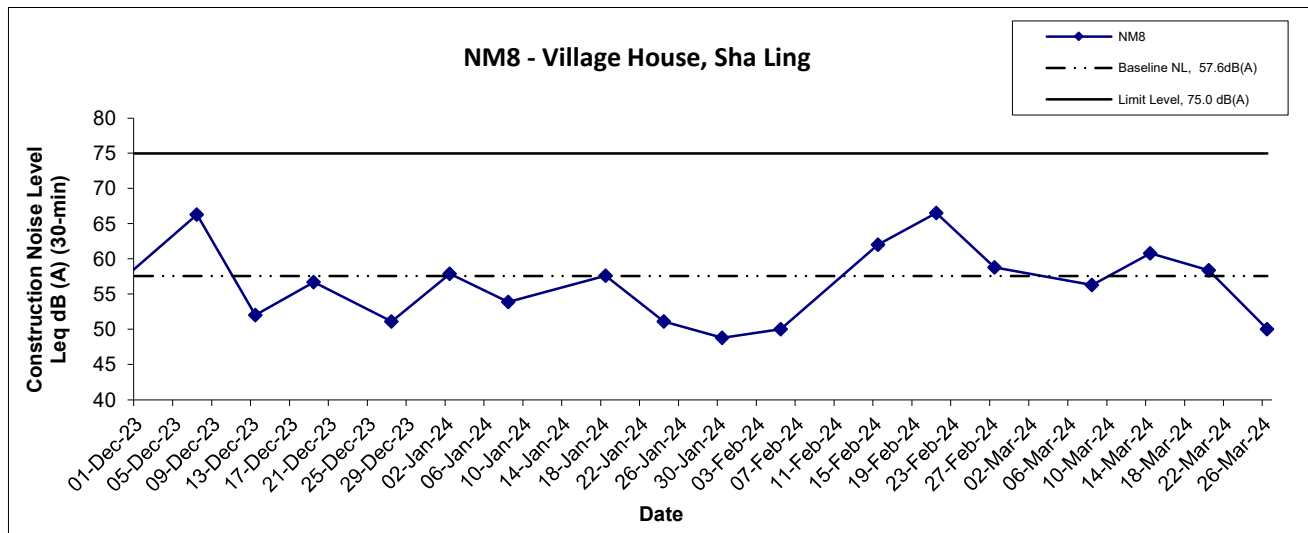
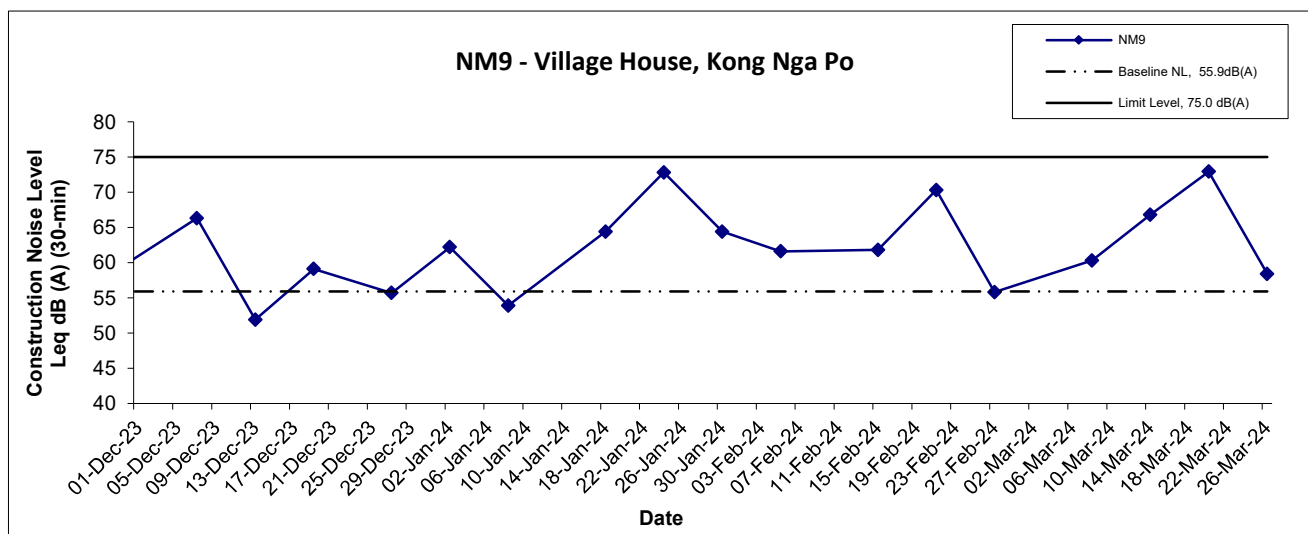
Noise Levels

Title Service Contract No. NDO 07/2019 Environmental Team for Site Formation and Infrastructure Works for Police Facilities in Kong Nga Po Graphical Presentation of Construction Noise Monitoring Results	Scale	N.T.S	Project No.	WMA20001
	Date	Mar 24	Appendix	C

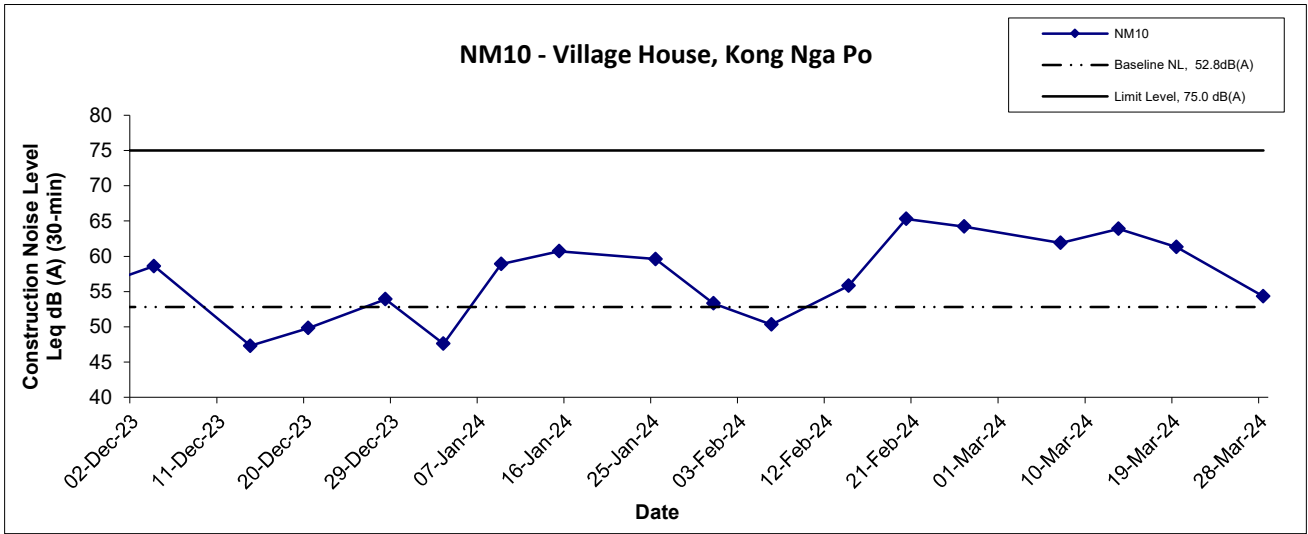
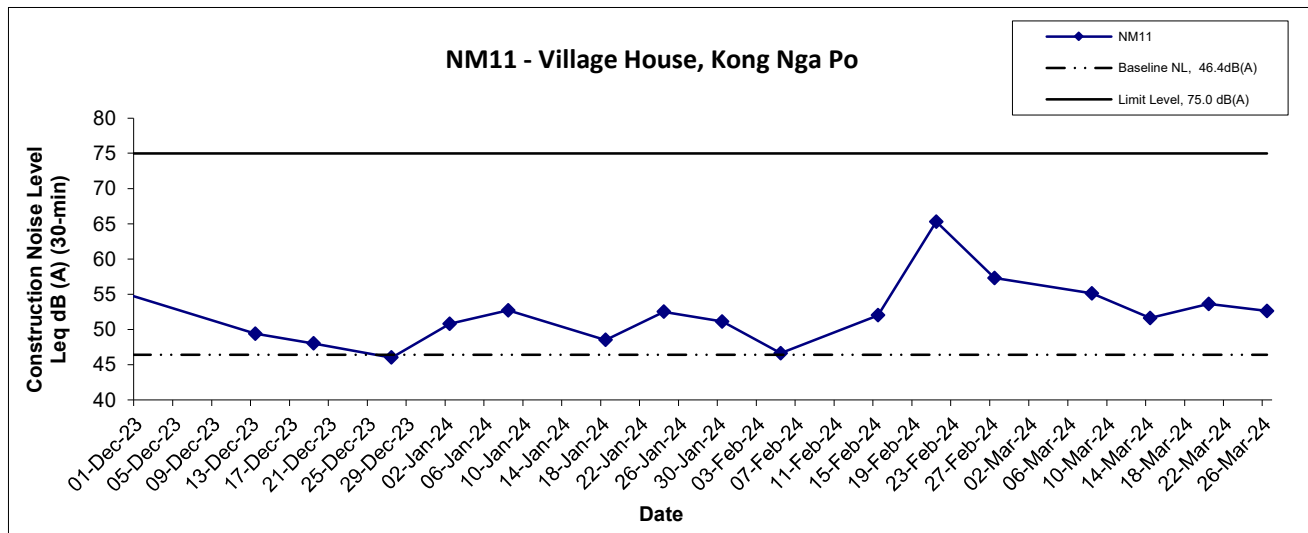
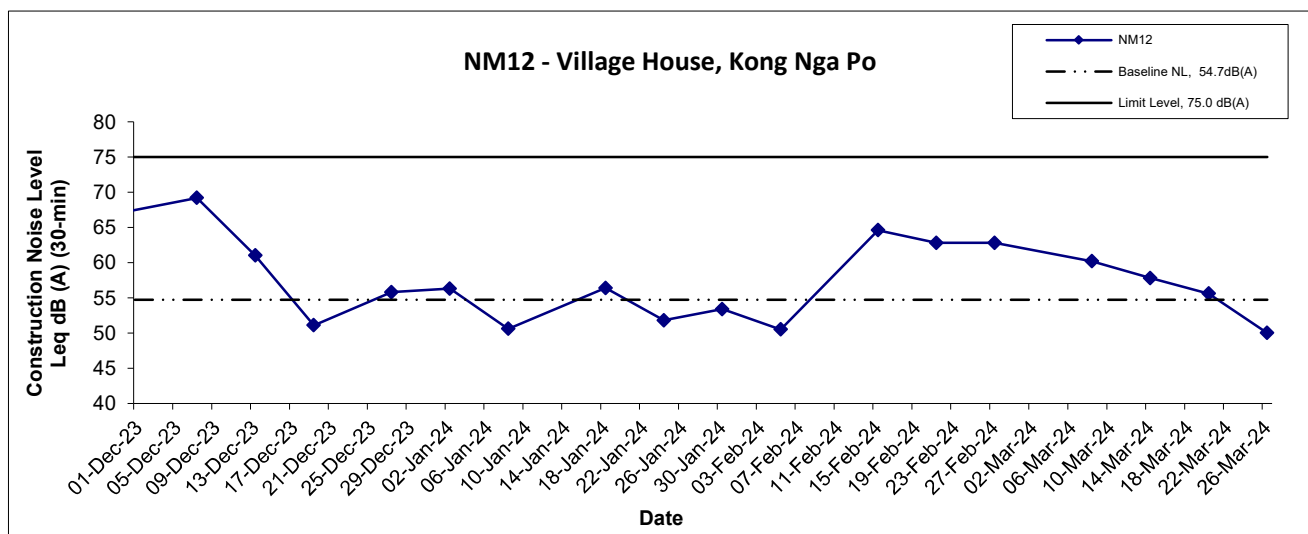
Noise Levels

Title Service Contract No. NDO 07/2019 Environmental Team for Site Formation and Infrastructure Works for Police Facilities in Kong Nga Po Graphical Presentation of Construction Noise Monitoring Results	Scale	Project No.	consulting . testing . research
	N.T.S	WMA20001	
Date	Mar 24	Appendix	C

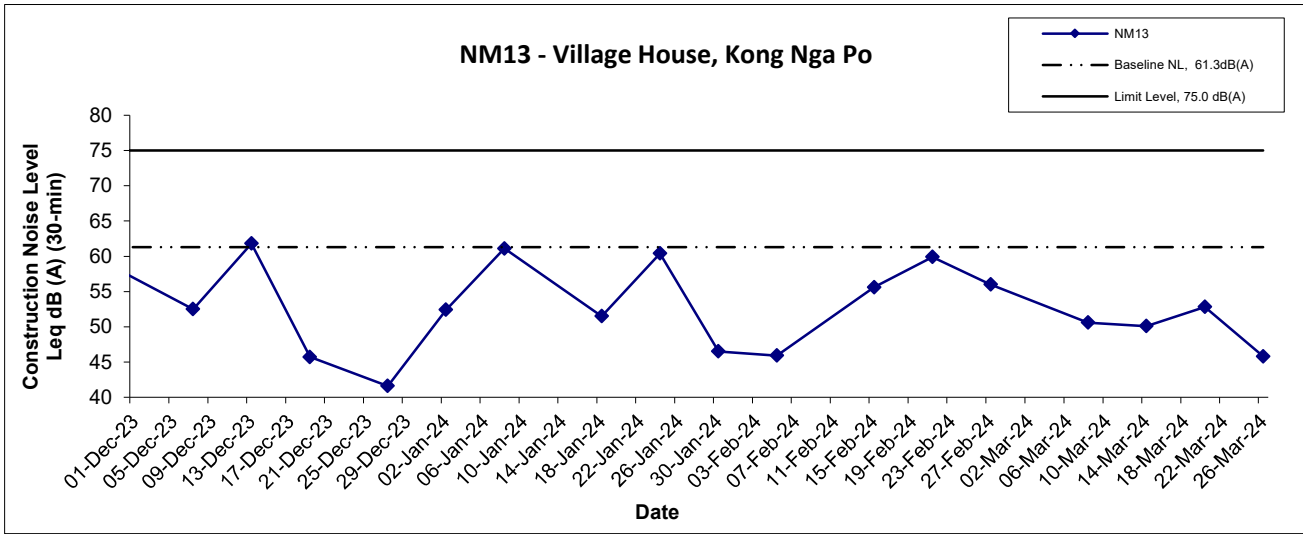
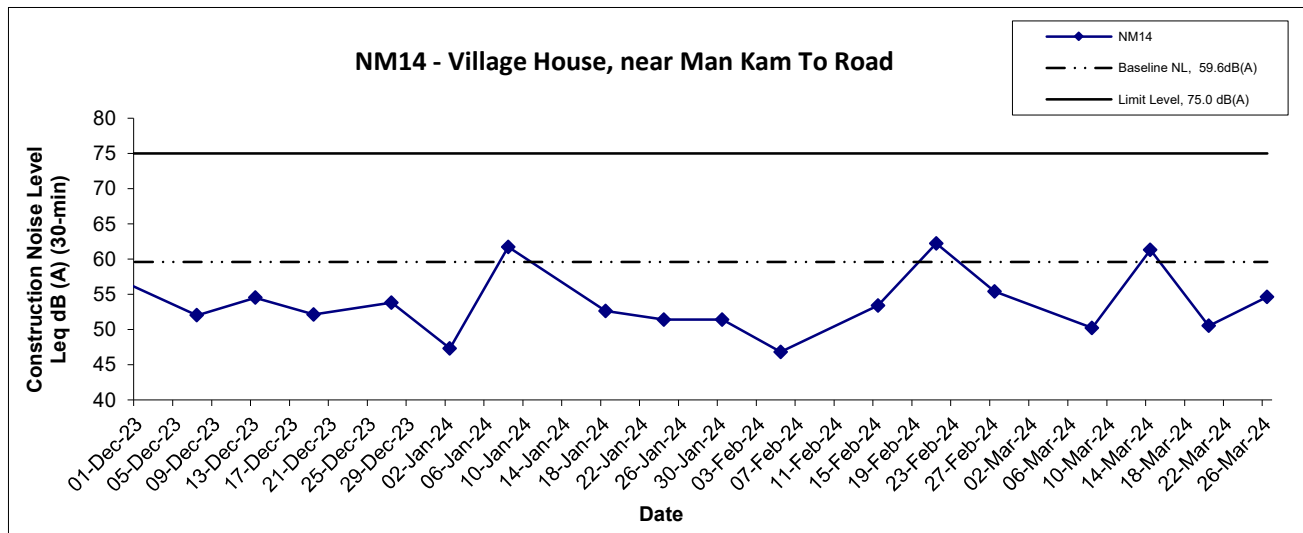
Noise Levels

Title Service Contract No. NDO 07/2019 Environmental Team for Site Formation and Infrastructure Works for Police Facilities in Kong Nga Po Graphical Presentation of Construction Noise Monitoring Results	Scale N.T.S	Project No. WMA20001	 consulting . testing . research
	Date Mar 24	Appendix C
