EP-510/2016 – Police Facilities in Kong Nga Po

**Service Contract No. NDO 07/2019
Environmental Team for Site Formation and
Infrastructure Works for Police Facilities in
Kong Nga Po**

**Quarterly Environmental Monitoring and
Audit Report for July to September 2024
(Version 1.0)**

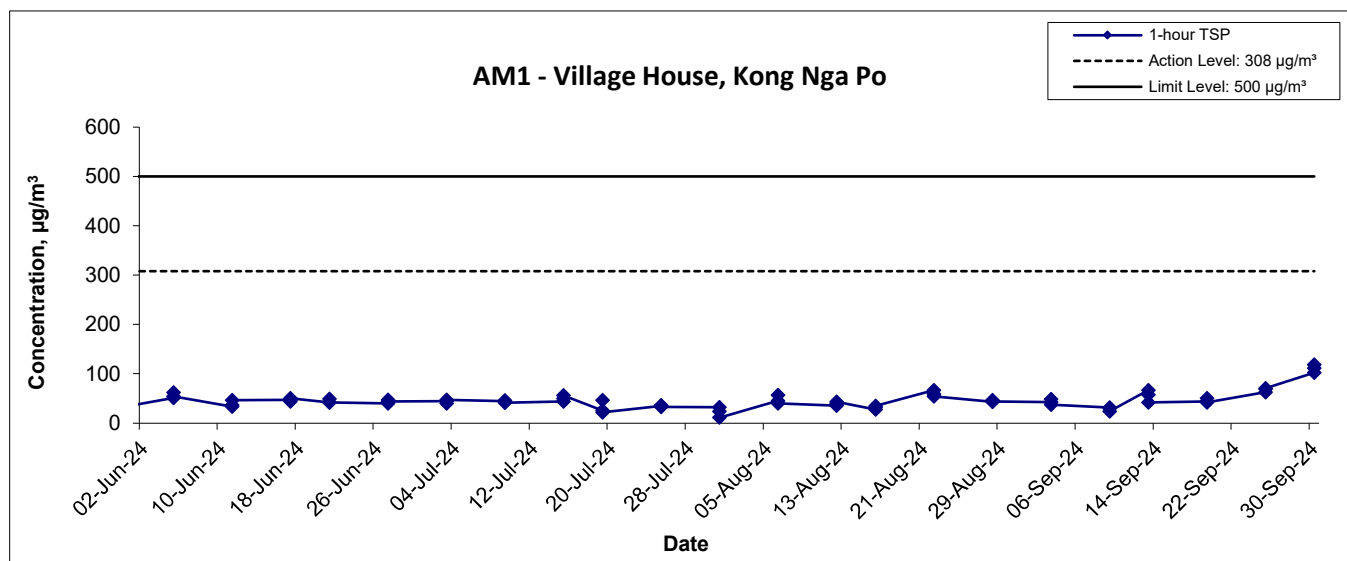
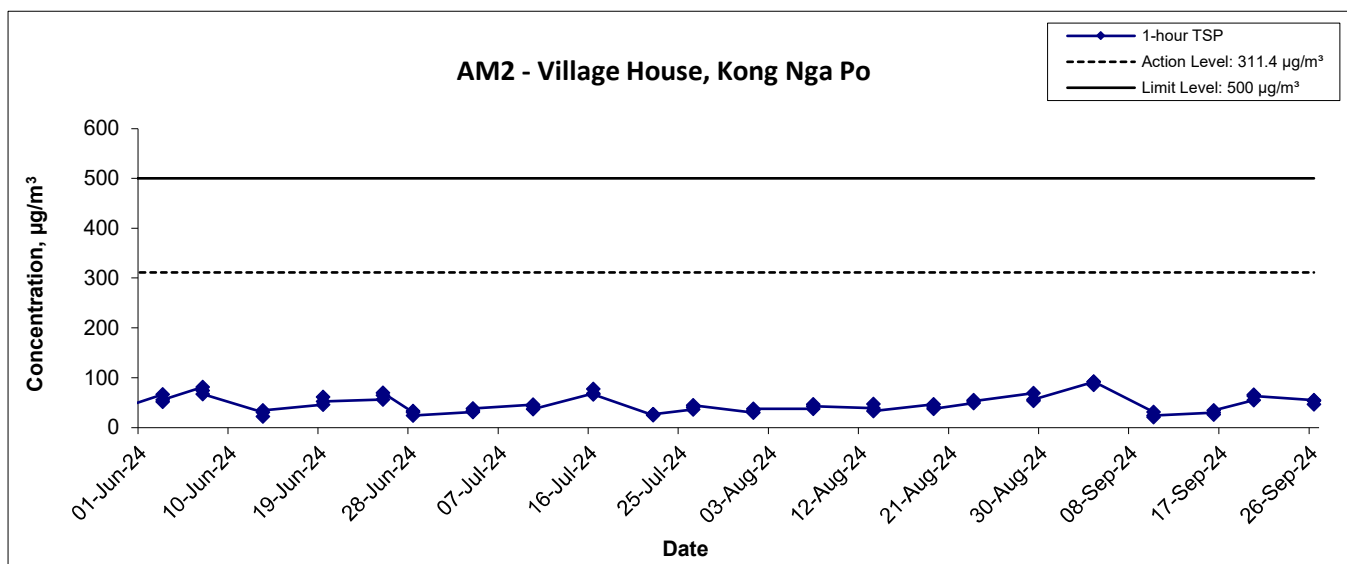
1-hr TSP Concentration Levels

Title Service Contract No. NDO 07/2019 Environmental Team for Site Formation and Infrastructure Works for Police Facilities in Kong Nga Po Graphical Presentation of 1-hour TSP Monitoring Results	Scale N.T.S	Project No. WMA20001

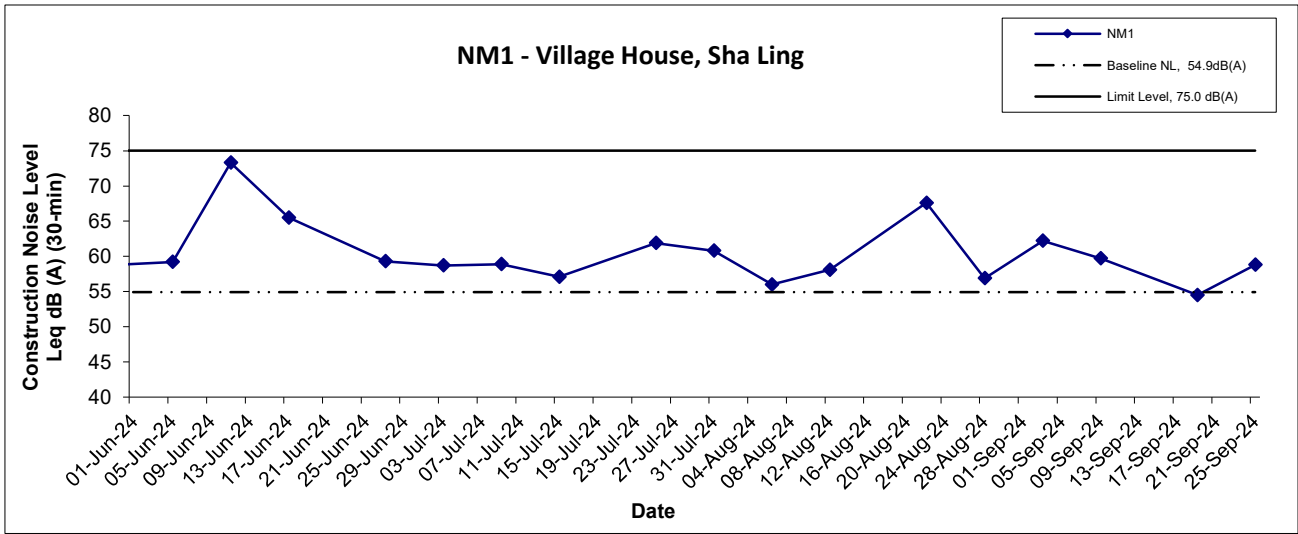
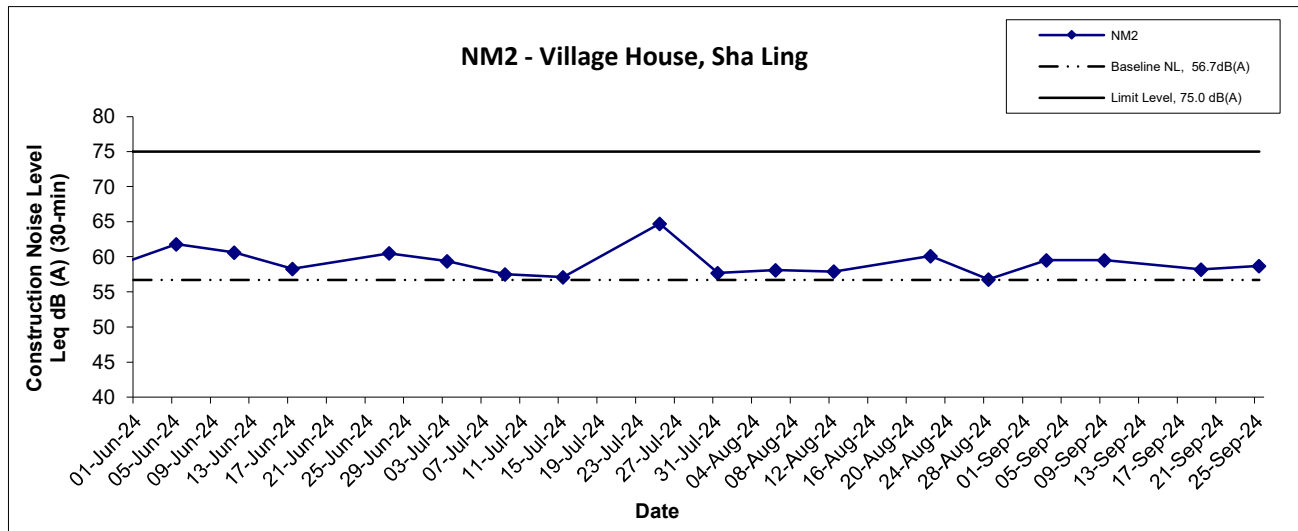
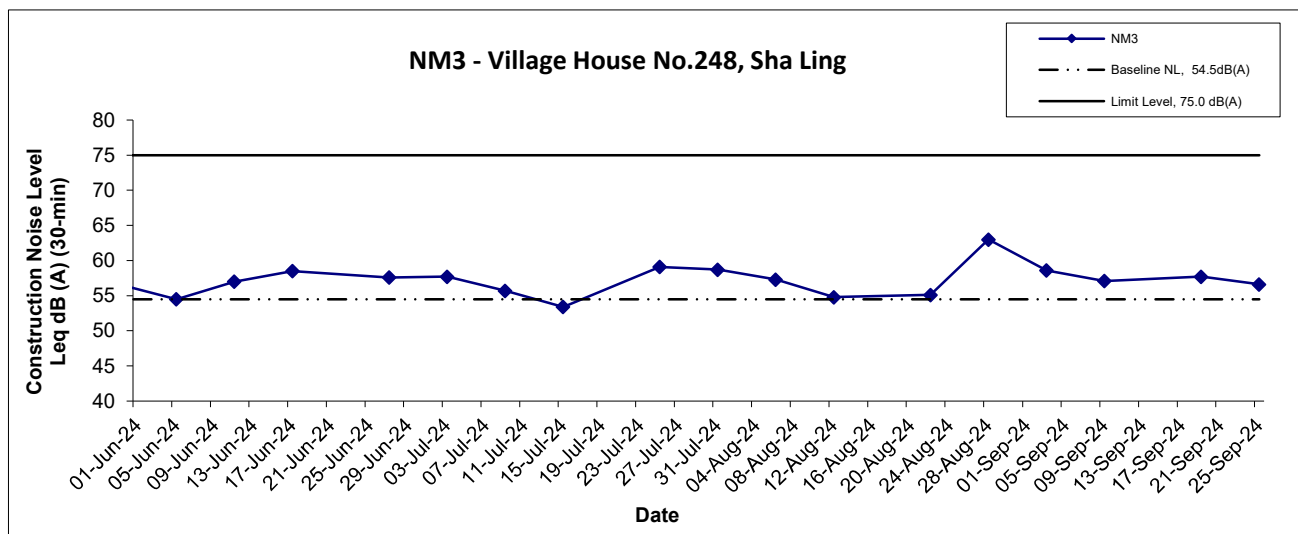
Noise Levels

Title Service Contract No. NDO 07/2019 Environmental Team for Site Formation and Infrastructure Works for Police Facilities in Kong Nga Po Graphical Presentation of Construction Noise Monitoring Results	Scale N.T.S	Project No. WMA20001	consulting . testing . research
	Date Sept 24	Appendix C

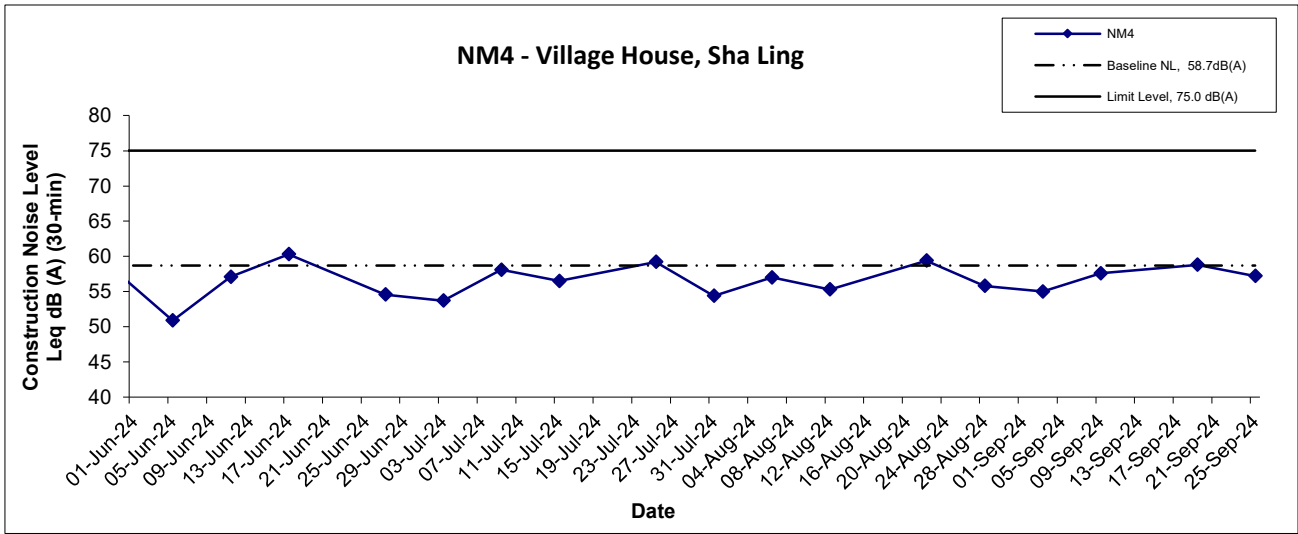
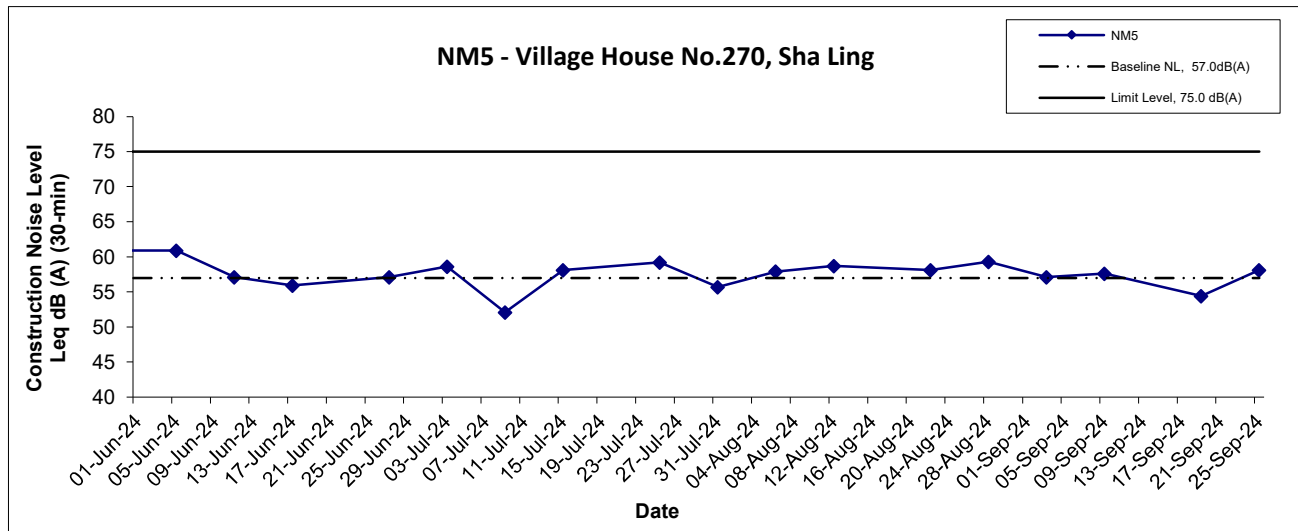
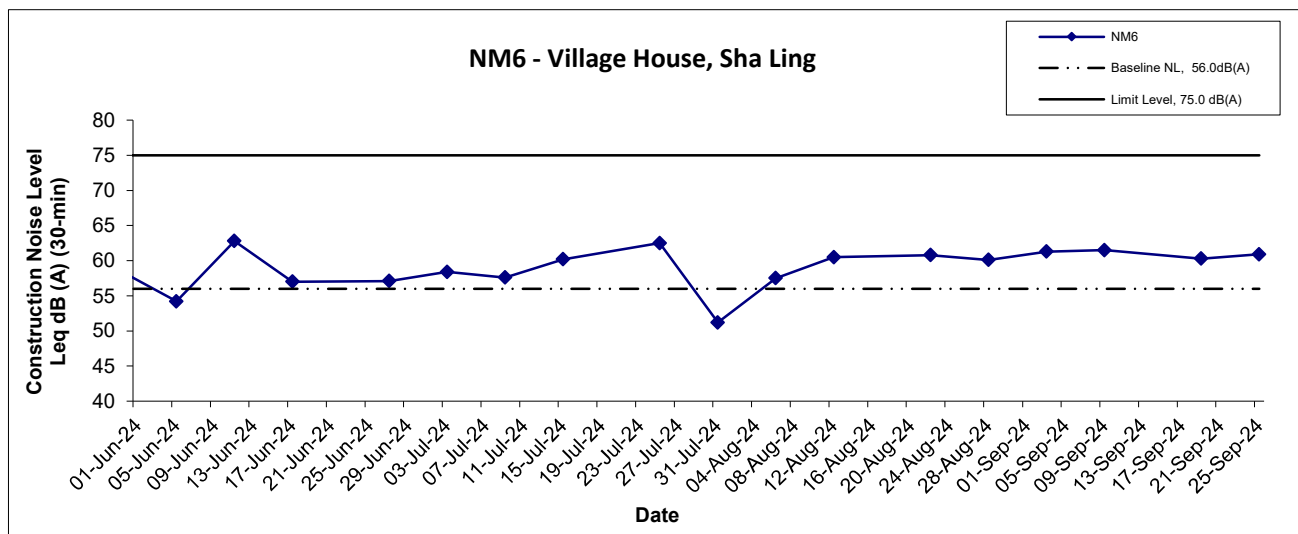
Noise Levels

Title Service Contract No. NDO 07/2019 Environmental Team for Site Formation and Infrastructure Works for Police Facilities in Kong Nga Po Graphical Presentation of Construction Noise Monitoring Results	Scale N.T.S	Project No. WMA20001	匯力 consulting . testing . research
	Date Sept 24	Appendix C

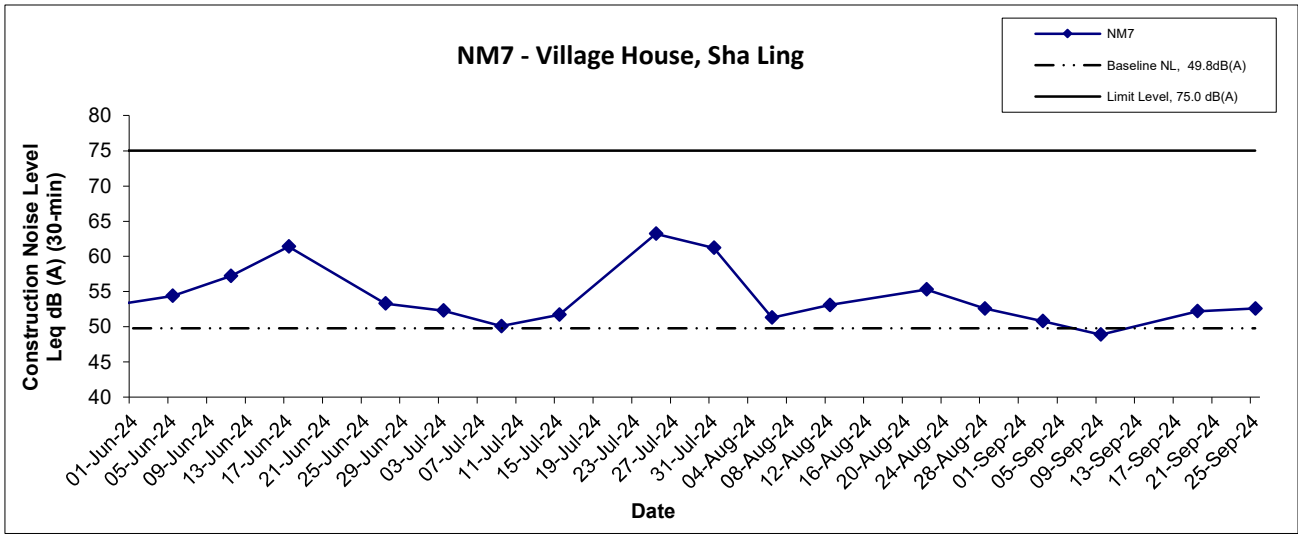
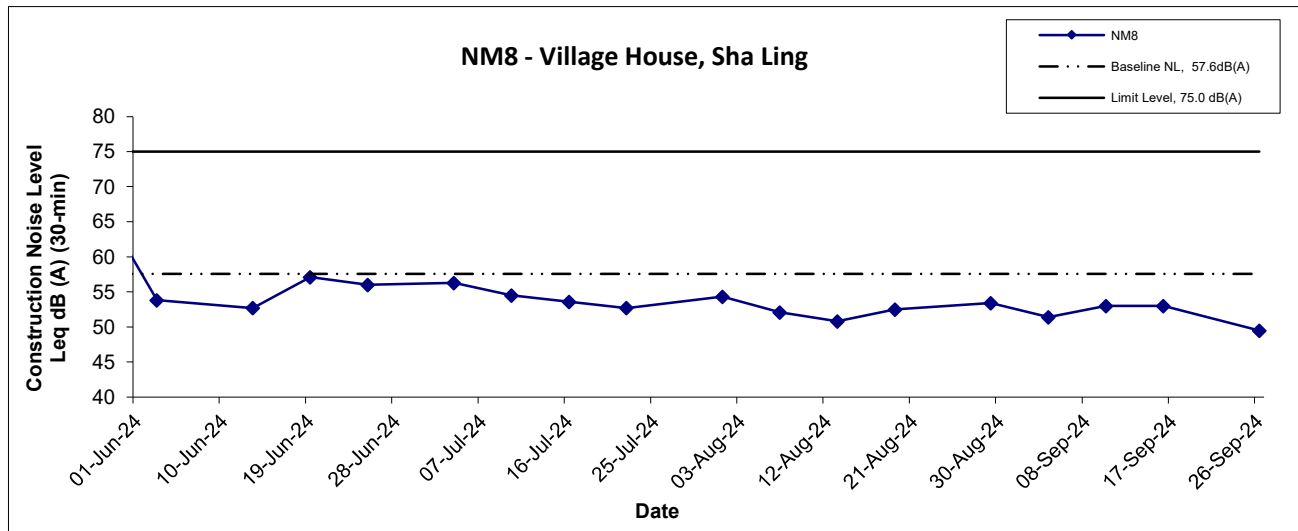
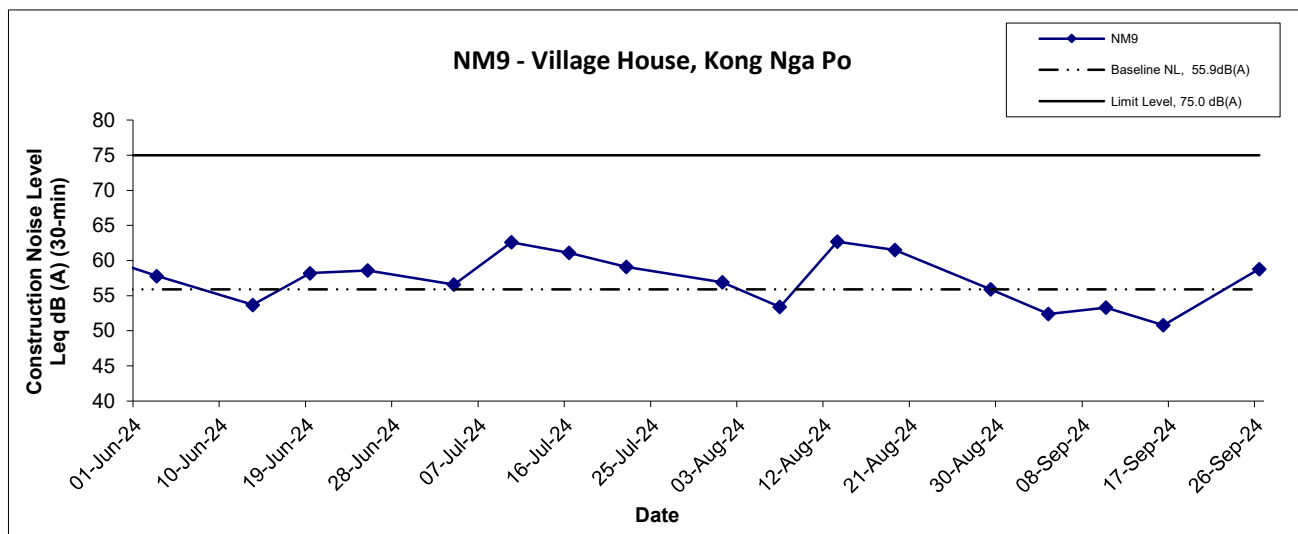
Noise Levels

Title Service Contract No. NDO 07/2019 Environmental Team for Site Formation and Infrastructure Works for Police Facilities in Kong Nga Po Graphical Presentation of Construction Noise Monitoring Results	Scale N.T.S	Project No. WMA20001	consulting . testing . research
	Date Sept 24	Appendix C

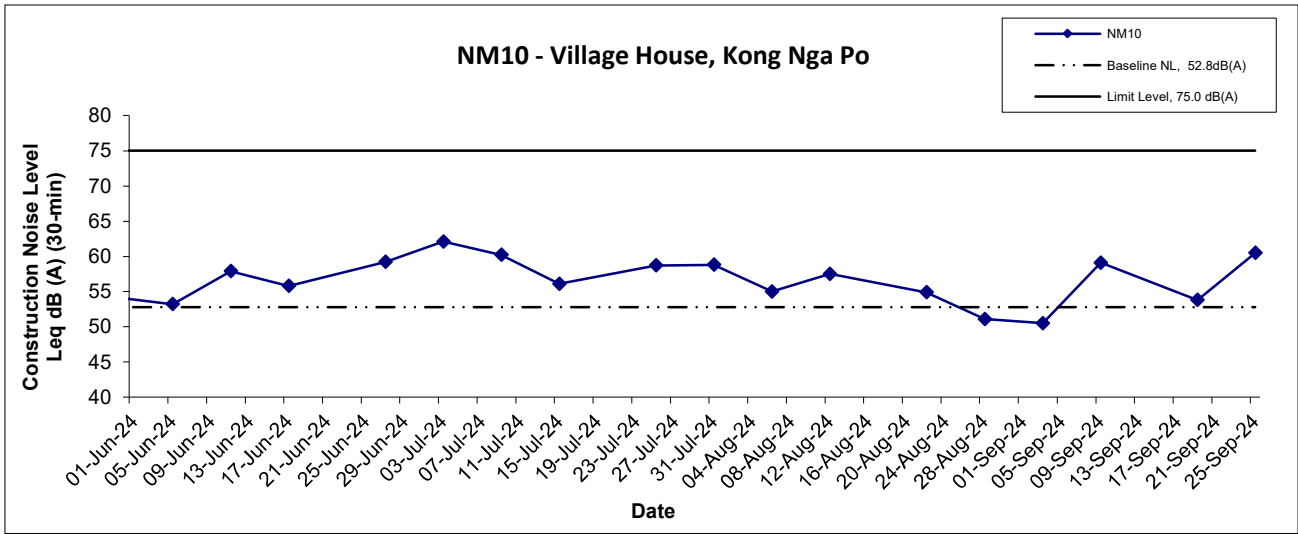
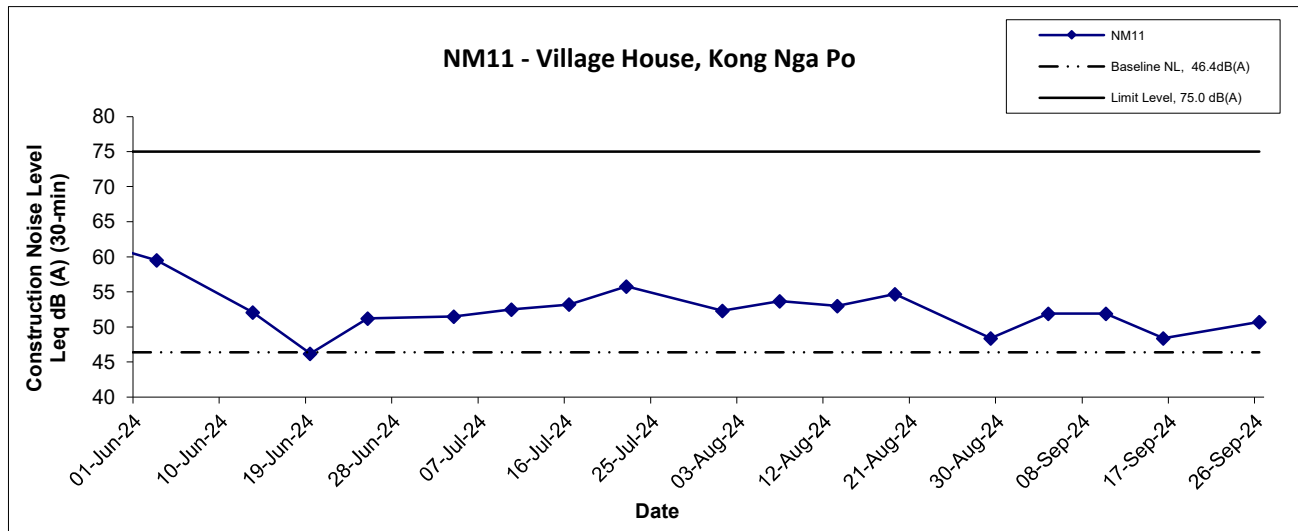
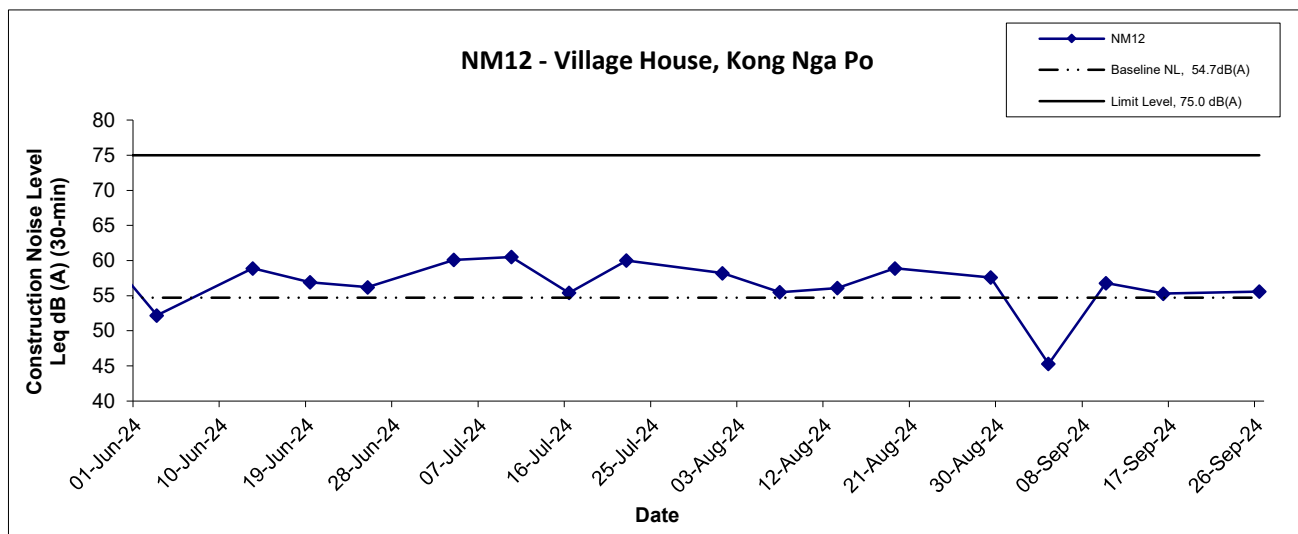
Noise Levels

Title Service Contract No. NDO 07/2019 Environmental Team for Site Formation and Infrastructure Works for Police Facilities in Kong Nga Po Graphical Presentation of Construction Noise Monitoring Results	Scale N.T.S	Project No. WMA20001	consulting . testing . research
	Date Sept 24	Appendix C

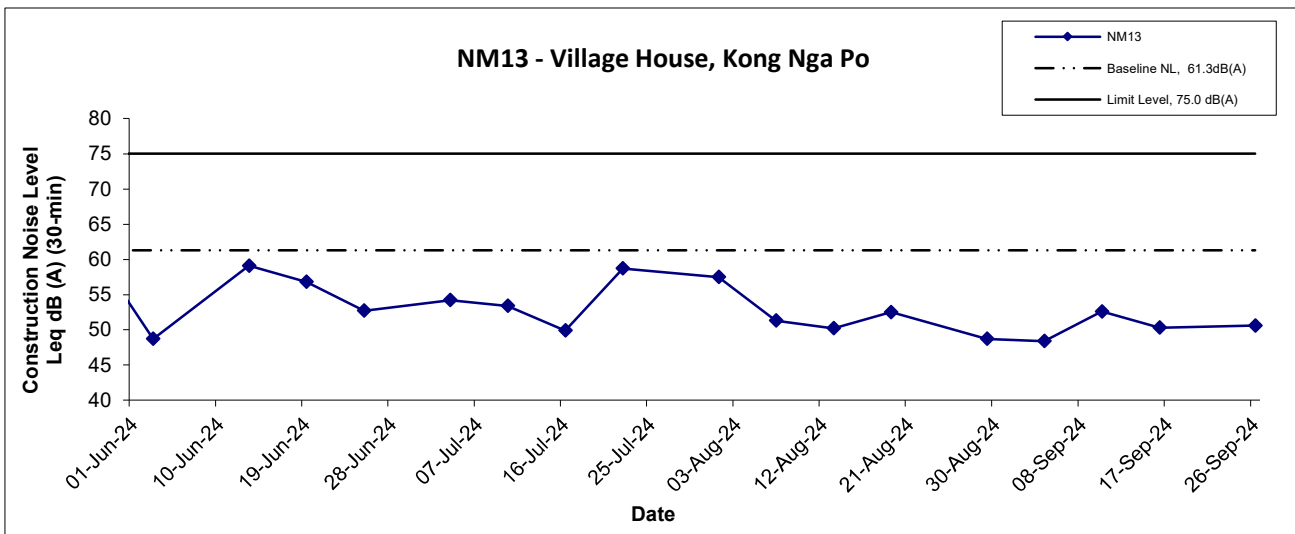
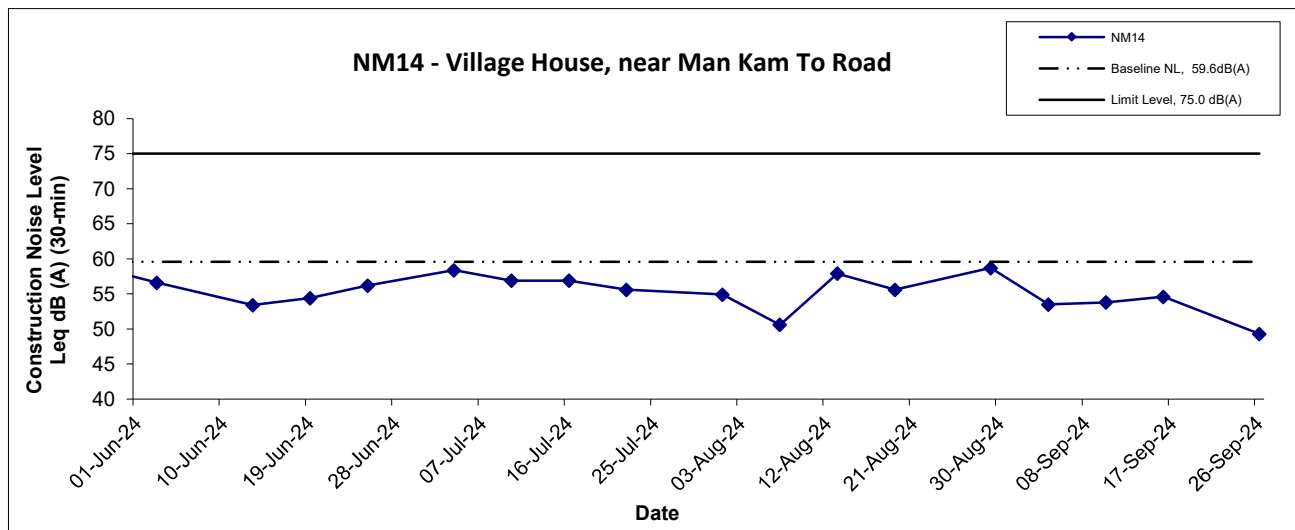
Noise Levels

Title Service Contract No. NDO 07/2019 Environmental Team for Site Formation and Infrastructure Works for Police Facilities in Kong Nga Po Graphical Presentation of Construction Noise Monitoring Results	Scale N.T.S	Project No. WMA20001	 consulting . testing . research
	Date Sept 24	Appendix C
