**Agreement No. CE 30/2018 (EP)
Environmental Team for Kai Tak Sports Park –
Design and Construction**

Monthly EM&A Report for August 2024

This is the 65th Monthly EM&A Report for the construction phase of the Project which summarizes findings of the EM&A programme during the reporting period from 1 to 31 August 2024.

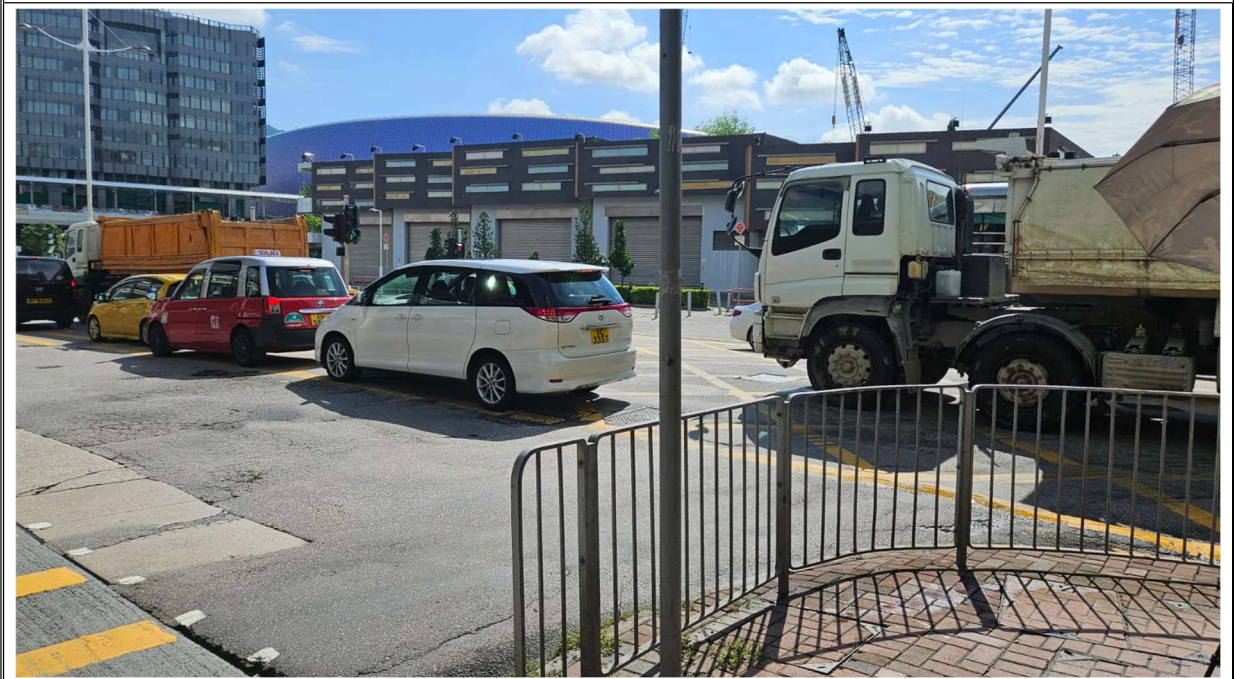
Photo 1a and 1b: Nearby road traffic along To Kwa Wan Road at NMS1-T2 on 13 August 2024.

RECOMMENDATIONS / MITIGATION MEASURES / ACTIONS			
Environmental mitigation measures have been maintained as follow:			
1. Power Mechanical Equipment with Quality Power Mechanical Equipment (QPME) labels were used at site to lower the noise nuisance to the nearby residents. (Photo 2)			
2. Regular site inspection was carried out to audit the implementation of mitigation measures on site. (Photo 3)			
5. Implementation of construction noise mitigation measures recommended in EIA's Environmental Mitigation Implementation Schedule.			
Prepared by:	Sunny Chan	Title:	Environmental Team Leader
Signature:

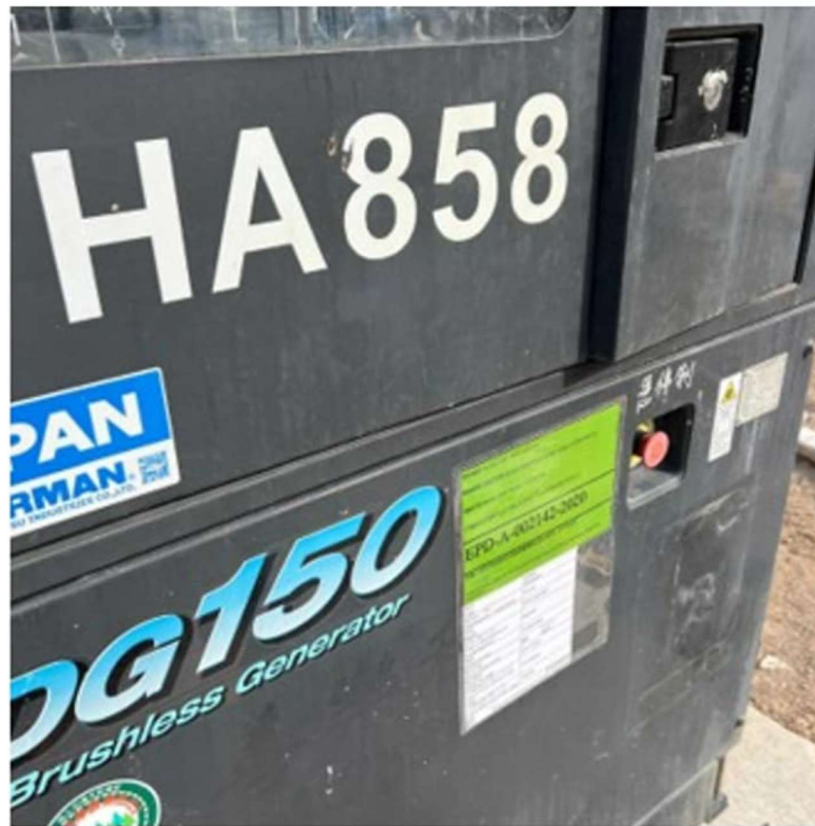
Photo 2: Power Mechanical Equipment with Quality Power Mechanical Equipment (QPME) labels were used at site to lower the noise nuisance to the nearby residents.

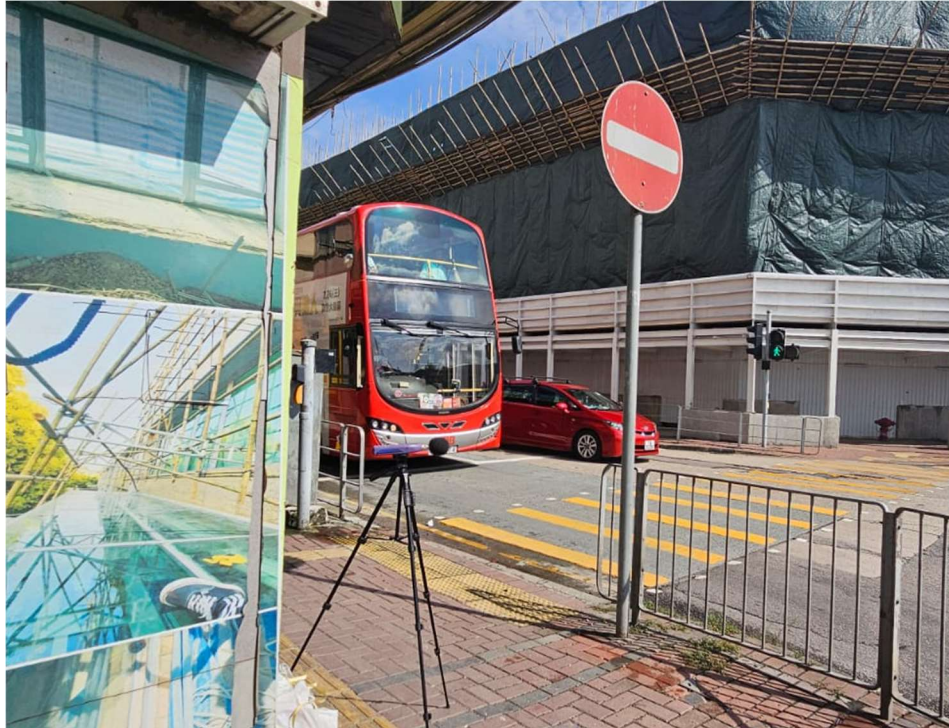
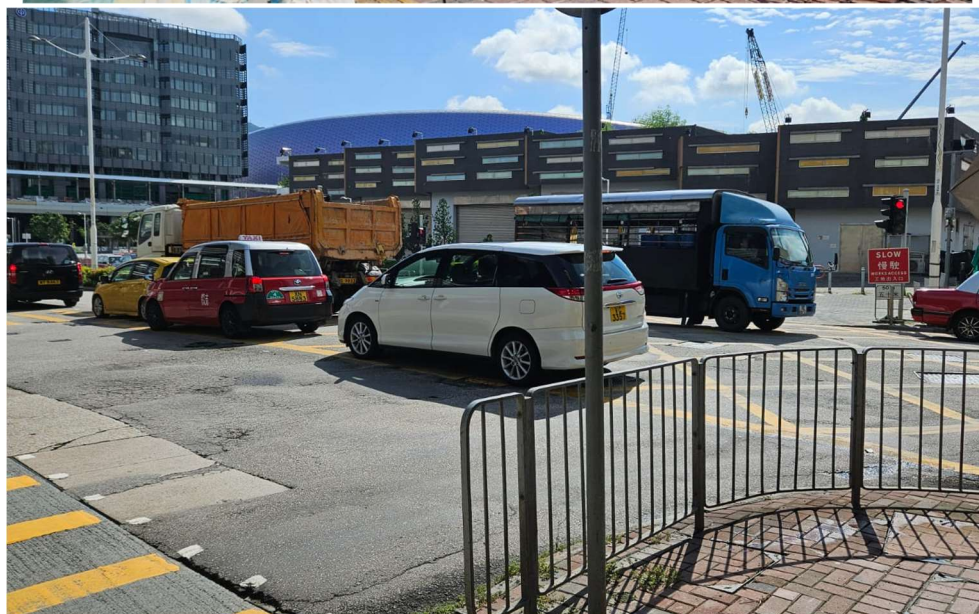
Photo 1a and 1b: Nearby road traffic along To Kwa Wan Road at NMS1-T2 on 19 August 2024.

RECOMMENDATIONS / MITIGATION MEASURES / ACTIONS			
Environmental mitigation measures have been maintained as follow:			
1. Power Mechanical Equipment with Quality Power Mechanical Equipment (QPME) labels were used at site to lower the noise nuisance to the nearby residents. (Photo 2)			
2. Regular site inspection was carried out to audit the implementation of mitigation measures on site. (Photo 3)			
5. Implementation of construction noise mitigation measures recommended in EIA's Environmental Mitigation Implementation Schedule.			
Prepared by:	Sunny Chan	Title:	Environmental Team Leader
Signature:

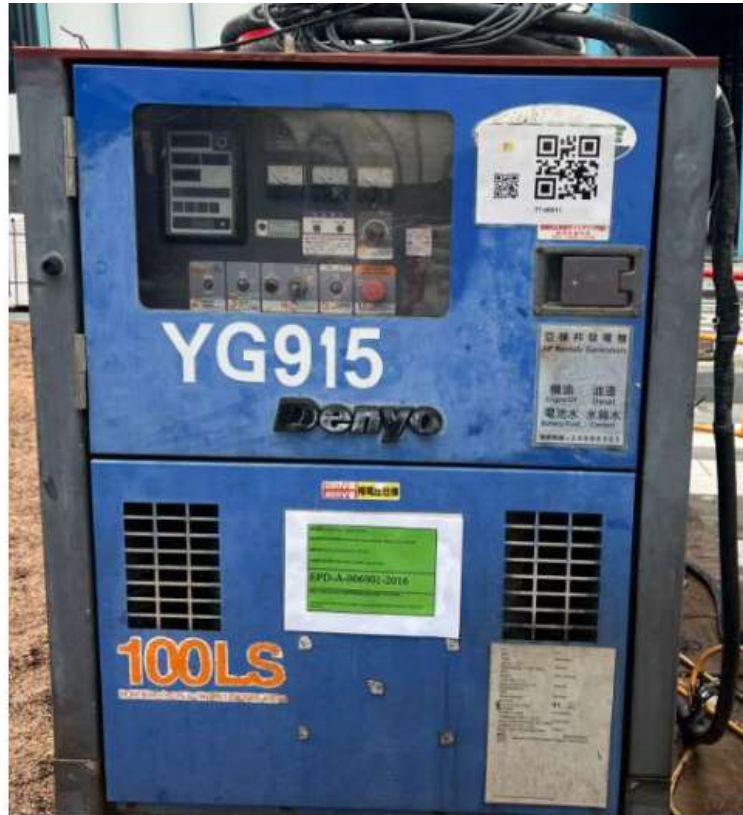
Photo 2: Power Mechanical Equipment with Quality Power Mechanical Equipment (QPME) labels were used at site to lower the noise nuisance to the nearby residents.

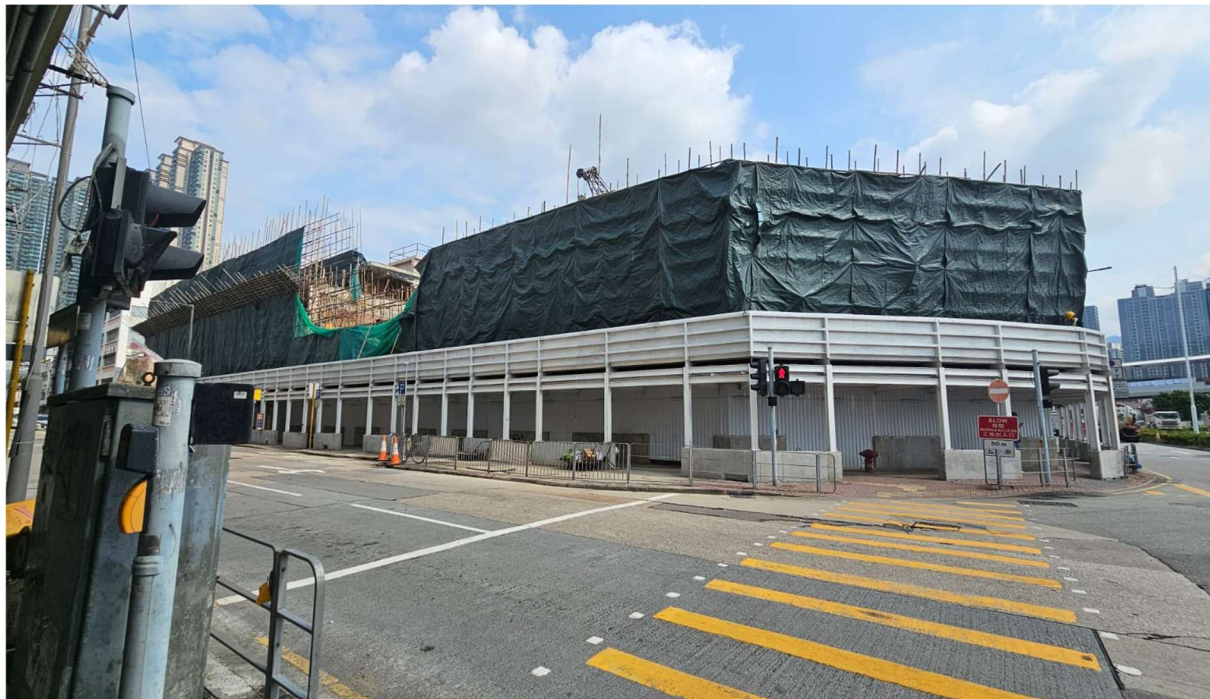
Photo 1a and 1b: Nearby demolition work at The Hong Kong Society for the Blind Workshop and Hostel on 29 August 2024.

RECOMMENDATIONS / MITIGATION MEASURES / ACTIONS			
Environmental mitigation measures have been maintained as follow:			
<ol style="list-style-type: none"> 1. Power Mechanical Equipment with Quality Power Mechanical Equipment (QPME) labels were used at site to lower the noise nuisance to the nearby residents. (Photo 2) 2. Regular site inspection was carried out to audit the implementation of mitigation measures on site. (Photo 3) 5. Implementation of construction noise mitigation measures recommended in EIA's Environmental Mitigation Implementation Schedule. 			
Prepared by:	Sunny Chan	Title:	Environmental Team Leader
Signature:

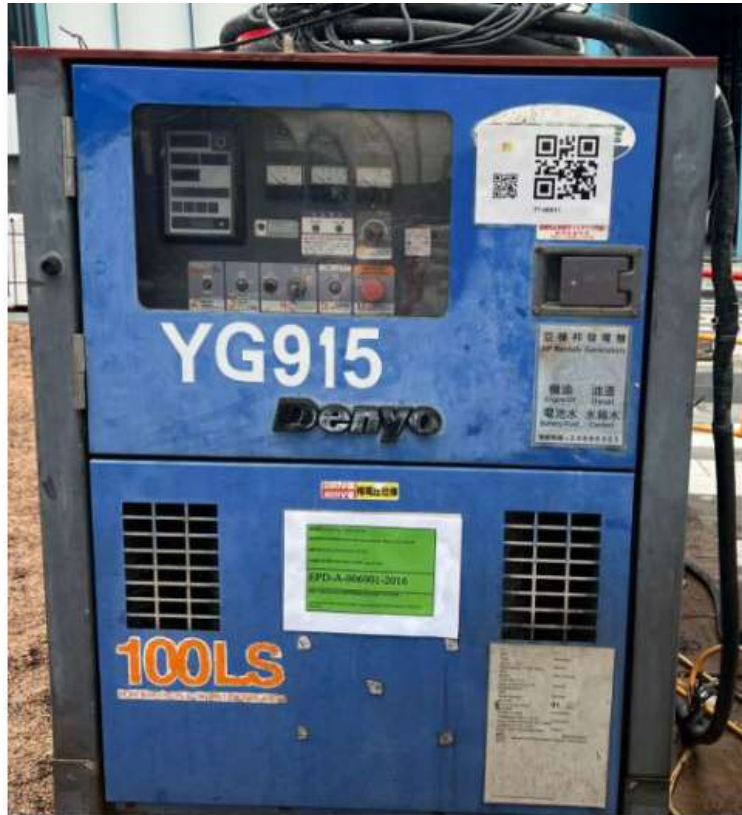
Photo 2: Power Mechanical Equipment with Quality Power Mechanical Equipment (QPME) labels were used at site to lower the noise nuisance to the nearby residents.
