**Agreement No. CE 30/2018 (EP)  
Environmental Team for Kai Tak Sports Park –  
Design and Construction**

Monthly EM&A Report for October 2024

### Kai Tak Sports Park - Investigation

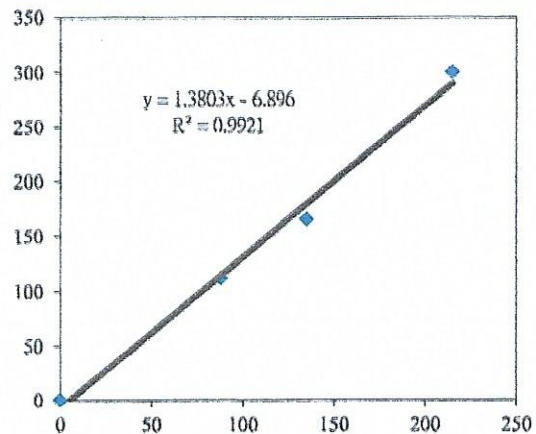
Slope (K-factor): 1.3803(µg/m³)/CPM  
Correlation Coefficient (R): 0.9960  
Date of Issue: 15-Dec-2023

- 1. Strong Correlation (>0.8)
- 2. Factor 1.3803 (µg/m³)/CPM should be applied for TSP monitoring

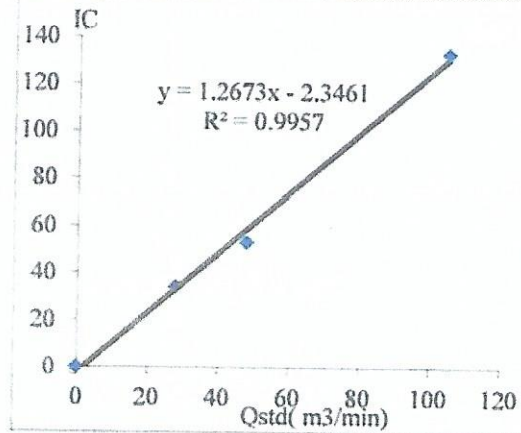
Slope (K-factor): 1.2673(µg/m³)/CPM  
Correlation Coefficient (R): 0.9978  
Date of Issue: 19-May-2024

- Strong Correlation (>0.8)
- Factor 1.2673(µg/m³)/CPM should be applied for TSP monitoring

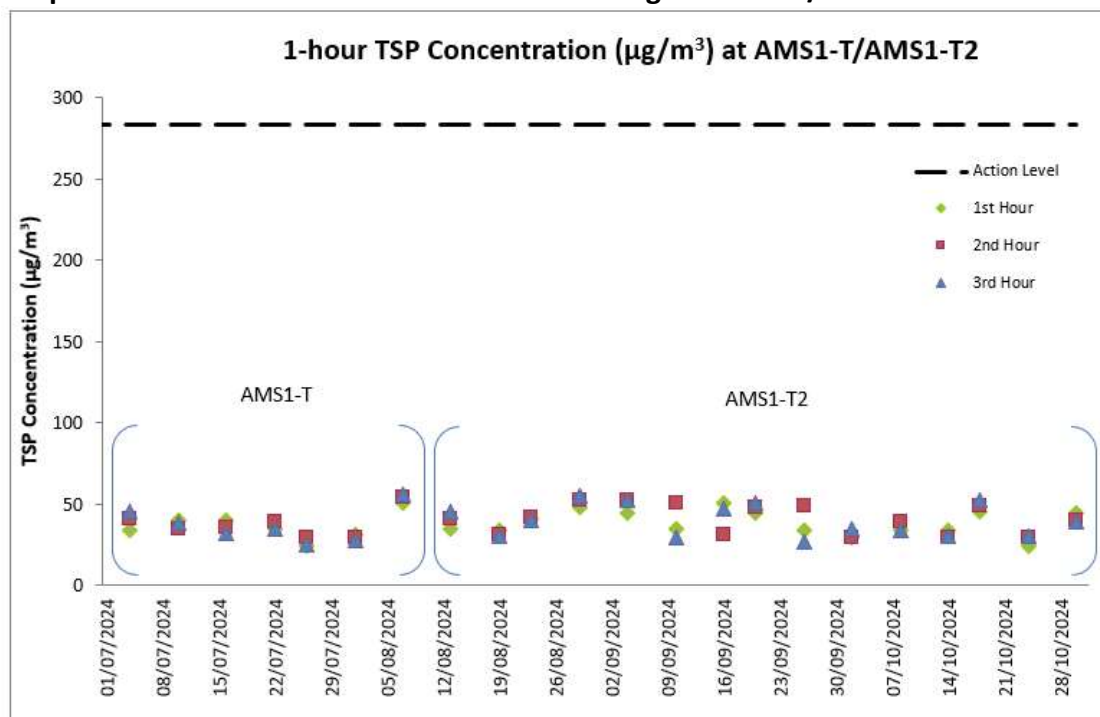
## Graphical Presentation for 1-hour TSP Monitoring at AMS1-T/AMS1-T2

During the reporting period, temporary monitoring station AMS1-T, was no longer accessible from 13 August 2024, due to the relocation of the Agriculture, Fisheries and Conservation Department Kowloon Animal Management Centre. Alternative temporary air quality monitoring station, AMS1-T2 was proposed by ET and agreed by IEC on 9 August 2024 and further approved by EPD on 28 August 2024 for conducting impact monitoring during the reporting period.

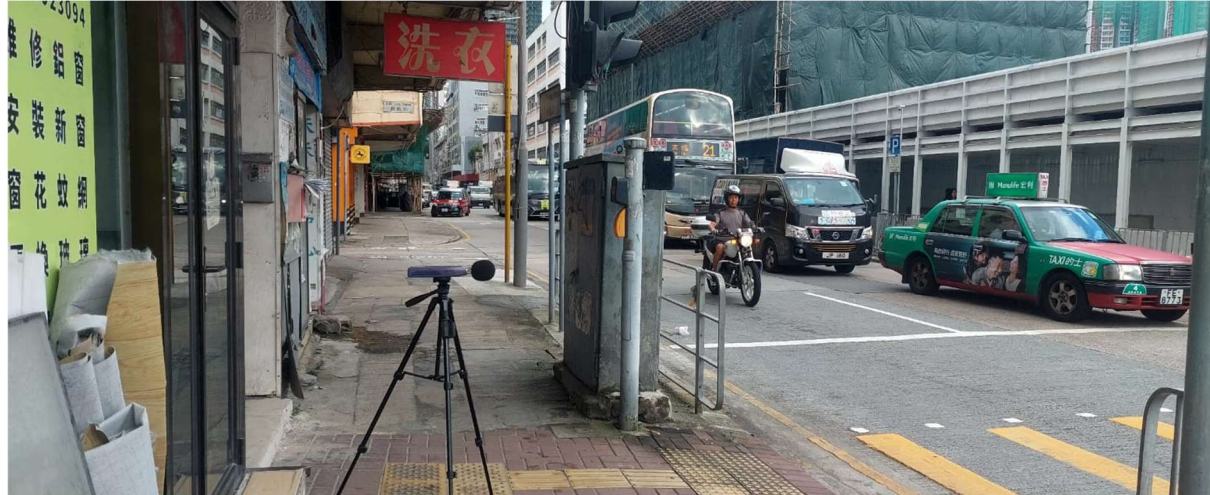
**Photo 1a and 1b:** Nearby road traffic along Mok Cheong Street and To Kwa Wan Road at NMS1-T2 on 8 October 2024.

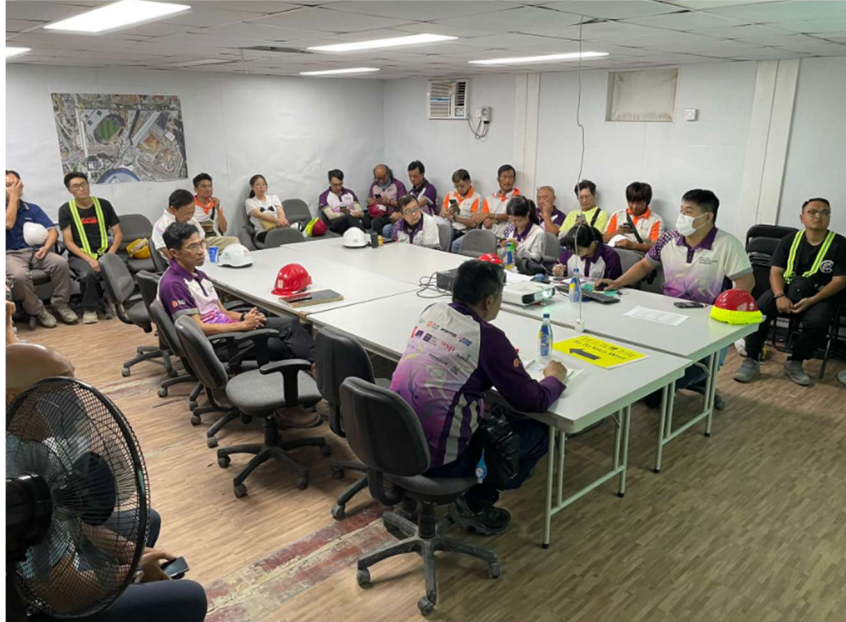
**Photo 1 :** Subcontractors had been reminded to finish the light testing at night as early as possible by 22:30 and completely switch off all external sports light by 23:00.

RECOMMENDATIONS / MITIGATION MEASURES / ACTIONS			
Environmental mitigation measures have been maintained as follow:			
1. Subcontractors had been reminded to finish the light testing at night as early as possible by 22:30 and completely switch off all external lighting by 23:00. (Photo 1)

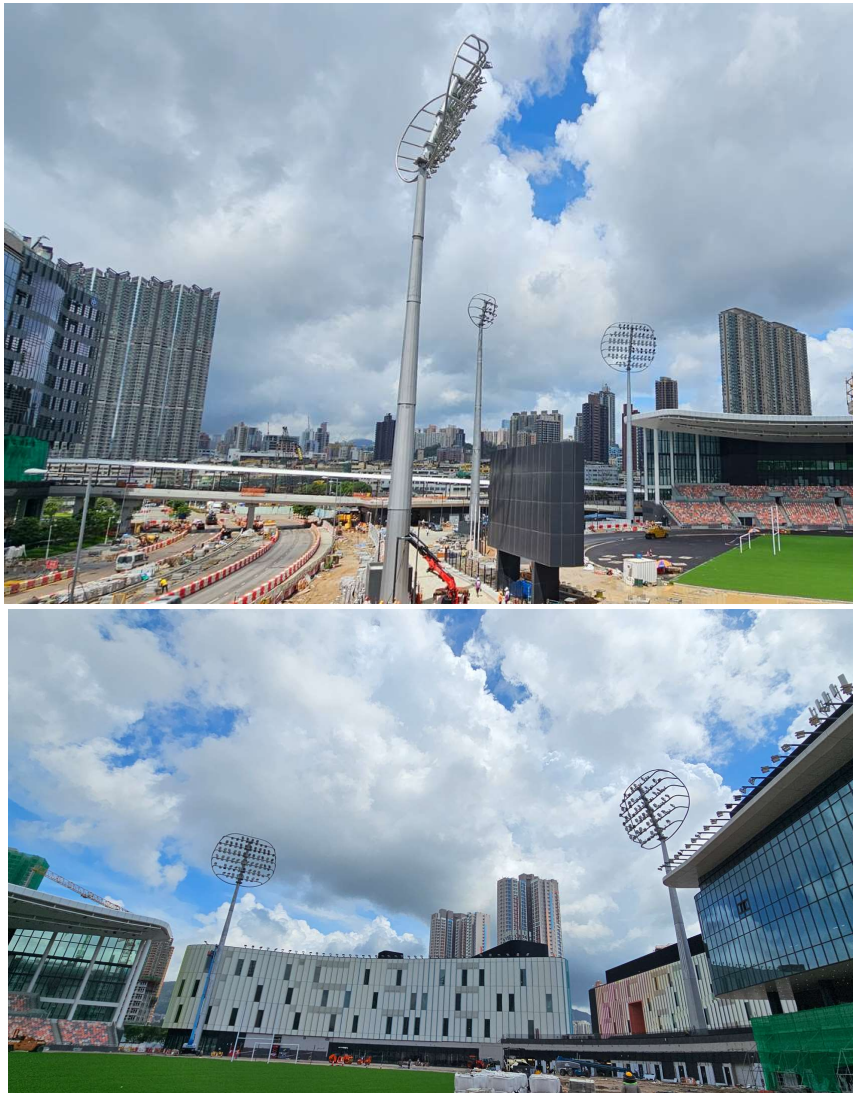
**Photo 3a and 3b:** Spot lights are adjusted to control lighting direction away from nearby residential.
