**CEDD SERVICE CONTRACT NO. WD/07/2022**

**YUEN LONG SOUTH FIRST PHASE DEVELOPMENT -  
ENVIRONMENTAL TEAM**

**BASELINE SURVEY FOR AQUATIC FAUNA**

TCS01267/22/600/R0157r1

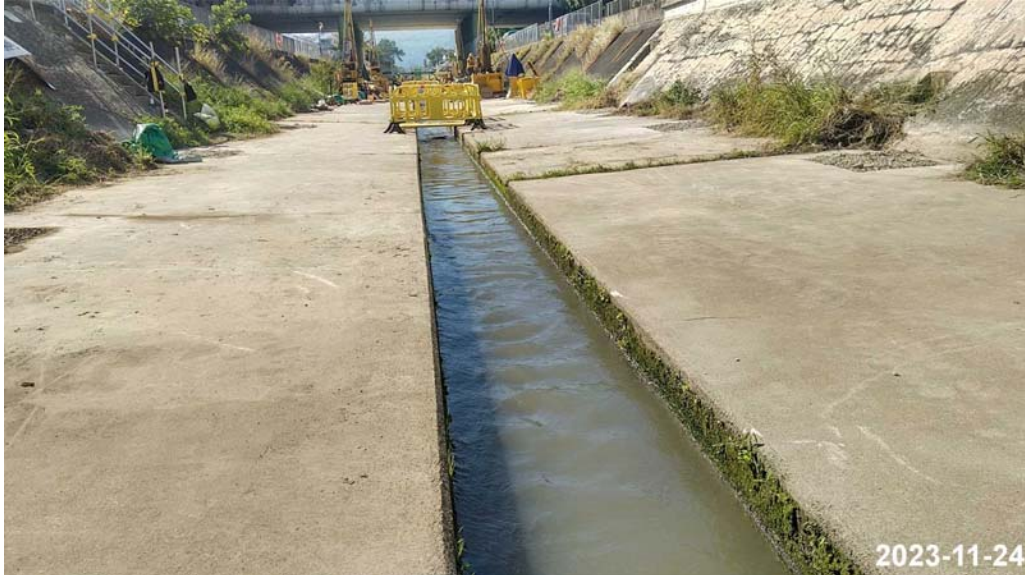
- 2.2.1 The baseline aquatic fauna survey for the sampling point C2-AQ1 was undertaken on 24<sup>th</sup> November 2023. The weather was fine on the day of survey, and water flow was only observed within the low flow channel of the nullah and found to be fast during the time of the survey; and the water was very mucky and heavily loaded with suspended refuse. On the other hand, bankside vegetation growth along the low flow channel is virtually absence and limited to the mosses adhered on the concrete embankment. Nonetheless, strips of herbaceous plants were established at the bottom of the sloped embankment of the nullah.

1. General Overview of the Site Condition at the Sampling Point C2-AQ1

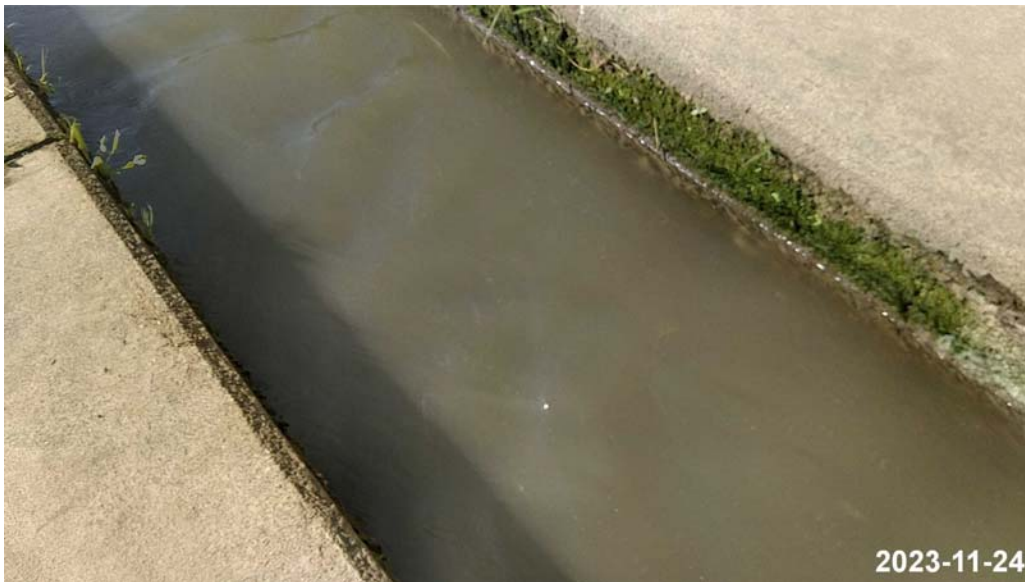
2. Mucky Water

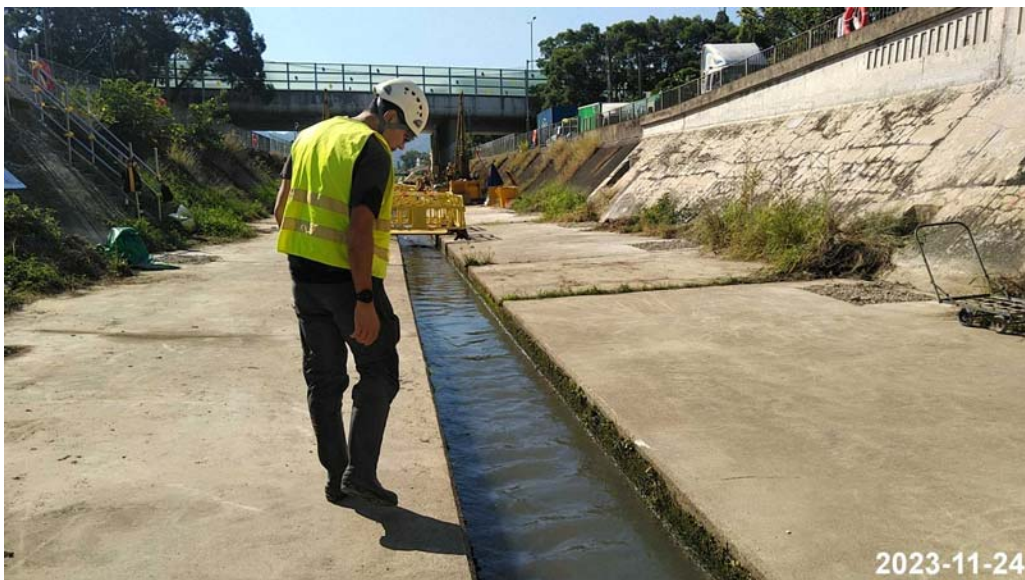
- 3.1.1 The baseline aquatic fauna survey undertaken at the sampling point C2-AQ1 was carried out by means of active searching and direct observation along the low flow channel as well as along the strip of vegetation established on the bottom of the embankment; and sweep netting has also been conducted within the low flow channel.
- 3.1.2 However, except several common odonate species which flying around the nullah (such as the Green Skimmer, Wandering Glider and Red-faced Skimmer), aquatic fauna has not been recorded within this section of the nullah during the baseline aquatic fauna survey. Nonetheless, low abundance of the exotic and common freshwater fishes Tilapia sp. and mosquito fish were noted at a confluence of the nullah downstream of the sampling point – where the water was relatively clearer.

3. Direct Observation and active searching at the low flow channel

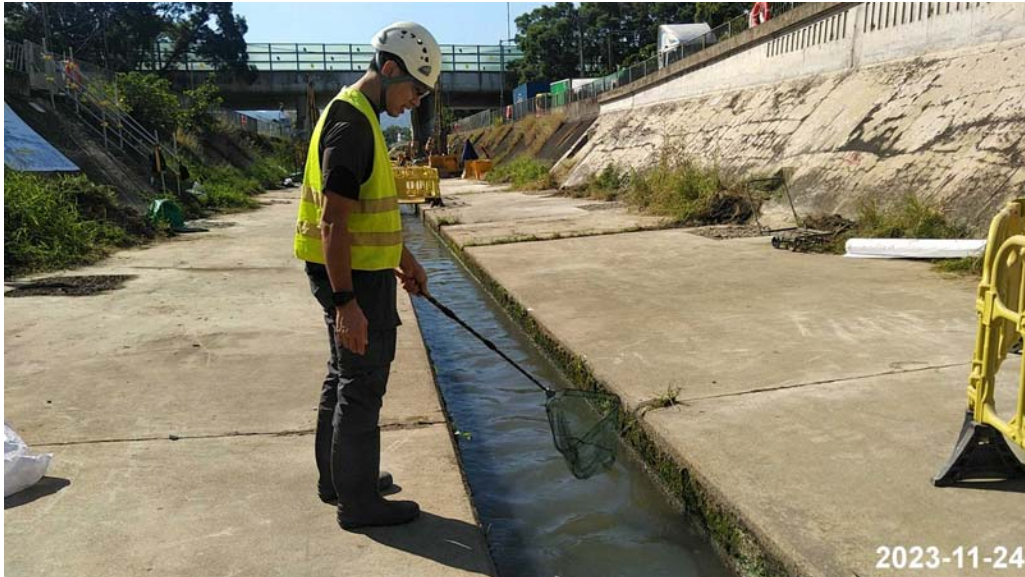
4. Sweep netting at low flow channel

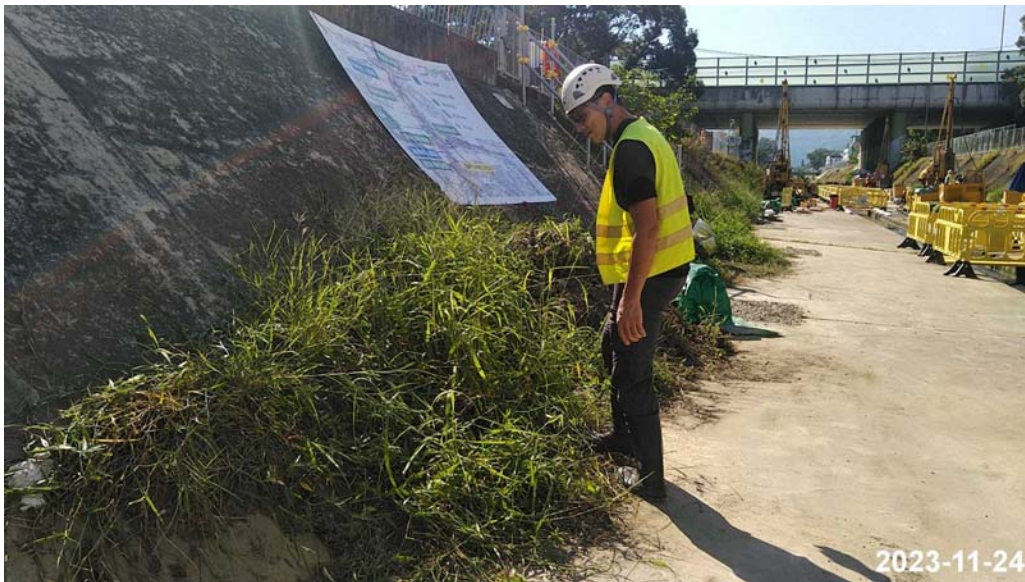
5. Direct Observation and active searching at the bottom of the embankment

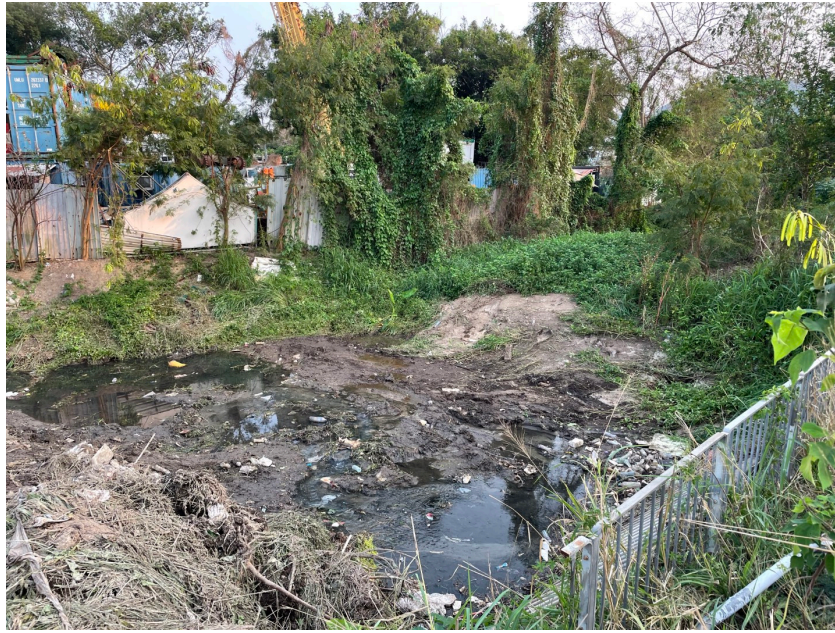
- 2.2.2 The baseline aquatic fauna survey for the sampling point C2-AQ9 was undertaken on 10<sup>th</sup> April 2024 and weather was fine on the day of survey. Although this section of watercourse is a natural watercourse where its bank is overgrown with herbaceous vegetation and the stream-bed is heavily deposited with dark and fine sediment, disturbance such as vegetation clearance/modification of its bankside or littering was found to be prominent. The water level and waterflow within the watercourse was shallow and low during the time of the survey; and the water was found to be fairly turbid.

1. General Overview of the Site Condition at the Sampling Point C2-AQ9

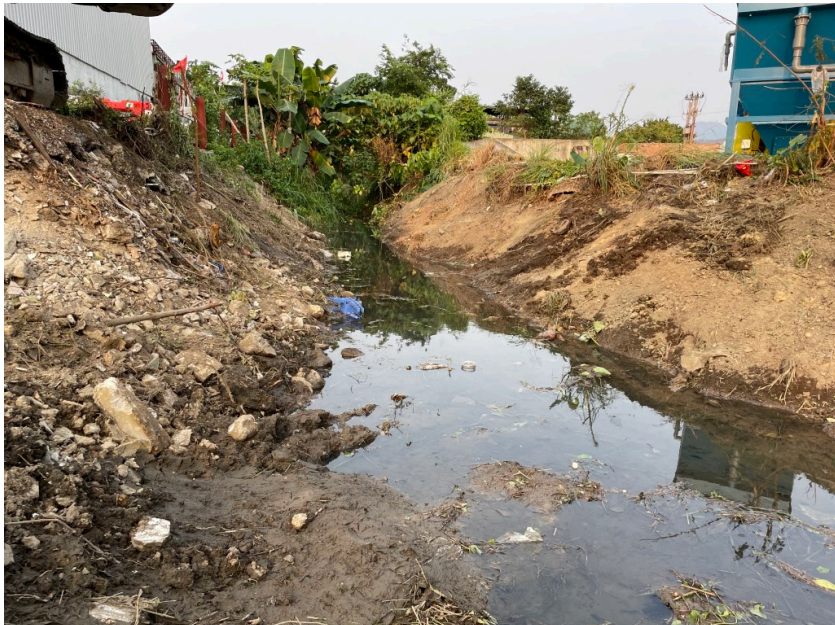
2. General Overview of the Site Condition at the Sampling Point C2-AQ9

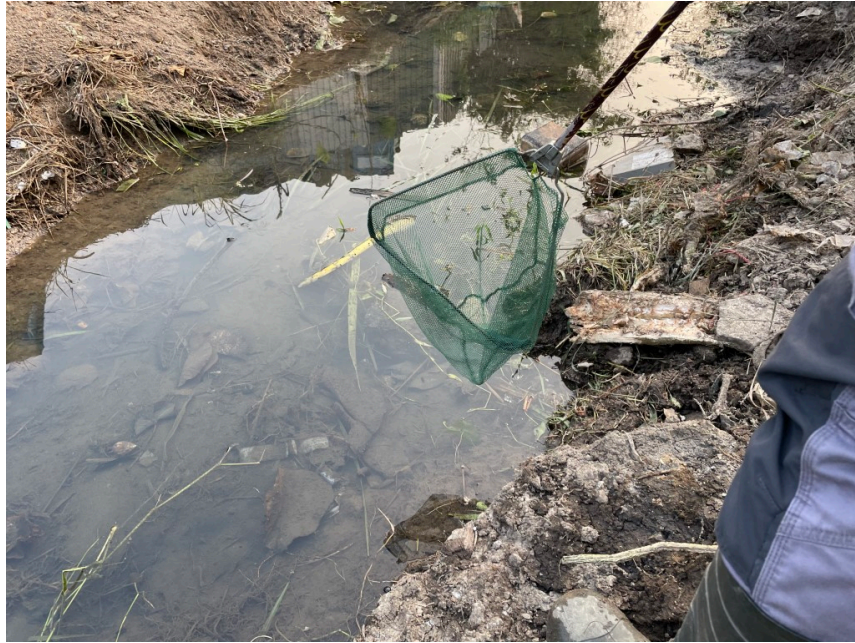
- 3.1.3 The baseline aquatic fauna survey undertaken at the sampling point C2-AQ9 was carried out by active searching and direct observation along the bankside; as well as sweep netting of the riparian vegetation. However, aquatic life recorded along the bankside was found to be sparse and only recorded with the exotic apple snail; and aquatic faunal species of conservation interest has not been recorded.

3. Sweep netting at the bankside
