**Peng Chau Cable System**

# **Post-Installation Coral Survey Report**

**ECO-ENVIRO CONSULTANTS COMPANY**

**Dec 2023**

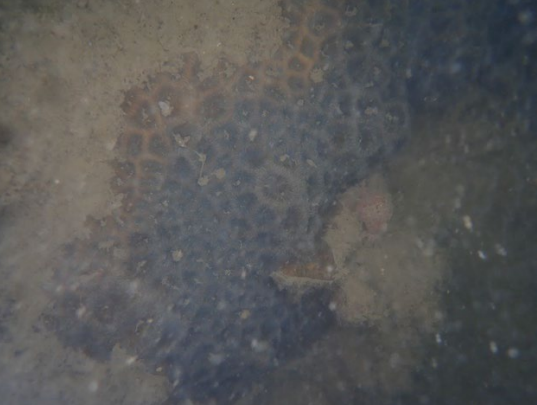
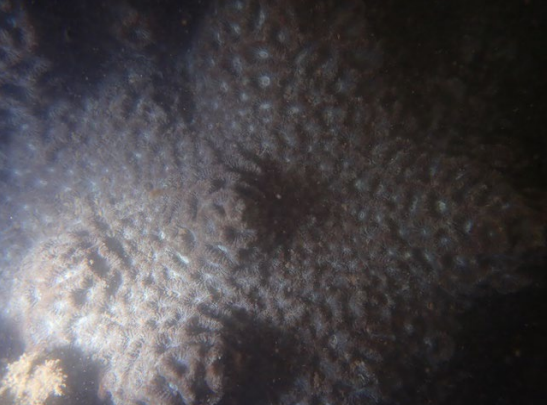
No.	Coral species	Size (cm)	% Bleaching	Partial Mortality	% Sediment	GPS Coordinates	
1	<i>Platygyra ryukyuensis</i>	46	0	0	0	22°17'32.39N	114°01'11.54E
2	<i>Platygyra ryukyuensis</i>	57	0	0	0	22°17'32.37N	114°01'11.63E
3	<i>Coelastrea aspera</i>	27	0	0	0	22°17'32.29N	114°01'12.24E
4	<i>Favites pentagona</i>	42	0	0	0	22°17'32.27N	114°01'12.82E

Coral #3 <i>Coelastrea aspera</i>	Coral #4 <i>Favites pentagona</i>

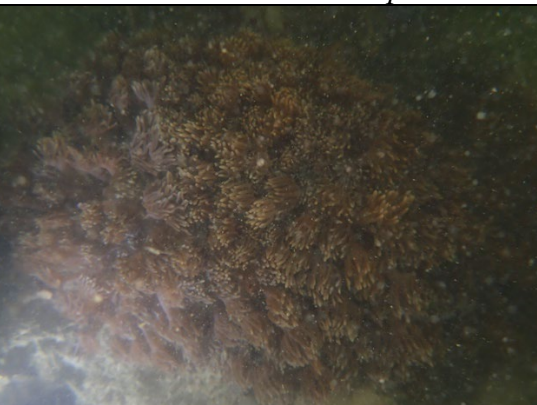
No.	Coral species	Size (cm)	% Bleaching	Partial Mortality	% Sediment	GPS Coordinates	
5	<i>Goniopora columna</i>	21	0	0	0	22°17'32.37N	114°01'13.05E

Coral #5 <i>Goniopora columna</i>

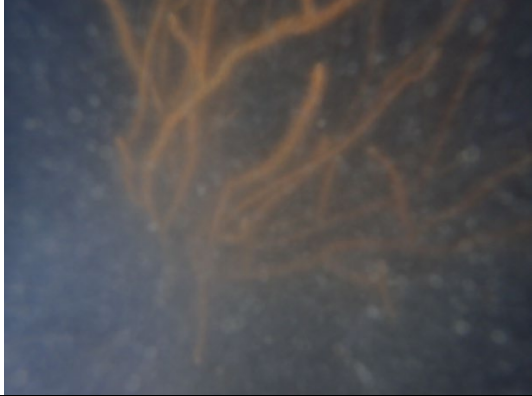
3.5 No hard coral was recorded in TL and only one gorgonian coral *Menella* sp. was recorded (at least 20 m away from the cable alignment) near the cable alignment. Photos of each coral colony were shown in **Photo Plate B**. The recorded coral colony in the survey area is common gorgonian species in Hong Kong water.

No.	Coral species	Size (cm)	% Bleaching	Partial Mortality	% Sediment	GPS Coordinates	
1	<i>Menella</i> sp.	32	0	0	0	22°17'20.71N	114°01'52.38E

Coral #1 <i>Menella</i> sp.
