Removal of 132kV Overhead Line and Pylons for B-Line and W-Line

Ecological Management Plan (B6-9,
B12, B17)

5 November 2024

0643361

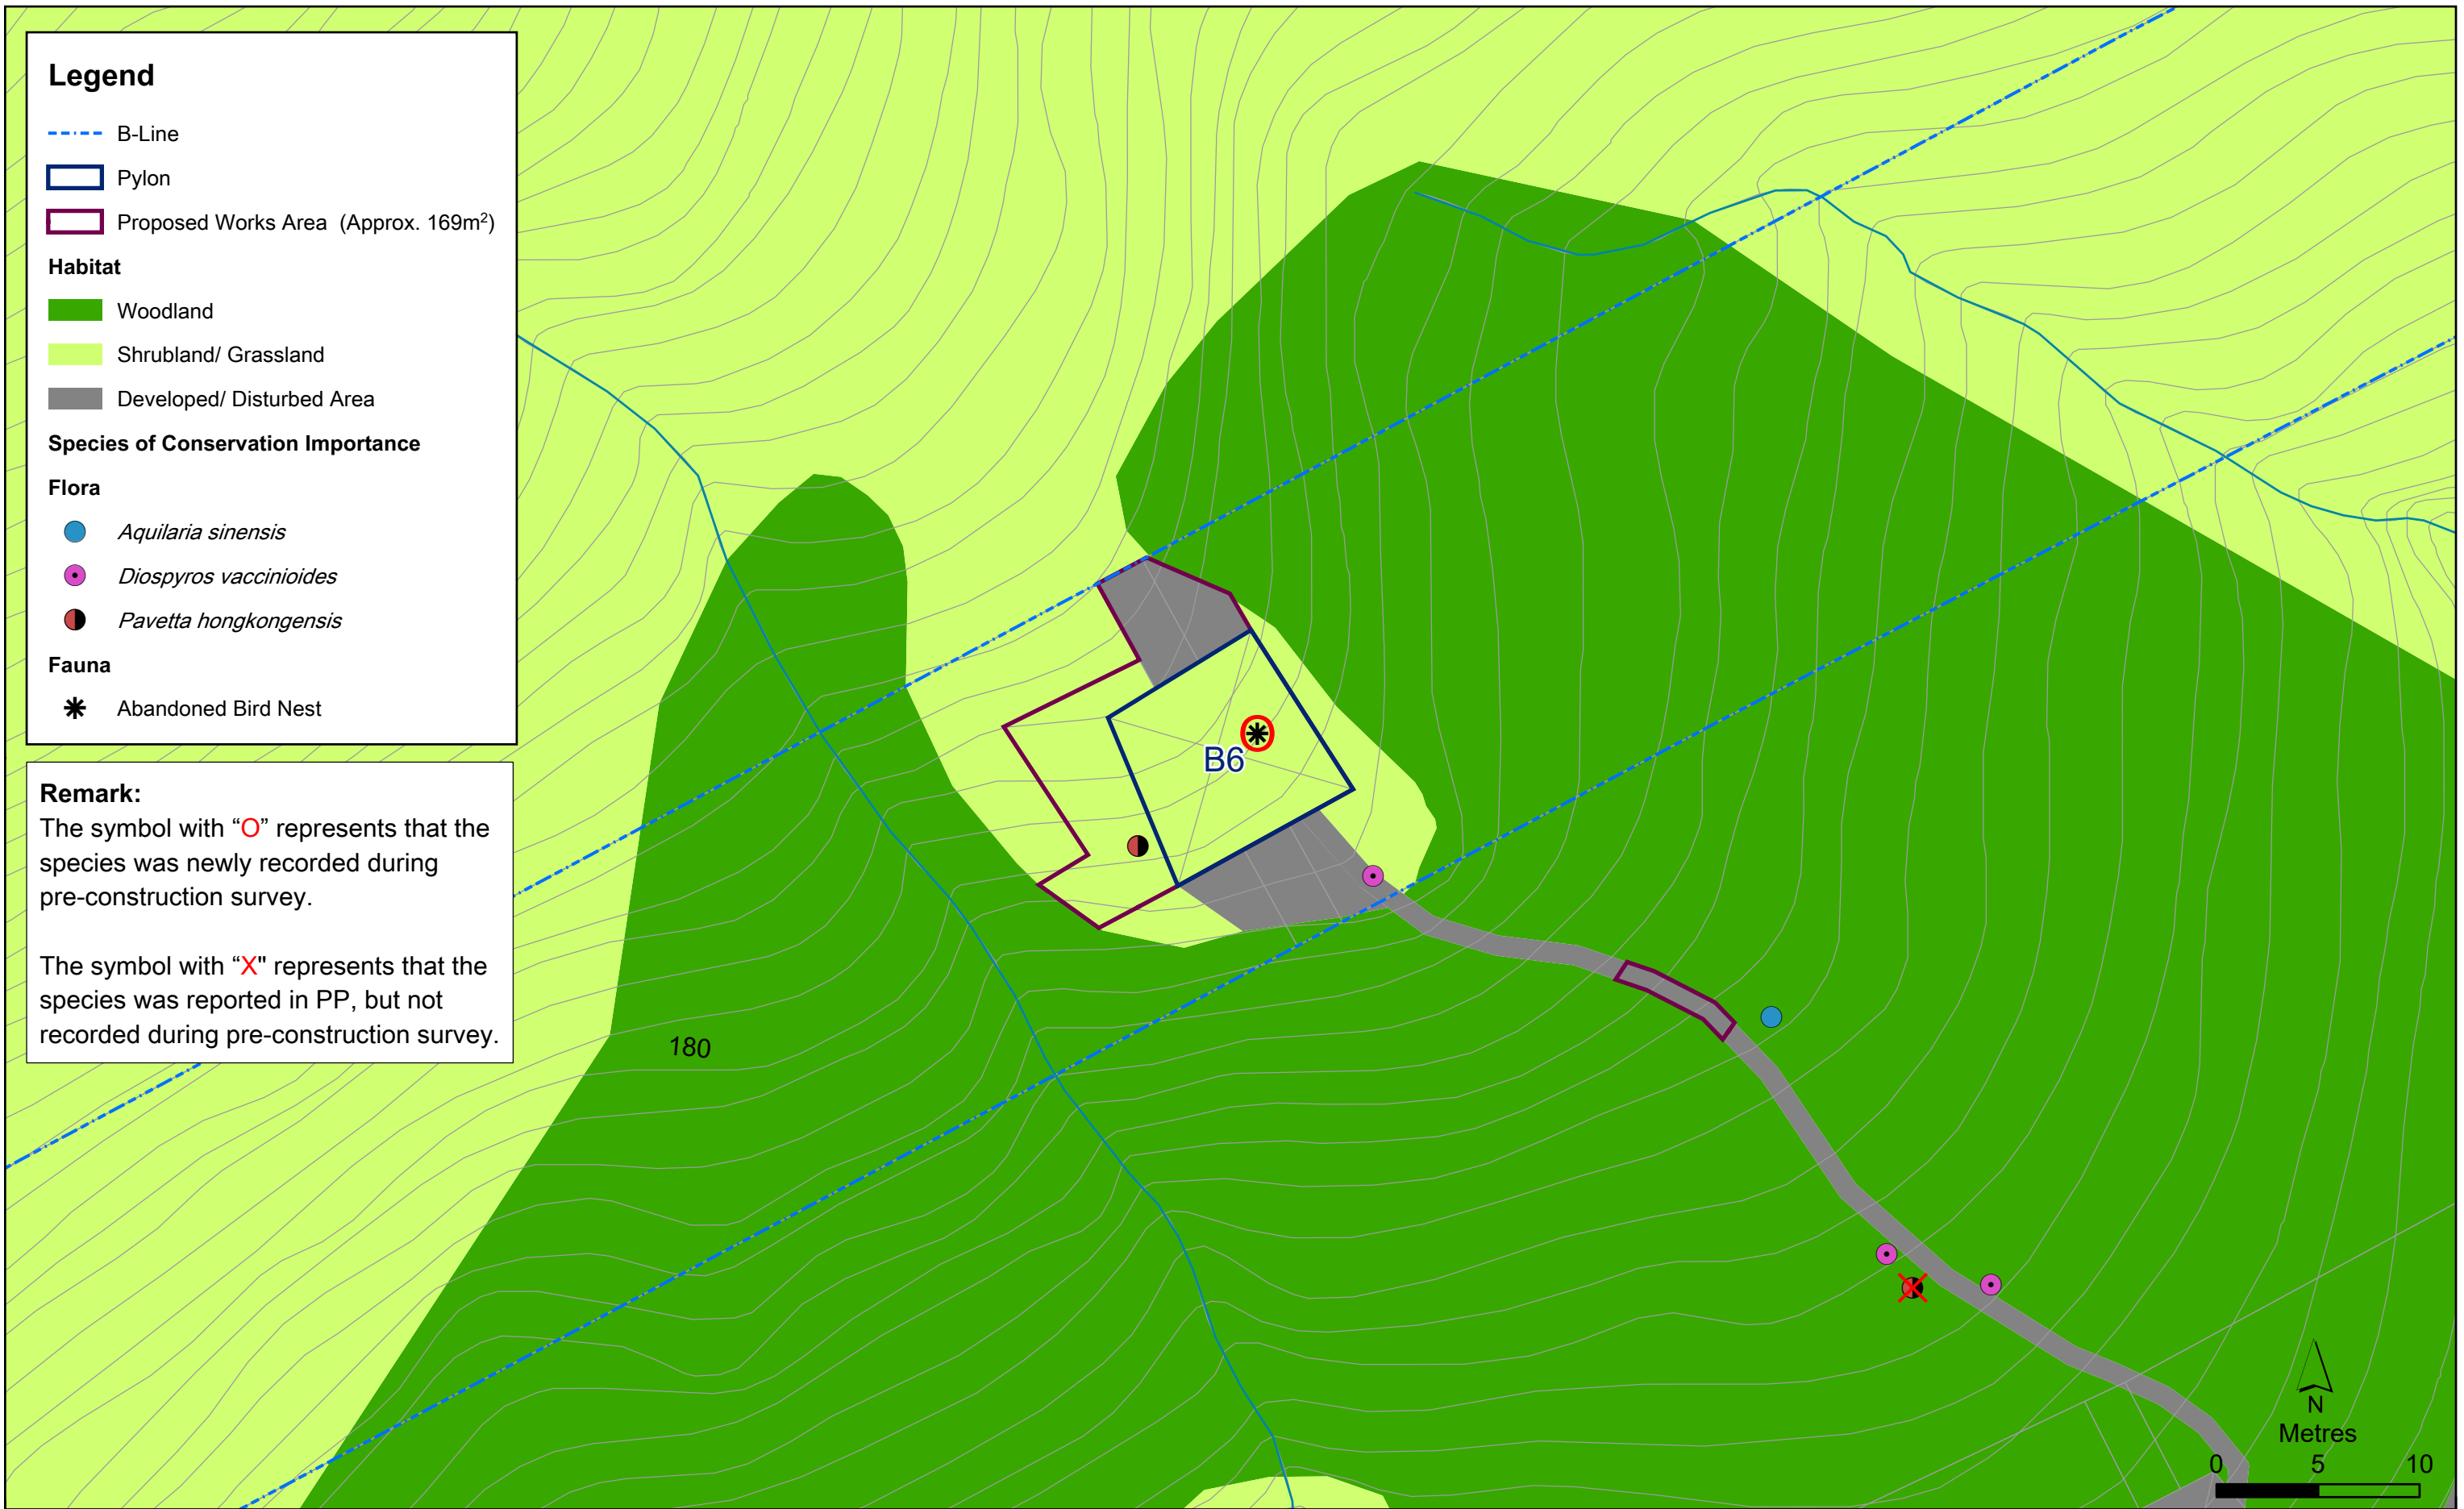
Figure 2.1.1

Zoom-in Habitat Map for Pylon B6

Pre-construction survey was carried out within the proposed works areas of B6 to B9, B12 and B17 and access path connecting to the pylons (**Figures 2.1.1** to **2.1.6**). Subject to the up-to-date site conditions, the works areas may be fine-tuned with the aim to minimise direct impacts on the woodland habitat and shrubland/grassland habitats (i.e. with minimum level of vegetation clearance) and flora species of conservation importance. Should any new flora species of conservation importance be identified during the pre-construction vegetation survey, avoidance and/or, if not practicable, similar means of protective measures should be applied to minimise potential damage on the plant(s).

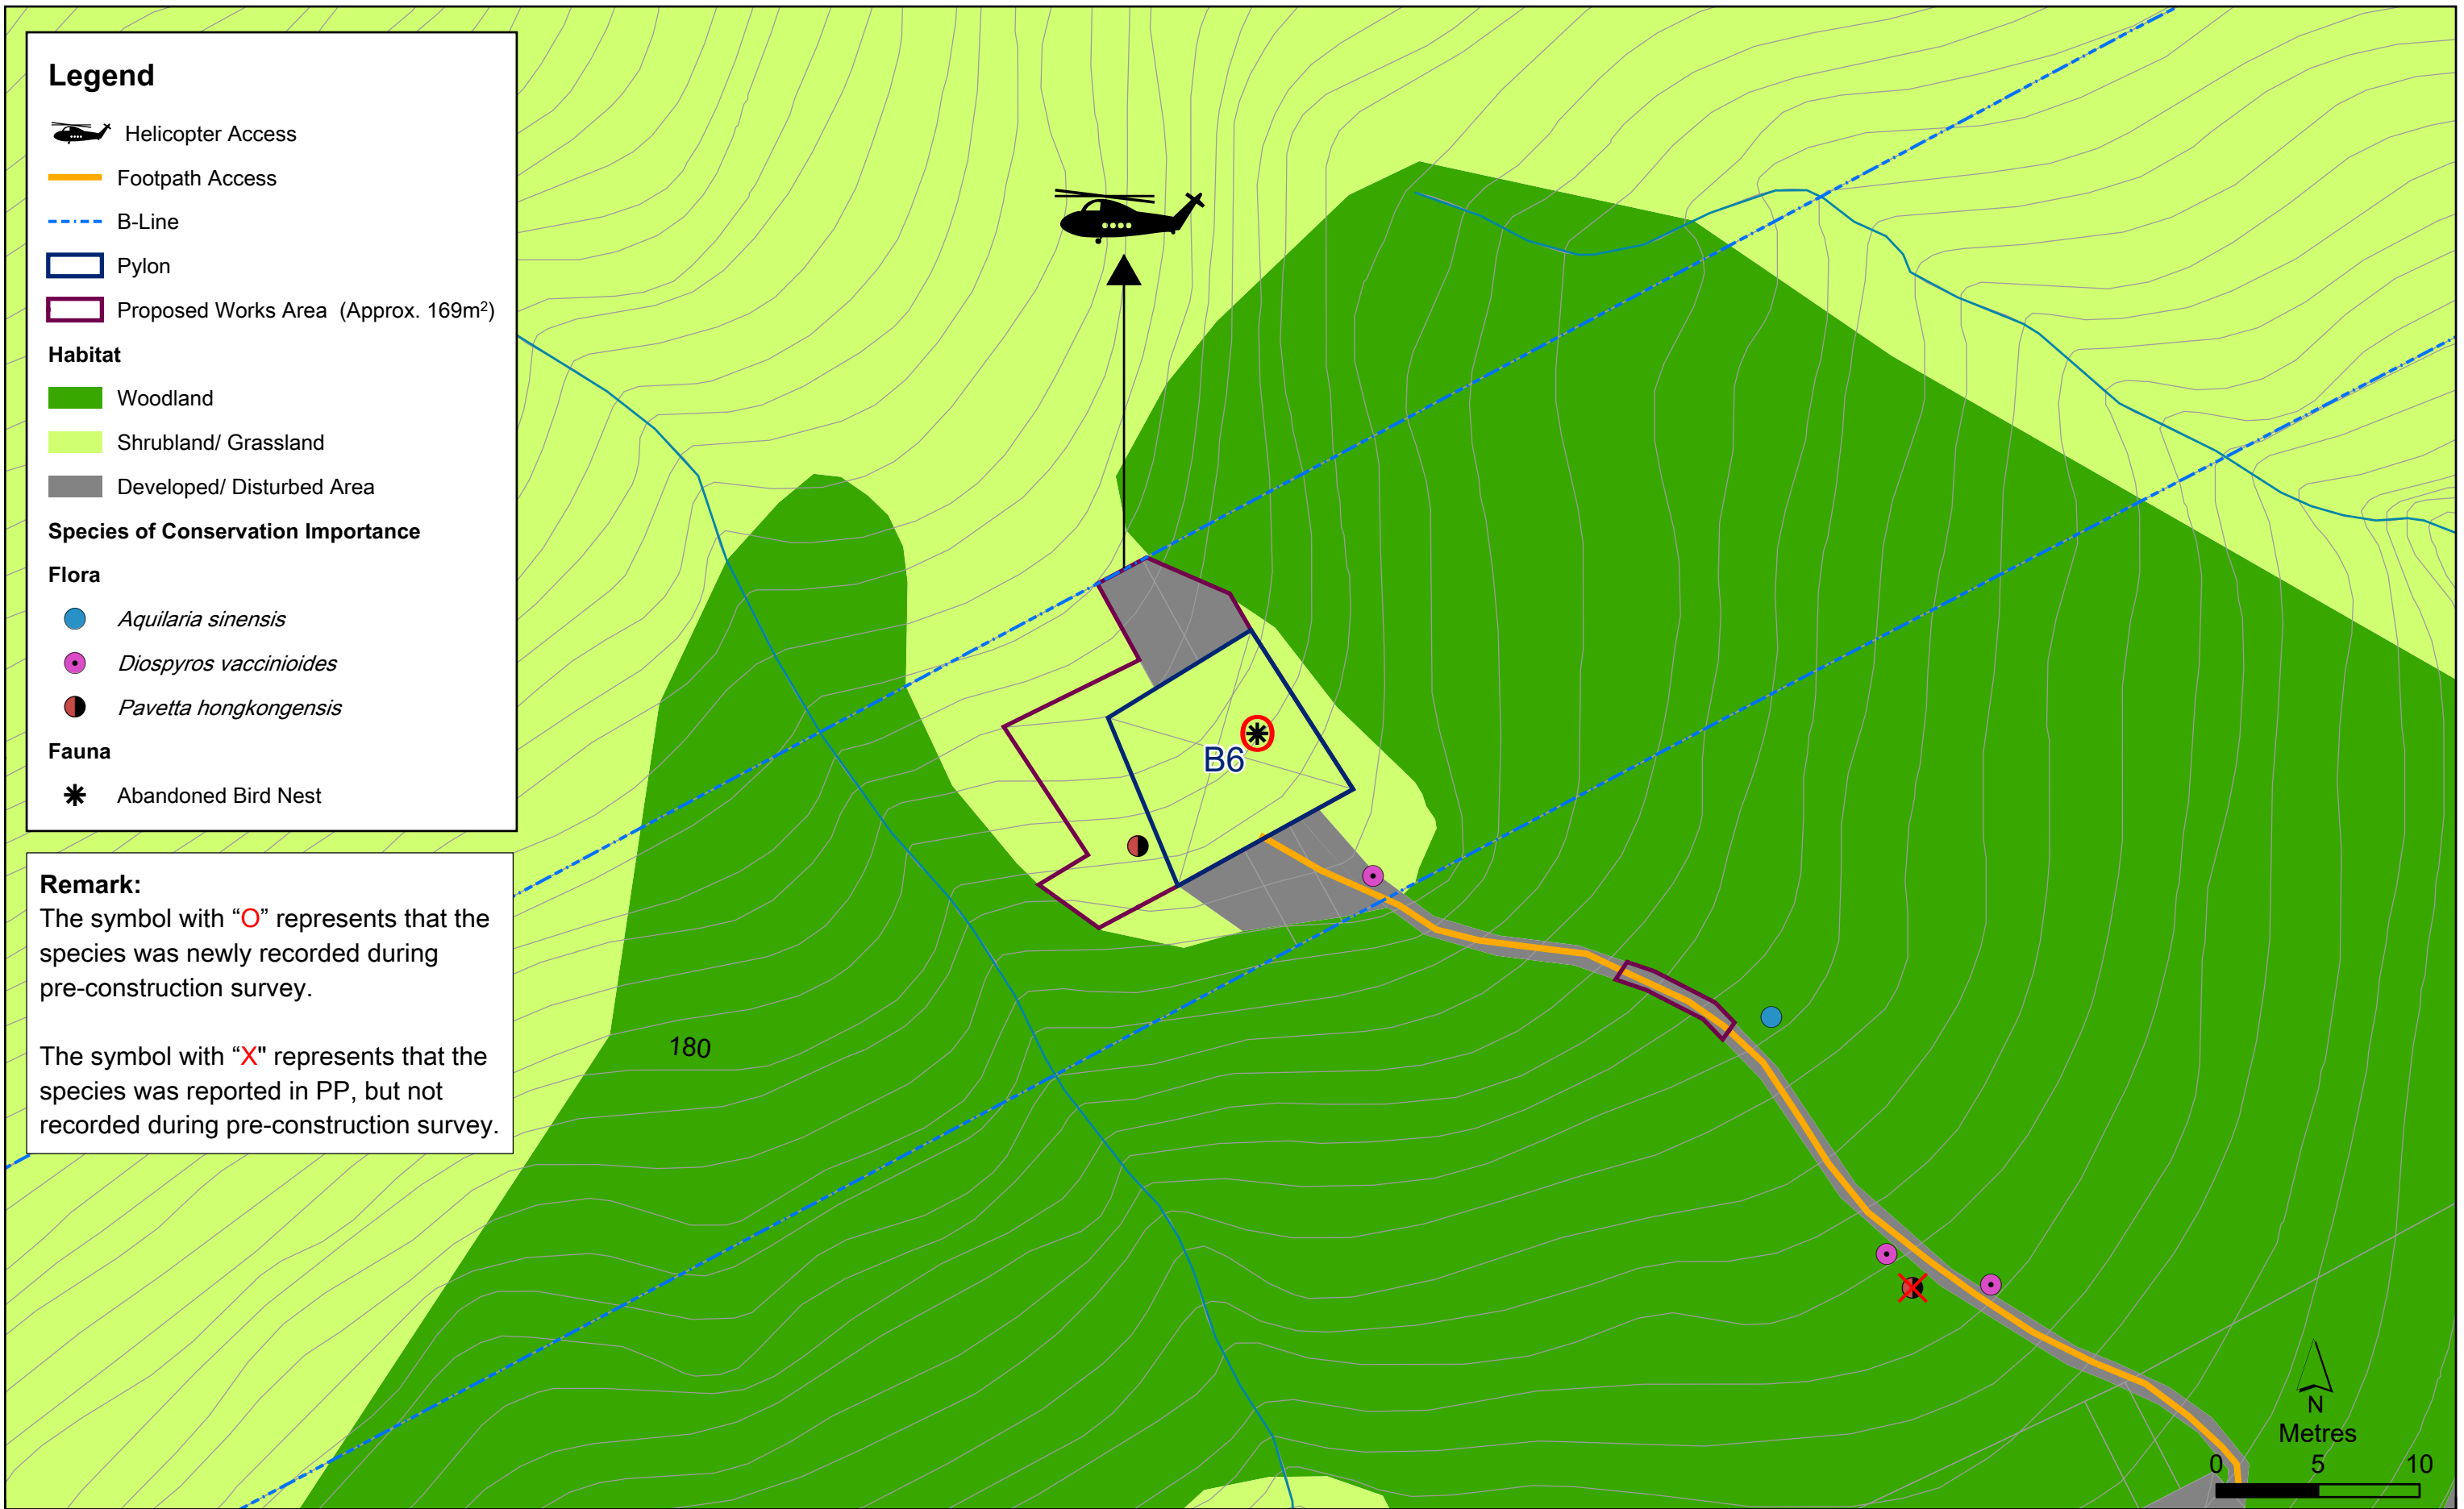
Figure 2.1.1a

Zoom-in Habitat Map for Pylon B6

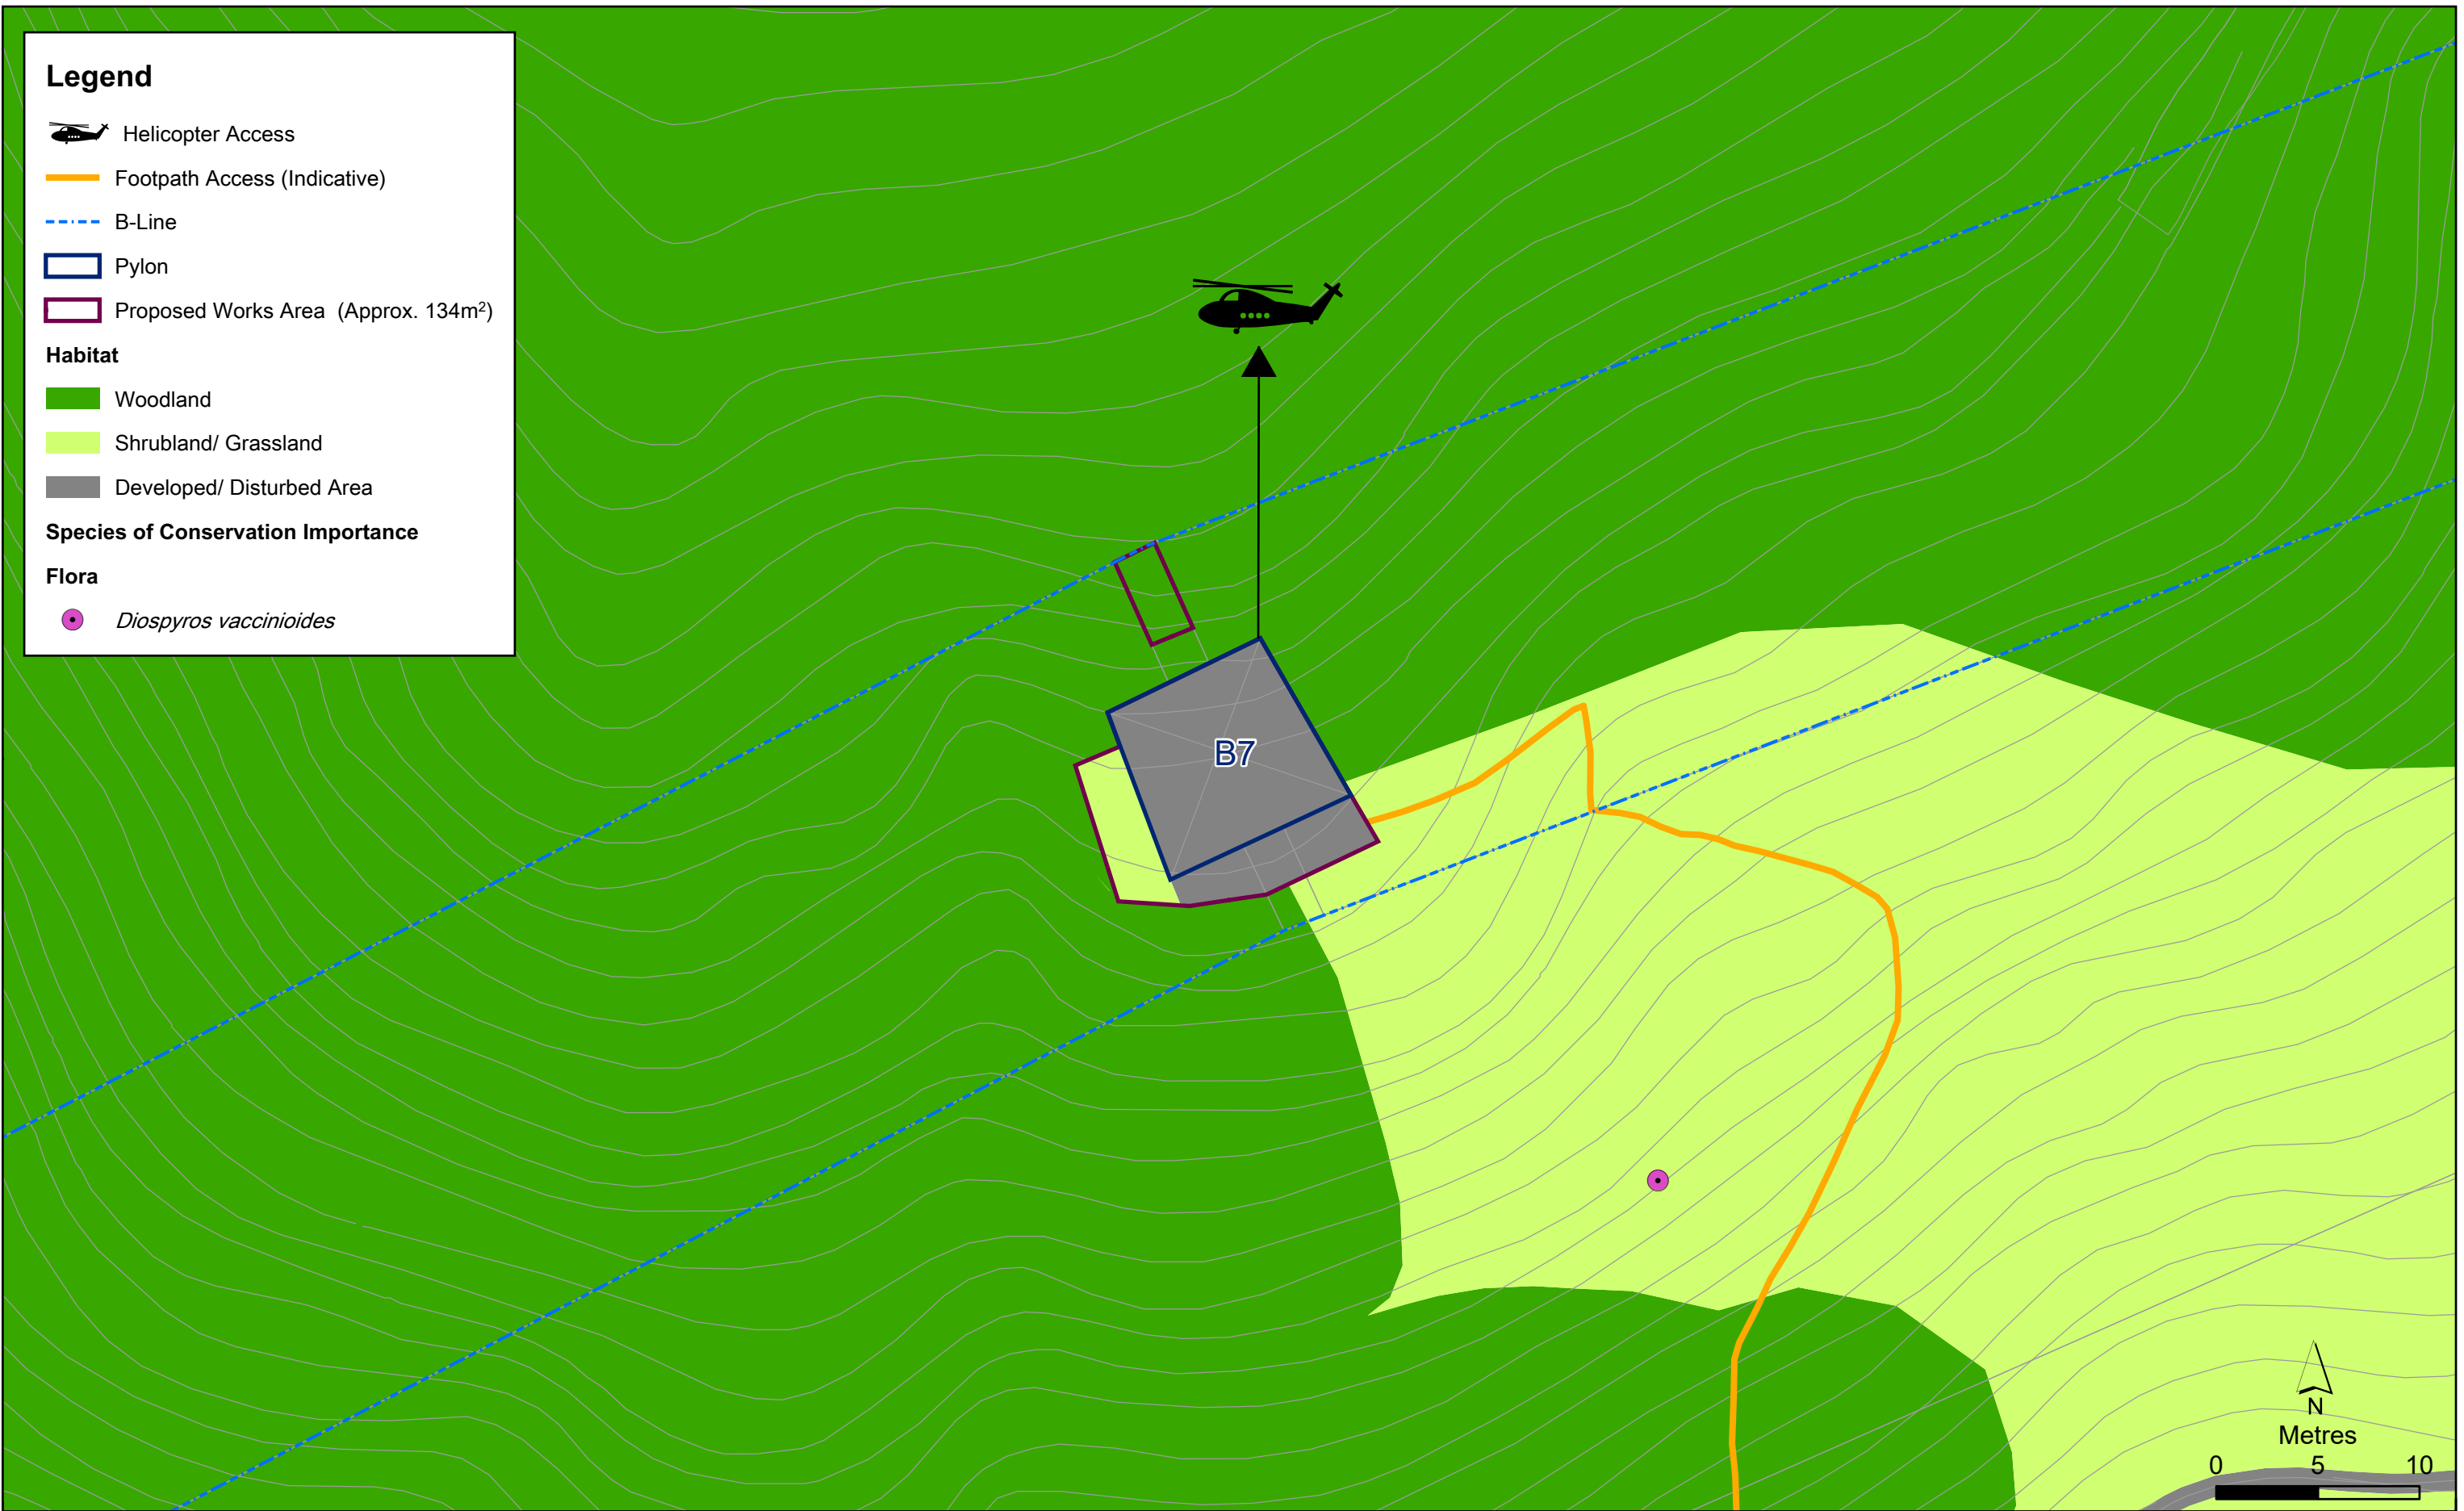
Figure 2.1.2a

Zoom-in Habitat Map for Pylon B7

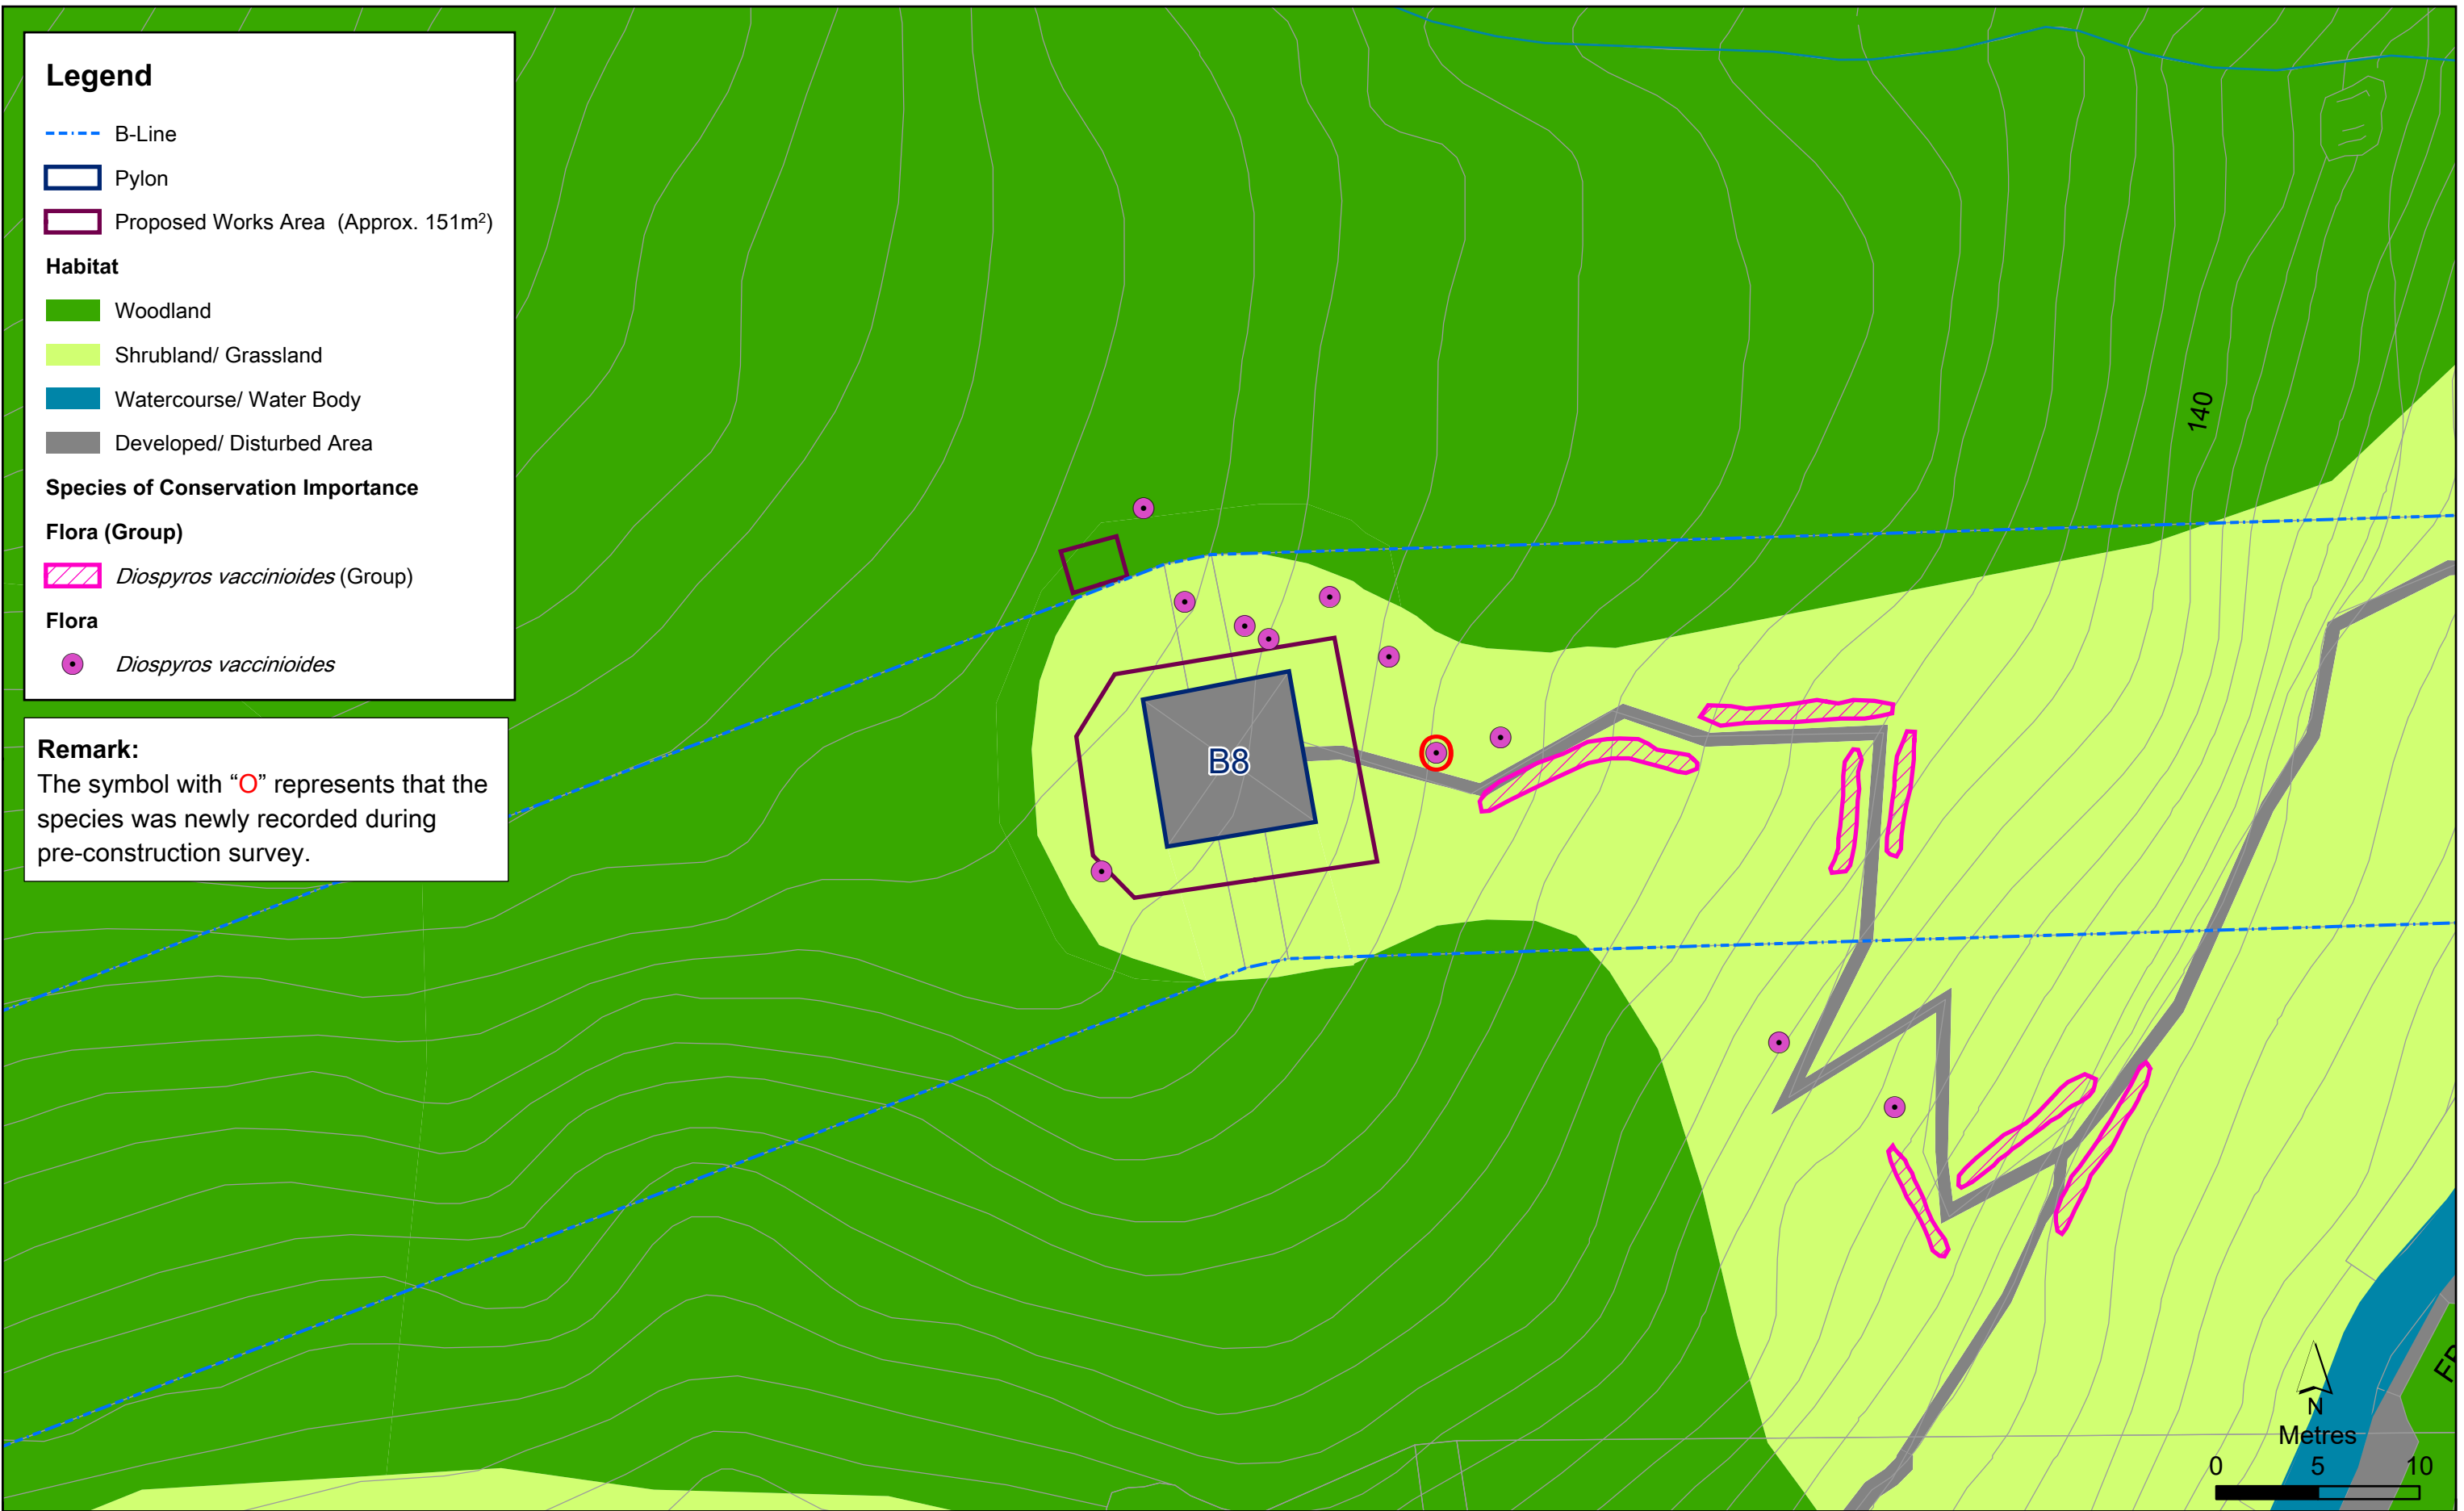
Figure 2.1.3

Zoom-in Habitat Map for Pylon B8

Based on the survey records, the newly recorded flora specie of conservation importance, *Diospyros vaccinioides* at B8; *Endospermum chinense* at B12; two groups and one individual of *Diospyros vaccinioides* at B17, were located outside the proposed works areas (**Figures 2.1.3**, **Figure 2.1.5** and **Figure 2.1.6**), and thus this is not subject to any direct impact from the dismantling works. Other flora species of conservation importance within and near the pylons recorded from PP are still present except *Pavetta hongkongensis* at B6 and one *Diospyros vaccinioides* at B17 recorded from PP were found disappeared during this survey.

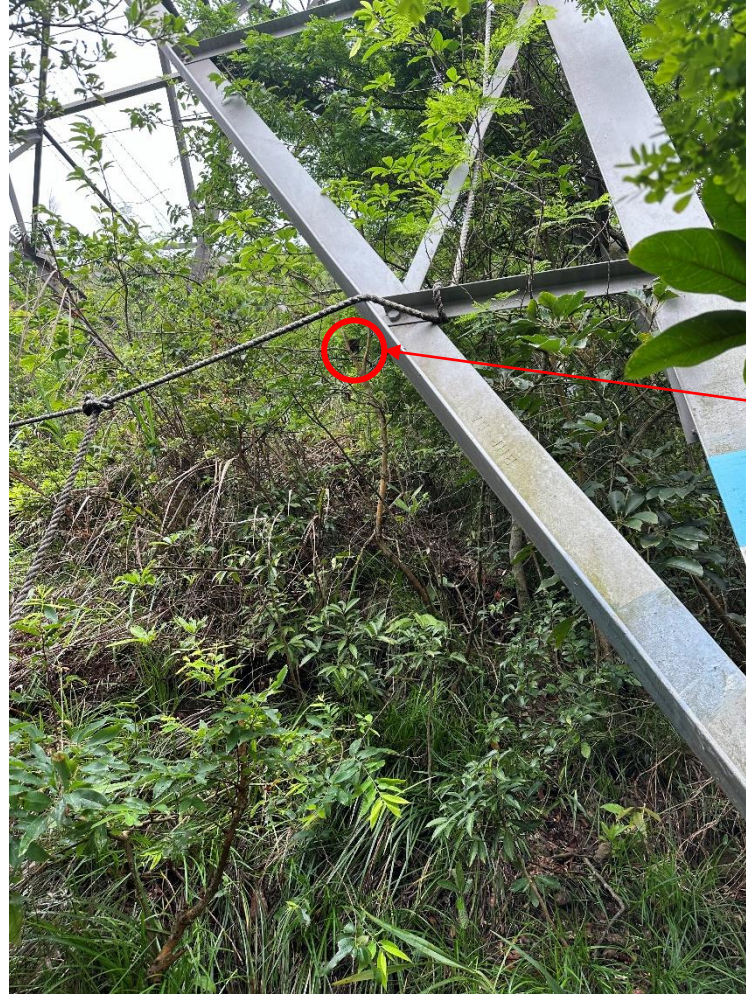
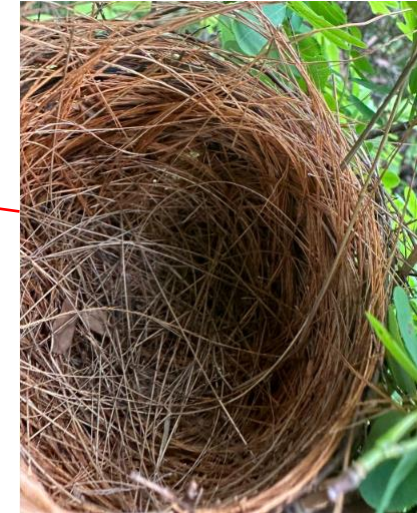
Figure 3.1

During the pre-construction survey, two bird nests which were considered as abandoned, were discovered within proposed works area on Pylon B6 and B17 (shown in **Figure 3.1** and **Figure 3.2**). There was no adult bird nearby the nest and no observable eggs and fledglings inside the nest spotted during the survey.

The nest was found empty

An abandoned bird nest was spotted at Pylon B6, no eggs or chicks were spotted, no bird interaction was observed.

Abandoned bird nest (B6)

During the survey, the nest observed at B6 and B17 were considered as abandoned nests and thus there were no particular measure is required. However, the contractor should actively be aware of any bird encounter or interaction with the bird nest; if any were spotted, further actions should be taken, including temporarily suspension of the dismantle works, photo recording of the bird nest in-use, reporting to AFCD and discussing the follow-up actions with AFCD.

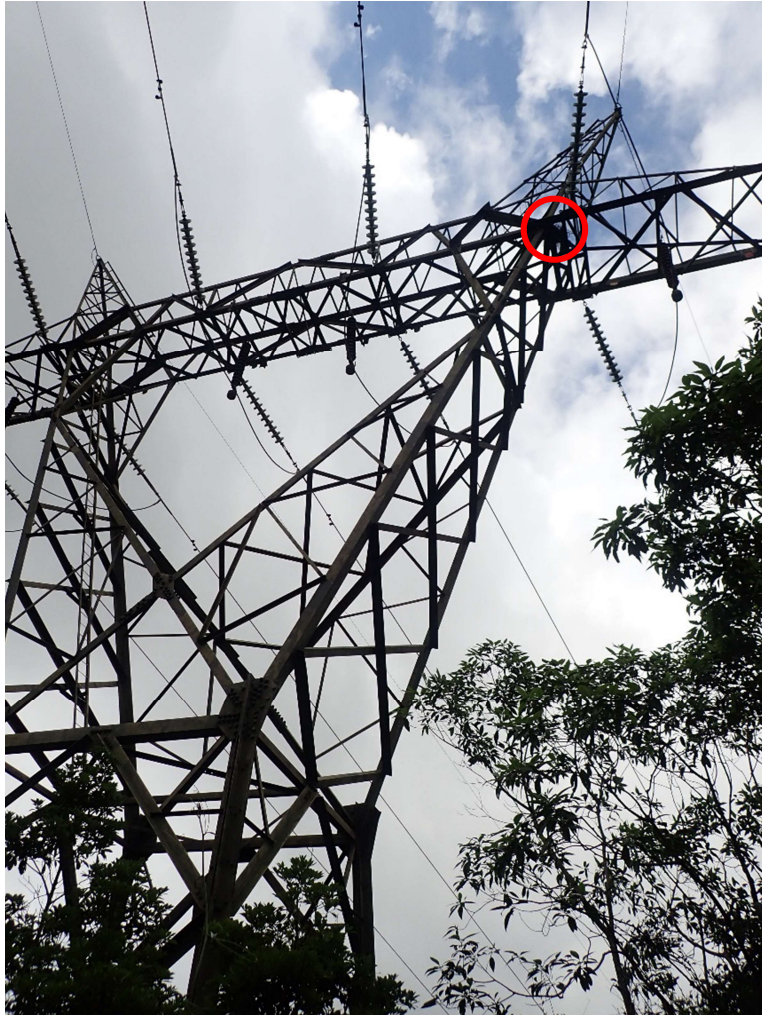
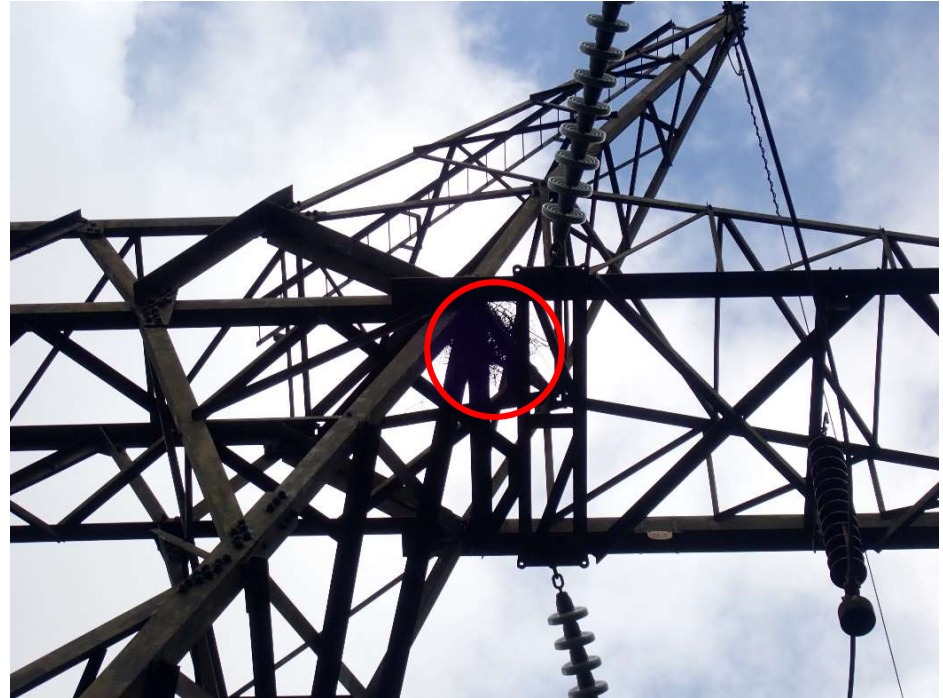
Figure 3.2

An abandoned bird nest was spotted at Pylon B17, no eggs or chicks were spotted, no bird interaction was observed.

Abandoned bird nest (B17)

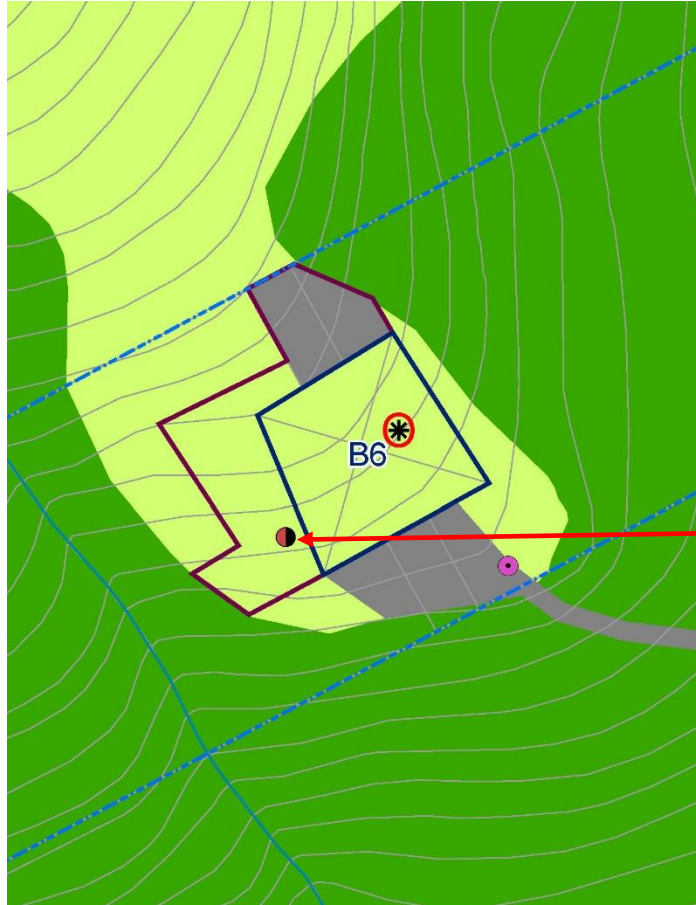
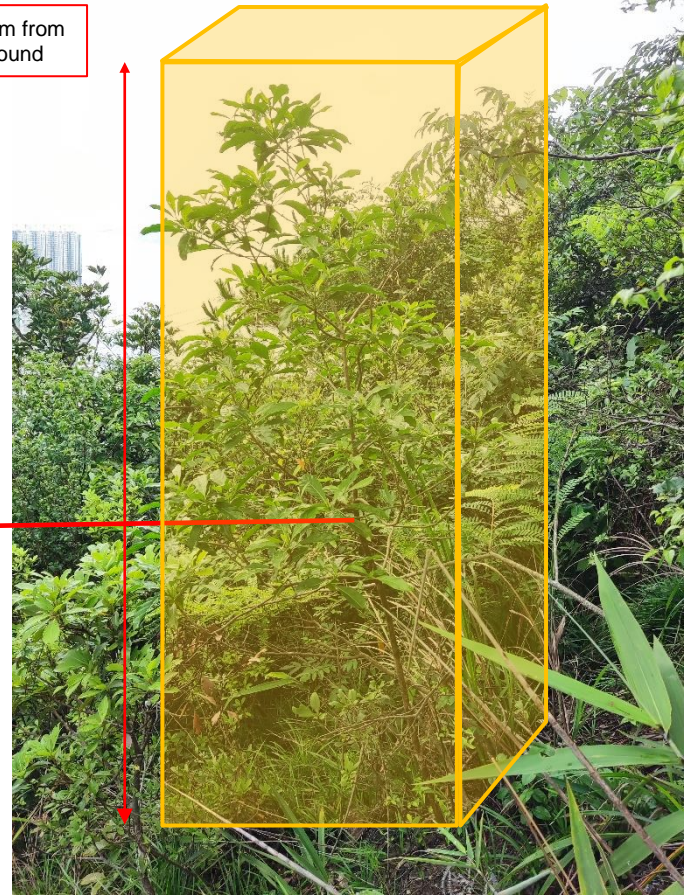
1.5m - 2m from the ground

Pavetta hongkongensis was recorded within the proposed work area.

A temporary metal cage of around 1.5m - 2m high will be built around the identified plant with the aim to avoid damage during the dismantling works.

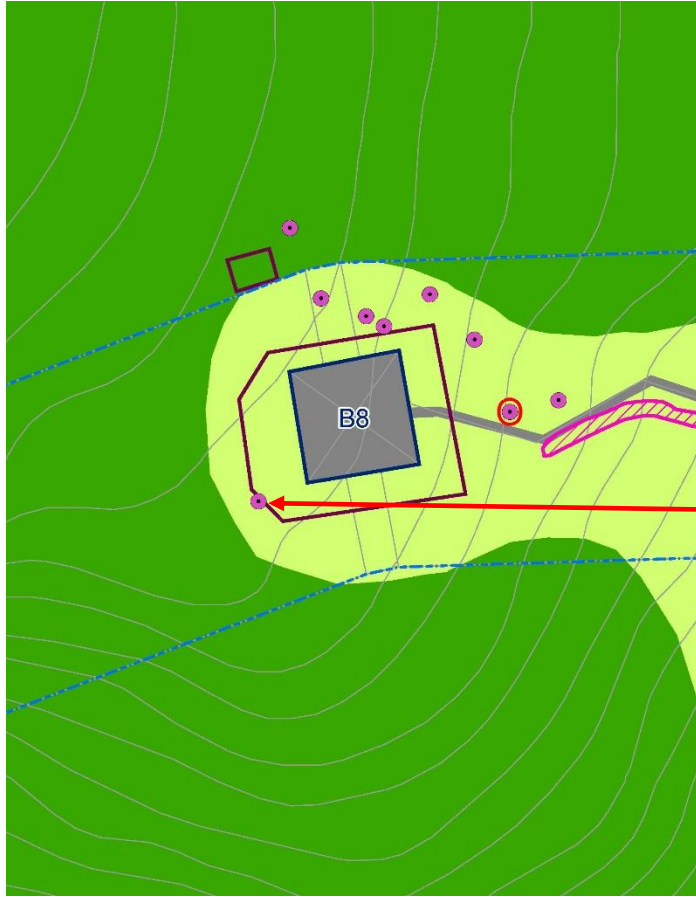
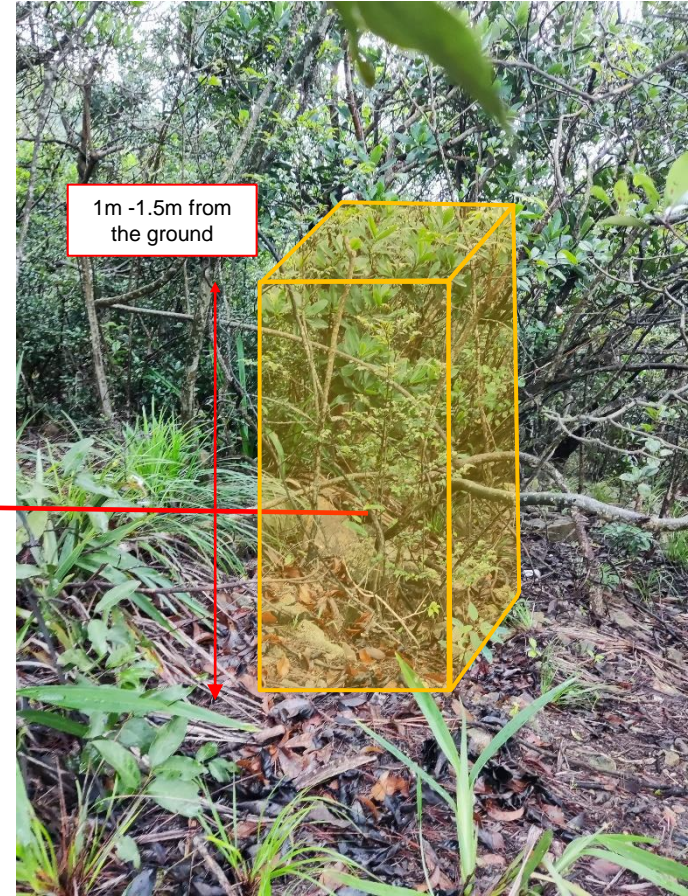
Diospyros vaccinioides was recorded immediately adjacent to the proposed work area.

A temporary metal cage of around 1m - 1.5m high will be built around the identified plant with the aim to avoid damage during the dismantling works.

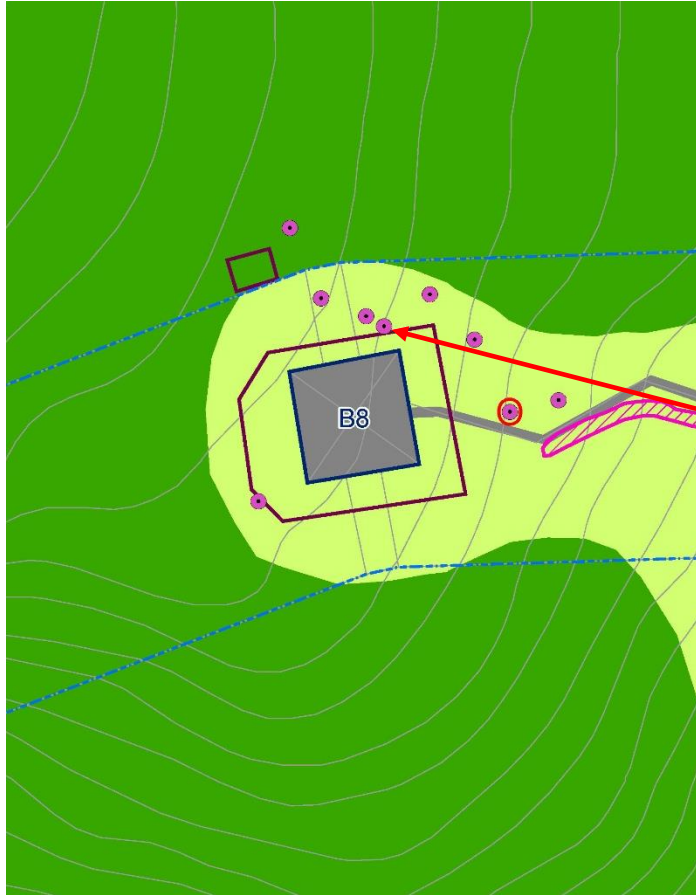
Diospyros vaccinioides was recorded immediately adjacent to the proposed work area.

A temporary metal cage of around 1m - 1.5m high will be built around the identified plant with the aim to avoid damage during the dismantling works.

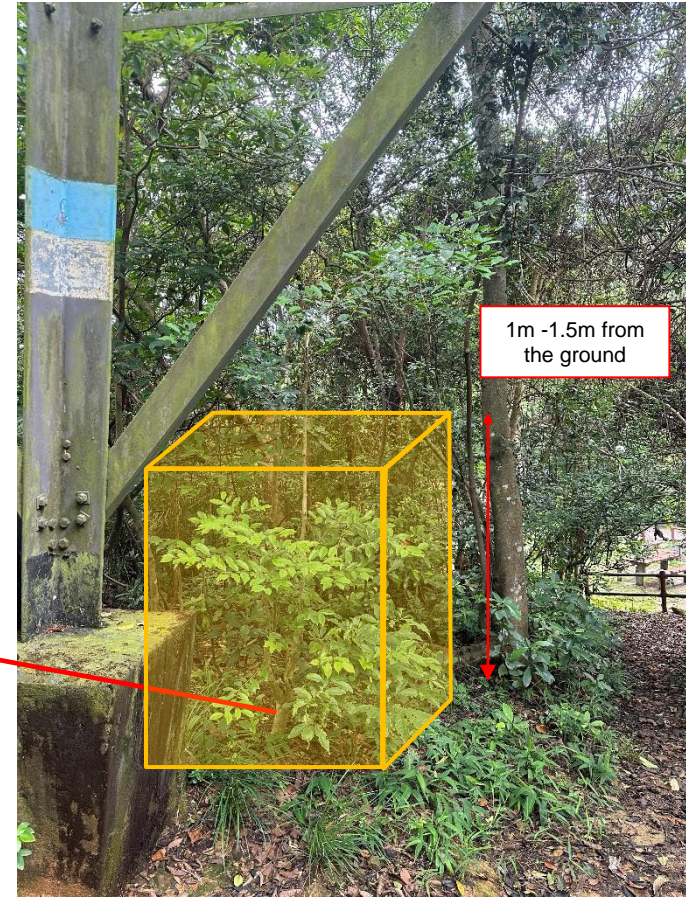
Aquilaria sinensis was recorded immediately adjacent to the proposed work area.

A temporary metal cage of around 1m - 1.5m high will be built around the identified plant with the aim to avoid damage during the dismantling works.
