Phase III Redevelopment of The Hong Kong Federation of Youth Groups Jockey Club Sai Kung Outdoor Training Camp

Quarterly EM&A Summary Report for 1 July – 30 September 2012

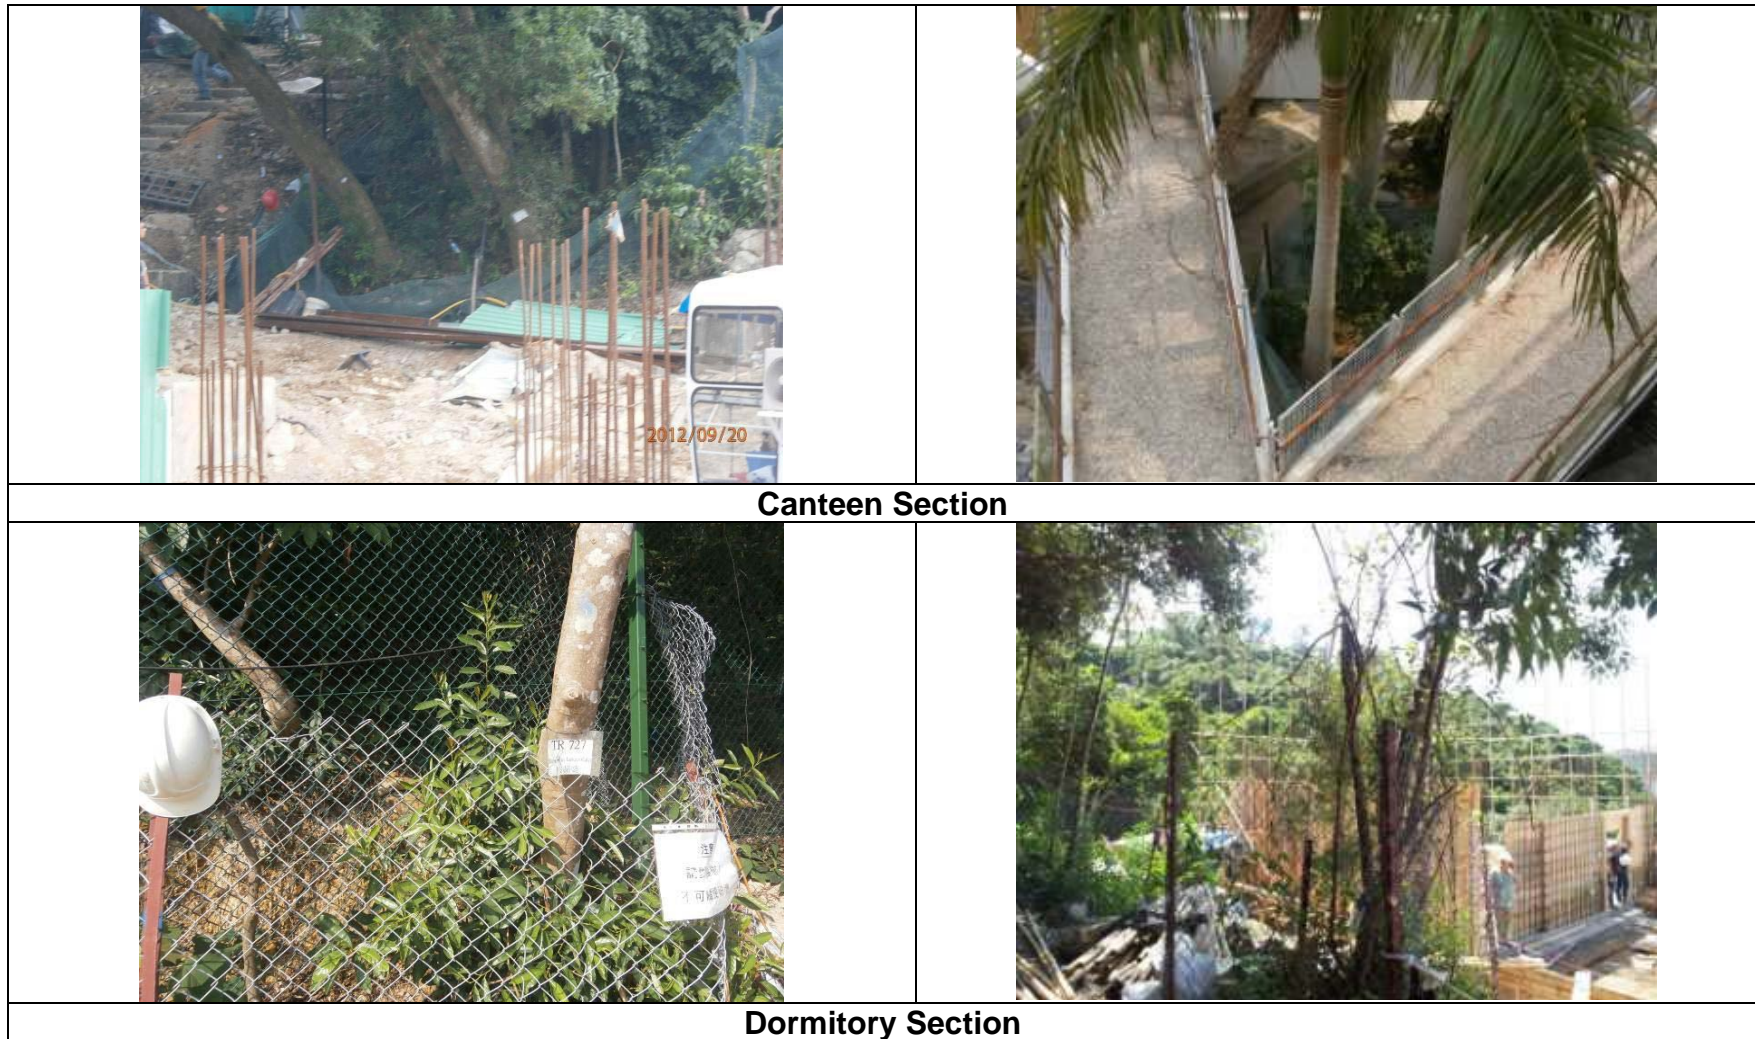
Figure 4.1 Photo Records of Tree Protection Status

4.1.1 Tree felling at both the Canteen Block and Dormitory sections has been commenced. Tree protection measures including construction of chain link fence at the Canteen Block area are completed in August 2011. Hoarding and tree protection work in the Dormitory area were completed in March 2011. During site inspection, the contractor was also reminded of proper tree protection measures such as not encroaching tree protecting zones, repairing damaged fences, and carrying out remedial measures on retained trees with poor conditions. Inspection of the tree protection measures will continue. Photo records of the tree protection status are shown in **Figure 4.1**.

6.1.6 Generally, the Contractor had provided proper landscape and visual mitigation measures during inspection. Damaged tree protection fences were observed at both the canteen and dormitory sites but were rectified

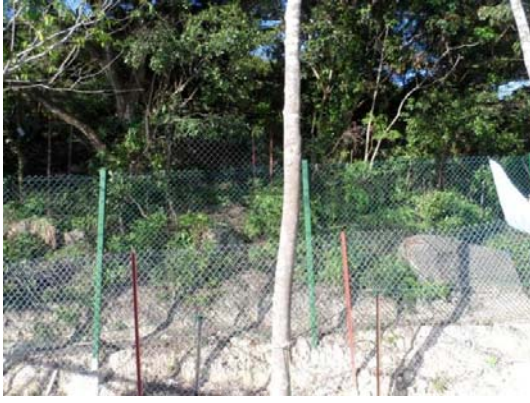
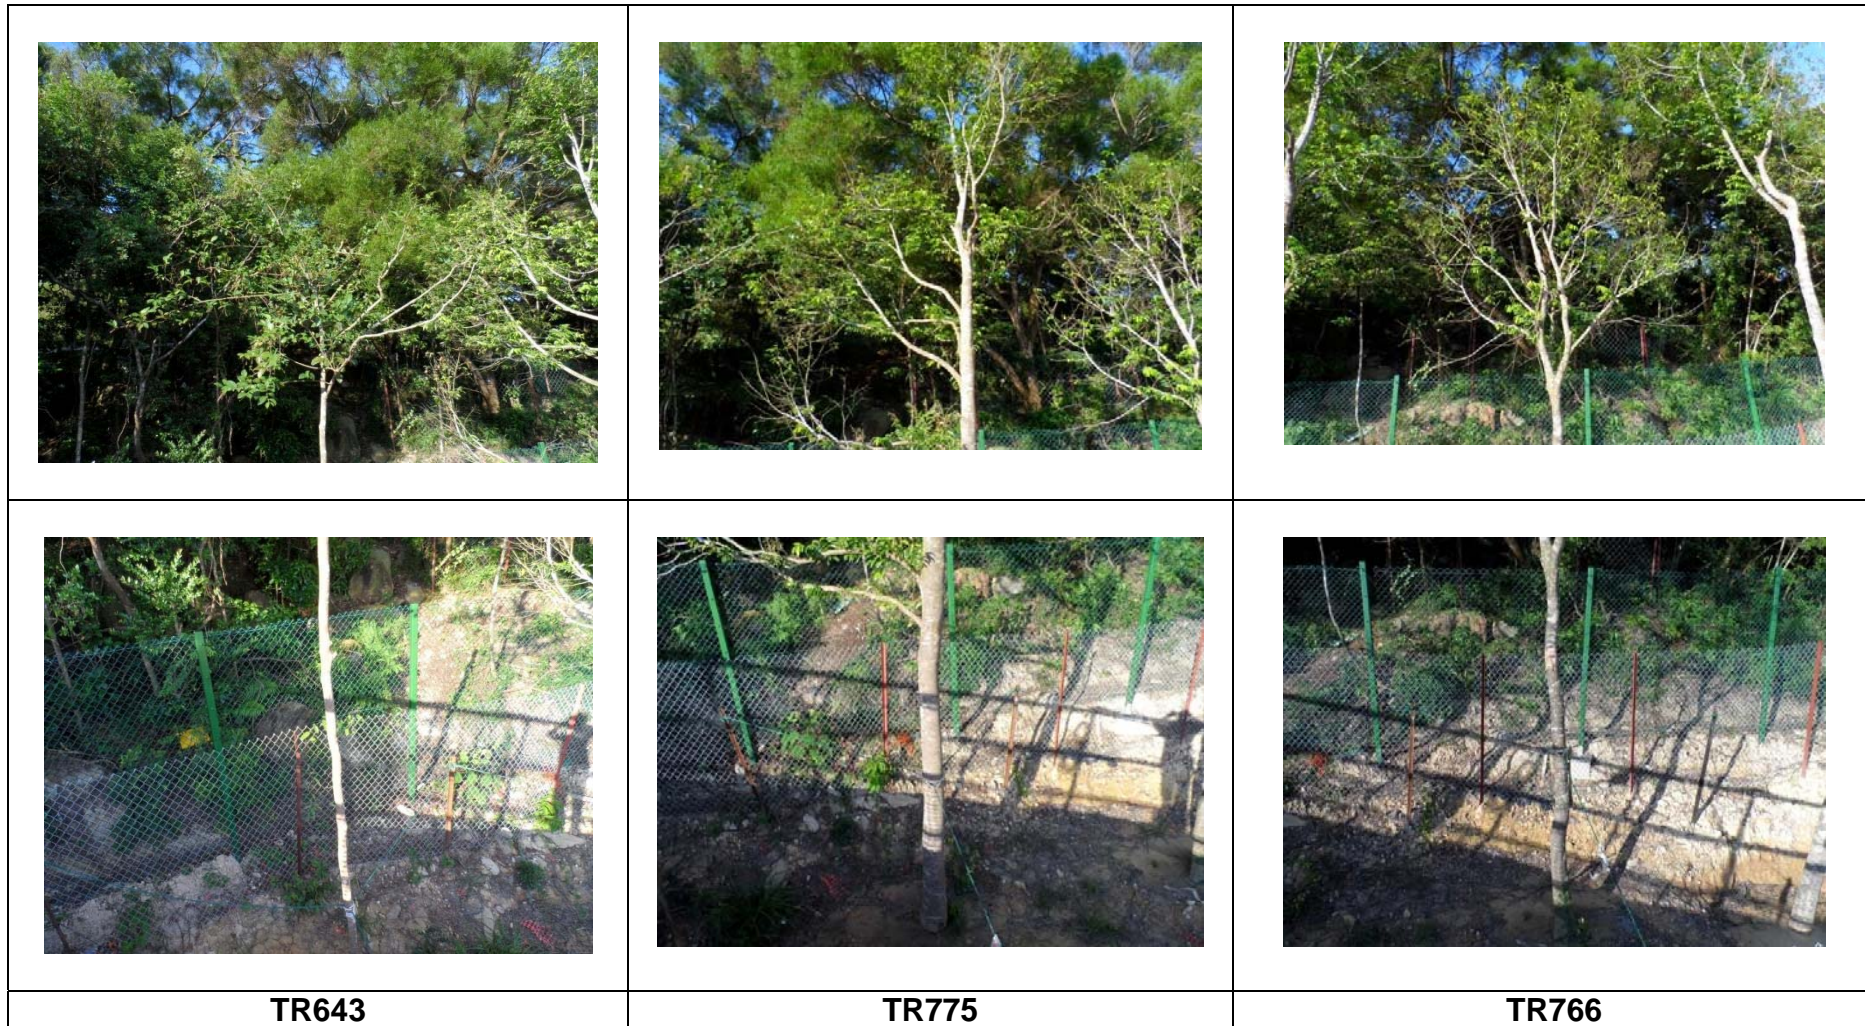
Figure 4.3 Photo Records of Transplanted Trees

5.1.1 Monitoring of the 5 transplanted Trees was conducted on 23 August 2012. The transplanted trees were in fair conditions (**Figure 4.3**). The canopy of TR775, TR766, TR644 and TR639 continued to develop. TR639 was leaning toward TR644 after typhoon in July 2012, but the problem was fixed by adjustment of the guying afterward. TR643 (Tree ID rectified as *Homalium cochinchinensis* were flowering. No signs of disease or stress were observed. Monitoring will continue in November 2012. .

TR644	TR639	Overview

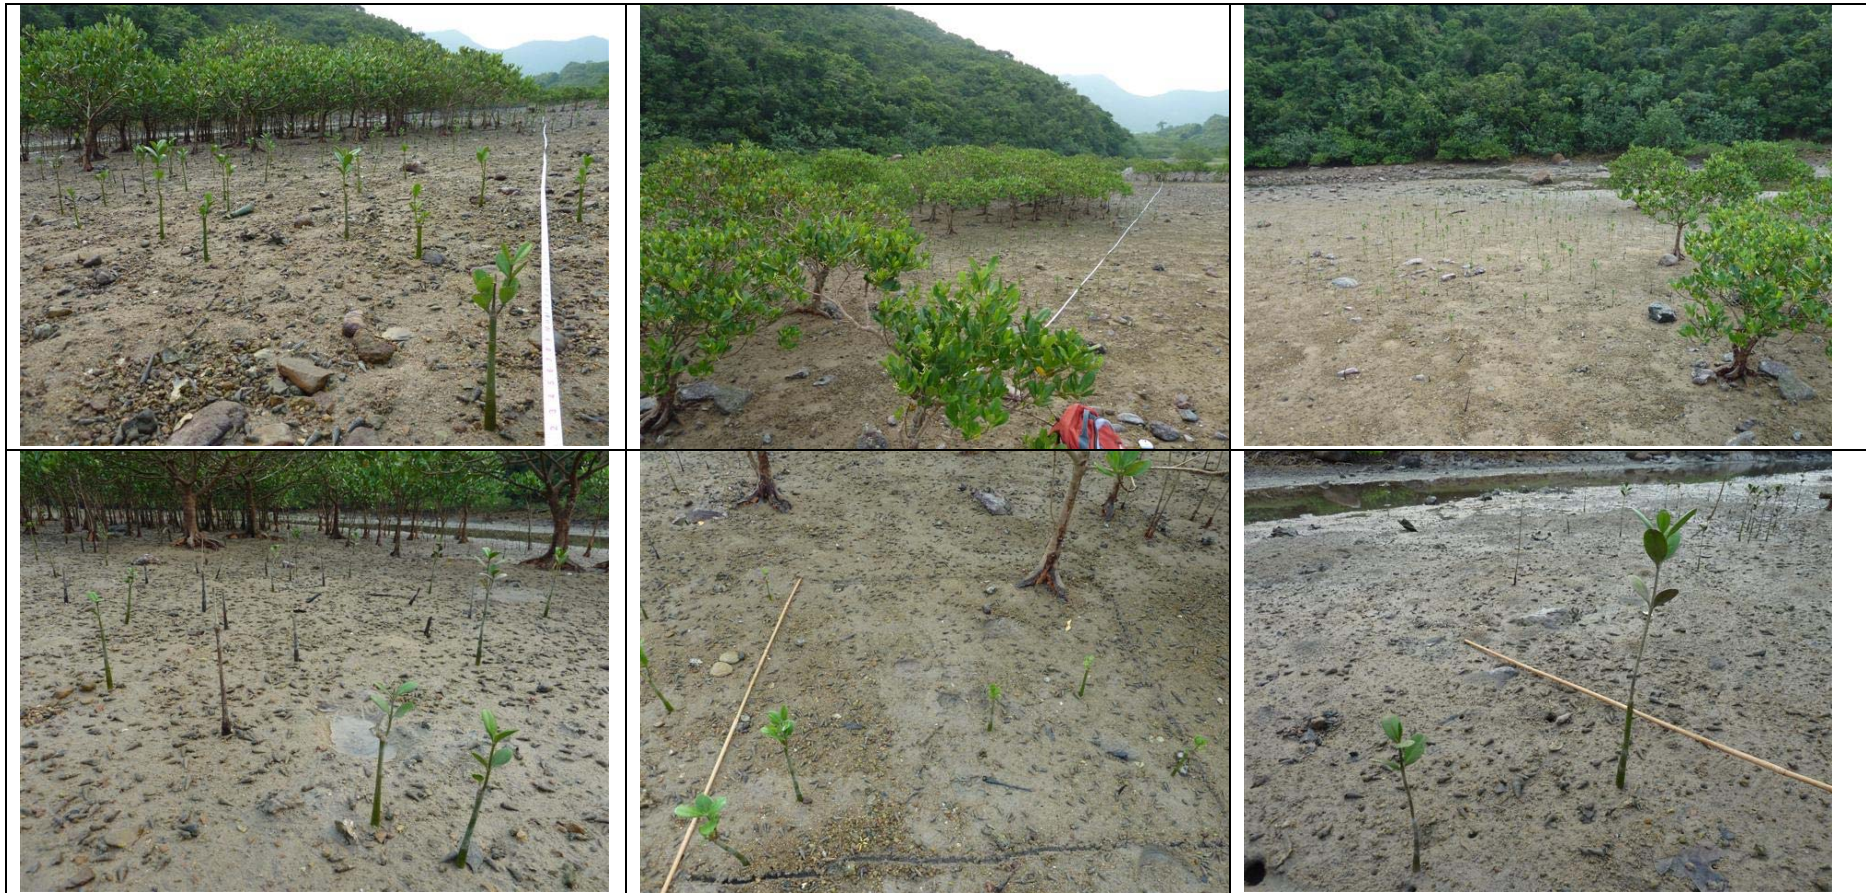
Figure 5.2 Photo Records of Mangrove Plantings as of August 2012

5.2.2 Monitoring was conducted on 23 August 2012, which was the last session of monitoring. A total of 23 seedlings with an average height of 23.1 cm was found within the 10 quadrats (**Appendix H**). The average height of mangrove had increased as compared with previous quarter. The health condition was fair. New 3-5 pairs of leaves were observed from the newly planted seedlings. Photo records of the mangrove plantings were shown in **Figure 5.2**.

10.1.2 Monitoring results of compensatory mangrove planting in August 2012 showed that both growth and survival was stabilised. Mangrove monitoring is completed and planting will be implemented as a conservation education programme from time to time. .

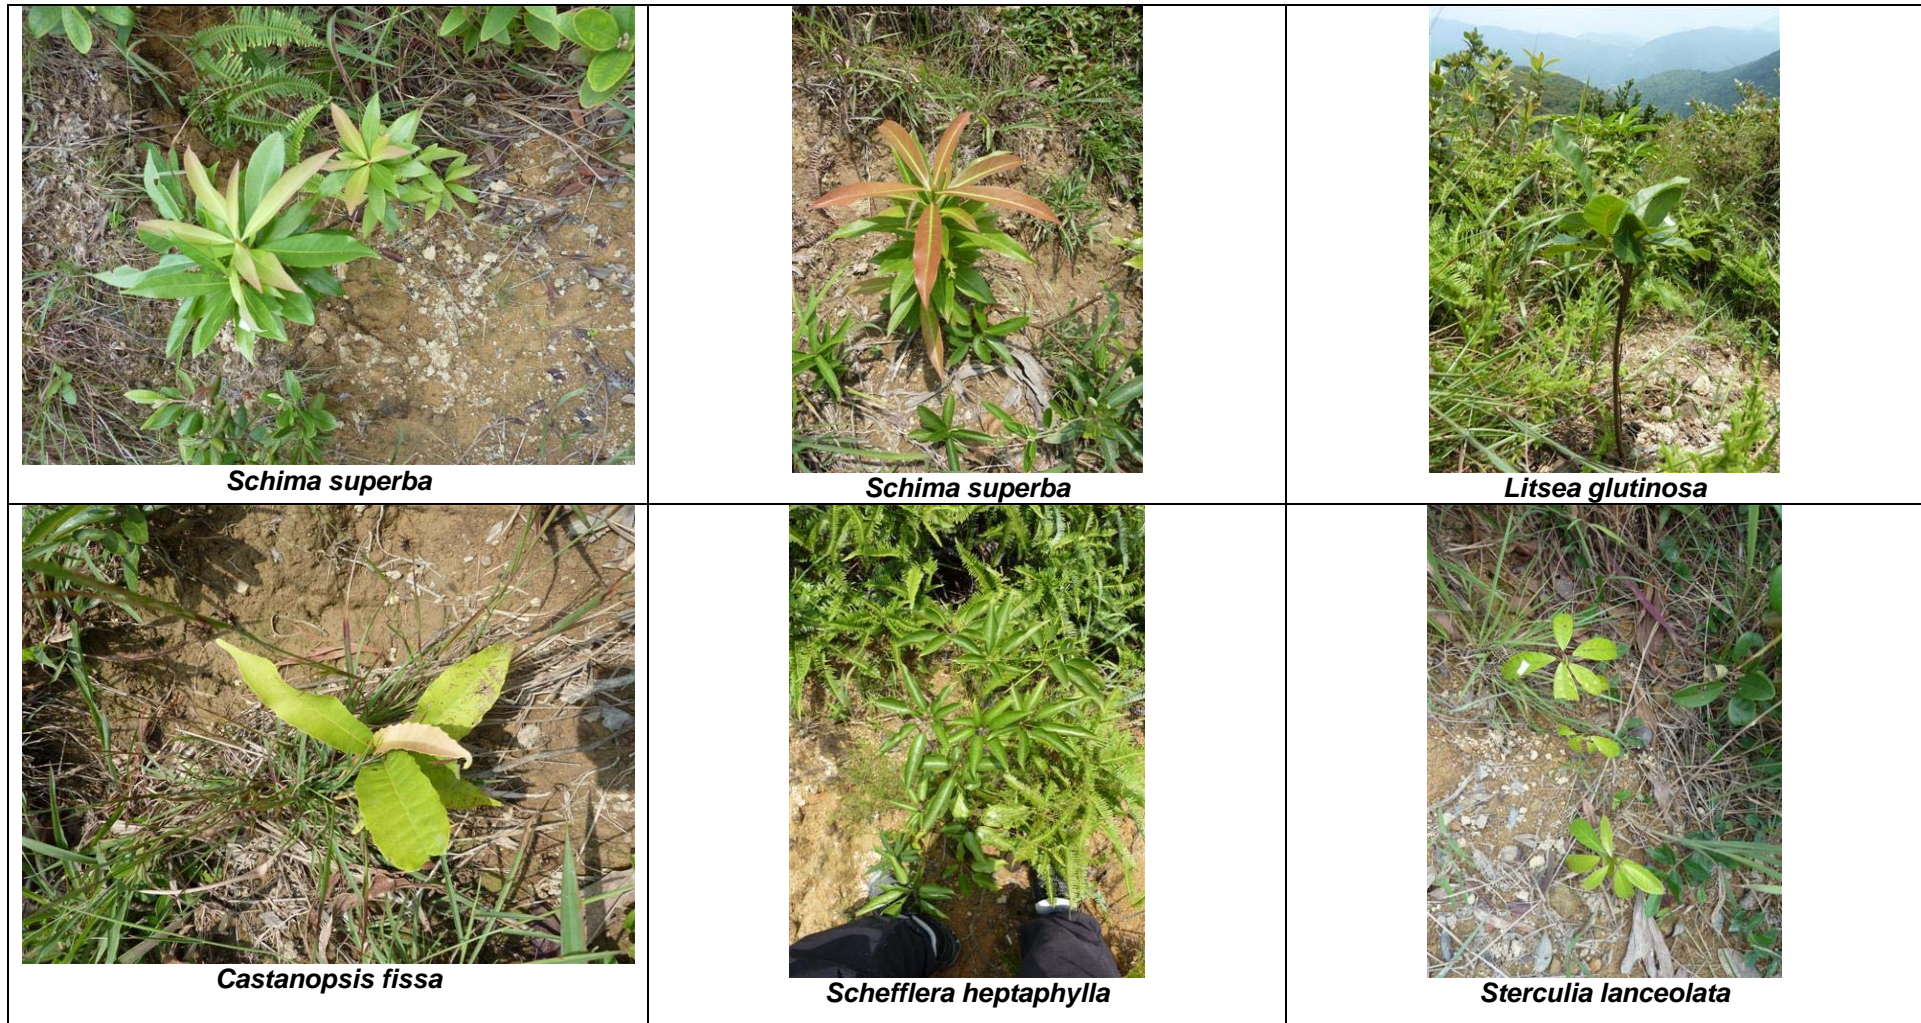
Figure 5.4 Photo Records of Off-Site Woodland Compensatory Planting at Lui Ta Shek as of August 2012

5.3.1 The Tree Whip Planting Plan for Off-Site Woodland Compensatory Planting at Lui Ta Shek is shown in **Figure 5.3**. Due to poor condition of the plantings, and according to the Event and Action Plan for Ecological Impact (**Appendix E**), actions due to non-compliance were taken in accordance with the action plan. Monitoring was increased to monthly in October and November 2011. IEC was informed. The landscape contractor was informed regarding the situation and reminded of the required remedial and maintenance work. It was reported with photo records by the landscape contractor that firming up for the seedlings was conducted in November 2011. A remedial action proposal including replacement planting in April 2012 was submitted to the Project Proponent. Due to similar conditions of plantings observed from August to November 2011, implementation of maintenance work in November 2011 and remedial action in April 2012, monitoring frequency was resumed from monthly to quarterly after November 2011. Monitoring was conducted on 23 August 2012 to check the growing conditions of the plants and the replacement plantings. Photo records of the planting and monitoring were shown in **Figure 5.4**.

5.3.2 Individuals of the six planted species were in fair to poor conditions. Of the survived seedlings, more individuals of *Schima superba* and *Schefflera heptaphylla* had new healthy leaves during this growing season and were in fair conditions. Other species including *Castanopsis fissa*, *Machilus* sp., *Sterculia lanceolata*, and *Litsea glutinosa* were in fair to poor conditions. Some of the individuals showed a few small resprouted leaves while herbivory were also observed. A remedial action proposal including replacement planting in April 2012 was submitted to the Project Proponent. Due to issues of sourcing, the planting exercise would tentatively be scheduled in April 2013.

- 10.1.3 Survival and growth of the off-site woodland compensatory planting at Lui Ta Shek plantings was in fair to poor conditions during the reporting quarter. A remedial action proposal including replacement planting in April 2012 was submitted to the Project Proponent. A remedial action proposal including replacement planting in April 2012 was submitted to the Project Proponent. Due to issues of sourcing, the planting exercise would tentatively be scheduled in April 2013. The next monitoring session will be conducted in November 2012 to check the growing conditions of the plants and the replacement plantings, and remedial actions will be monitored until rectification has been completed.
