Contract No. EP/SP/66/12
Integrated Waste Management Facilities, Phase 1

Quarterly EM&A Report No.2 (Period from 1 October to 31 December 2018)

(Clause 3.3, Further Environmental Permit FEP-01/429/2012/A)

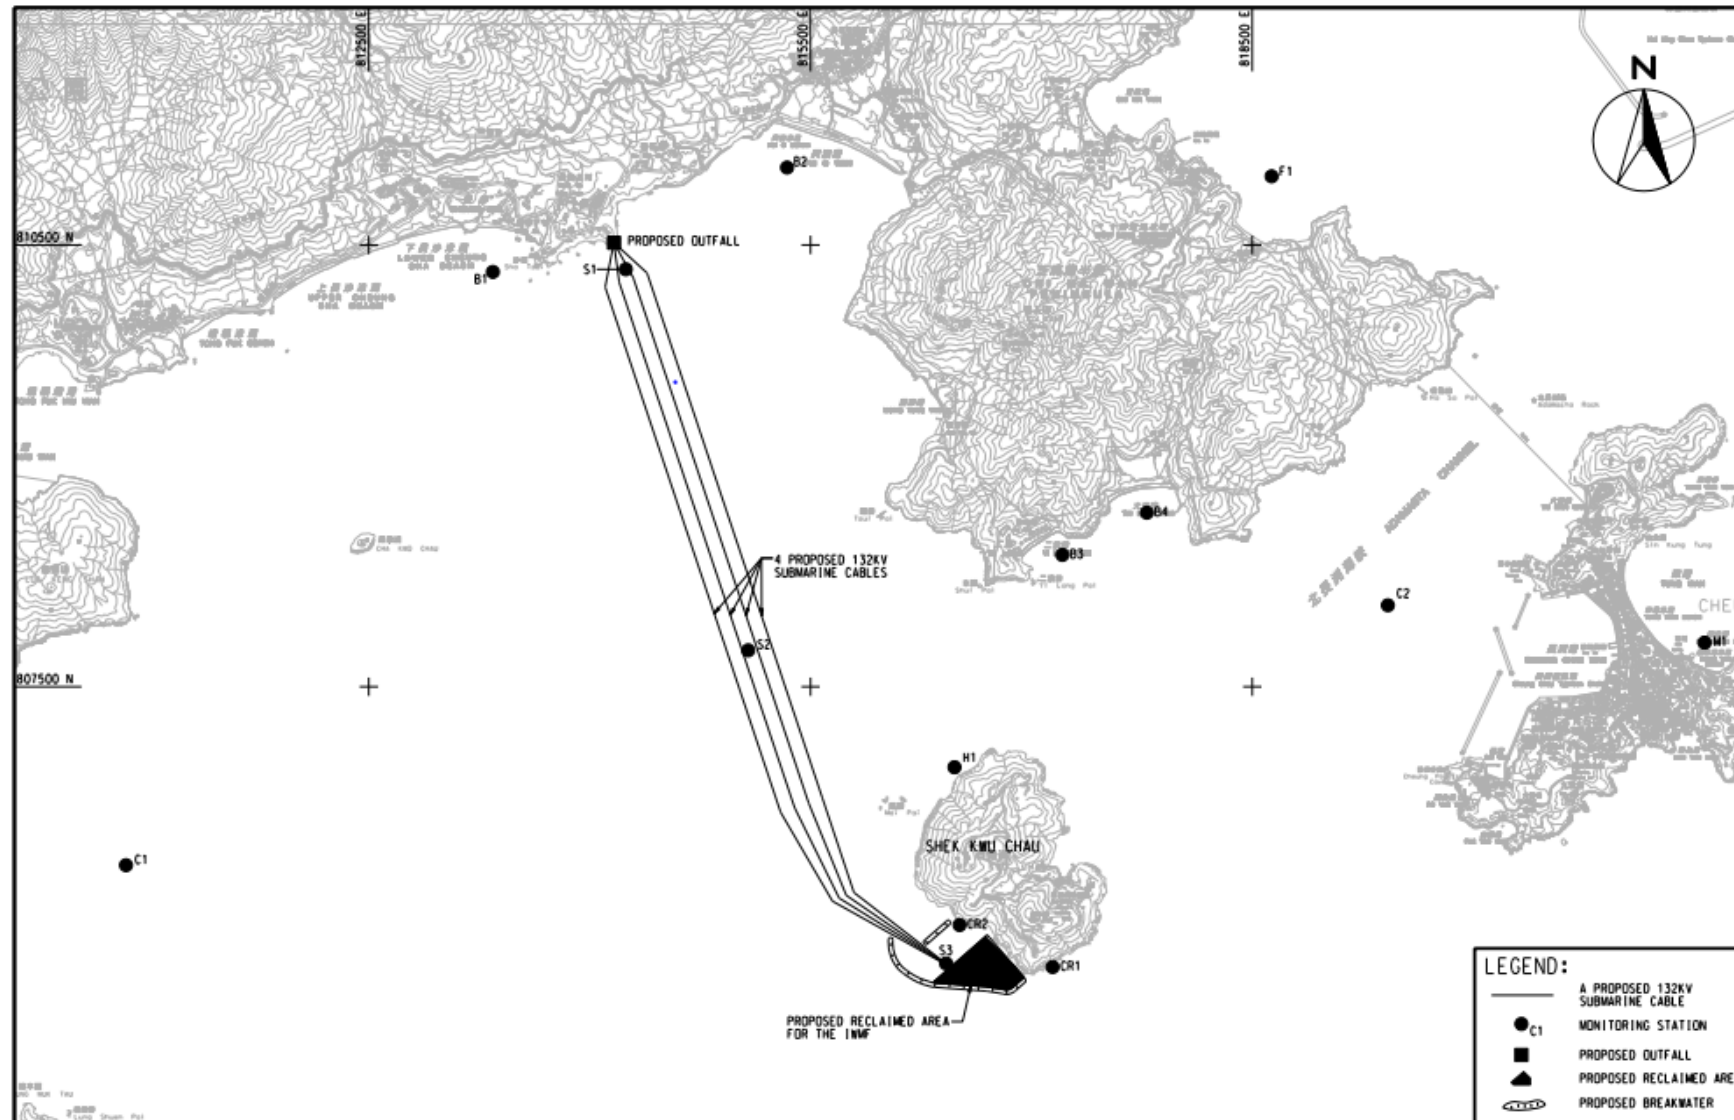
Figure 2.1 Water monitoring locations at Artificial Island near SKC

- 2.2.1 Impact water quality monitoring was conducted at eleven monitoring locations during general water quality monitoring and fourteen water monitoring locations during regular DCM monitoring, as shown in **Figure 2.1**.

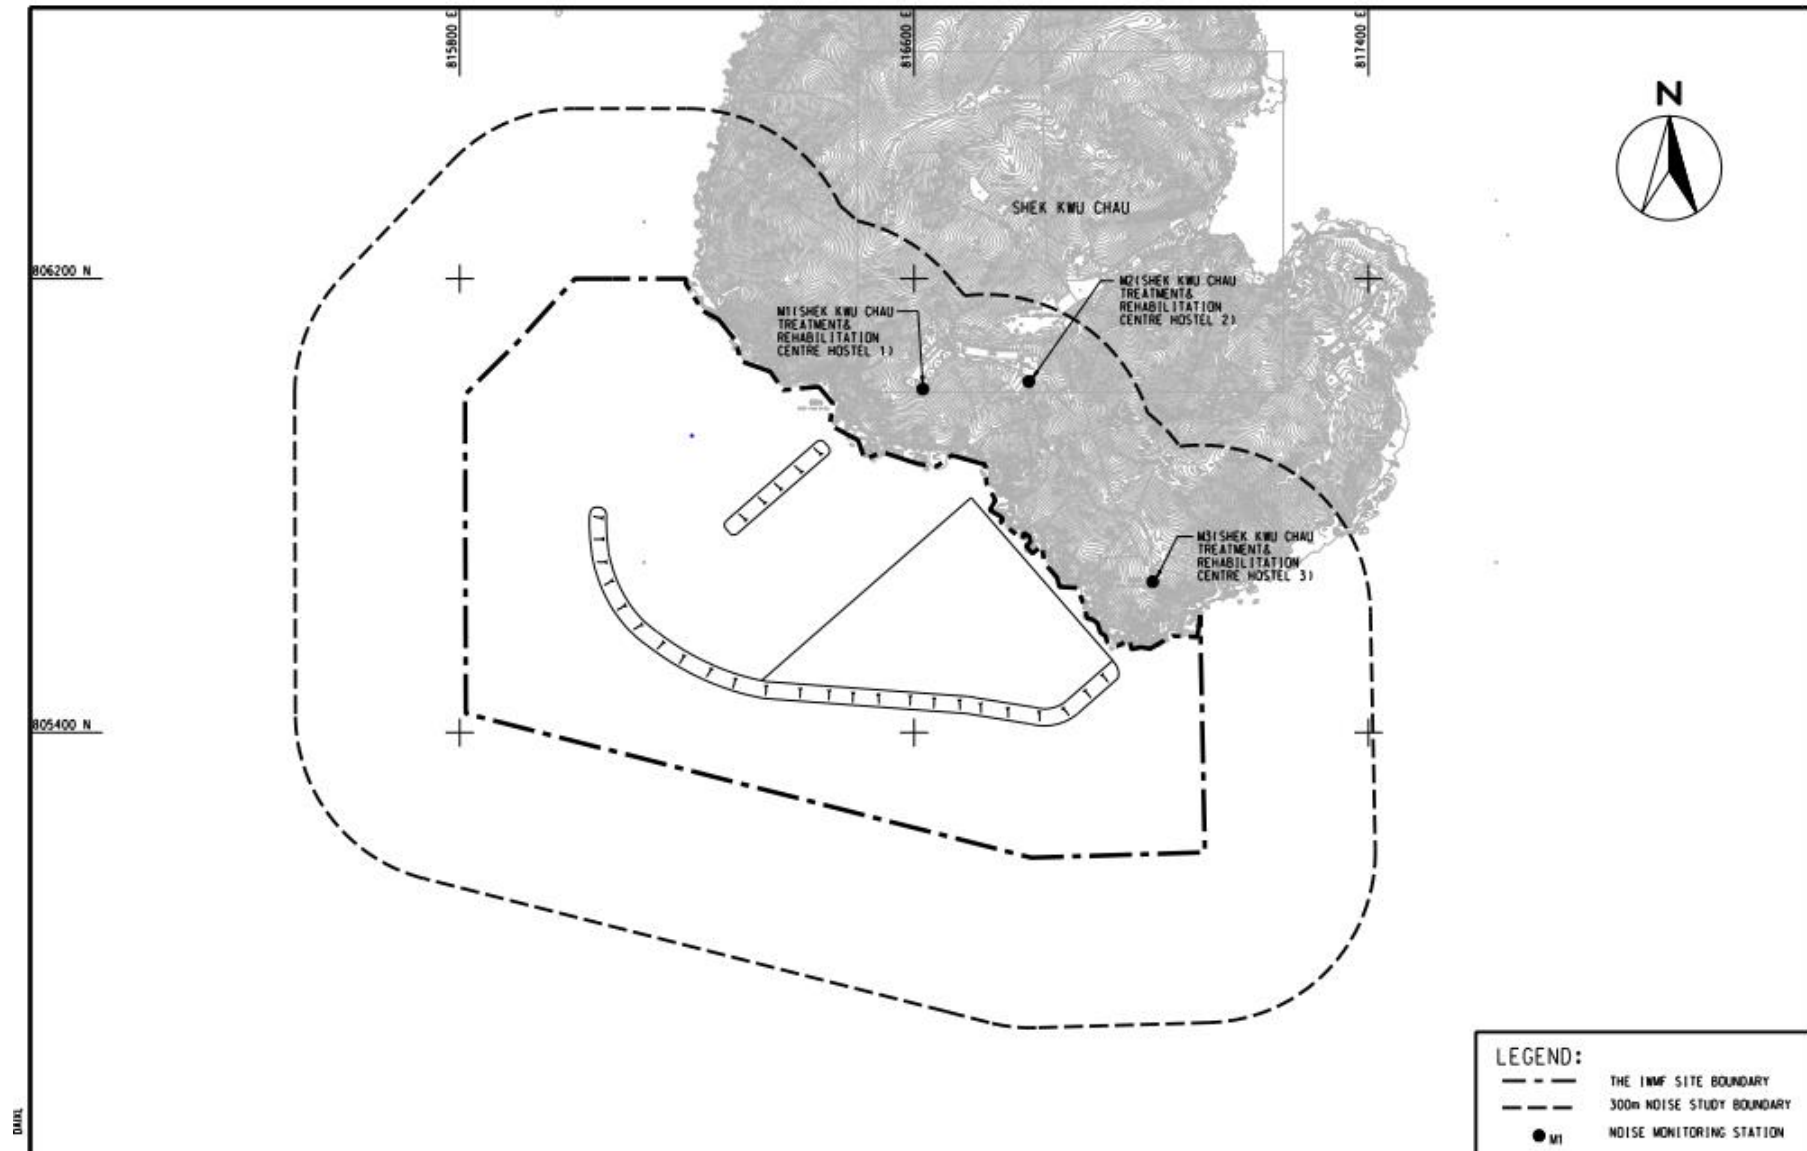
Figure 3.1 Noise monitoring locations at SKC

3.2.1 Three noise monitoring locations for impact monitoring at the nearby sensitive receivers are shown in **Figure 3.1**

- 3.2.2 M1, M2 and M3 are Shek Kwu Chau Treatment and Rehabilitation Centre Hostel 1, 2 and 3 respectively of The Society for the Aid and Rehabilitation of Drug Abusers (SARDA) located at southern part of Shek Kwu Chau.
- 3.2.3 Measurement at M1, M2 and M3 were conducted at a point 1m from the exterior of the sensitive receivers building façade and at a position 1.2m above the ground. The noise monitoring stations are summarized in **Table 3.2** below.

3.4.4 Major sources of noise dominating the monitoring stations observed during the impact noise monitoring was installation of air-conditioning units nearby at M1 & M2 and air-conditioning units nearby at M3.

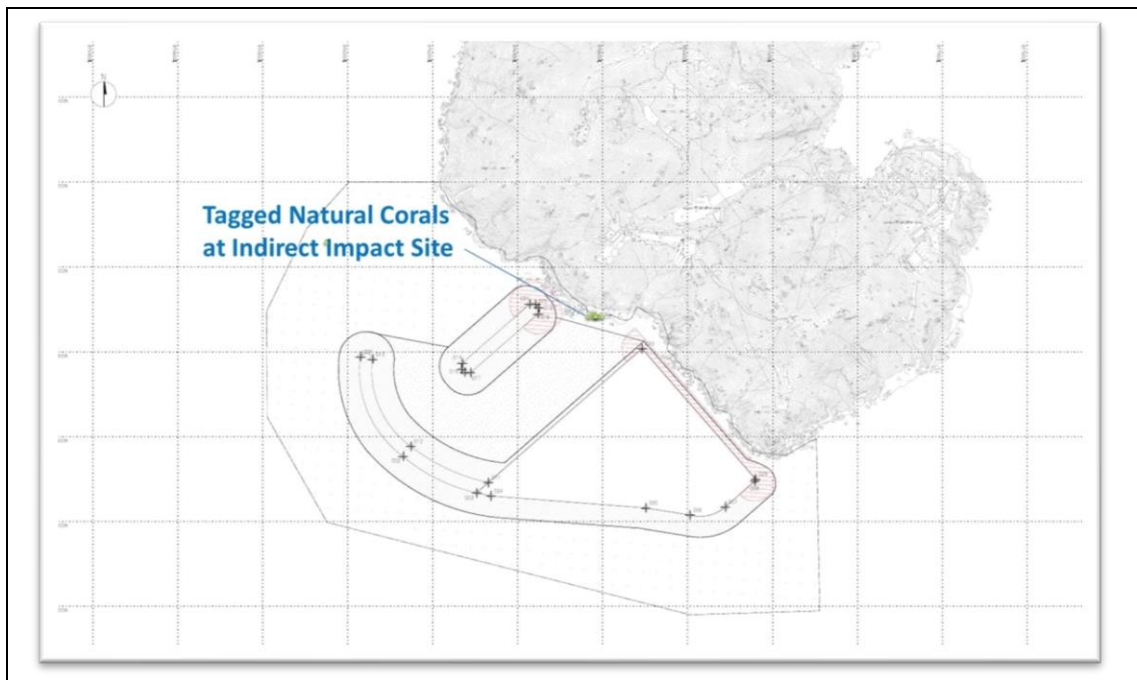
Figure 5.1 Tagged Natural Corals at Indirect Impact Site Near SKC for re-tagging after typhoon Mangkhut

5.4.1 After strong hitting of the super typhoon Mangkhut in mid-September 2018, the whole bottom at the Indirect Impact Site were covered with 1m thick of sand and mud in which all ten tagged hard coral colonies were all missing. For the control site of Soko Island, most of the rocks at the bottom were turned over by the super typhoon Mangkhut in mid-September 2018, however, only 4 tagged coral colonies were missing. Since there was a suspension order on diving activities due to the fatal accident on 15 October 2018, the coral re-tagging event planned on late-October at both Indirect Impact Site and Control Site were cancelled and postponed to November and December 2018 due to adverse weather. During the reporting period, the re-tagging activity at Indirect Impact Site was conducted on 23 November 2018 while the re-tagging activity at Control Site was conducted on 3 December 2018 (**Figure 5.1** and **5.2** respectively); and the weather conditions were summarized in **Table 5.6**.

- 5.4.6 All re-tagged coral colonies at Indirect Impact site and Control site showed good health condition during the reporting period.
- 5.4.7 After the super typhoon Mangkhut hitting Hong Kong on 15th and 16th September 2018. The whole bottom at the Indirect Impact Site were covered with 1 m thick of sand and mud in which the ten tagged hard coral colonies were all missing during the third month monitoring. At the control site of Soko Island, most of the rocks at the bottom were turned over by the super typhoon Mangkhut, however only 4 tagged coral colonies were missing during the monitoring survey.

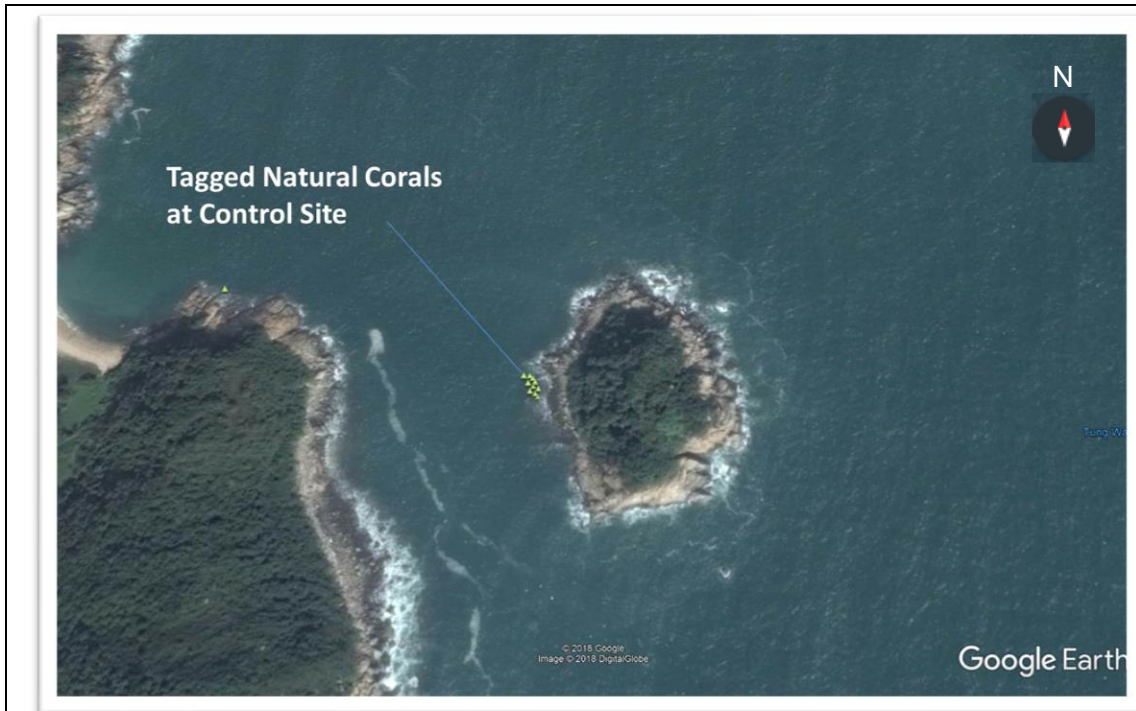
Figure 5.2 Tagged Natural Corals at Control Site Near Yuen Kong Chau for re-tagging after typhoon Mangkhut

5.4.2 Four (4) and ten (10) re-tagged hard coral colonies were re-tagged at each site of Control and Indirect Impact sites respectively during 4th to 6th months construction phase monitoring as suggested in the Coral Monitoring Plan. After the retagging at both sites are finished, one additional monthly monitoring survey will be conducted in January 2019 and those monitoring results will be reported in 3rd Quarterly and 7th Monthly EM&A report. The general health conditions (size, condition, mortality,

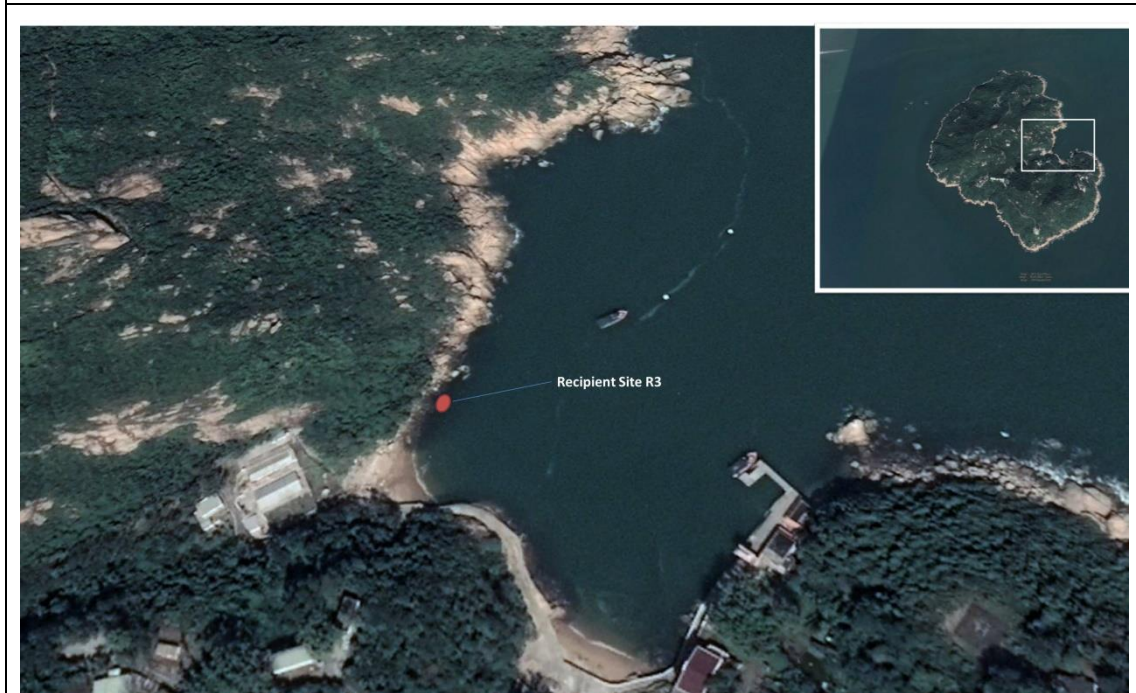
Figure 5.3 Tagged Translocation Corals at Recipient Site R3 near SKC

5.4.3 The third Post-translocation Monitoring was performed on 3 December 2018 for the Recipient Site R3 (**Figure 5.3**) and the weather conditions were summarized in **Table 5.7**.

- 5.4.9 The third post-translocation coral monitoring was carried out on 3 December 2018. Sixteen (16) movable hard coral colonies were monitored at the recipient site R3. However, 9 translocated coral colonies were missing during the second monitoring survey and only 7 left (**Table 5.11**). The remaining translocated coral colonies also showed an increased mortality from 5% to 15% (**Table 5.11**). The missing colonies probably were swept away by the strong wave action caused by the Super Typhoon Mangkhut hitting Hong Kong on 15th and 16th September 2018.

- 5.4.10 Ten (10) natural hard coral colonies were also monitored at the recipient site as control and 1 coral colony was missing during the monitoring survey (**Table 5.12**). Similar to the translocated coral colonies, the missing tagged coral colony probably was swept away by the strong wave action caused by the Super Typhoon Mangkhut hitting Hong Kong on 15th and 16th September 2018.

- 5.4.11 Since all missing tagged coral colonies at the Recipient Site R3 were caused by the Super Typhoon Mangkhut, the AL/LL will not be applied at this time. Post-translocation monitoring survey will be continued to monitor the remaining tagged coral colonies for both translocated coral and natural coral colonies.

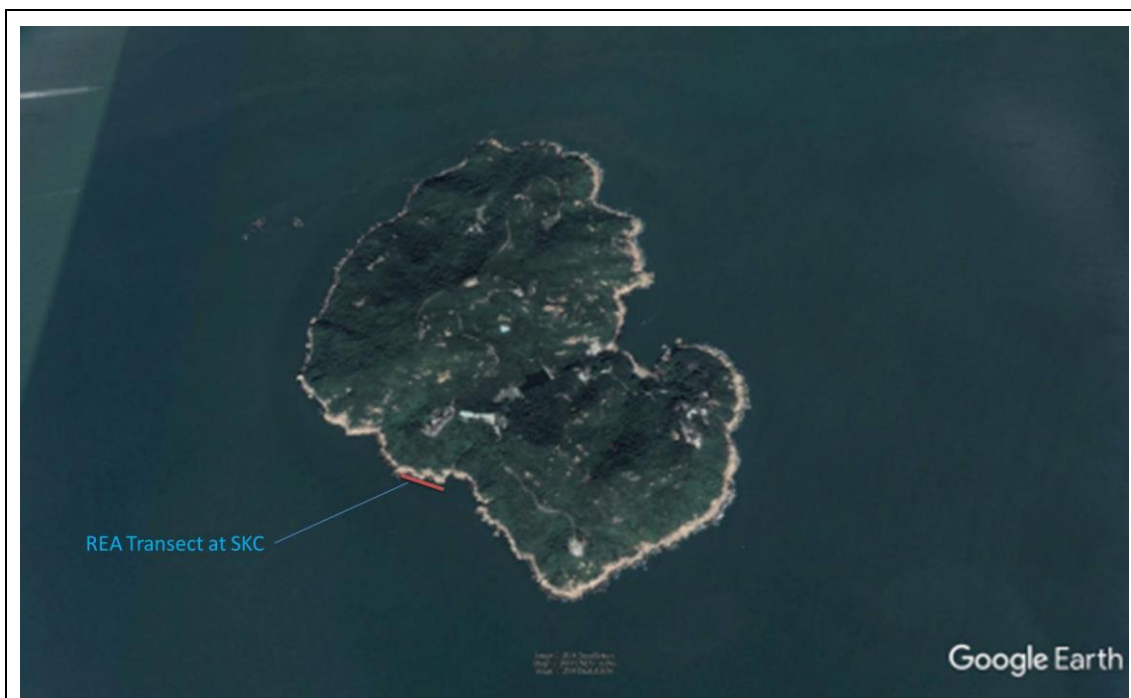
Figure 5.4 REA Transect at Indirect Impact Site near SKC

5.4.4 An additional 100m REA survey was carried out on 3 December in the proposed Indirect Impact site (**Figure 5.4**) to further assess the seabed condition after super typhoon Mangkhut. GPS coordinates of the REA transect starting and ending points, maximum depth and bottom substrate of the site were summarized in **Table 5.8**. The findings of ecological & substratum attributes and taxon abundance along the REA transect survey were summarized in **Table 5.13** and **5.14** respectively.

- 5.4.12 The REA survey was carried out on 3 December 2018 in the Indirect Impact Site. Only three species of hard coral were recorded during the survey and most of them are in fair condition after the typhoon. Some common coral colonies still appeared in shallow water which are suitable for re-tagging during the construction phase monitoring. All the coral colonies recorded along the transect were all common hard coral species in Hong Kong (**Appendix F**).

- 5.4.13 From the REA survey, the monitoring site was mainly composed of natural bedrock and big boulders down to 3.5 meters water depth along the surveyed route (**Table 5.13**). Scattered hard coral colonies were recorded along the REA transect and only 3 species of hard coral were recorded. The abundance of hard coral species recorded along the transect was shown in **Table 5.14**. Besides, some invertebrates such as common sea snail: *Thais luteostoma*, Sea urchins: *Anthodiaris crassispina* and common green mussel: *Septifer virgatus* were found at the surface of the boulders.

- 5.4.14 This site supported a sparse and patchy cover (<1%) of hard corals. All the recorded coral colonies grew on the big boulders and bedrock surfaces. All hard coral colonies recorded along the transect were common hard coral species in Hong Kong water and in fair health condition.

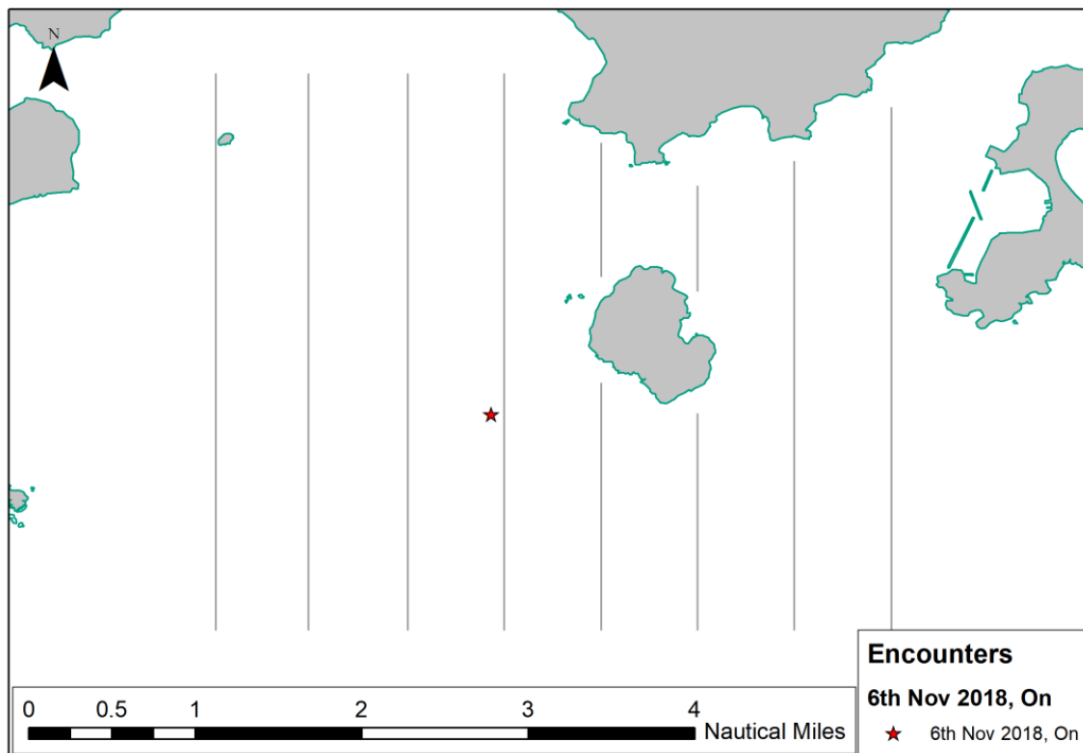
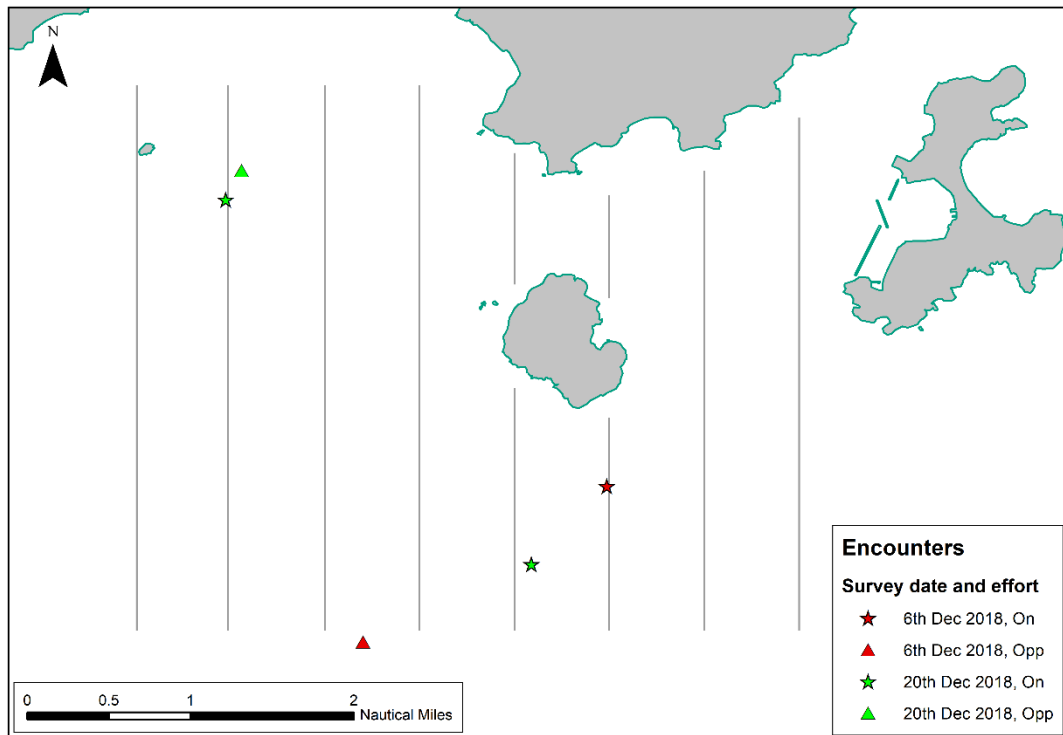
Figure 6.2 Location of sightings recorded during November and December 2018 Vessel-based Line-transect Survey

Date	Species	Sighting No.	Time	Group Size	PSD	Behaviour	Latitude	Longitude	Area	Effort Type	Season
6-Nov-18	Finless Porpoise	1	11:47	1	139	Unknown	22.18955	113.9735	SEL	Impact	Autumn
6-Dec-18	Finless Porpoise	2	11:30	1	N/A	Travel	22.1645	113.9681	SEL	Impact	Winter
6-Dec-18	Finless Porpoise	3	12:37	2	3	Travel	22.1804	113.993	SEL	Impact	Winter
20-Dec-18	Finless Porpoise	4	13:38	1	N/A	Unknown	22.2127	113.9557	SEL	Impact	Winter
20-Dec-18	Finless Porpoise	5	11:26	2	52	Travel	22.2097	113.9541	SEL	Impact	Winter
20-Dec-18	Finless Porpoise	6	12:53	1	65	Travel	22.1724	113.9853	SEL	Impact	Winter

A review of all the porpoise sightings in the survey area for October to December between 2009-2017 indicates that there are fluctuations between the number of sightings usually recorded in October to December. Given the similar survey conditions and the low encounter rate recorded for porpoise in the project area during the reporting period, an increase in sightings within this area in October to December 2018 is in agreement with the detailed in AFCD long term monitoring data.

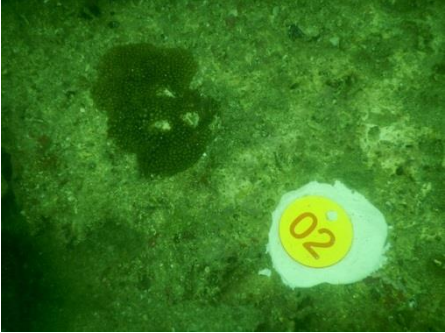
Tag #	3 December 2018	
#2R

An underwater photograph showing a coral colony with a white tag attached. The tag is circular with a yellow center containing the number '02' in black. The surrounding coral is green and appears somewhat bleached or damaged.

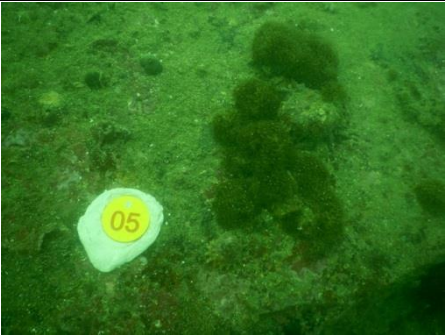
#5R

An underwater photograph showing a coral colony with a white tag attached. The tag is circular with a yellow center containing the number '05' in black. The surrounding coral is green and appears somewhat bleached or damaged.

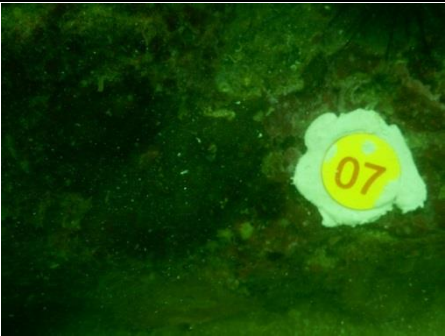
#7R

An underwater photograph showing a coral colony with a white tag attached. The tag is circular with a yellow center containing the number '07' in black. The surrounding coral is green and appears somewhat bleached or damaged.

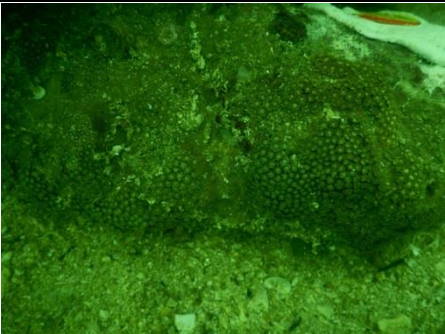
#10R

An underwater photograph showing a coral colony with a white tag attached. The tag is circular with a yellow center containing the number '10' in black. The surrounding coral is green and appears somewhat bleached or damaged.

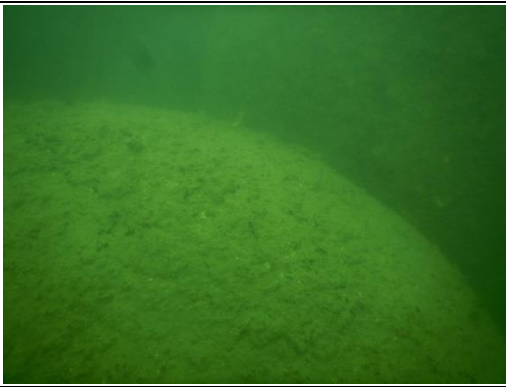
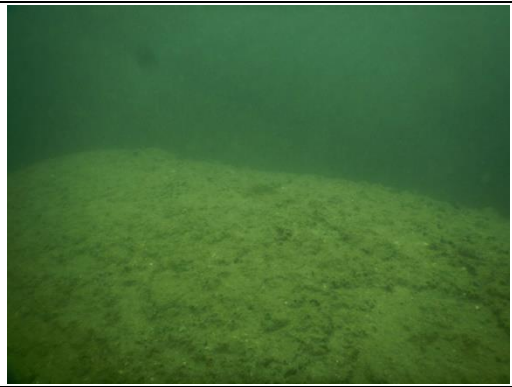
Photo Plate for Representative photo records during the REA survey

Big Boulders

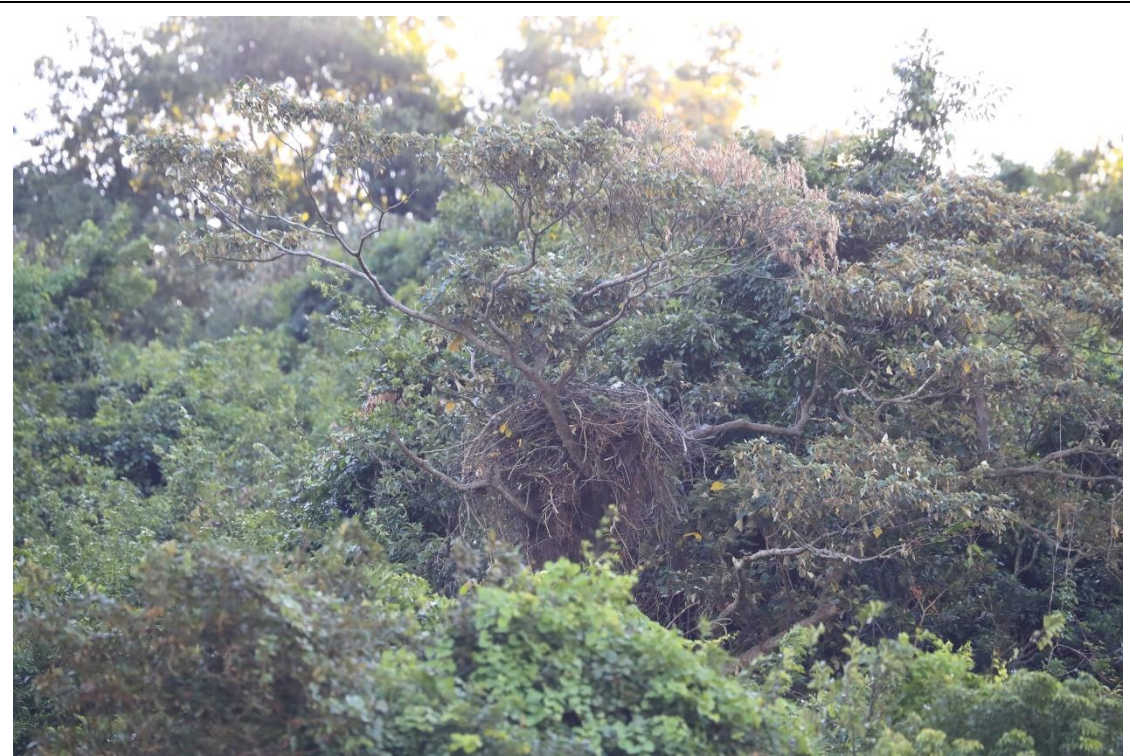
New nest of WBSE

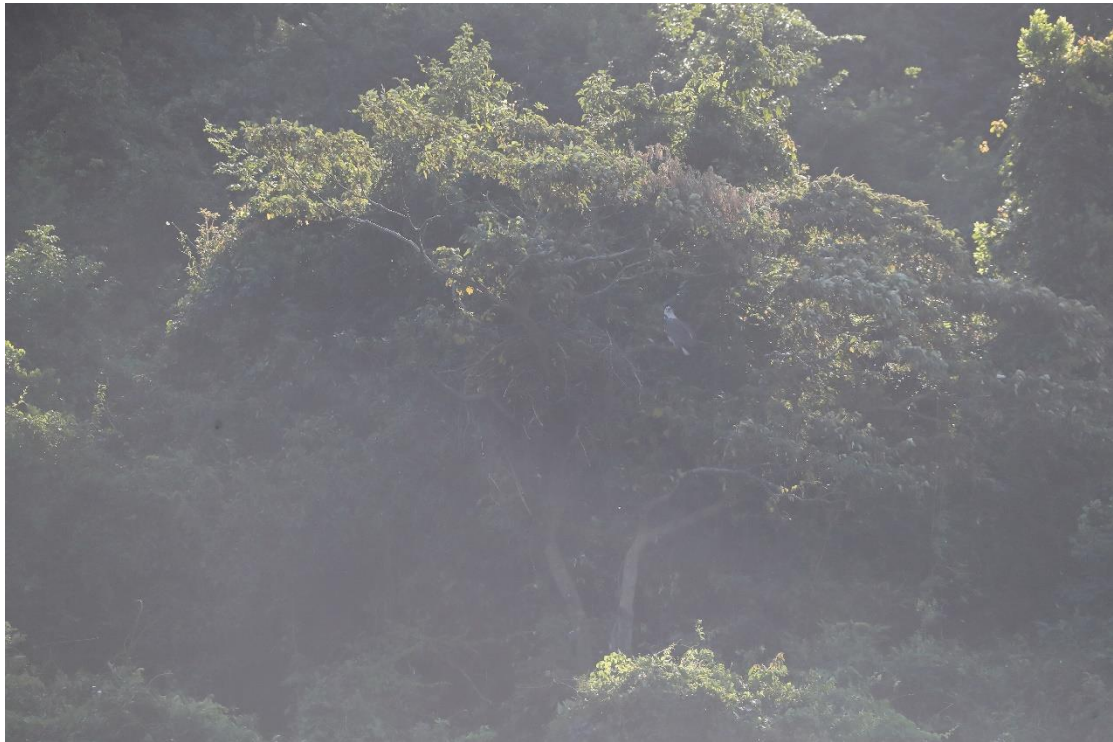
WBSE standing next to the new nest
