Contract No. EP/SP/66/12
Integrated Waste Management Facilities, Phase 1
Quarterly EM&A Report No.3

Quarterly EM&A Report No.3 (Period from 1 January to 31 March 2019)

(Clause 3.3, Further Environmental Permit FEP-01/429/2012/A)

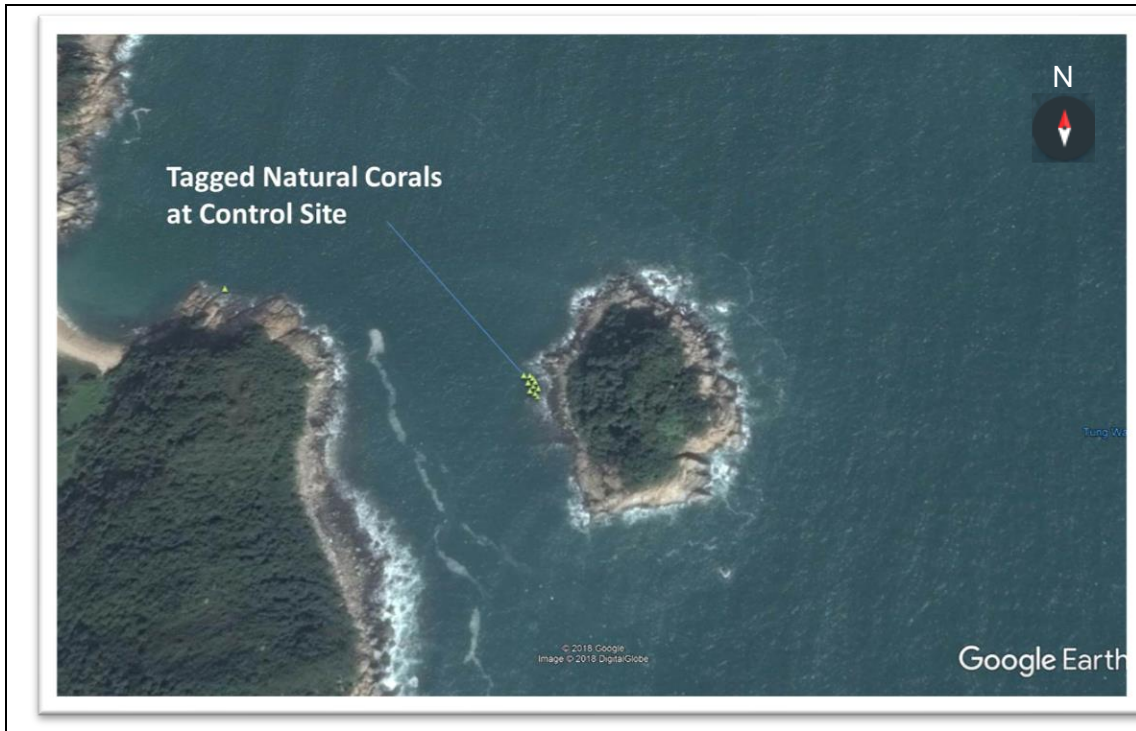
Figure 5.2 Tagged Natural Corals at Control Site Near Yuen Kong Chau for re-tagging after typhoon Mangkhut

Location of the ten tagged coral colonies at each of the proposed indirect impact site, control site, the recipient site R3 and REA transect at proposed indirect impact site are shown in **Figure 5.1**, **Figure 5.2** and **Figure 5.3** respectively:

- 5.4.1 After the re-tagging activities were finished at both Control site and Indirect Impact site (**Figure 5.1** and **5.2** respectively), the additional monthly monitoring after coral re-tagging due to the hitting of super typhoon Mangkhut in mid-September 2018 was conducted on 10 January 2019; and the weather condition was summarized in **Table 5.6**.

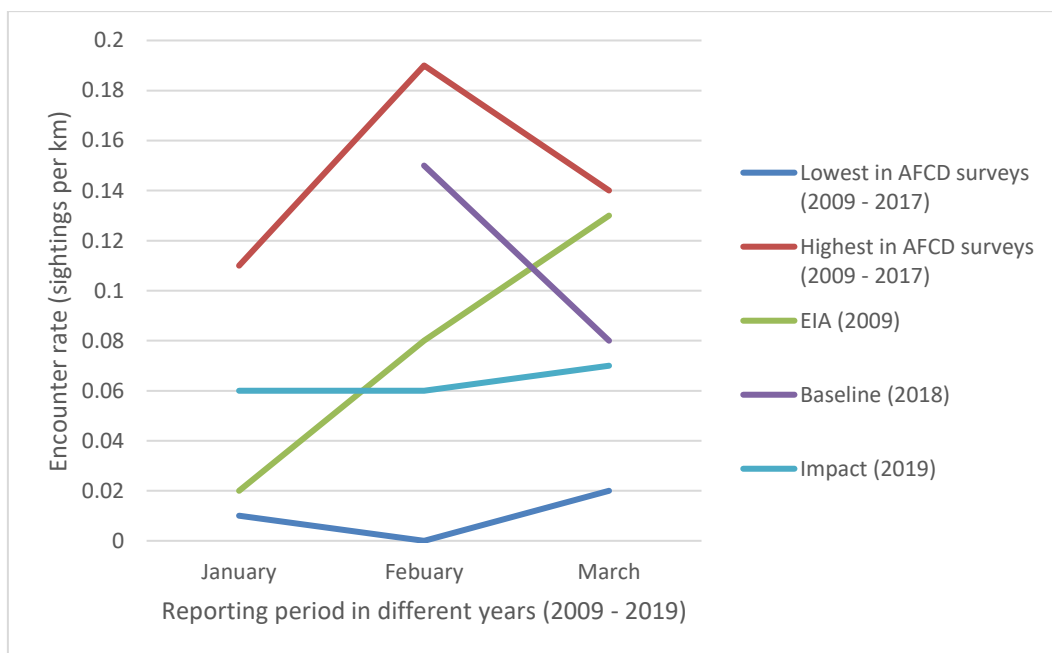
Figure 6.3 Plot of encounter rate during January to March in 2009 – 2019 from different surveys

A review of the long term AFCD marine mammal monitoring programme, the EIA and the pre-construction baseline monitoring report for this project was conducted. Both the EIA and the pre-construction baseline monitoring were conducted during the peak porpoise months (Dec 2008 to May 2009 and Feb-April 2018, respectively). The AFCD long term monitoring data, the EIA and baseline information could be compared directly to Impact Survey results of the reporting period.
