**Contract No. EP/SP/66/12**  
**Integrated Waste Management Facilities, Phase 1**  
**5<sup>th</sup> Quarterly EM&A Report**

# Quarterly EM&A Report No.5

## (Period from 1 July to 30 September 2019)

*(Clause 3.3, Further Environmental Permit FEP-01/429/2012/A)*

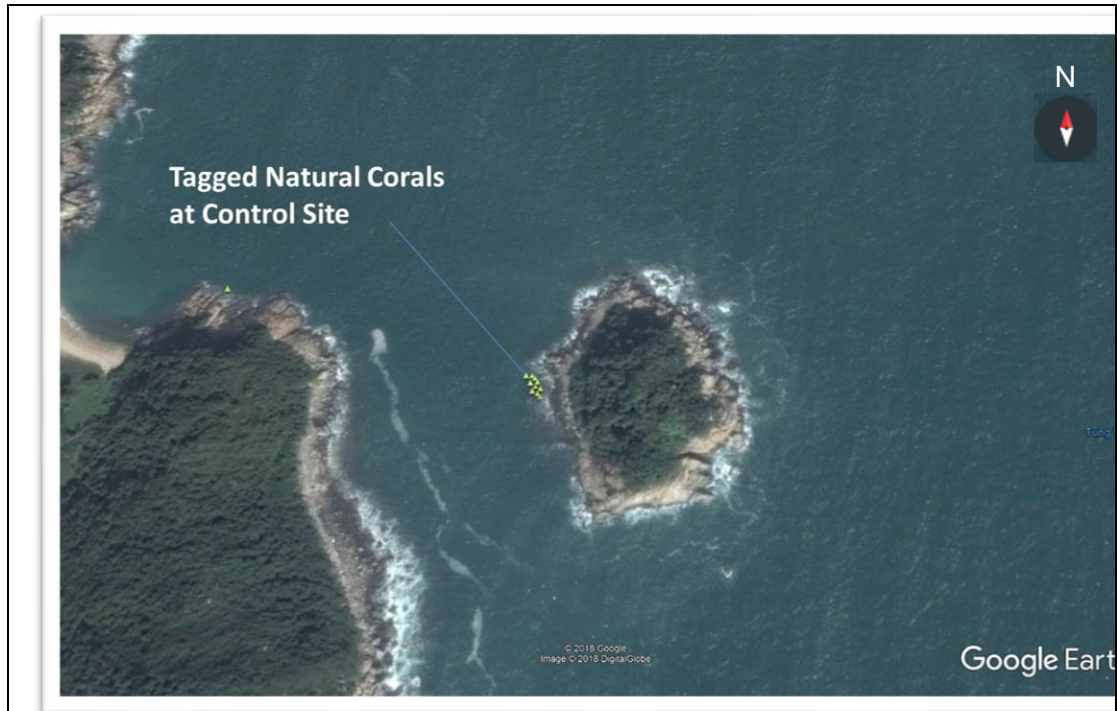
**Figure 5.2 Tagged Natural Corals at Control Site Near Yuen Kong Chau for re-tagging after typhoon Mangkhut**

Location of the ten tagged coral colonies at each of the proposed indirect impact site, control site, the recipient site R3 and REA transect at proposed indirect impact site are shown in **Figure 5.1**, **Figure 5.2** and **Figure 5.3** respectively:
