Re: Contract No. SS K/509
Provision of Independent Environmental Checker Consultancy for Design and Construction of Kong Nga Po Police Training Facilities
Verification of Monthly EM&A Report (July 2024)

**Provision of Environmental Team consultancy
for Design and Construction of Kong Nga Po Police
Training Facilities (Programme No. 279LP)**

**Monthly Environmental Monitoring and
Audit Report for July 2024
(Version 2)**

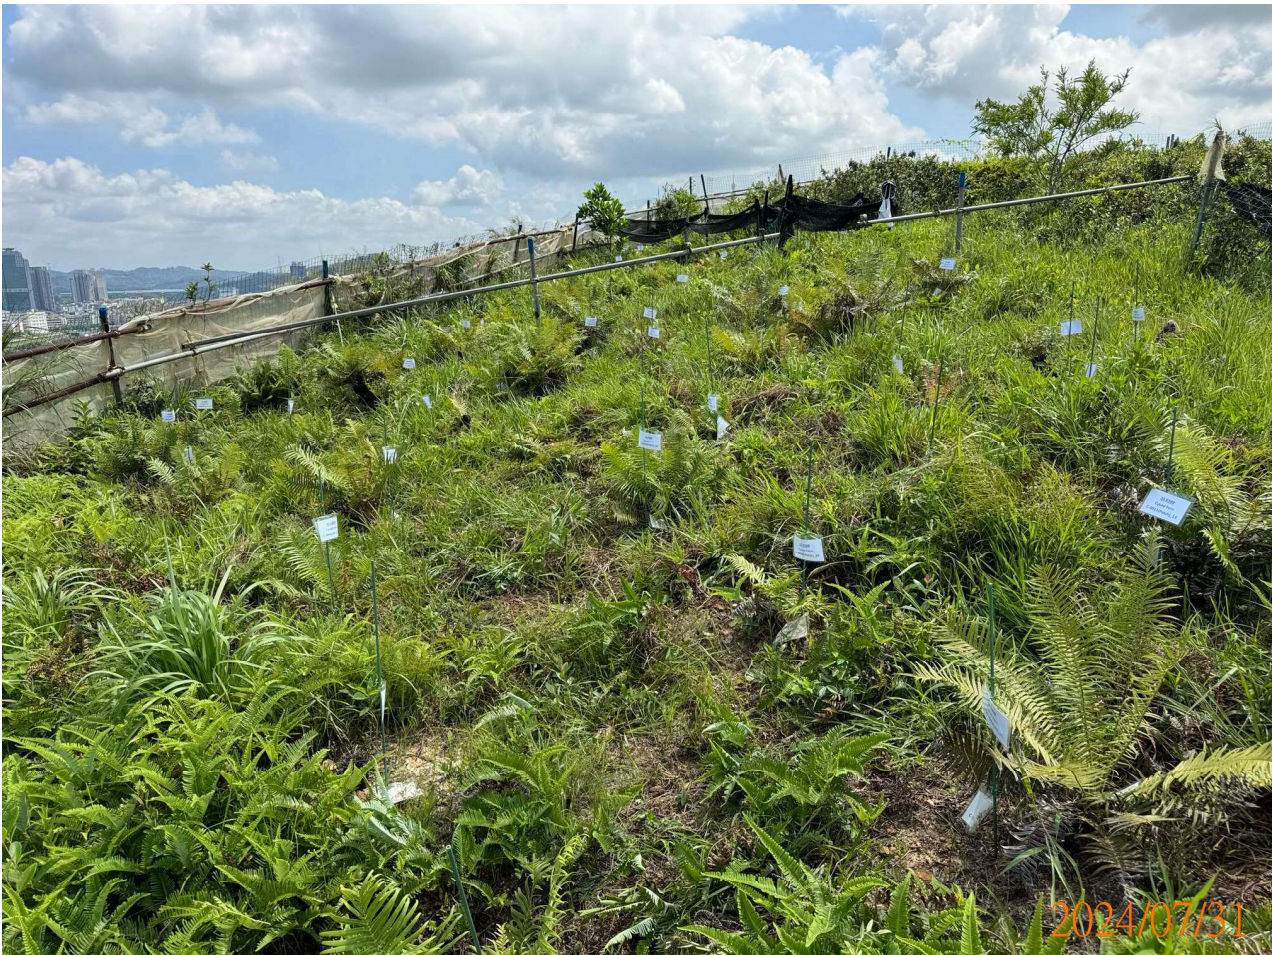
replacement of tags

- 1) To provide new identification tags for any *Brainea insignis* that were missing them;
- 2) To substitute any plant labels at the receptor site that had become illegible due to fading;
- 3) To refer to the soil improvement guidelines published by the Greening, Landscape and Tree Management Section (GLTMS) of the Development Bureau (2022) for application in the monitoring and upkeep of the transplanted plant species;
- 4) To set up shade nets;
- 5) To ensure the soil remains moist by adhering to the necessary daily watering schedule.

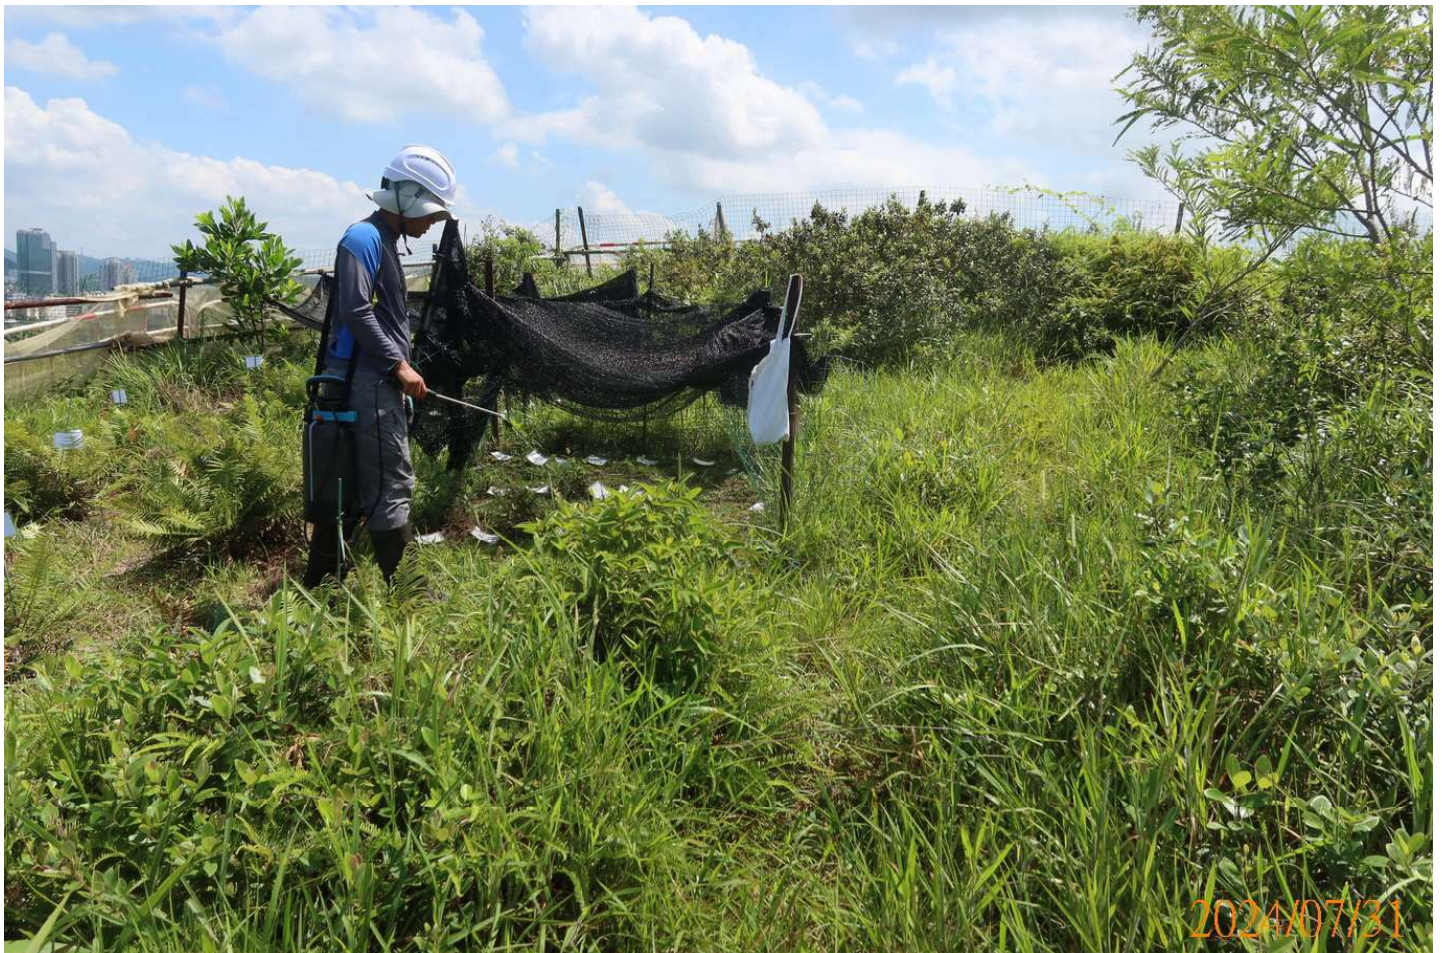
watering

of the Construction Phase. It was recommended to water the transplants daily for the first three months following the move, as well as throughout periods of drought, to maintain soil moisture. Additional maintenance tasks, such as mulching and weeding, should be performed as necessary.

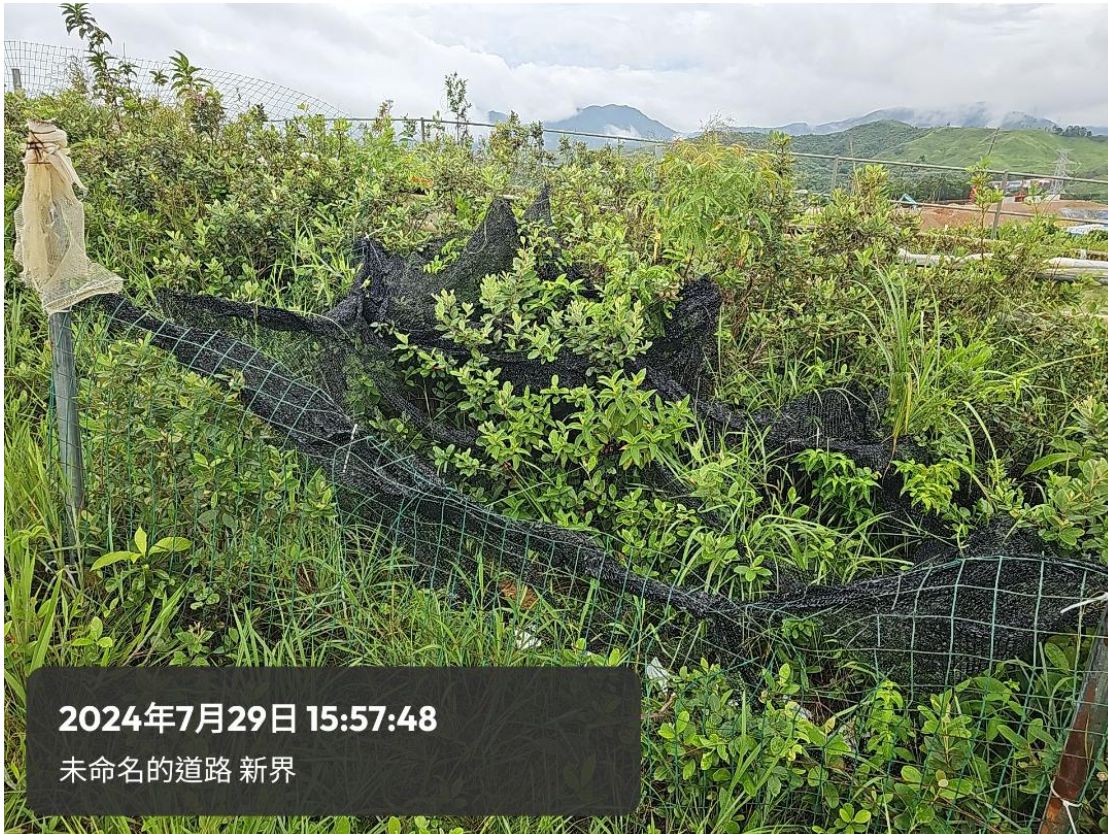
2024年7月29日 15:57:48

- 1) Please refer to the guidelines on soil improvement issued by the Greening, Landscape and Tree Management Section (GLTMS) of the development bureau (2022) to apply to monitoring and maintenance of transplanted flora species.
- 2) Daily watering frequency is needed to keep the soil moist.
- 3) Installation of a shaded net is provided below.
- 4) The wild plants that are growing in undesirable areas should be removed.
- 5) The damaged Black Shade Net should be repaired or replaced with a new one.
