RECONSTRUCTION OF JETTY
AT LUNG KWU CHAU

(CED CONTRACT NO.: CV/2002/11)

FIRST MONTHLY EM&A REPORT
(09 JUNE TO 08 JULY 2003)

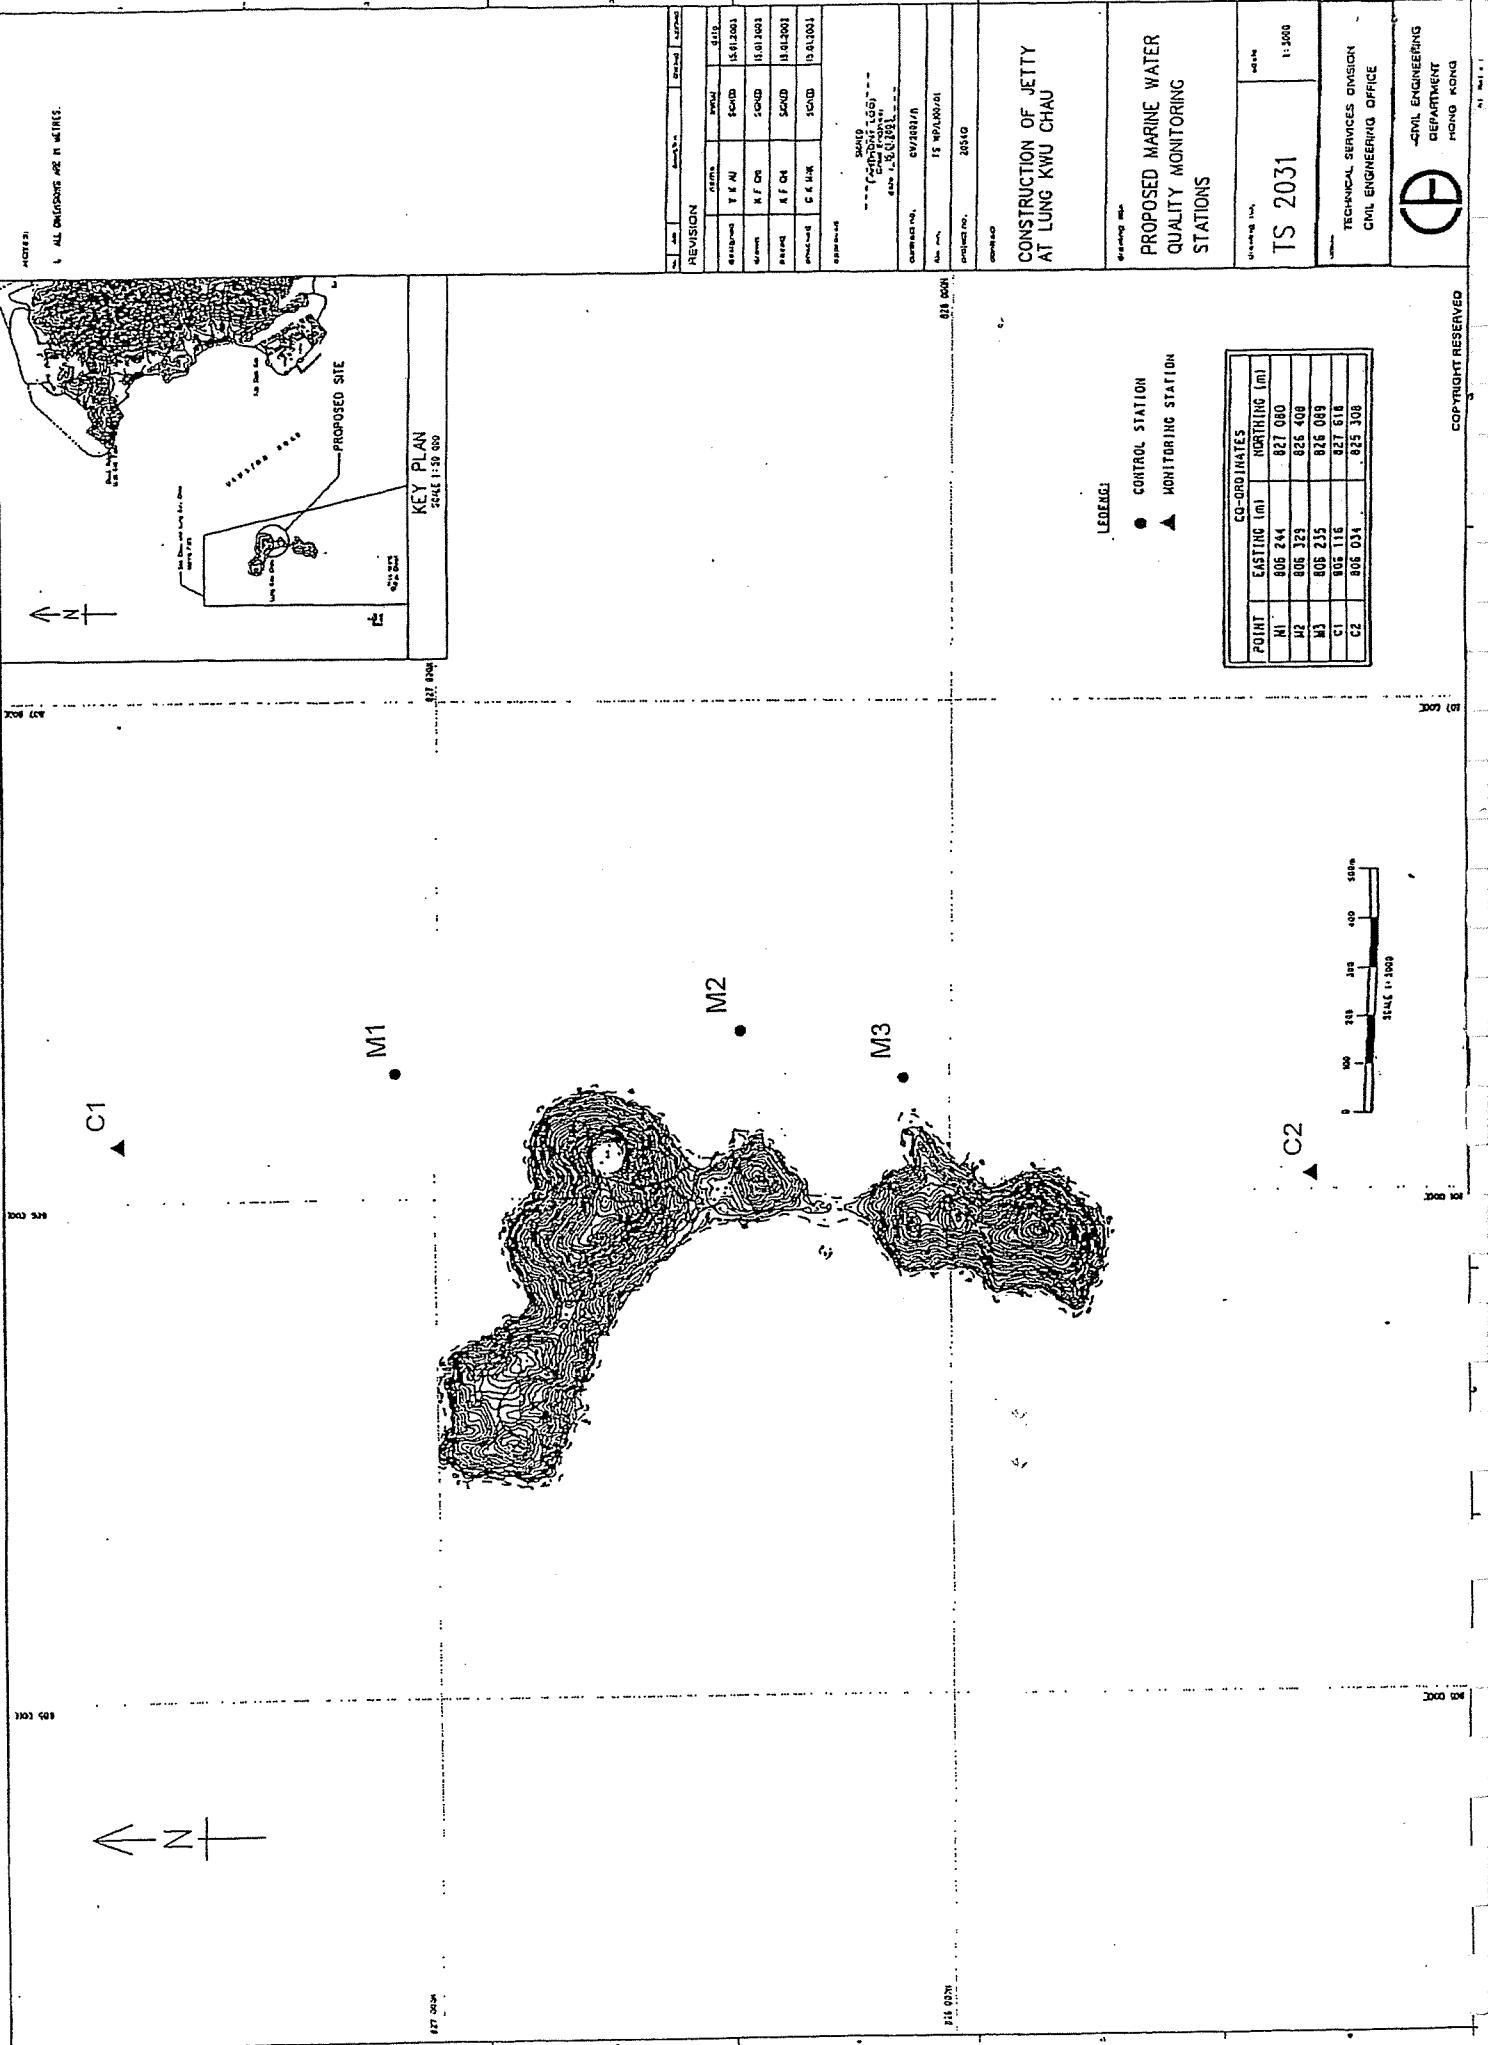
The marine water quality monitoring stations during the dredging works for the jetty and catwalk foundation and approach channel are shown in TS-2031. The co-ordinates of the marine water monitoring stations are listed in Table 4.1.

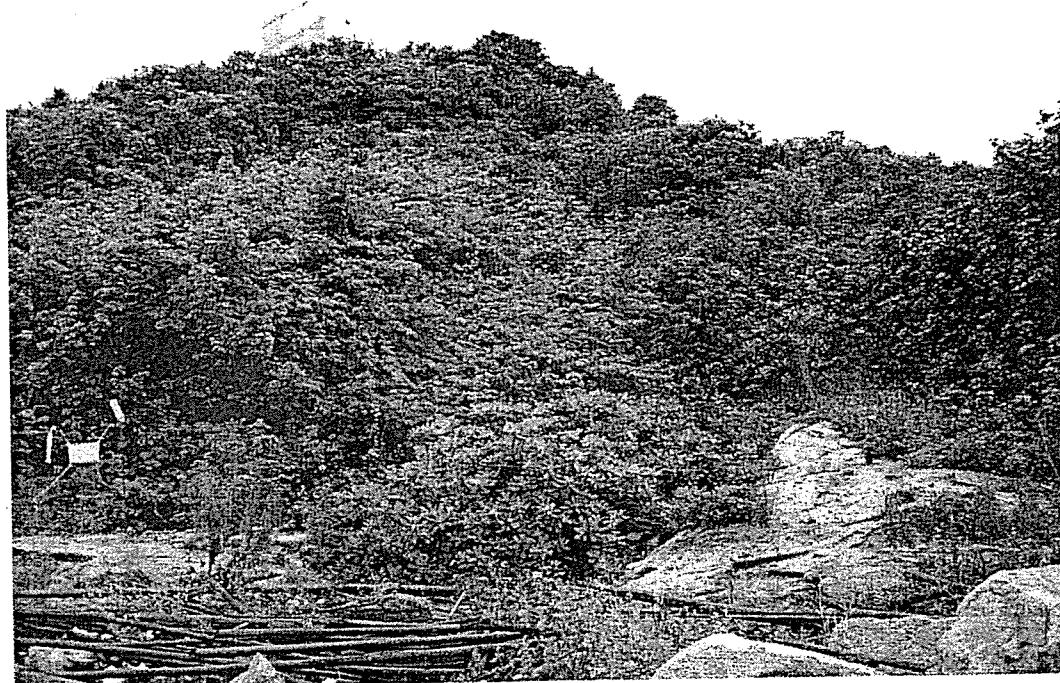
Photo 3

A summary of the implementation status of the mitigation measures for terrestrial ecology and marine ecology on site inspections is presented in Appendix H. Photos for the surrounding terrestrial habitat (e.g. backshore vegetation and grass/shrubland) were shown in Photo 1 to Photo 10.
