Dragages -China Harbour-VSL JV

Contract HY/2011/09
Hong Kong-Zhuhai-Macao Bridge
Hong Kong Link Road-Section between
HKSAR Boundary and Scenic Hill
Monthly EM&A Report
February 2015
(Version 2.0)

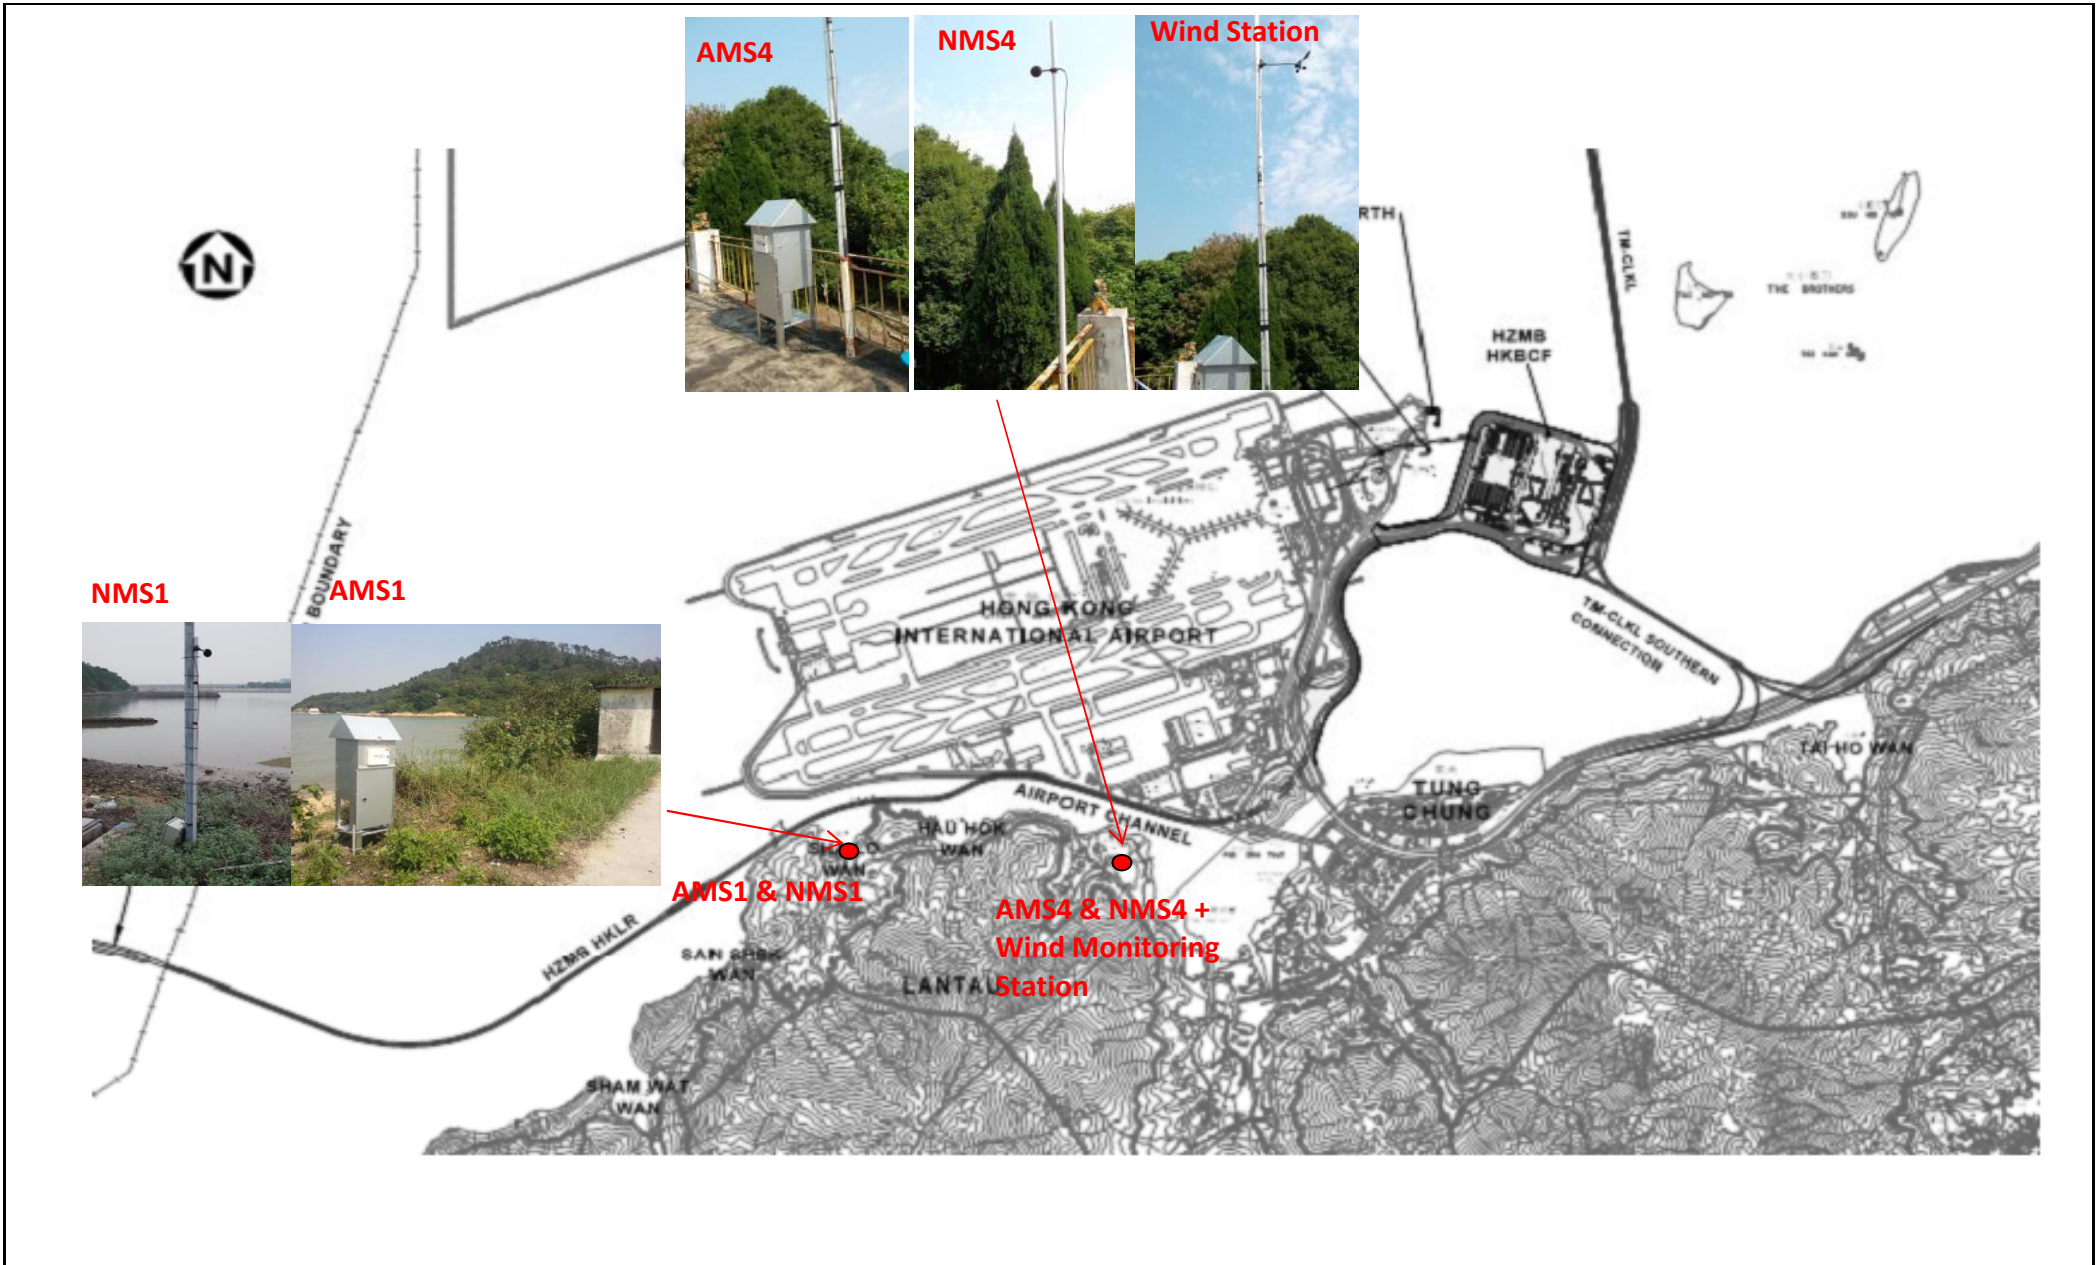
Title	Contract No. HY/2011/09 Hong Kong-Zhuhai-Macao Bridge Hong Kong Link Road – Section between HKSAR Boundary and Scenic Hill	Scale	N.T.S	Propose No.	MA12014	CINOTECH
		Date	Feb-13	Figure	3	
Locations of Air Quality and Noise Monitoring Stations

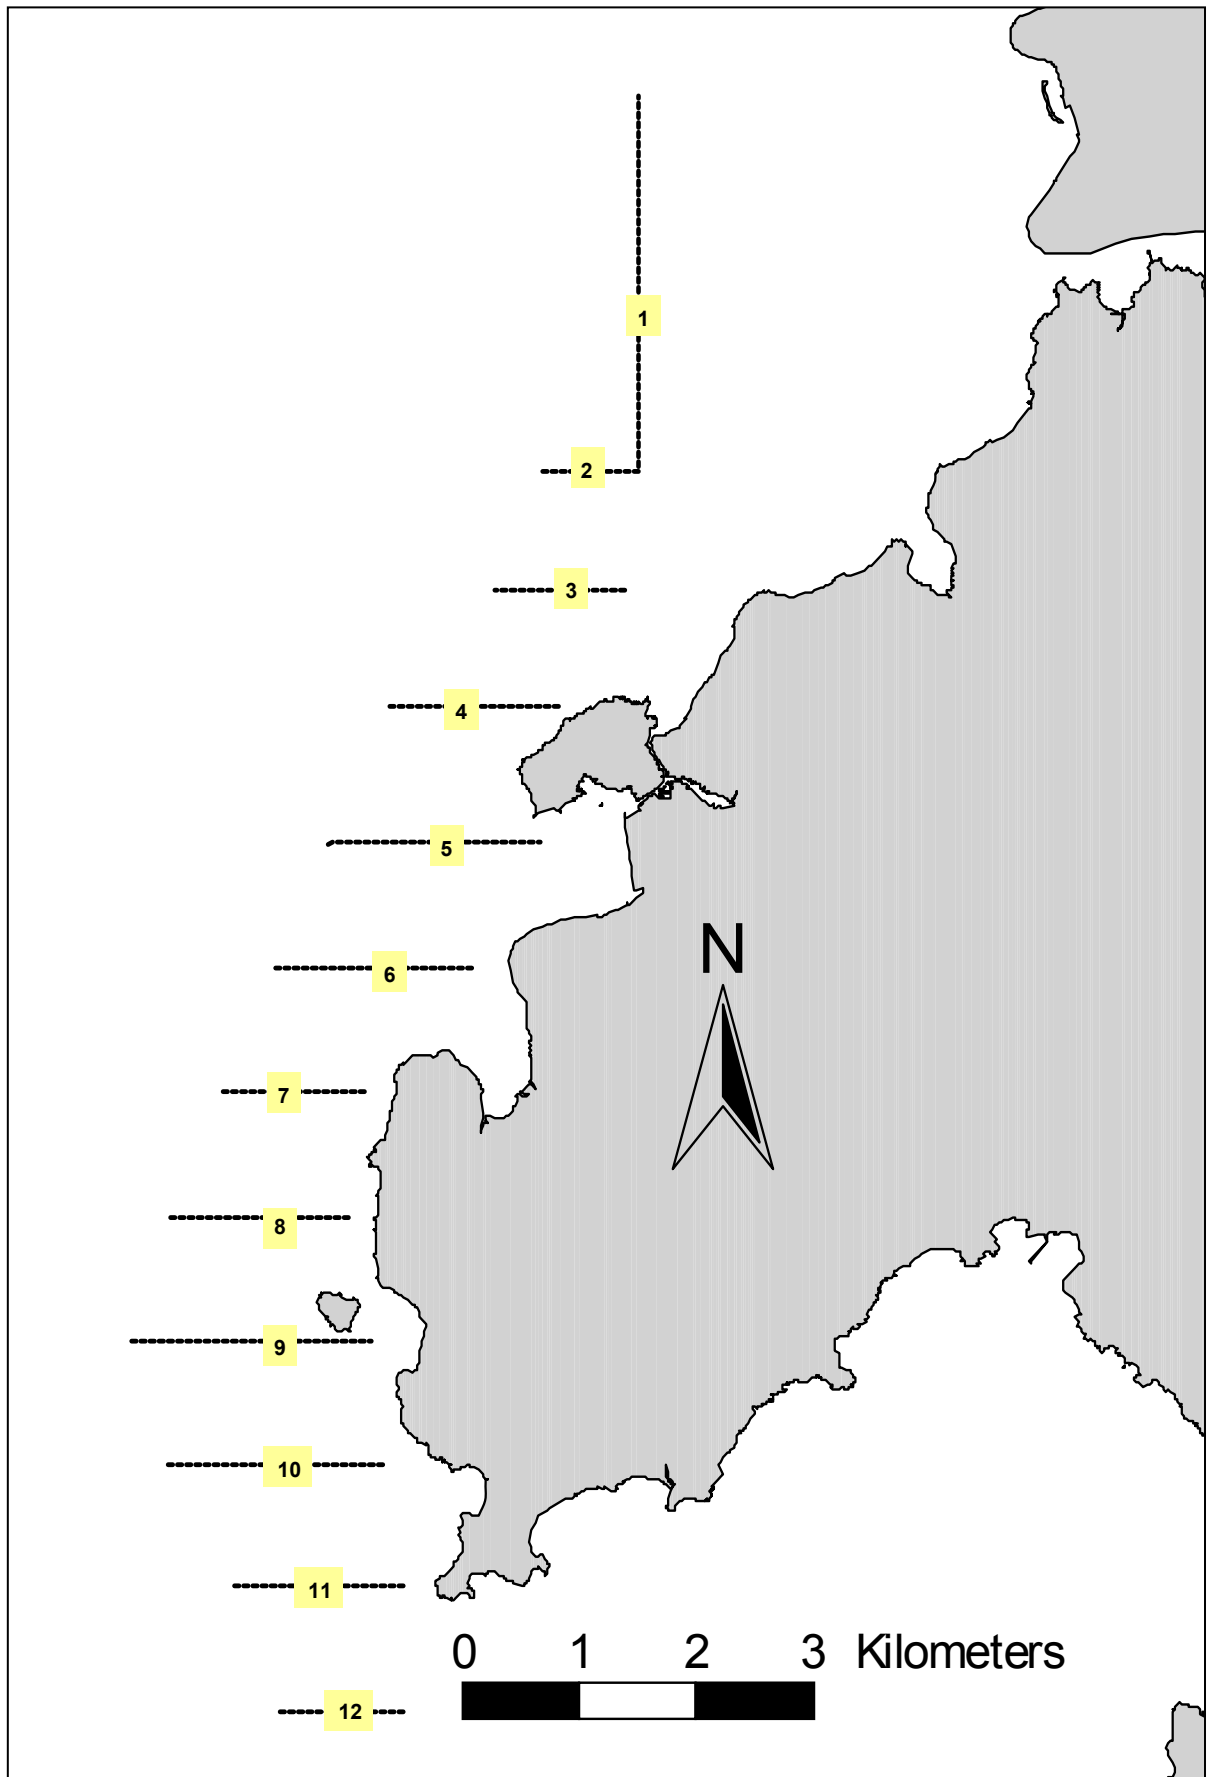
Figure 1. Transect Line Layout in West Lantau Survey Areas

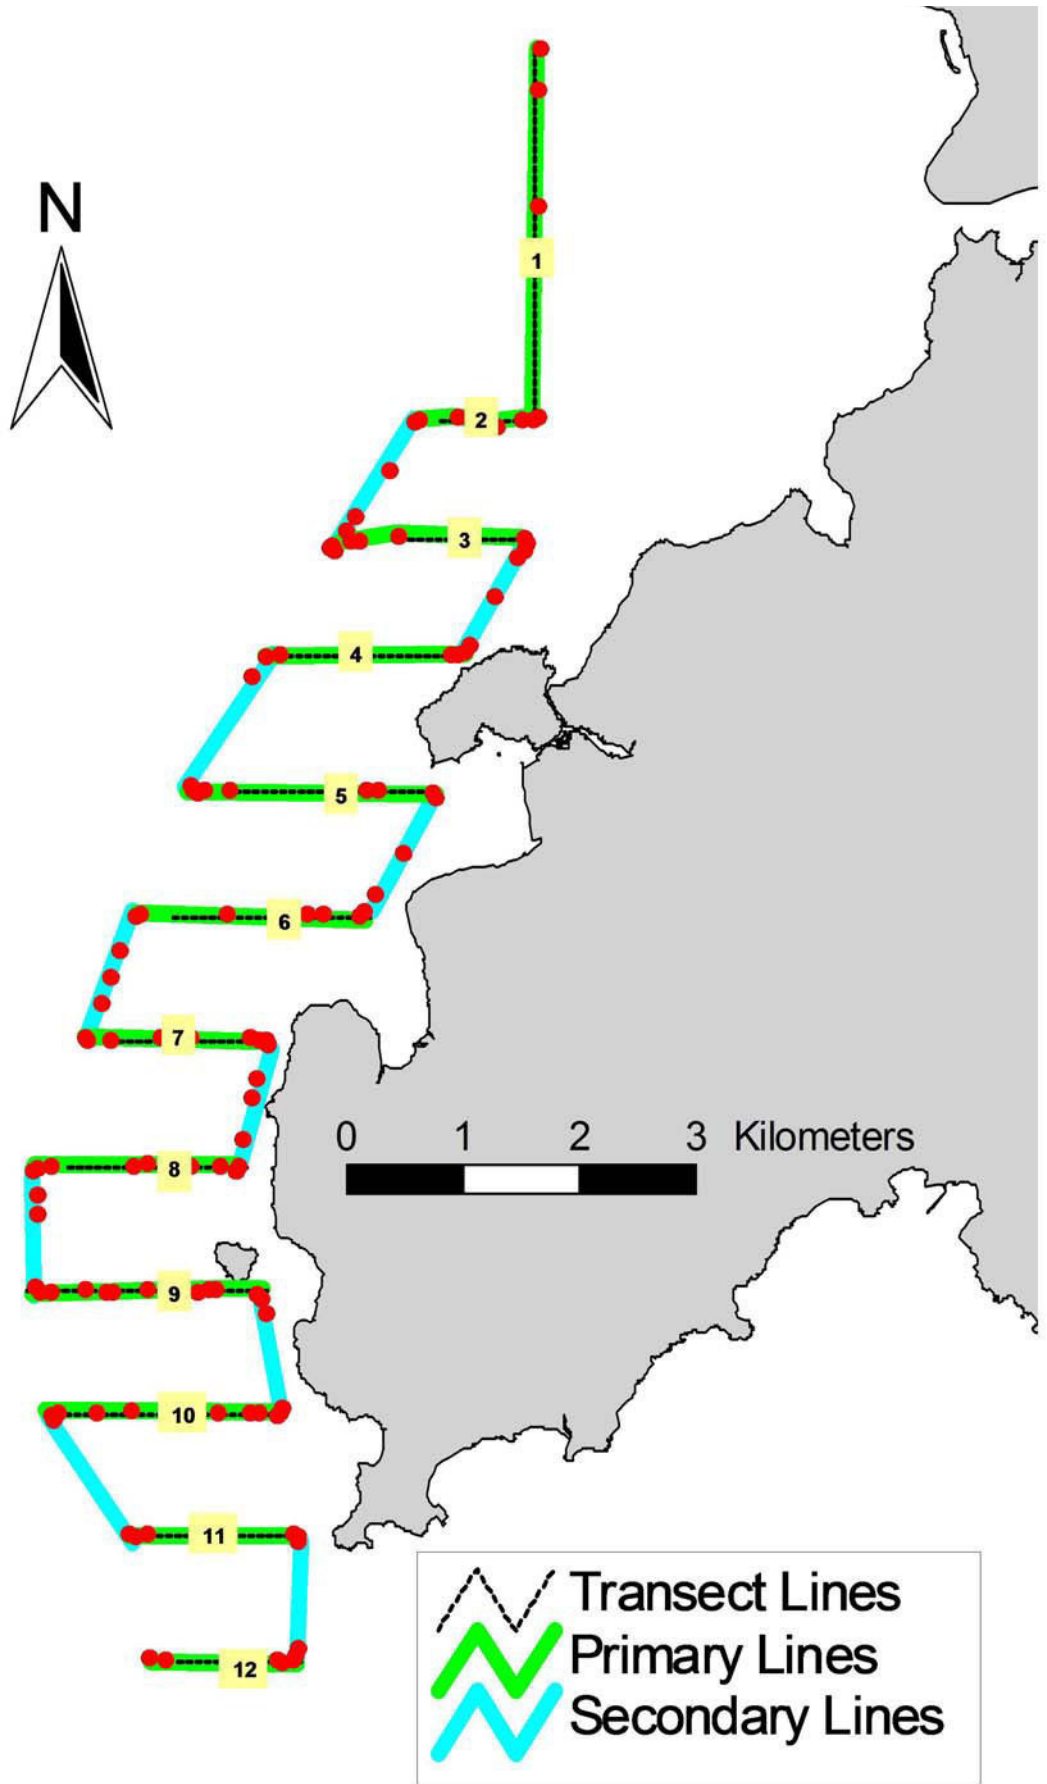
Figure 2. Survey Route on February 3rd, 2015 (note: red dots represent the tracked positions of survey boat logged continuously by GPS throughout the course of the survey)

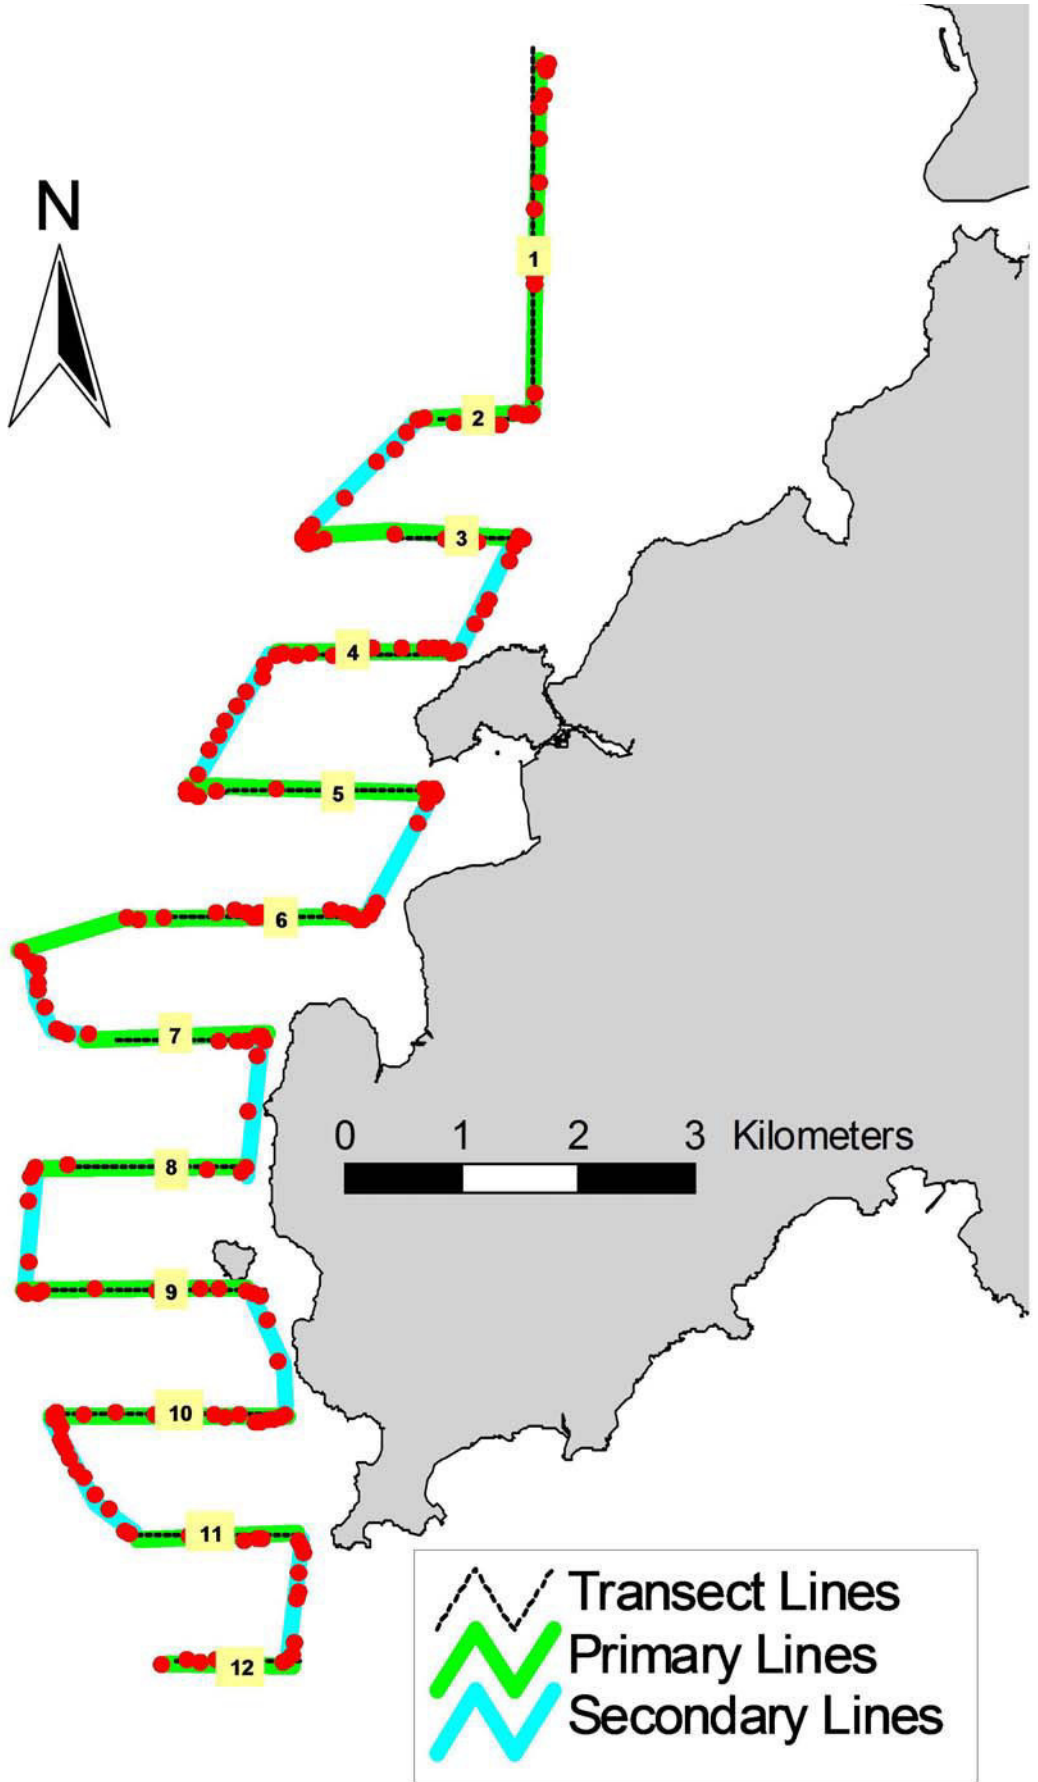
Figure 3. Survey Route on February 10th, 2015 (note: red dots represent the tracked positions of survey boat logged continuously by GPS throughout the course of the survey)

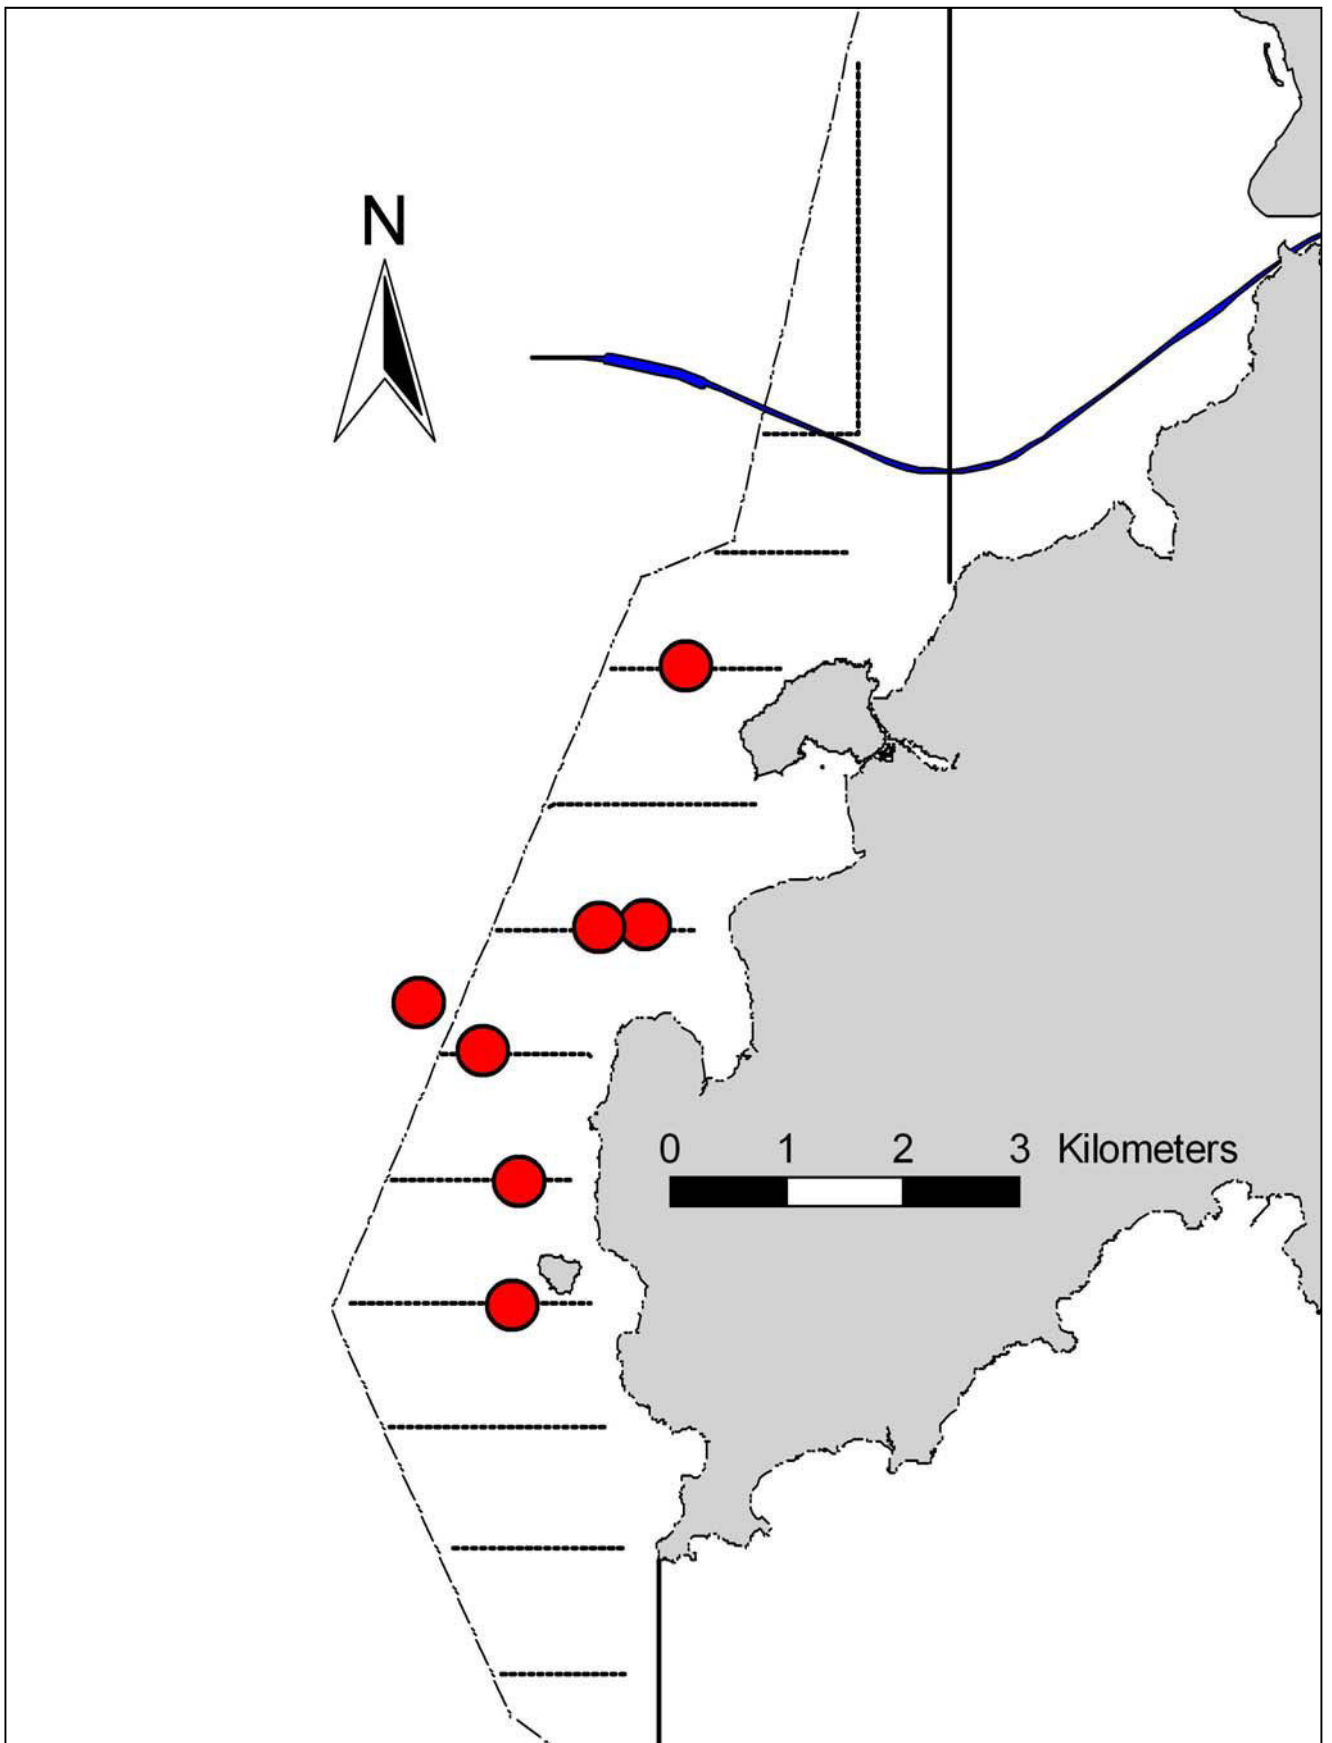
Figure 4. Distribution of Chinese White Dolphin Sighting during February 2015 HKLR09 Monitoring Surveys

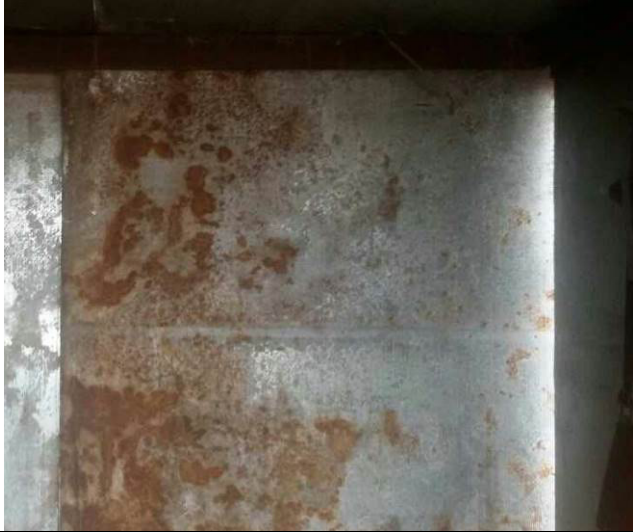
<p>Ref No: 150119-R03</p> <p>Impact: Noise (E5)</p> <p>Details: Properly check and repair the noise enclosure at P71 to ensure it comply with Construction Noise Permit.</p> <p>Follow Up: The damage part of noise enclosure was repaired.</p>

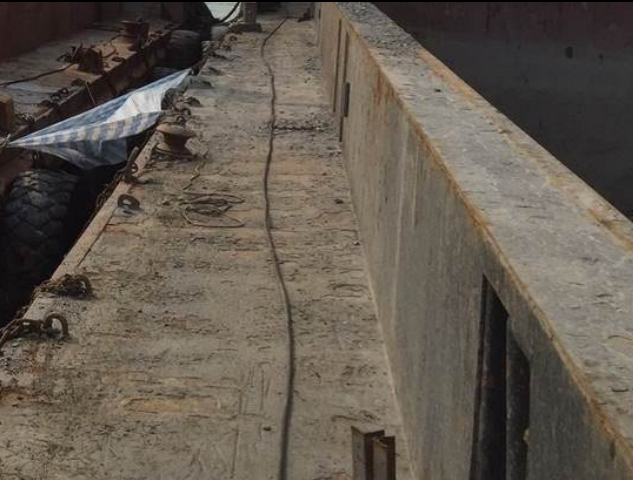
<p>Ref No: 150130-R01</p> <p>Impact: Water Quality (B20)</p> <p>Details: Clear the excess rockfill materials at the deck of barge at P68.</p> <p>Follow Up: The excess rockfill materials at the deck of barge has been cleared.</p>

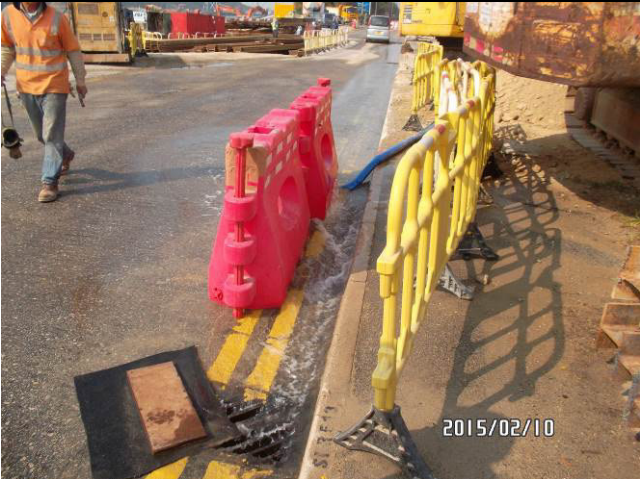
<p>Ref No: 150210-O02</p> <p>Impact: Water Quality (B3i.)</p> <p>Details: Wastewater was observed pumping out to the gully directly at P82. The Contractor was reminded to provide sedimentation facilities and discharge the treated wastewater to approved discharging location.</p>

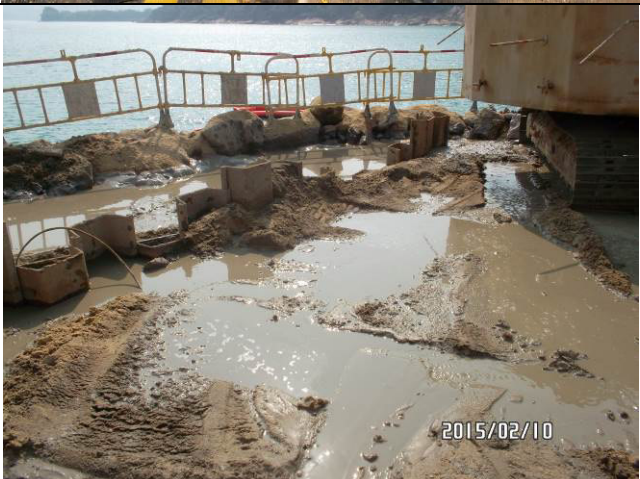
<p>Ref No: 150210-O03</p> <p>Impact: Water Quality (B2ii. & B3i.)</p> <p>Details: Muddy water generated from bored piling works and accumulated at P82. The Contractor was reminded to pump the muddy water to the sedimentation tank and discharge to approved discharging location.</p>
