Contract HY/2011/09
Hong Kong-Zhuhai-Macao Bridge
Hong Kong Link Road-Section between
HKSAR Boundary and Scenic Hill

Monthly EM&A Report

March 2015
(Version 2.0)

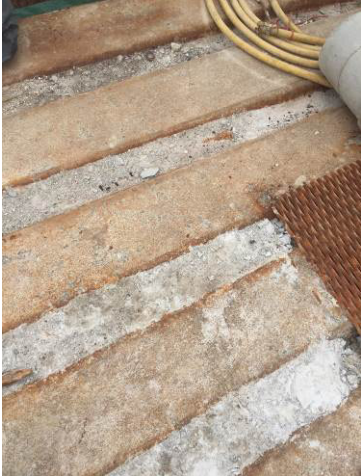
<p>Ref No: 150224-R01</p> <p>Impact: Water Quality (B20)</p> <p>Details: Clear the excess concrete debris at the platform at P15.</p> <p>Follow Up: The excess concrete debris was cleared.</p>

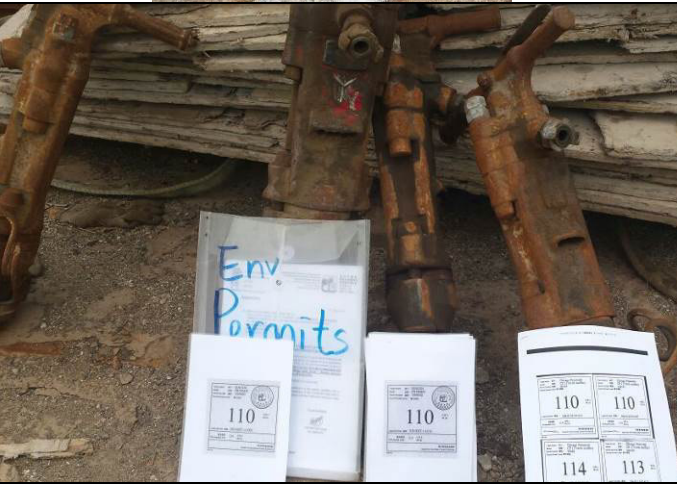
<p>Ref No: 150224-R02</p> <p>Impact: Noise (E8)</p> <p>Details: Provide noise emission labels for the hand held breaker at the platform at P15.</p> <p>Follow Up: Noise emission labels have been provided for hand held breaker.</p>

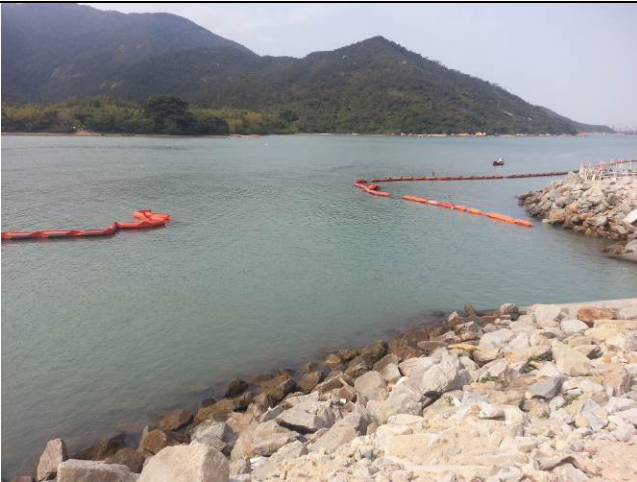
Details:
The silt curtain at P98 and P95 should be used to surround the works area to avoid the gap.

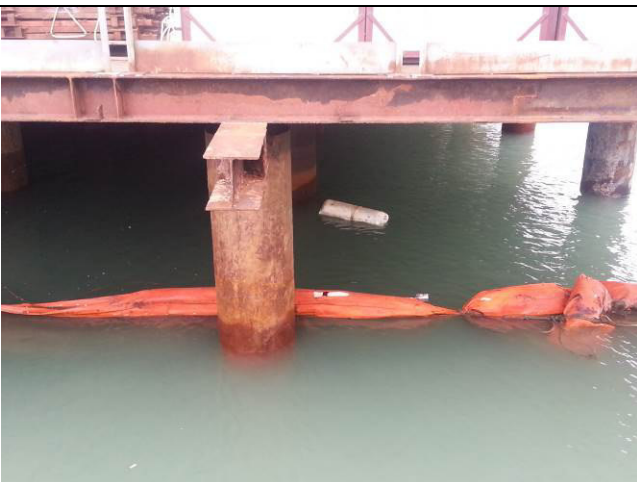
Details:
Regular check and provide well maintenance for the silt curtain at P68 to ensure it can function properly.

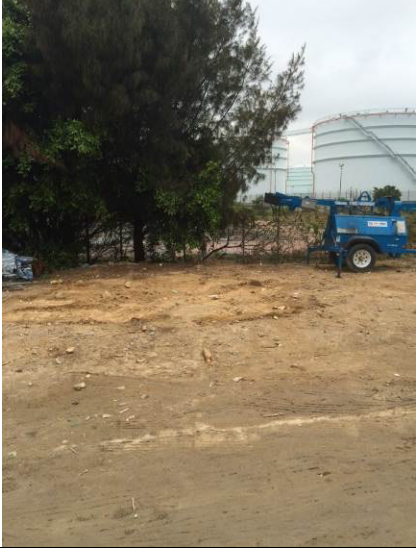
<p>Ref No: 150303-R01</p> <p>Impact: Waste / Chemical Management (F4ii.)</p> <p>Details: Clear the accumulated construction wastes at near P107.</p> <p>Follow Up: The accumulated construction waste were cleared.</p>

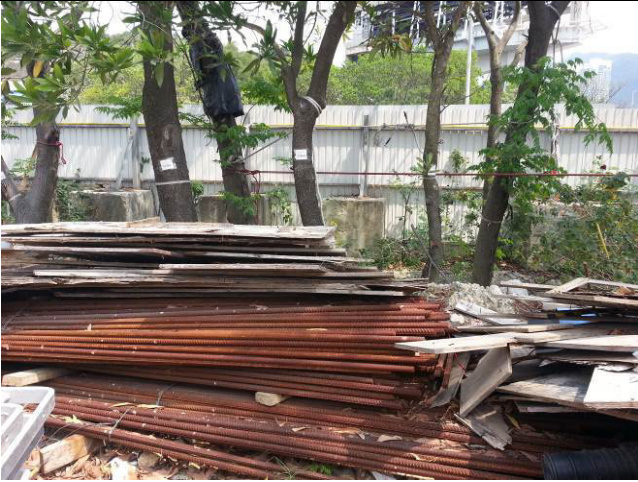
P113

B. Ecology	
150317-R04	• Clear the construction materials at near the trees at P113, P102 and P100.	C30
	C. Air Quality	
	• No environmental deficiency was identified during site inspection.

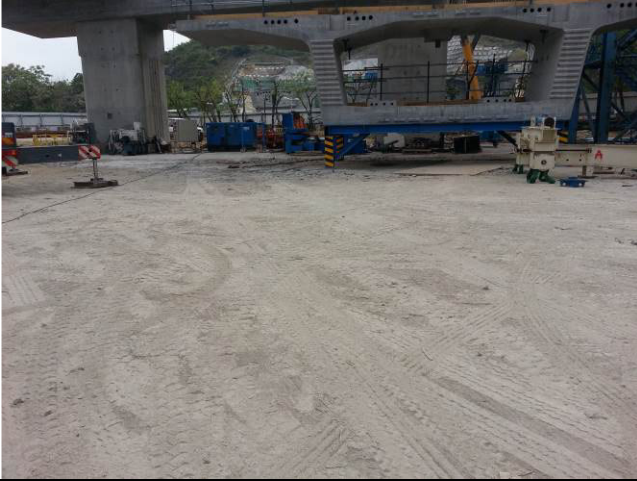
Ref No: 150323-R01

Impact:
Air Quality (D5, D6, D14)

Details:
The unpaved site area at near P113 should be watered regularly to avoid dust generation.

<p>Ref No: 150323-R01</p> <p>Impact: Air Quality (D5, D6, D14)</p> <p>Details: The unpaved site area at near P113 should be watered regularly to avoid dust generation.</p>
  <p>P70</p>	<p>Ref No: 150323-R02</p> <p>Impact: Water Quality (B25)</p> <p>Details: The silt curtain at P71 and P70 should be used to surround the works area to avoid the gap.</p> <p>Follow Up: No gap was observed at the silt curtain.</p>
  <p>P71</p>

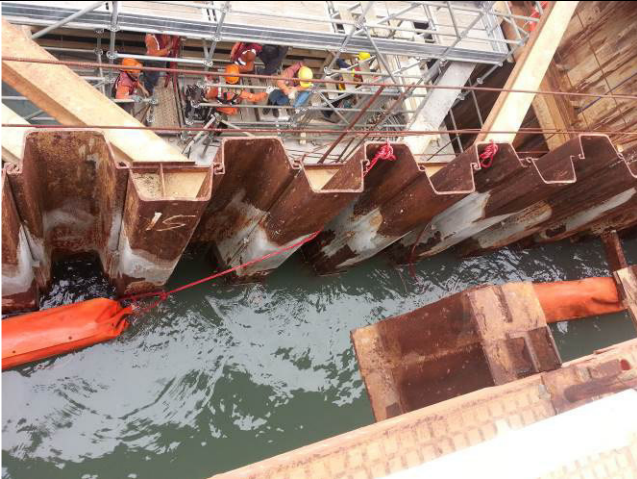
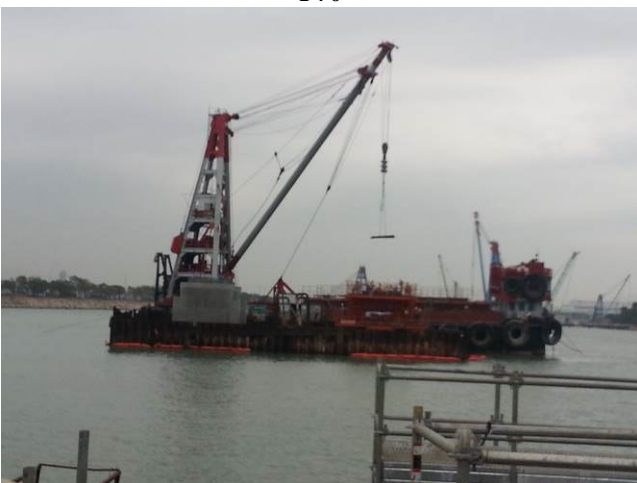
Ref No: 150323-R02

Impact:
Water Quality (B25)

Details:
The silt curtain at P71 and P70 should be used to surround the works area to avoid the gap.

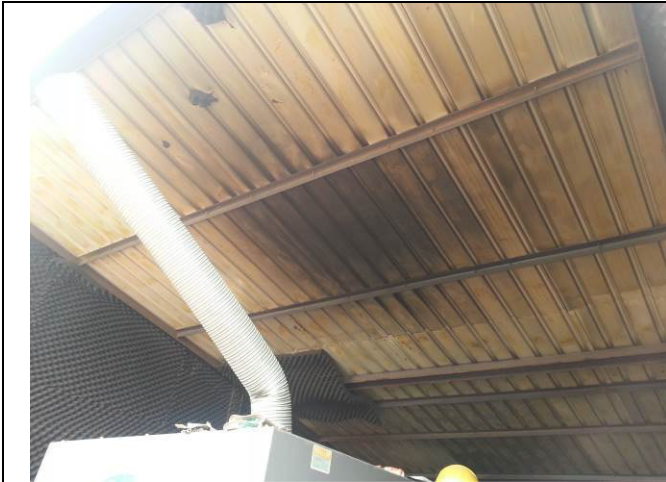
Ref No: 150323-R03

Impact:
Noise (E7)

Details:
To repair the noise enclosure at P70.

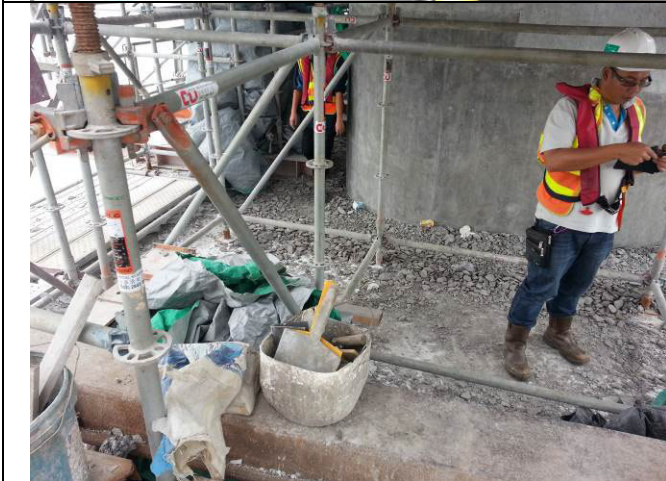
Ref No: 150323-R04

Impact:
Waste / Chemical Management (F4ii.)

Details:
Clear the concrete debris and used cement bags at P50.

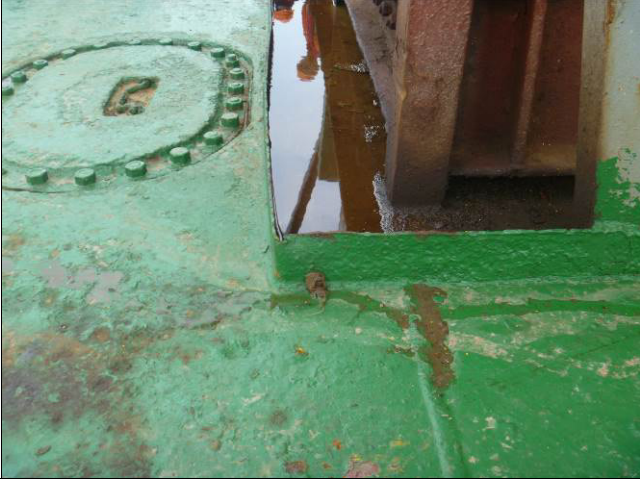
<p>Ref No: 150317-R01</p> <p>Impact: Water Quality (B16)</p> <p>Details: To seal the hole at the bunded area at barge (B22595Y) near P29.</p> <p>Follow Up: The hole at the bunded area was sealed.</p>

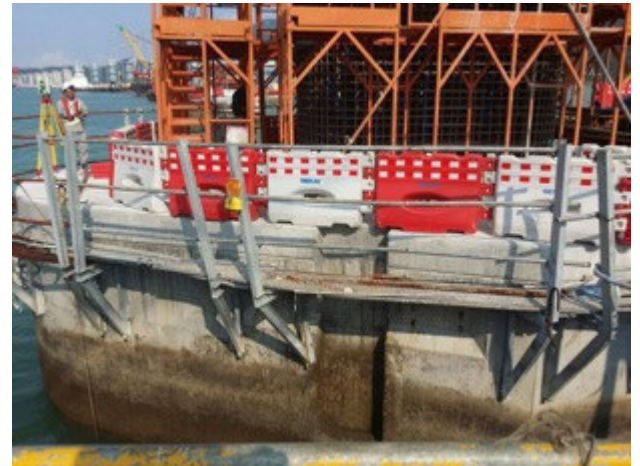
<p>Ref No: 150317-R02</p> <p>Impact: Waste / Chemical Management (F4ii.)</p> <p>Details: Clear the construction wastes at the side of pile cap of P27.</p> <p>Follow Up: The construction wastes at the side of pile cap were cleared.</p>

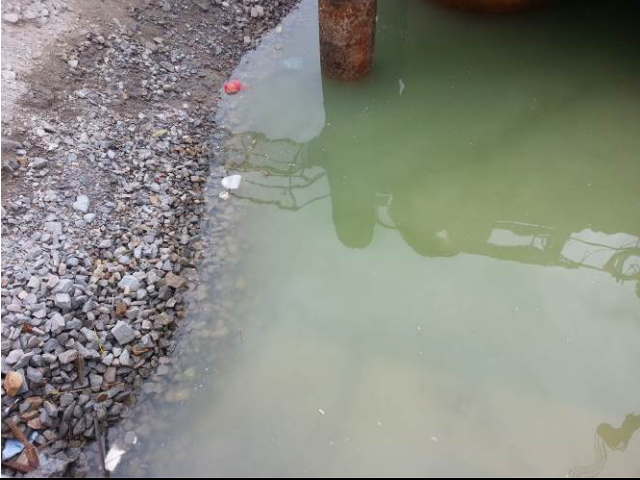
<p>Ref No: 150331-R02</p> <p>Impact: Water Quality (B21)</p> <p>Details: Clear the waste materials at near the rockfill platform at P68.</p>

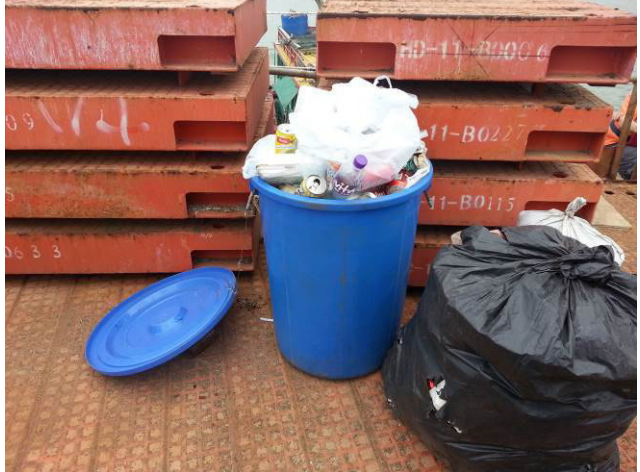
<p>Ref No: 150331-R03</p> <p>Impact: Waste / Chemical Management (F1i. & F1iii.)</p> <p>Details: Clear the accumulated general refuse at platform at P70.</p>

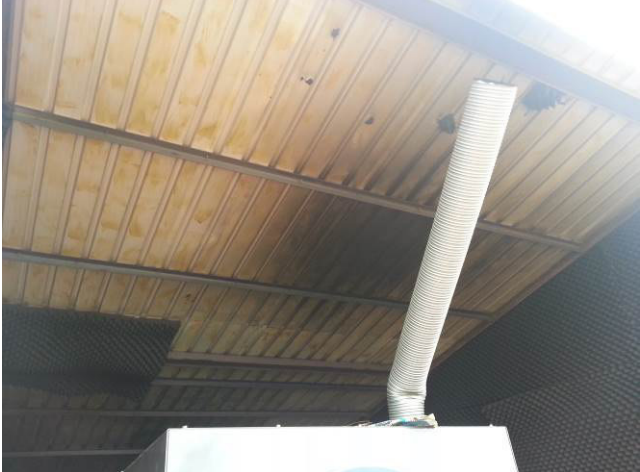
<p>Ref No: 150331-R04</p> <p>Impact: Noise (E7)</p> <p>Details: To repair the noise enclosure at P70.</p>
