**Re: Agreement No. CE 48/2011 (EP)
Environmental Project Office for the
HZMB Hong Kong Link Road, HZMB Hong Kong Boundary Crossing
Facilities, and Tuen Mun-Chek Lap Kok Link – Investigation**

**Contract No. HY/2011/09 HZMB Hong Kong Link Road –
Section between HKSAR Boundary and Scenic Hill
Revised Monthly EM&A Report for August 2015 (EP-352/2009/D)**

Contract HY/2011/09
Hong Kong-Zhuhai-Macao Bridge
Hong Kong Link Road-Section between
HKSAR Boundary and Scenic Hill
Monthly EM&A Report
August 2015
(Version 1.0)

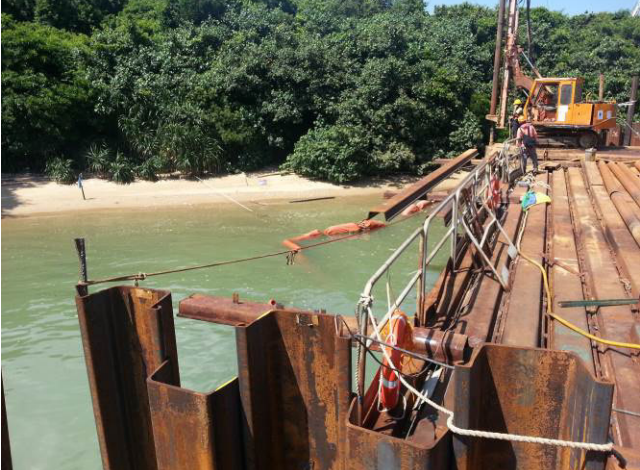
<p>Ref No: 150804-R03</p> <p>Impact: Water Quality (B25)</p> <p>Details: To repair the damaged silt curtain at P69.</p>

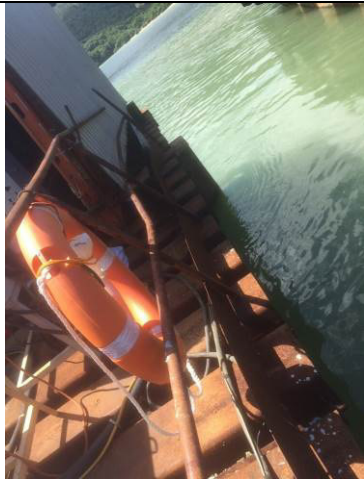
<p>Ref No: 150728-R04</p> <p>Impact: Water Quality (B20)</p> <p>Details: Clear the loose material at the platform at P78.</p> <p>Follow Up: The loose material was removed.</p>

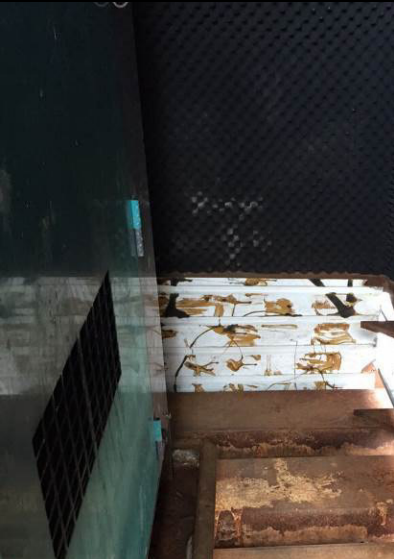
<p>Ref No: 150728-R06</p> <p>Impact: Noise (E7)</p> <p>Details: Ensure the noise enclosure is fully enclosed the equipment at P78.</p> <p>Follow Up: The gap at the noise enclosure was sealed. However, this noise enclosure is no longer required according to the valid construction noise permit.</p>

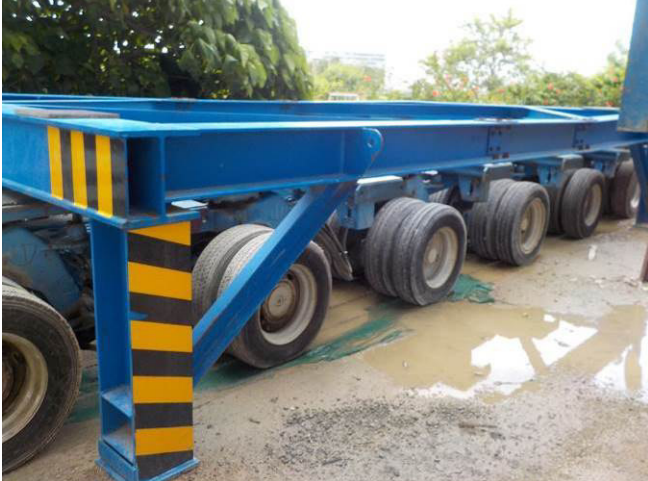
<p>Ref No: 150811-R04</p> <p>Impact: Waste / Chemical Management (F8)</p> <p>Details: Properly repair the scissor platform (segment carrier) to avoid oil leakage at near P108.</p> <p>Follow Up: Segment carrier was repaired and no further oil leakage was observed.</p>
