**Contract No. HY/2011/09 HZMB Hong Kong Link Road –
Section between HKSAR Boundary and Scenic Hill
Revised Monthly EM&A Report for September 2015 (EP-352/2009/D)**

Contract HY/2011/09
Hong Kong-Zhuhai-Macao Bridge
Hong Kong Link Road-Section between
HKSAR Boundary and Scenic Hill
Monthly EM&A Report
September 2015
(Version 2.0)

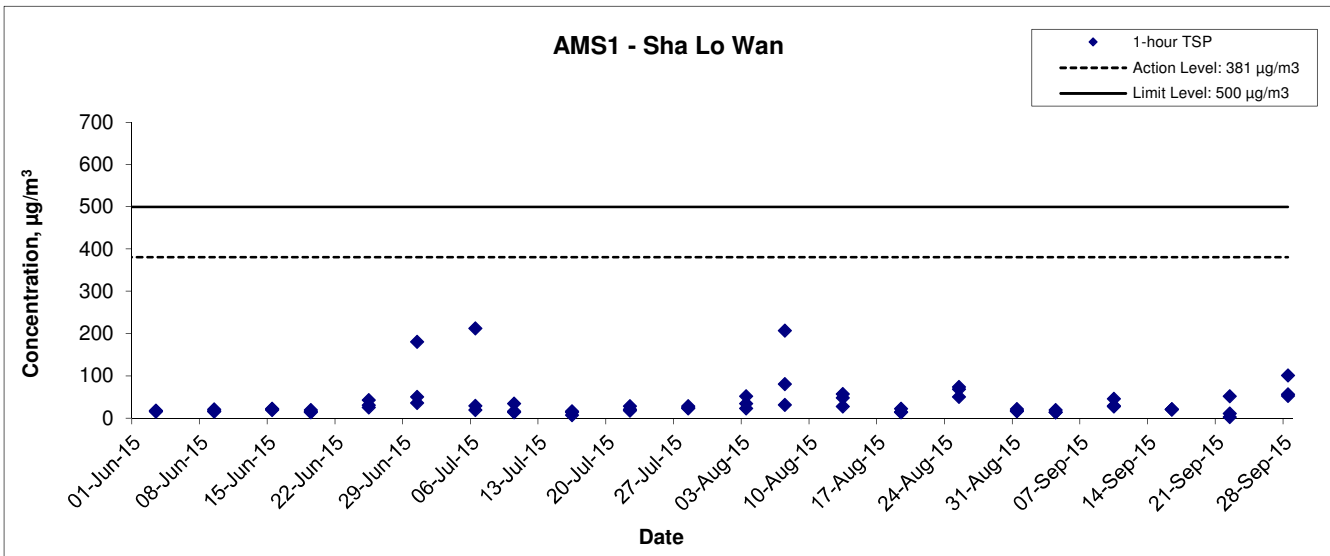
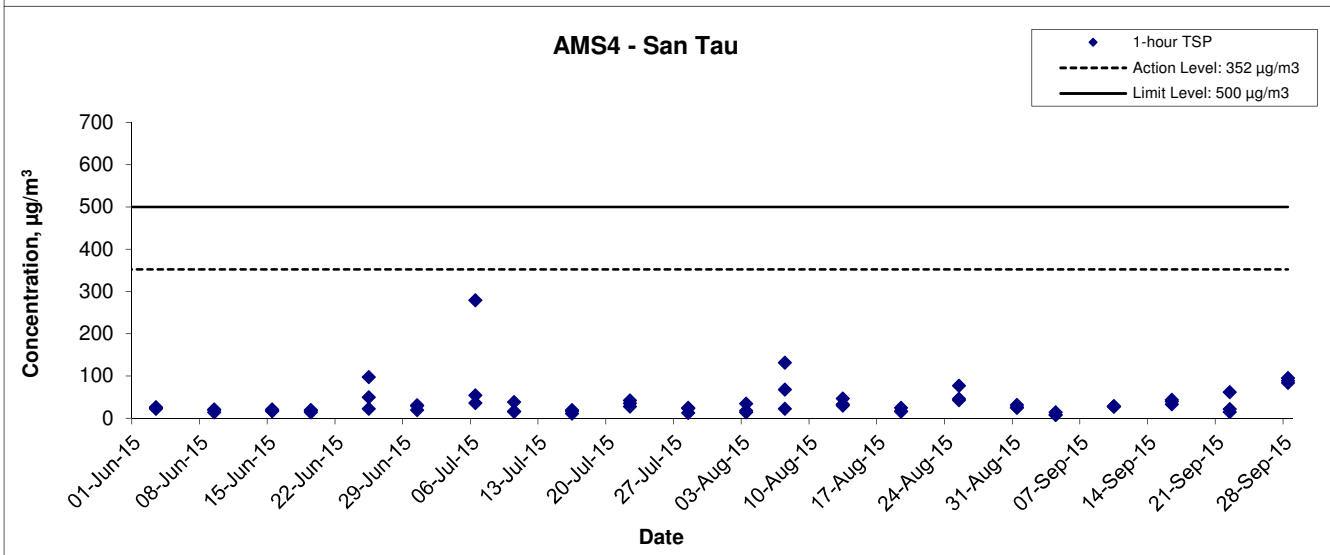
1-hour TSP Concentration Levels

Title Contract No. 11/2011/03 Hong Kong-Zhuhai-Macao Bridge Hong Kong Link Road – Section between HKSAR Boundary and Scenic Hill Graphical Presentation of 1-hour TSP Monitoring Results	Scale N.T.S	Project No. MA12014	
	Date Sep 15	Appendix E

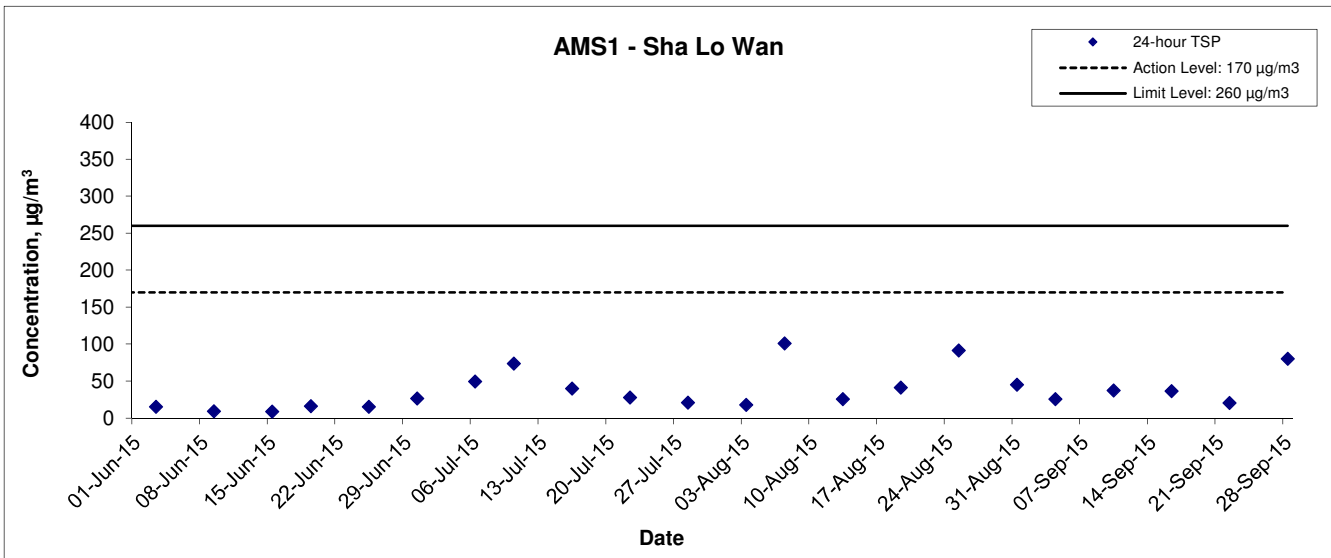
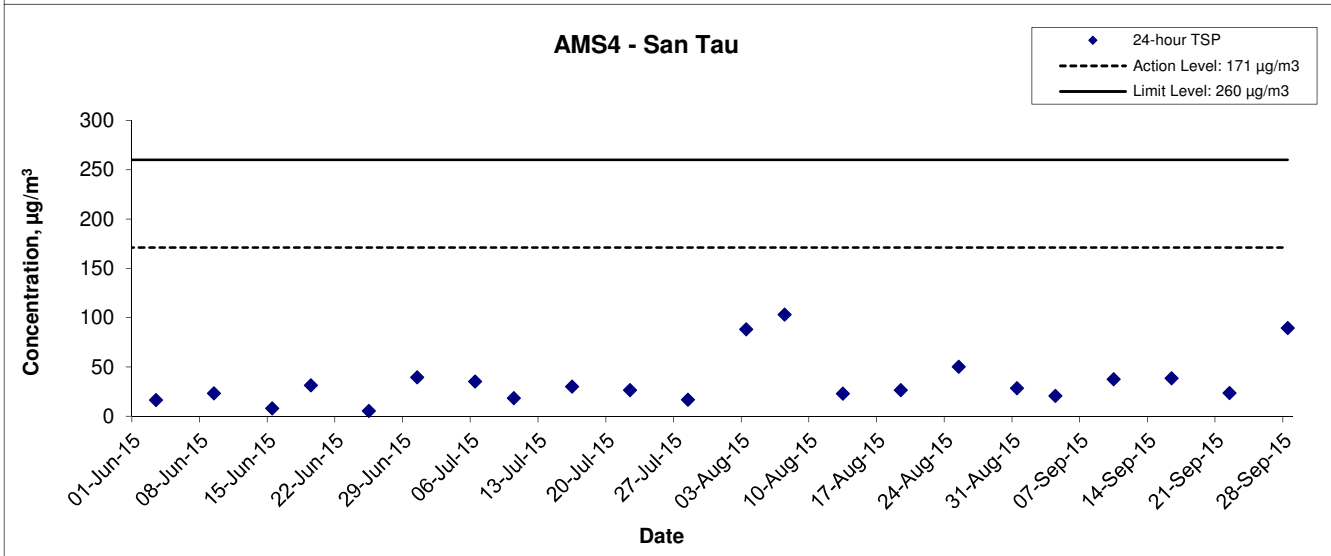
24-hour TSP Concentration Levels

Title Contract No.: 11/2011/03 Hong Kong-Zhuhai-Macao Bridge Hong Kong Link Road – Section between HKSAR Boundary and Scenic Hill Graphical Presentation of 24-hour TSP Monitoring Results	Scale N.T.S	Project No. MA12014	CINOTECH
	Date Sep 15	Appendix F

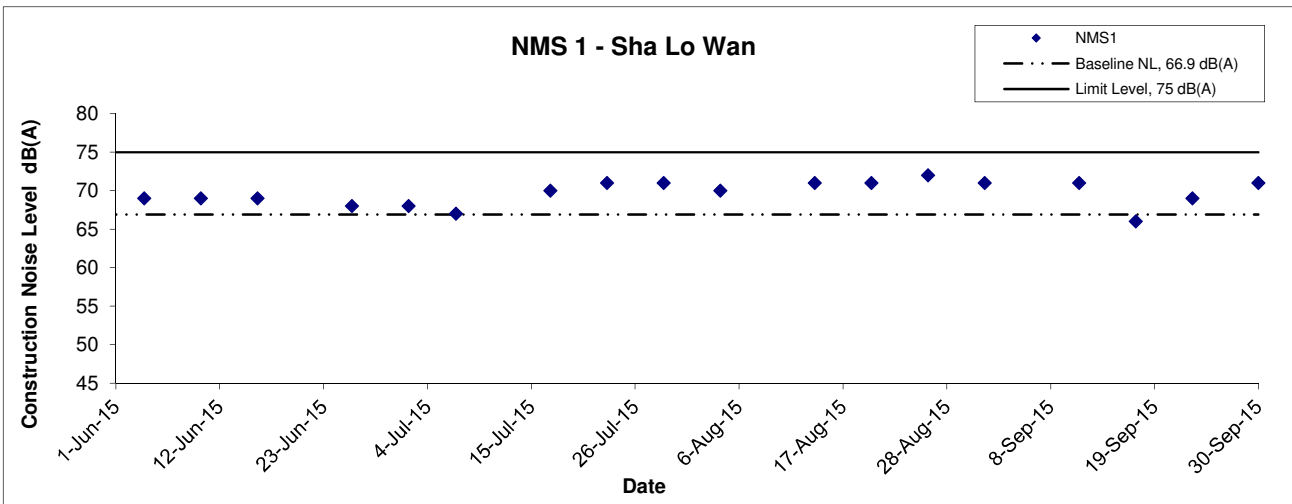
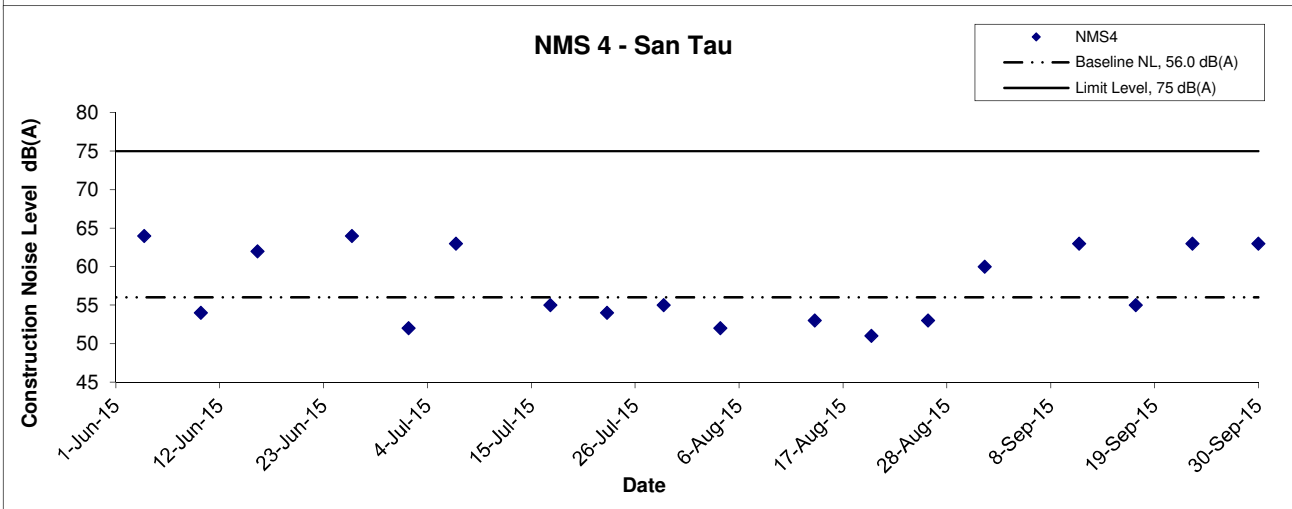
Noise Levels

Title Contract HY/2011/09 Hong Kong-Zhuhai-Macao Bridge Hong Kong Link Road-Section between HKSAR Boundary and Scenic Hill Graphical Presentation of Construction Noise Monitoring Results	Scale N.T.S	Project No. MA12014	
	Date Sep 15	Appendix G

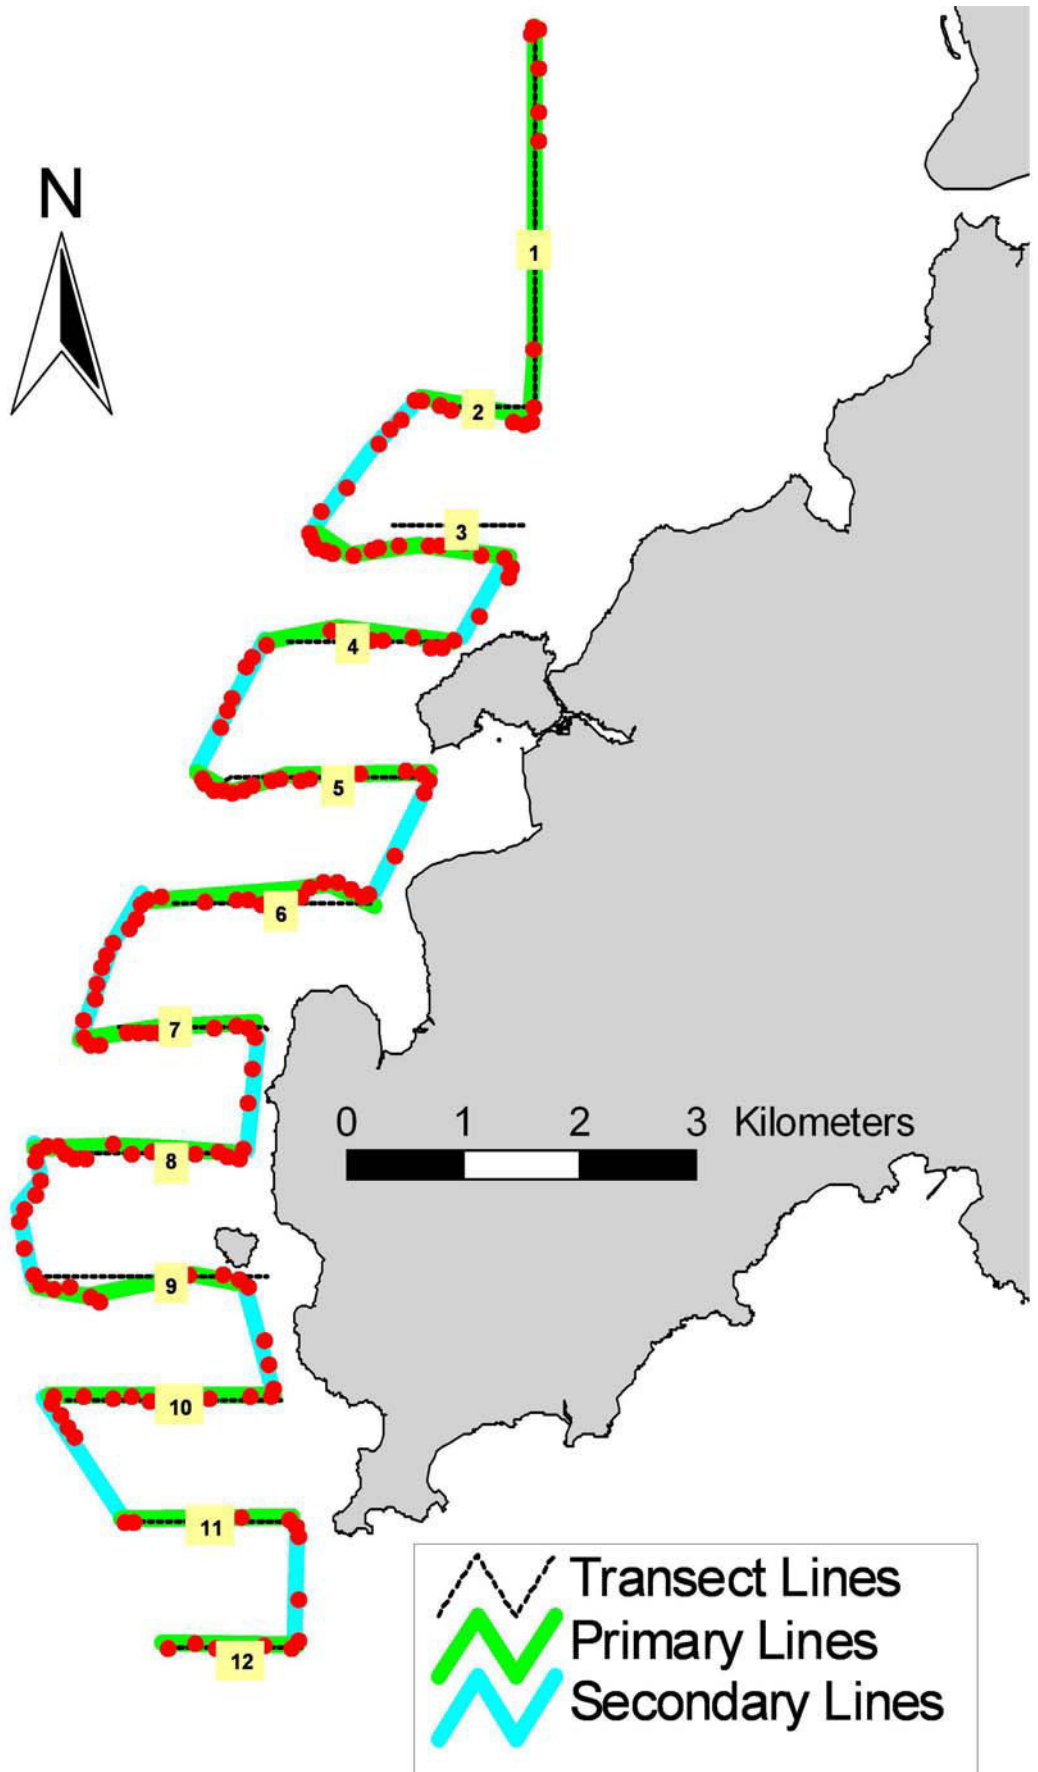
Figure 2. Survey Route on September 7th, 2015 (note: red dots represent the tracked positions of survey boat logged continuously by GPS throughout the course of the survey)

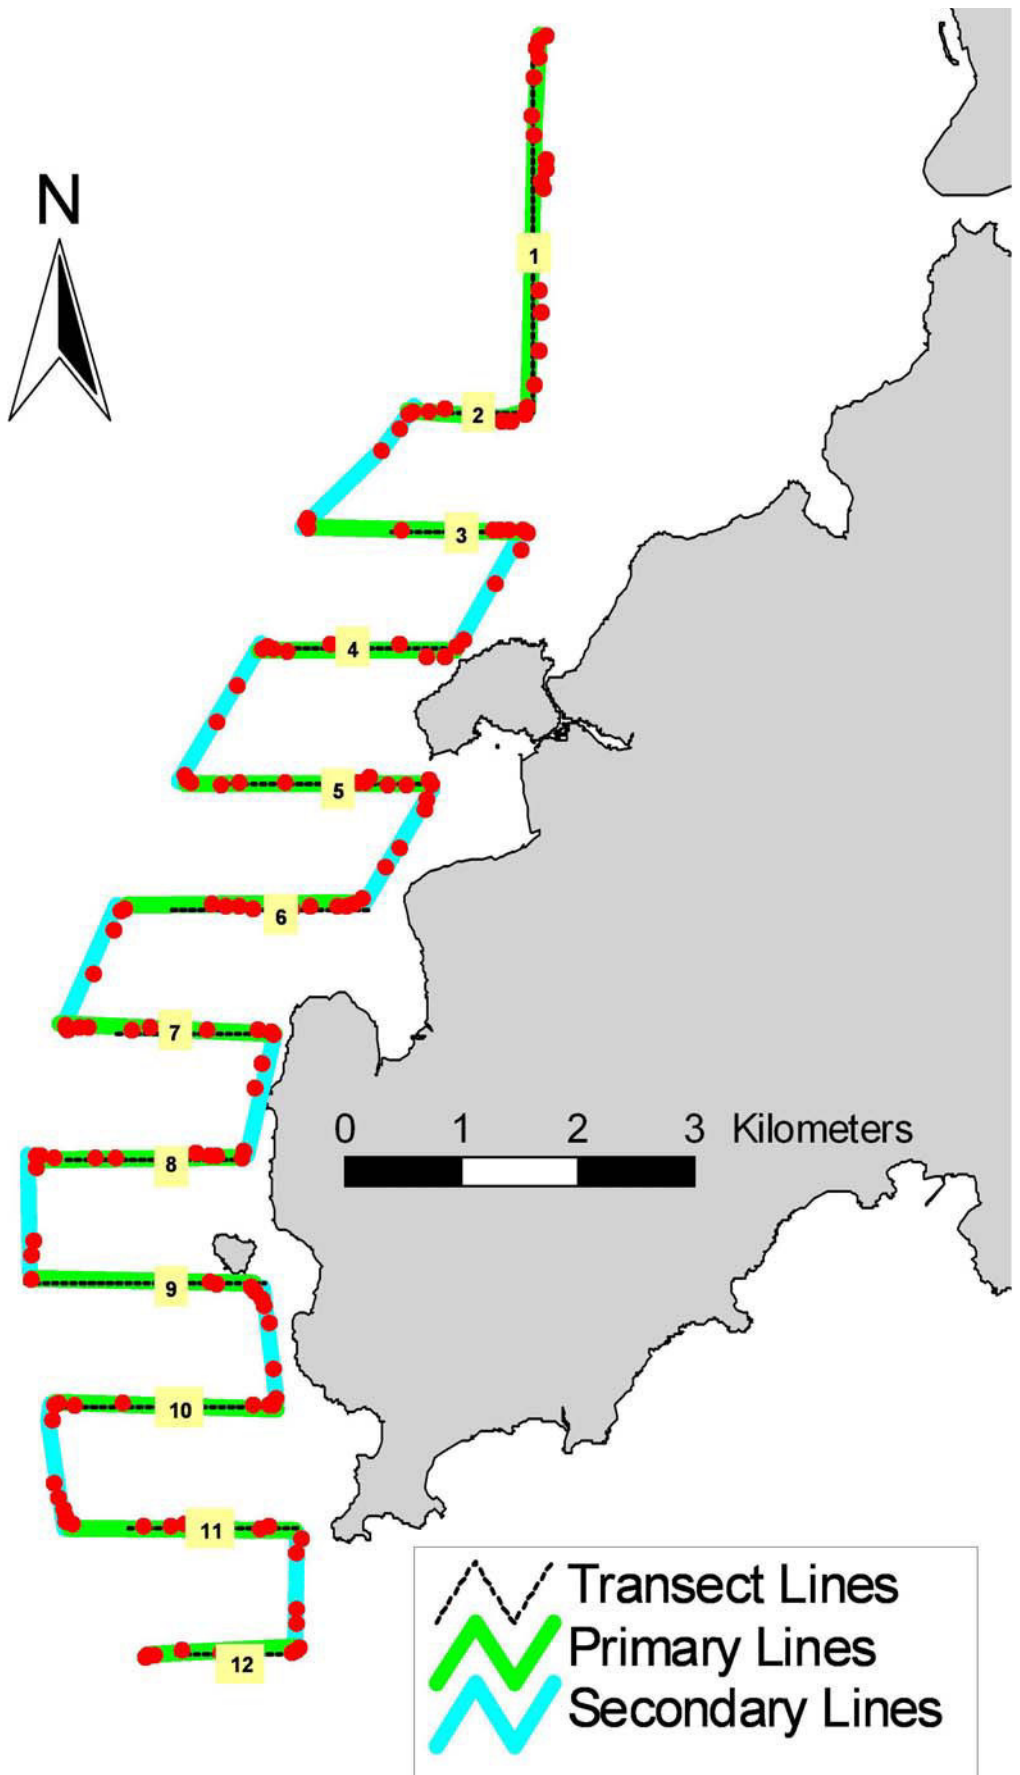
Figure 3. Survey Route on September 10th, 2015 (note: red dots represent the tracked positions of survey boat logged continuously by GPS throughout the course of the survey)

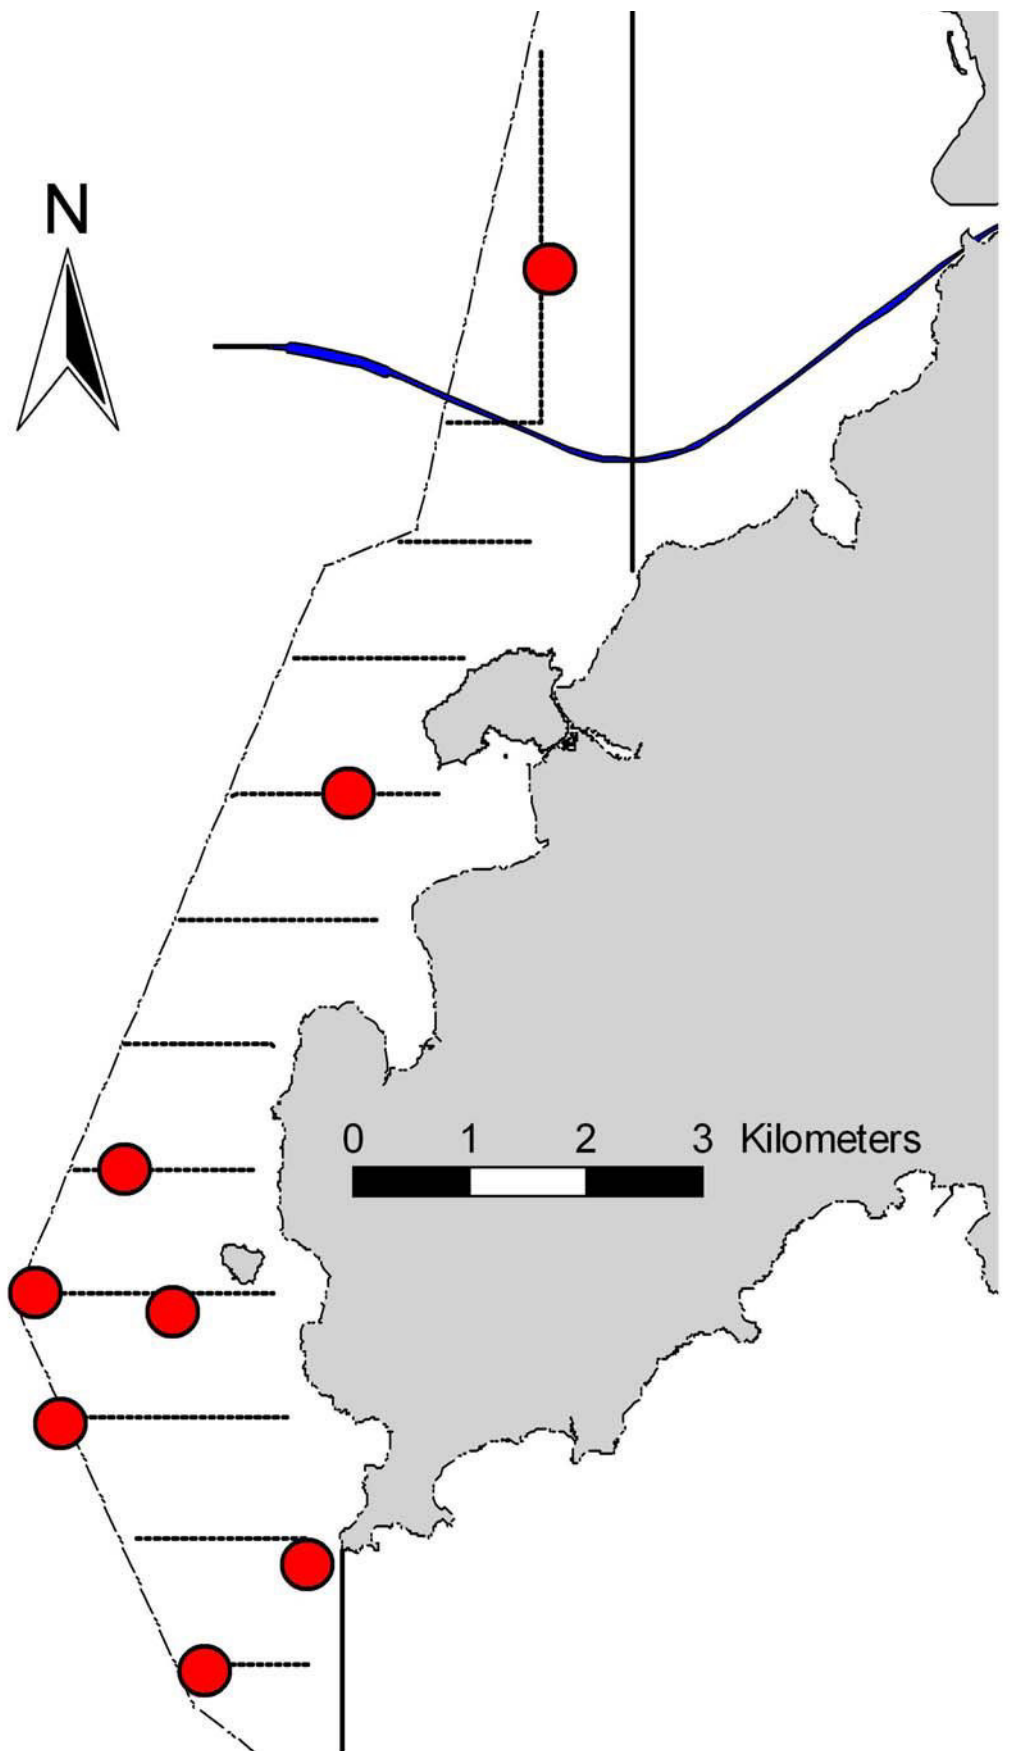
Figure 4. Distribution of Chinese White Dolphin Sighting during September 2015 HKLR09 Monitoring Surveys

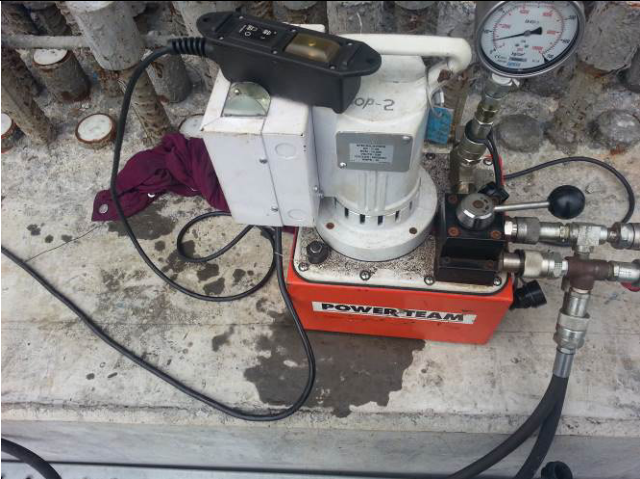
<p>Ref No: 150901-R05</p> <p>Impact: Waste / Chemical Management (F8)</p> <p>Details: Provide spill kit for oil leakage at P71.</p>

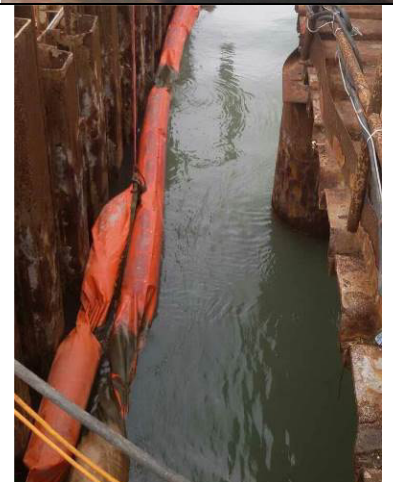
<p>Ref No: 150825-R06</p> <p>Impact: Water Quality (B25)</p> <p>Details: Properly deploy the silt curtain at P74.</p> <p>Follow Up: The damaged silt curtain was repaired.</p>

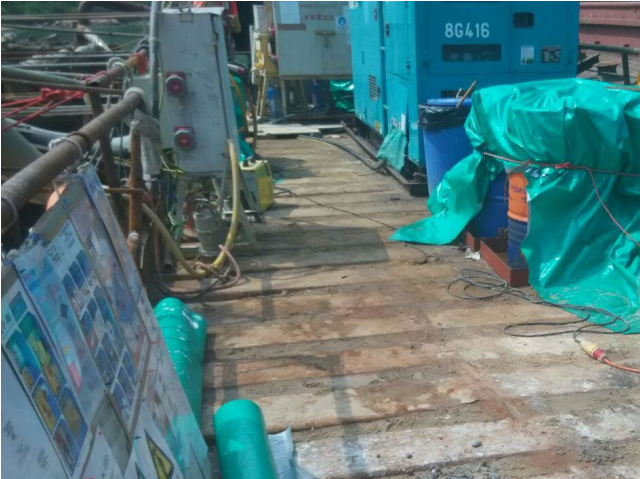
<p>Ref No: 150825-R07</p> <p>Impact: Waste / Chemical Management (F8)</p> <p>Details: Clear the contaminated sand around the generator at P74.</p> <p>Follow Up: The contaminated sand was cleared.</p>

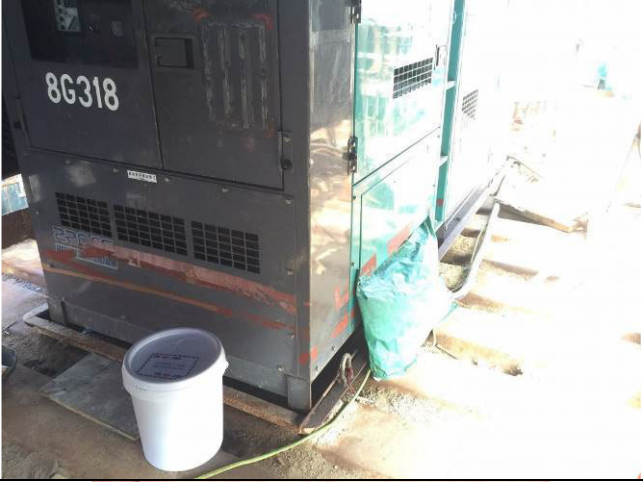
<p>Ref No: 150908-R01</p> <p>Impact: Waste / Chemical Management (F8)</p> <p>Details: Provide spill kit at the platform at P74.</p> <p>Follow Up: Spill kit was provided.</p>

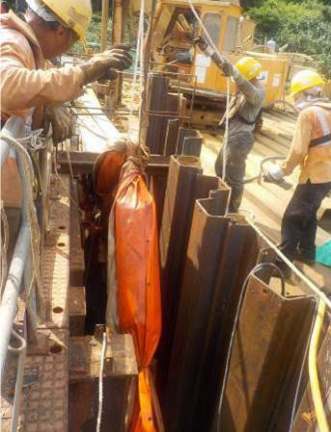
<p>P69</p>	<p>Ref No: 150908-R02</p> <p>Impact: Water Quality (B3i.)</p> <p>Details: Properly deploy the silt curtain at P74, P69 and P70.</p> <p>Follow Up: The damaged silt curtain was repaired and properly deployed.</p>
